**Report of Preconstruction Condition
Survey Services**

**ADJACENT PROPERTIES TO
THE WHARF – PHASE I
WASHINGTON, DC**

ECS PROJECT NO. 37:1306

OCTOBER 6, 2014

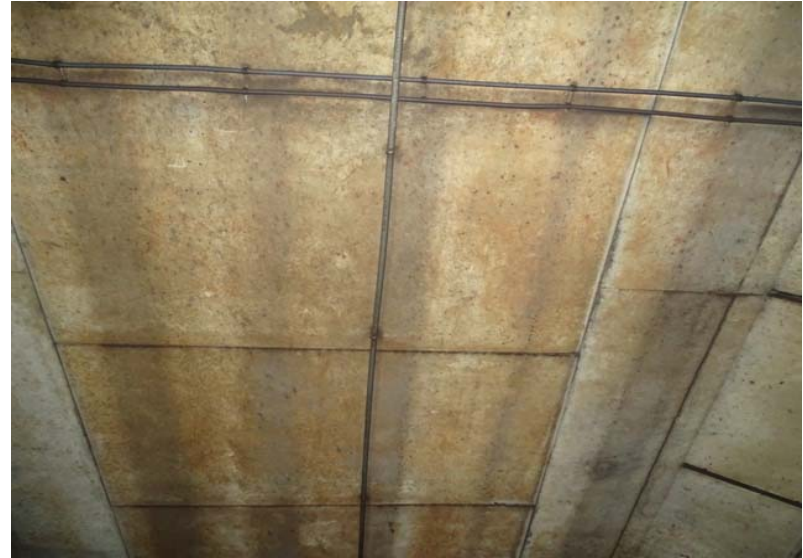
Photograph No. 133
Station 71+90 - cracks above east arch.

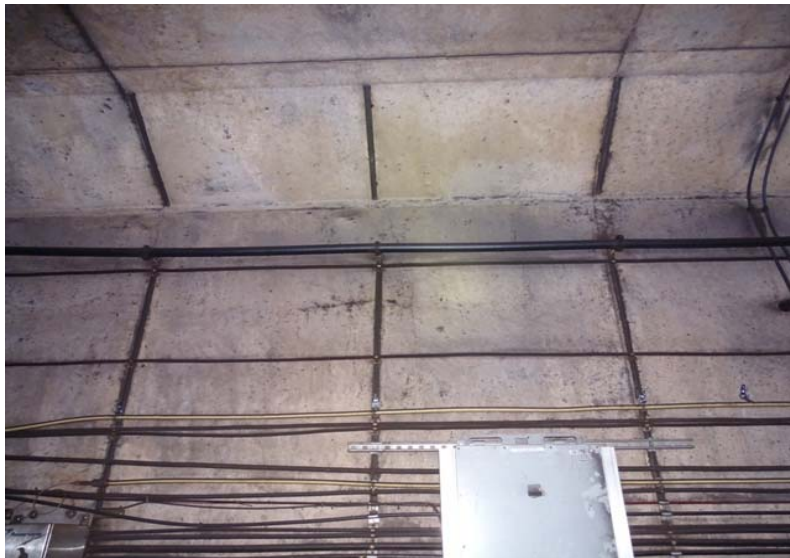
Photograph No. 134
Station 71+90, ceiling.

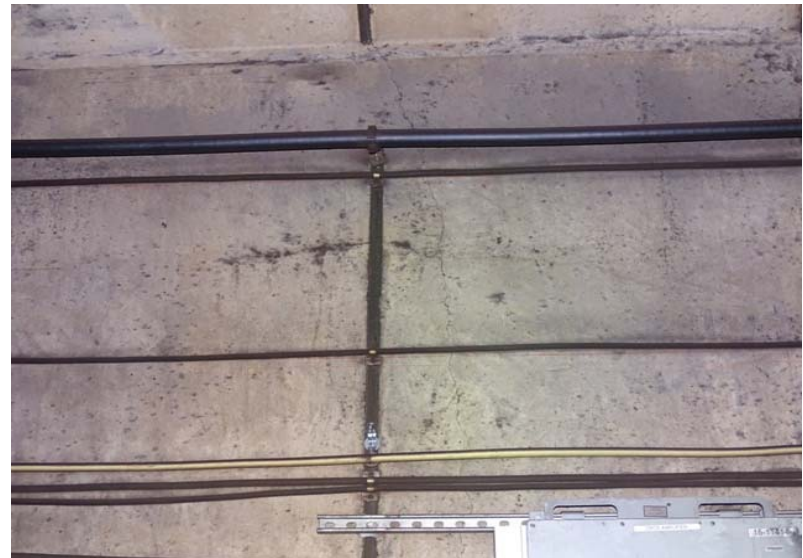
Photograph No. 135
Station 71+90, upper portion of west wall.

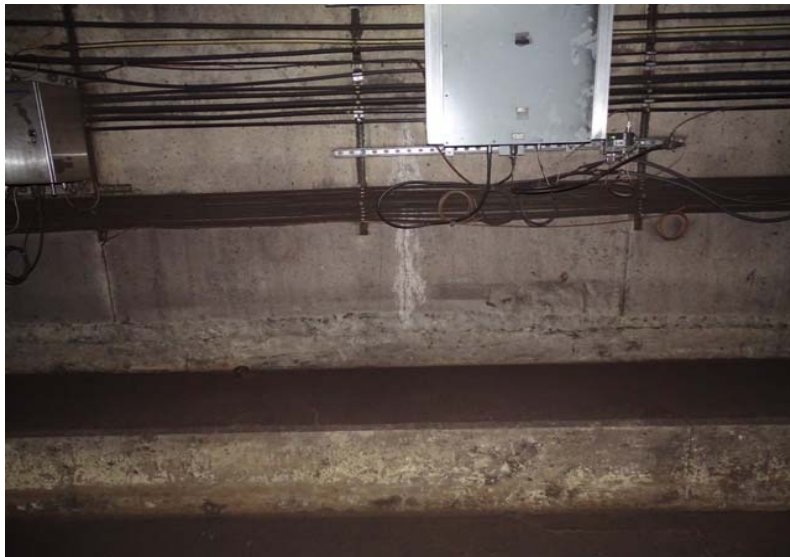
Photograph No. 136
Station 71+90 - crack on the west wall.

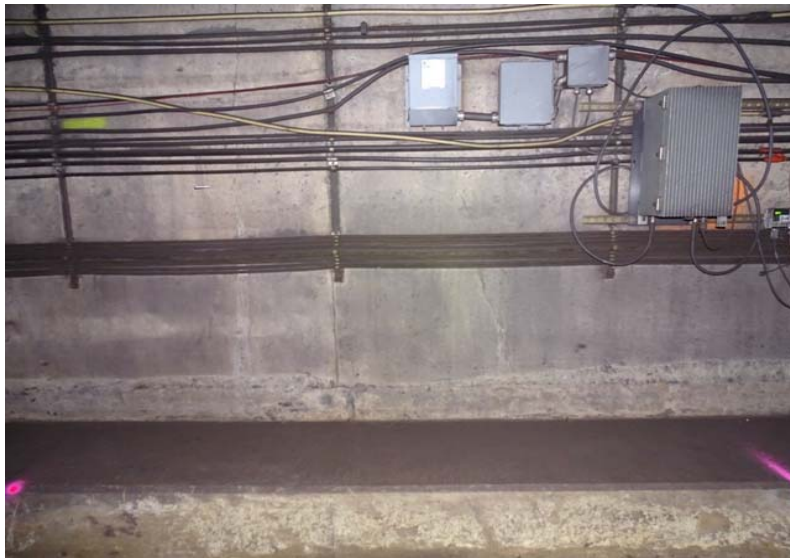
Photograph No. 142
Station 72+00, upper portion of west wall.

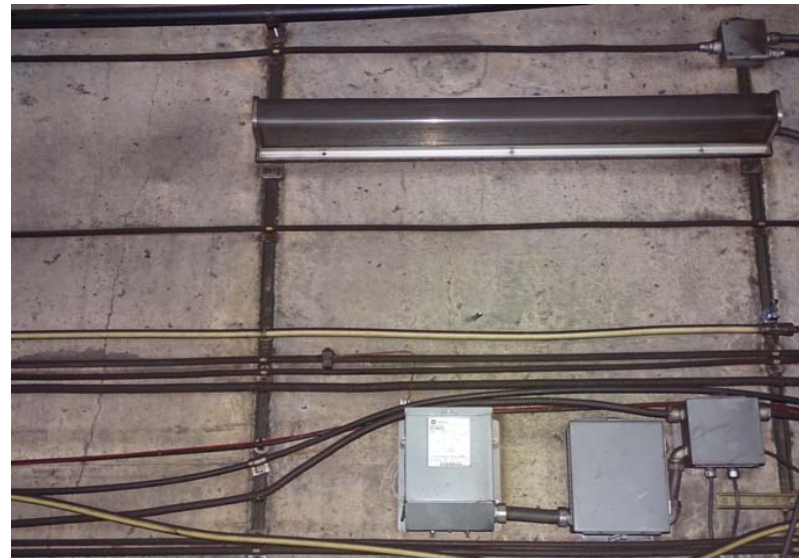
Photograph No. 143
Station 72+00, lower portion of west wall.

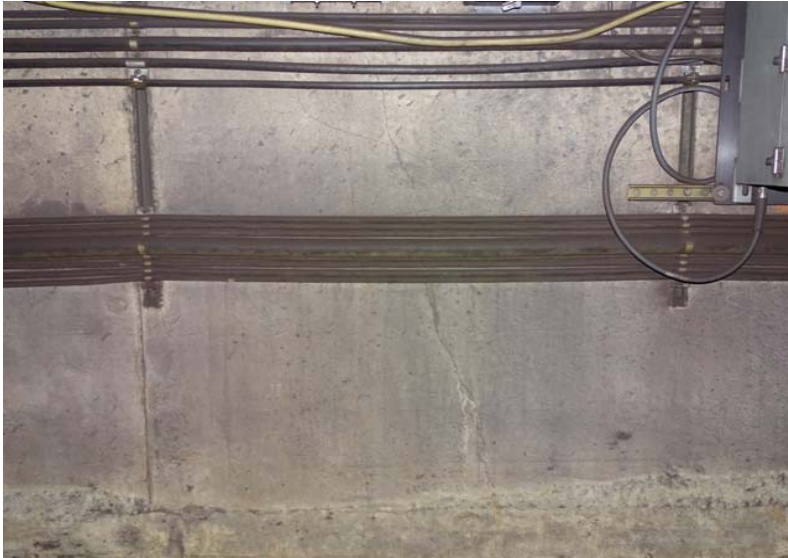
Photograph No. 144
Station 72+00 - cracks on west wall.

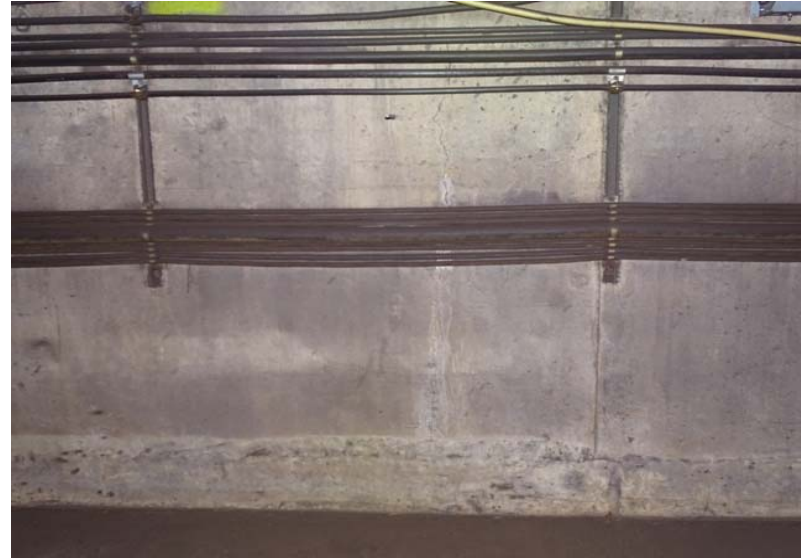
Photograph No. 145
Station 72+00 - crack on west wall.

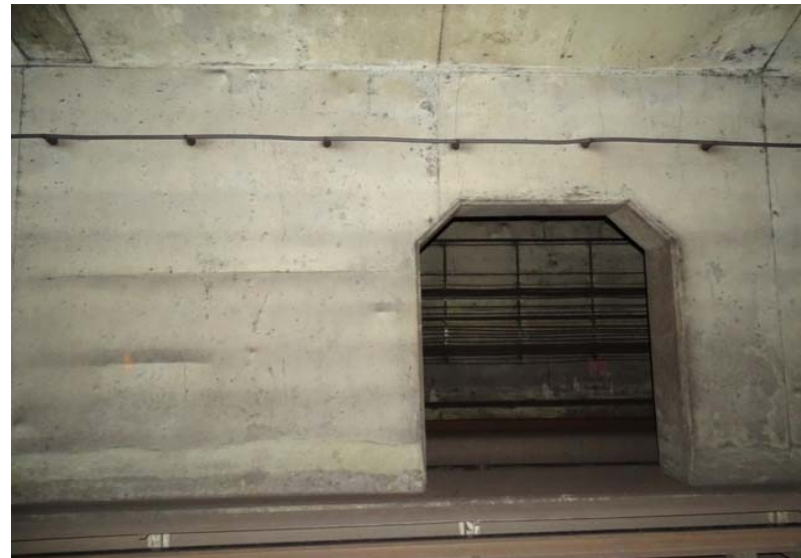
Photograph No. 147
Station 72+10, track bed.

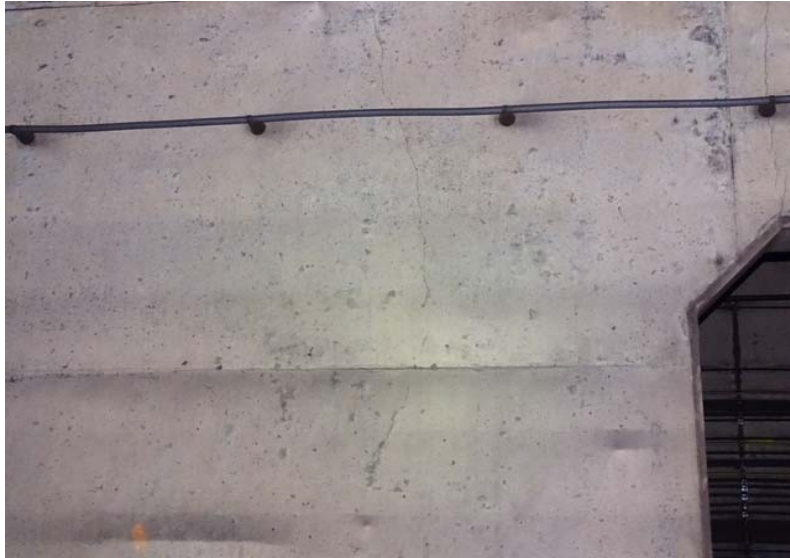
Photograph No. 148
Station 72+10, east wall.

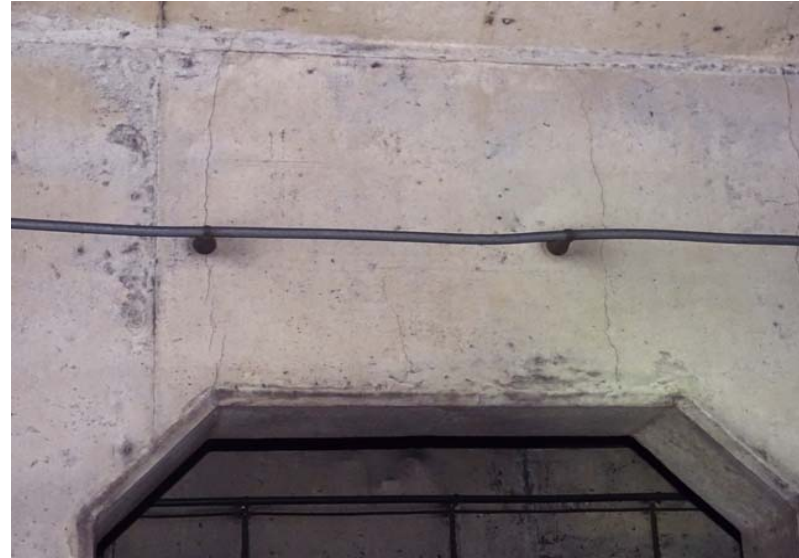
Photograph No. 149
Station 72+10 - crack on east wall.

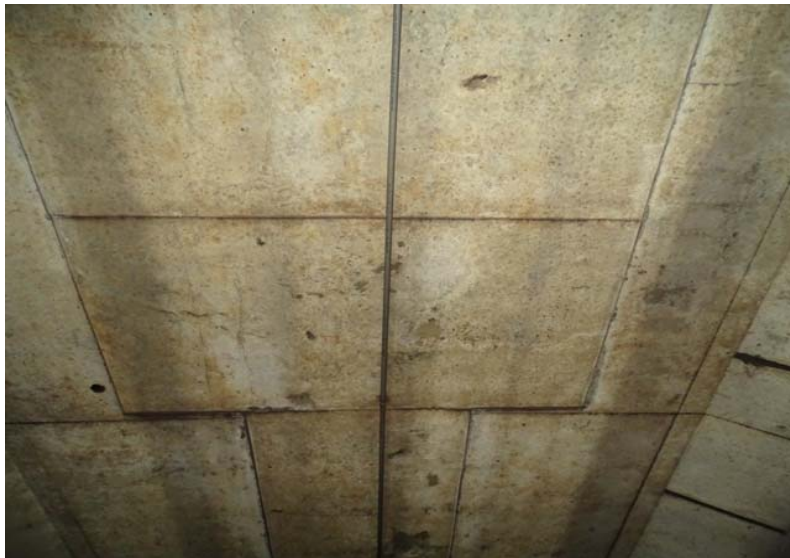
Photograph No. 150
Station 72+10 - cracks above east arch.

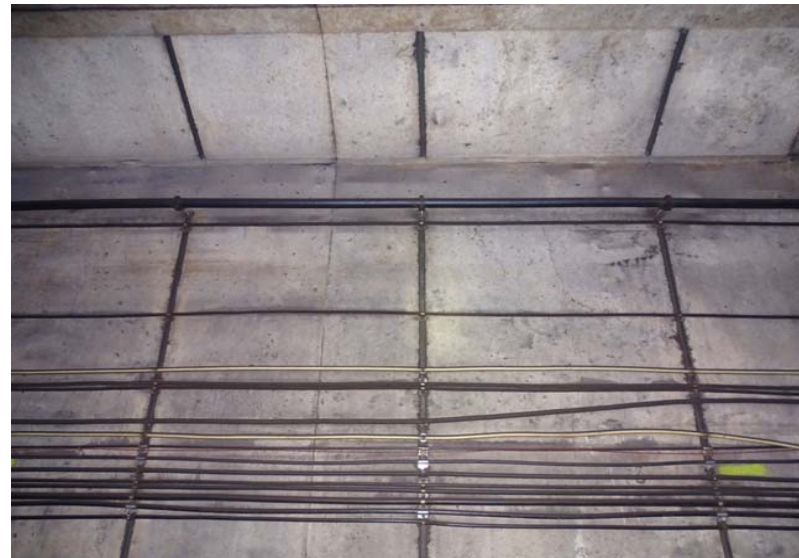
Photograph No. 151
Station 72+10, ceiling.

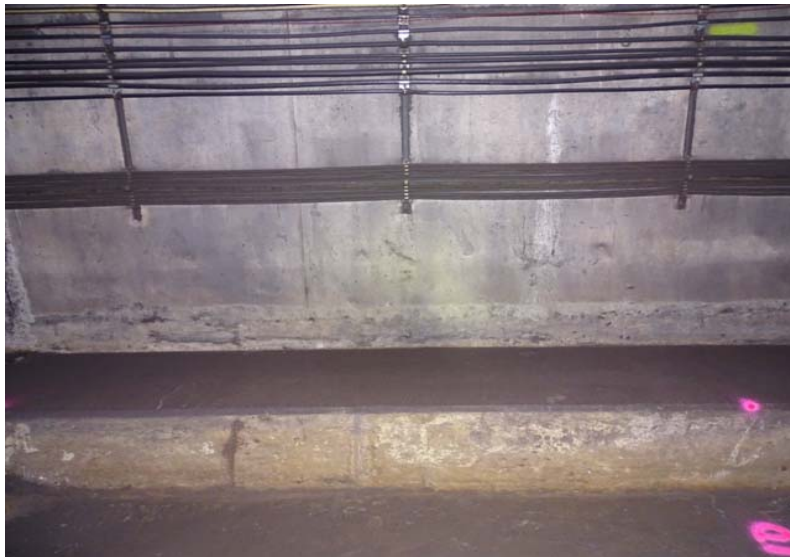
Photograph No. 152
Station 72+10, upper portion of west wall.

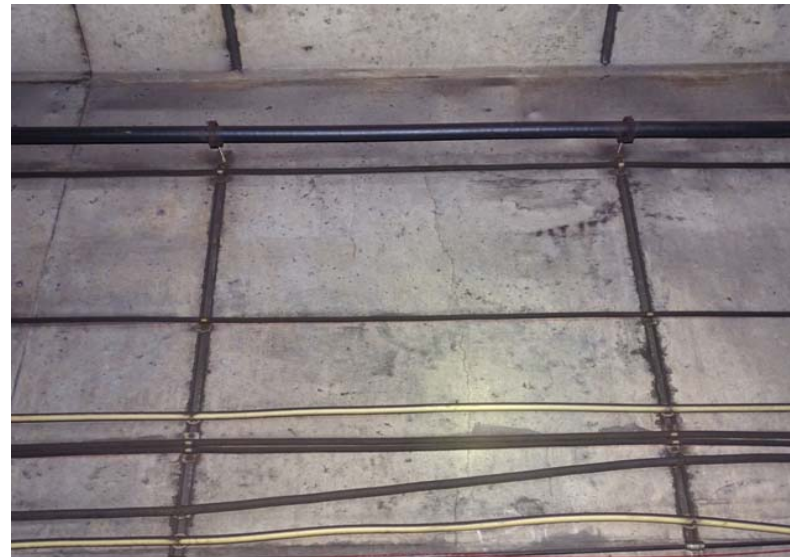
Photograph No. 153
Station 72+10, lower portion of west wall.

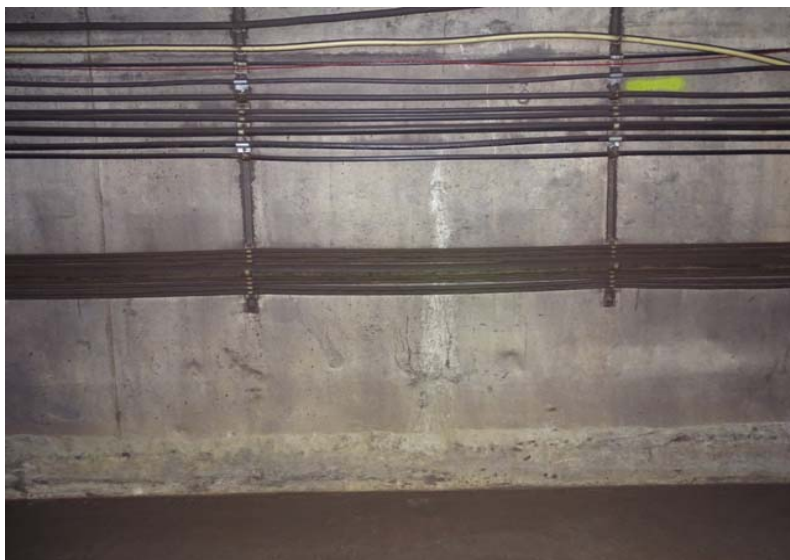
Photograph No. 154
Station 72+10 - crack on west wall.

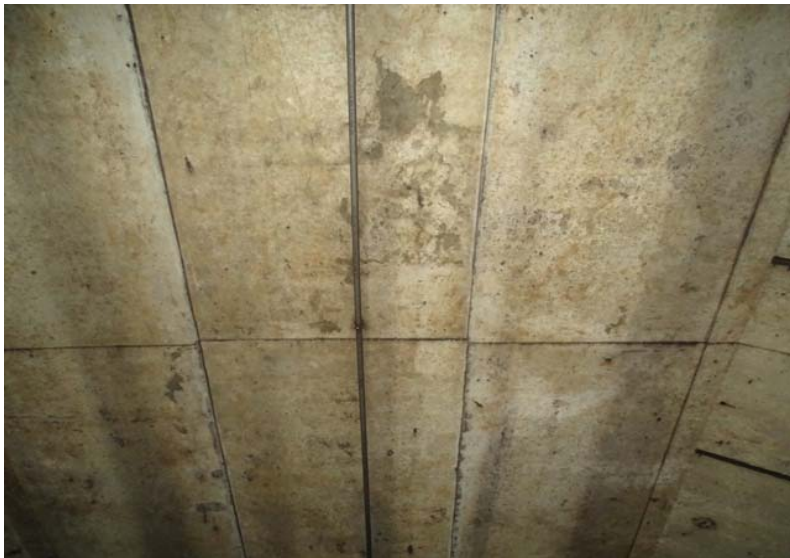
Photograph No. 158
Station 72+20 - cracks above east arch.

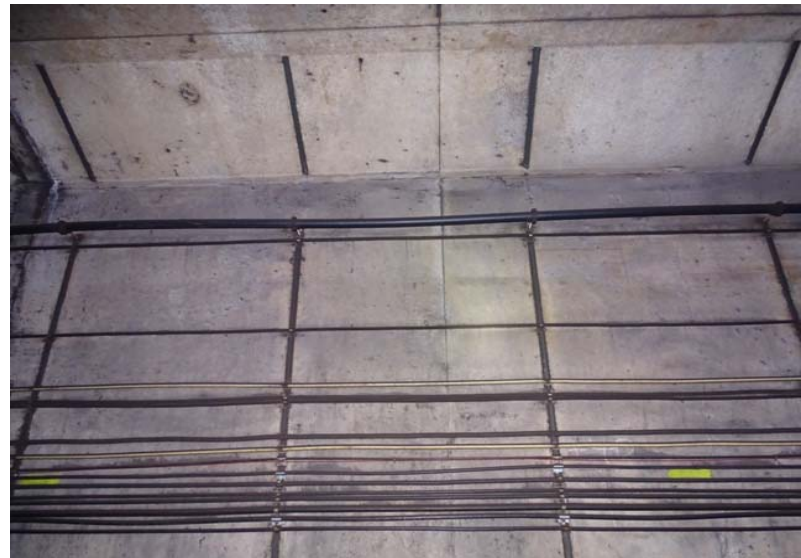
Photograph No. 159
Station 72+20, ceiling.

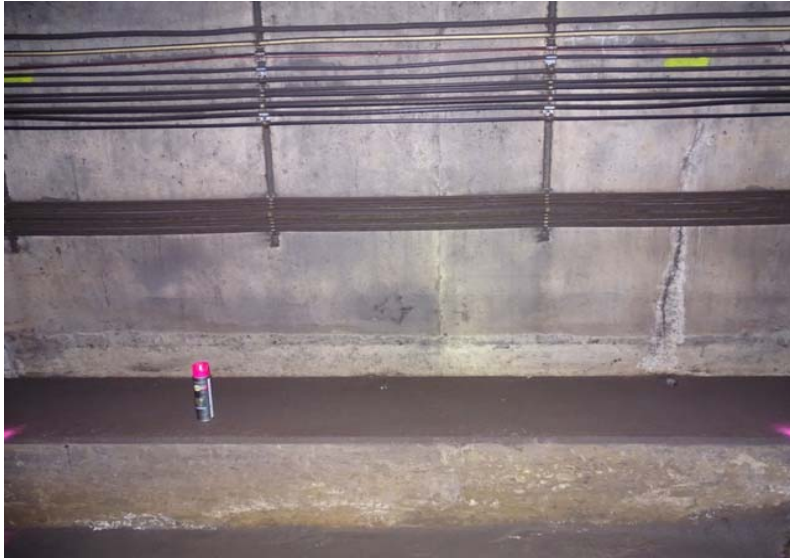
Photograph No. 160
Station 72+20, upper portion of west wall.

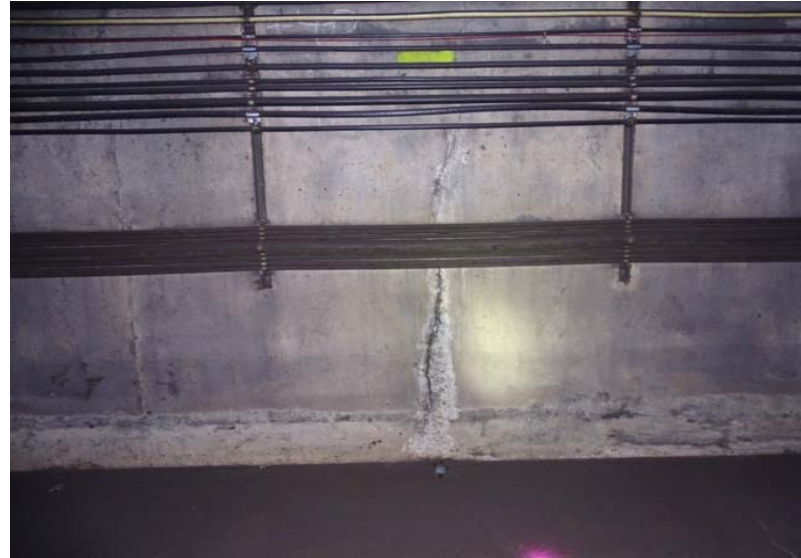
Photograph No. 162
Station 72+20 - crack and efflorescence on west wall.

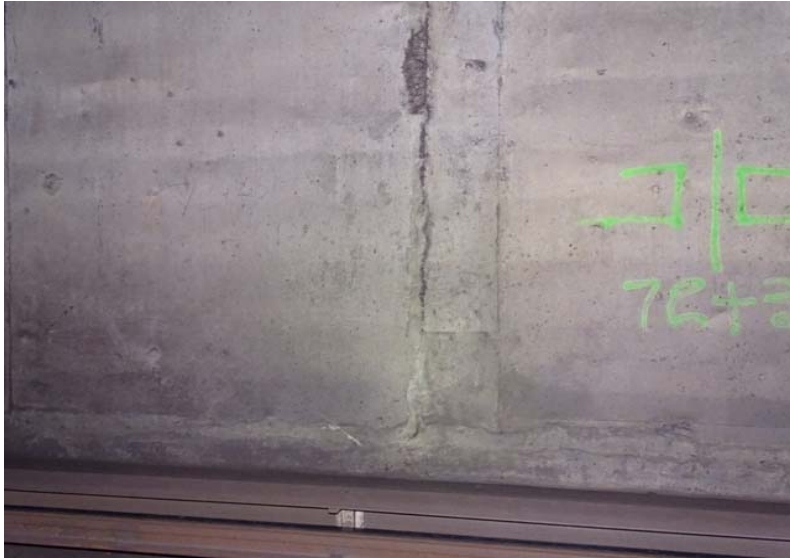
Photograph No. 165
Station 72+30 - crack on east wall.

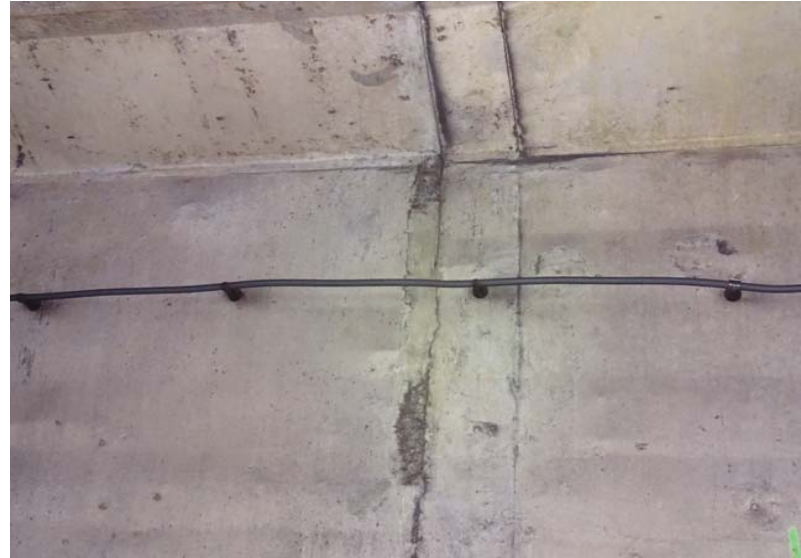
Photograph No. 166
Station 72+30 - damaged concrete on east wall.

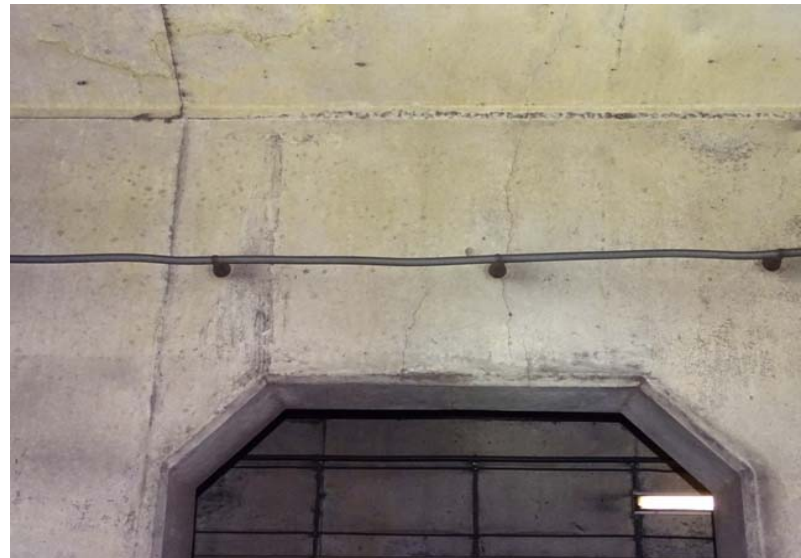
Photograph No. 172
Station 72+40 - cracks above east arch.

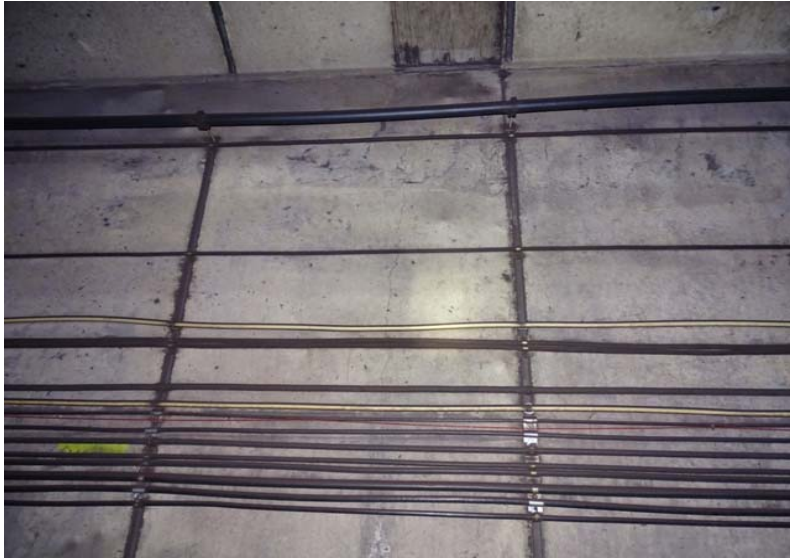
Photograph No. 181
Station 72+50 - crack and efflorescence on west wall.

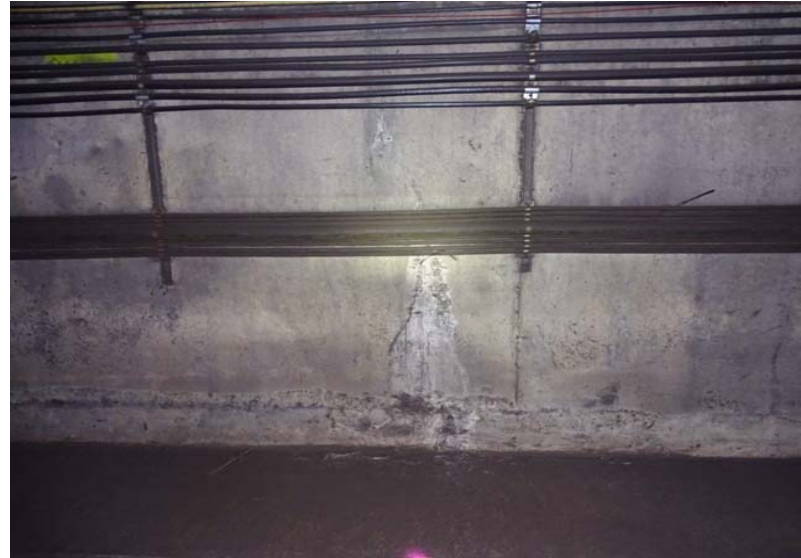
Photograph No. 182
Station 72+50 - crack on west wall.

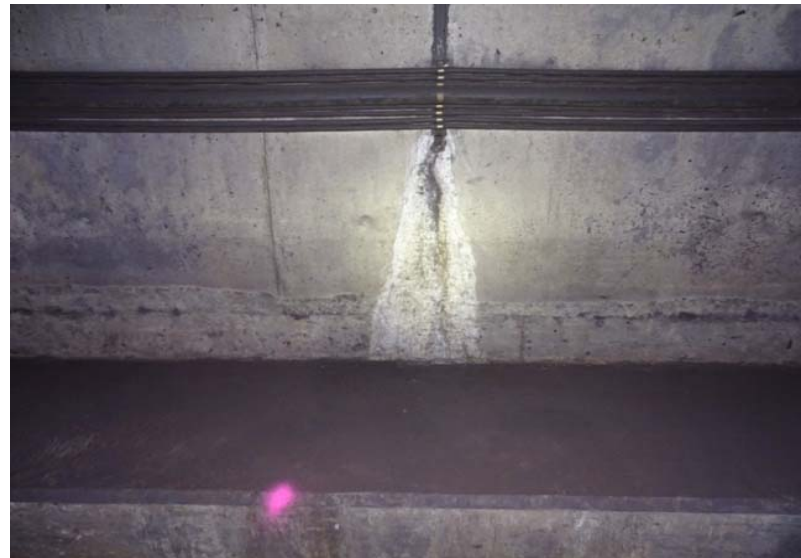
Photograph No. 188
Station 72+60 - crack and efflorescence on west wall.

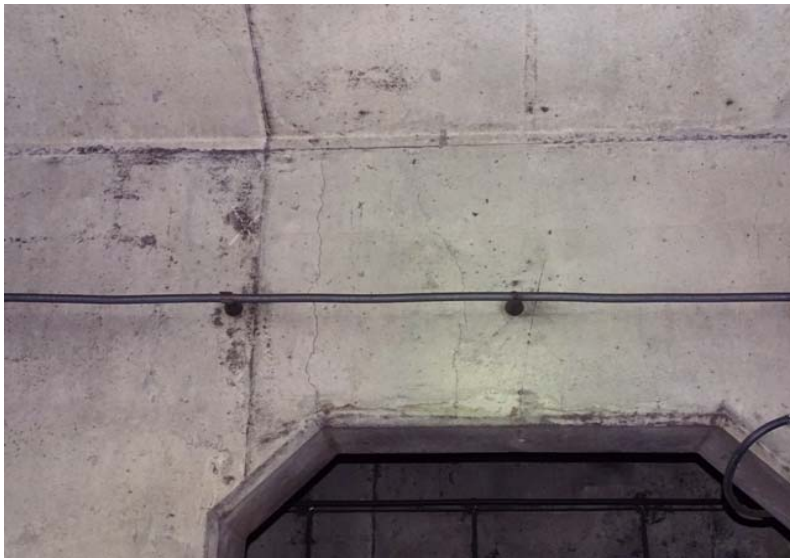
Photograph No. 191
Station 72+70 - cracks above east arch.

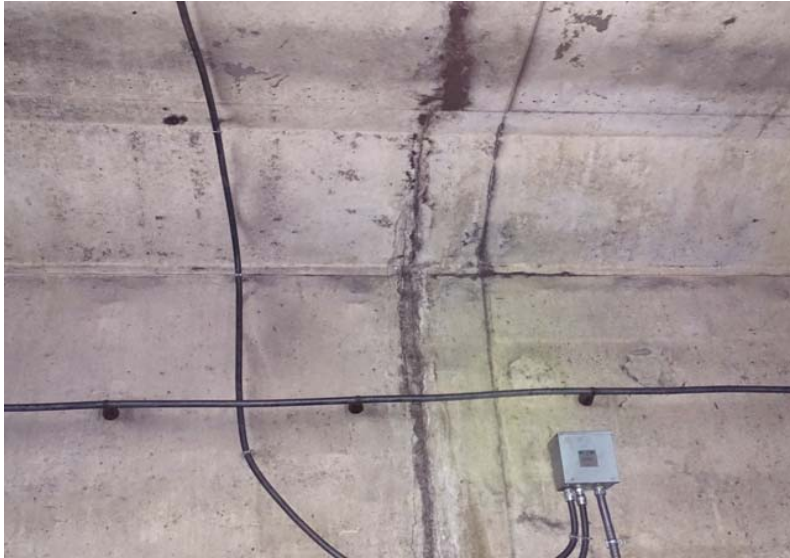
Photograph No. 197
Station 72+80 - stains and efflorescence on east wall.

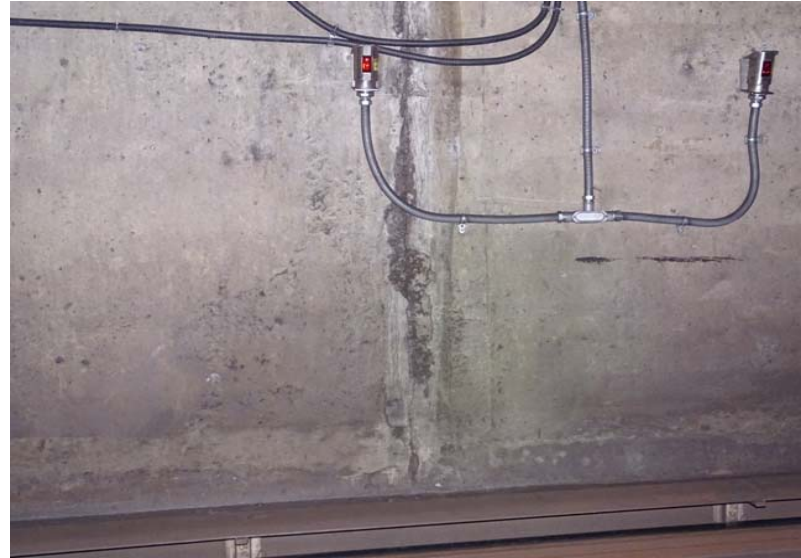
Photograph No. 198
Station 72+80 - stains and efflorescence on east wall.

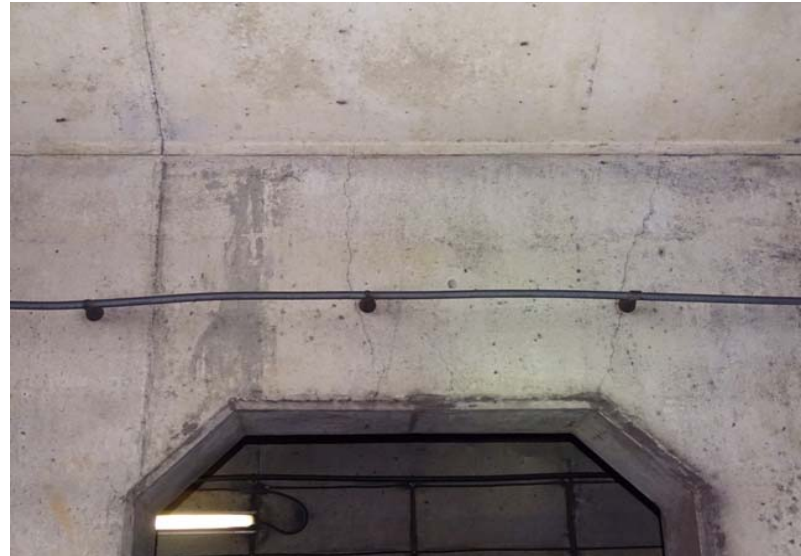
Photograph No. 204
Station 72+90 - cracks above east arch.

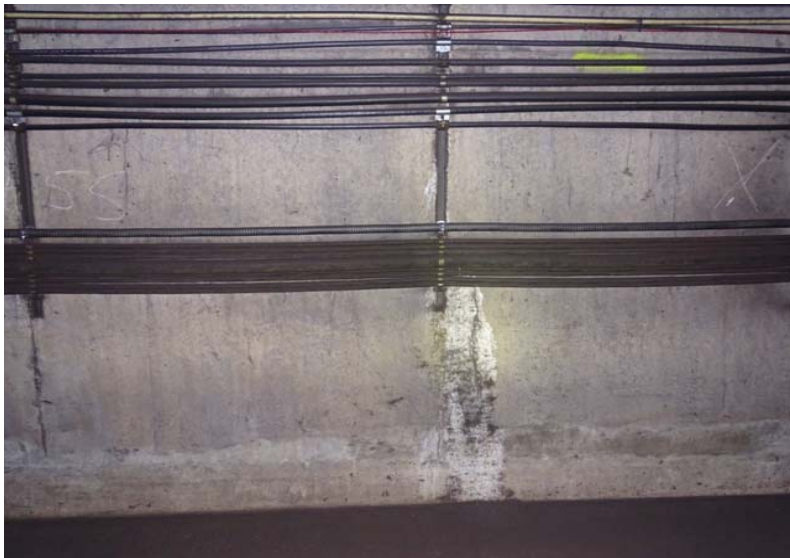
Photograph No. 215
Station 73+00 - crack and efflorescence on west wall.

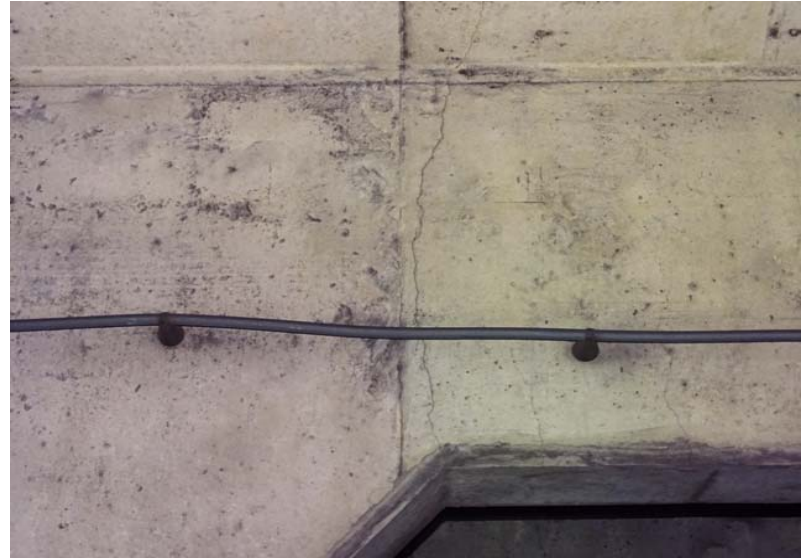
Photograph No. 218
Station 73+10 - cracks above east arch.

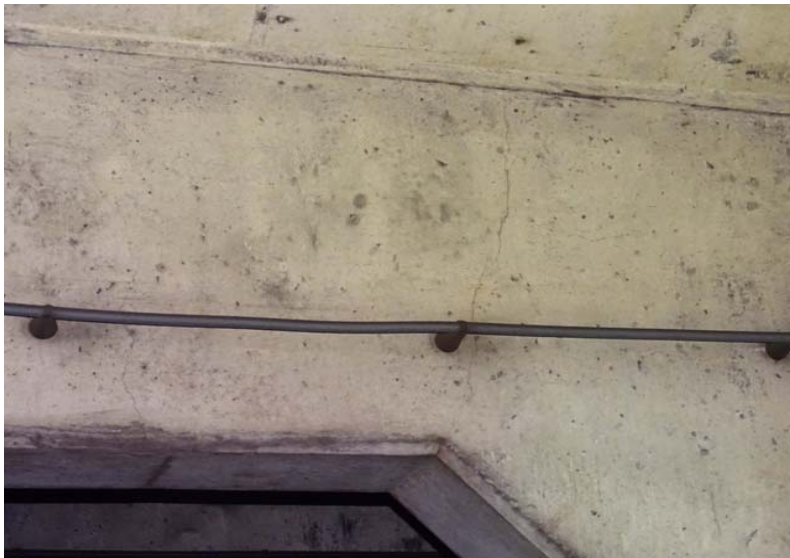
Photograph No. 219
Station 73+10 - cracks above east arch.

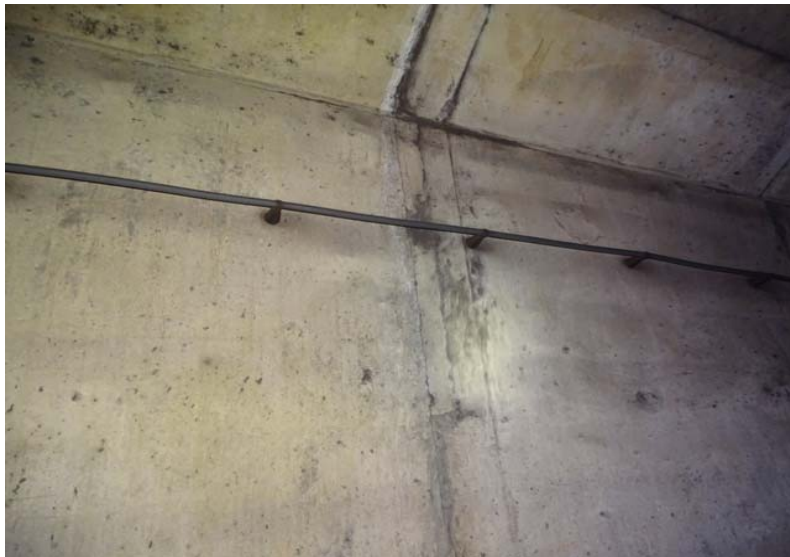
Photograph No. 225
Station 73+20 - crack and efflorescence on east wall.

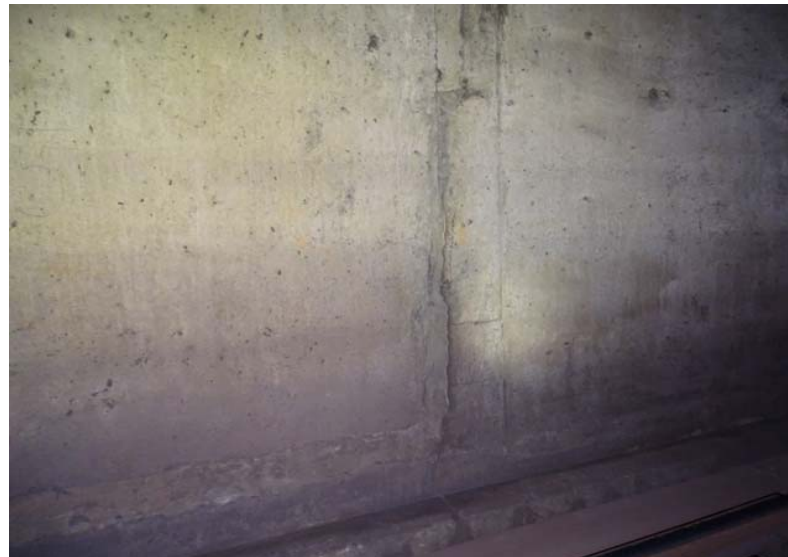
Photograph No. 226
Station 73+20 - crack on east wall.

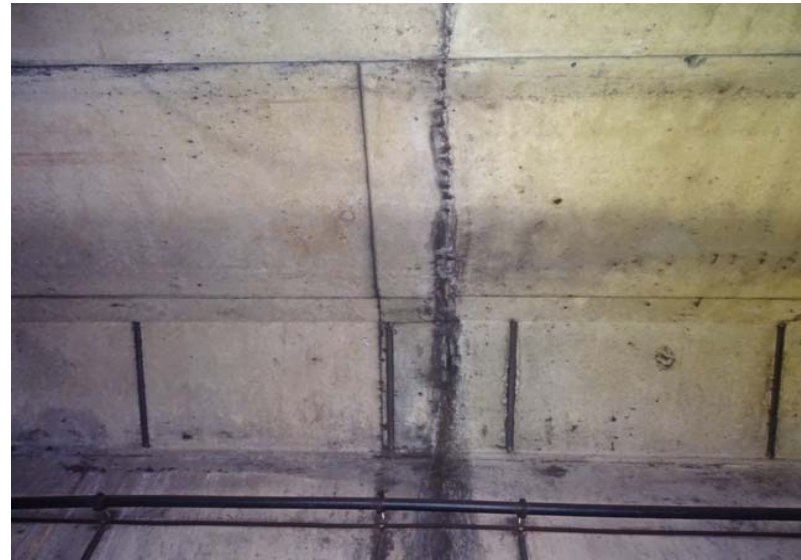
Photograph No. 230
Station 73+20 - stains and efflorescence on west wall.

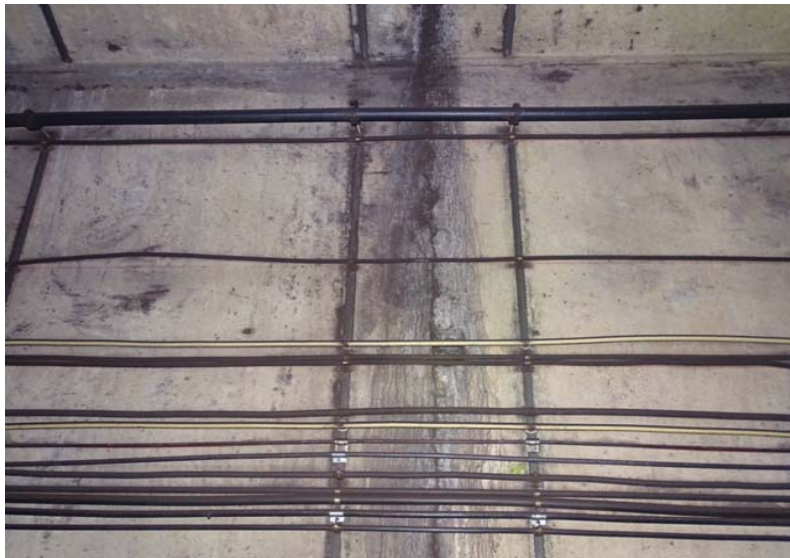
Photograph No. 231
Station 73+20 - stains and efflorescence on west wall.

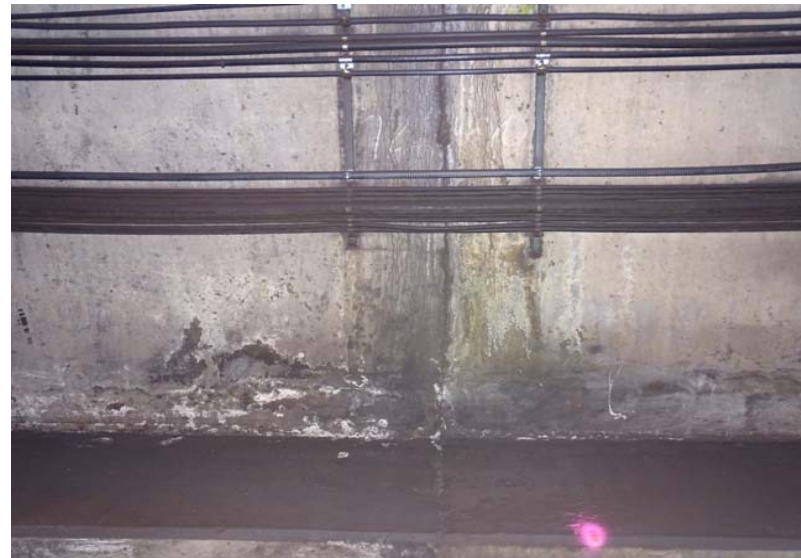
Photograph No. 232
Station 73+20 - stains and efflorescence on west wall.

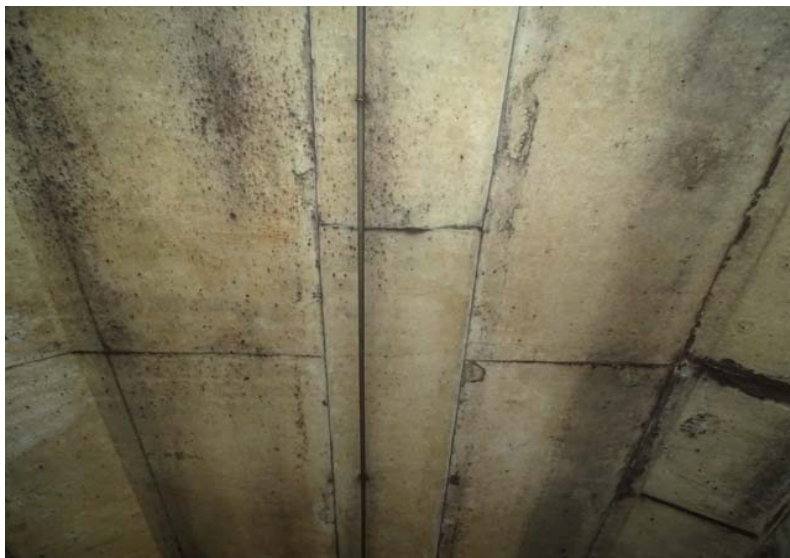
Photograph No. 240
Station 73+40 - cracks above east arch.

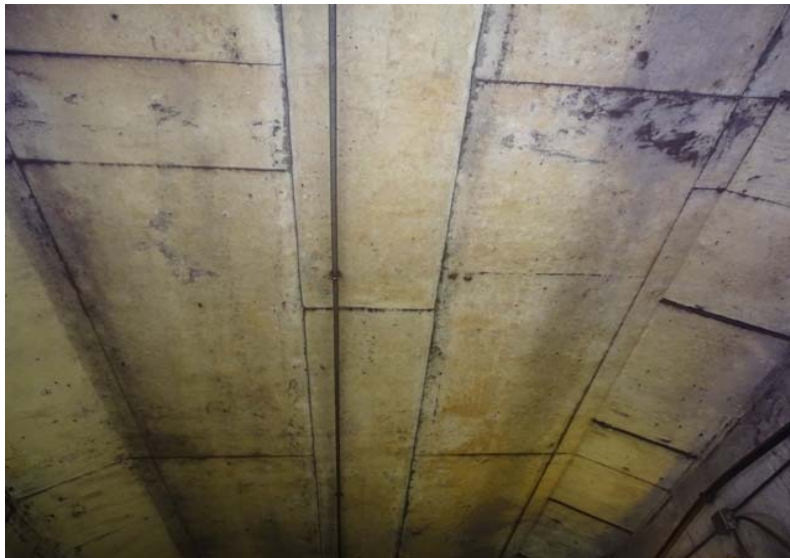
Photograph No. 246
Station 73+50 - cracks above east arch.

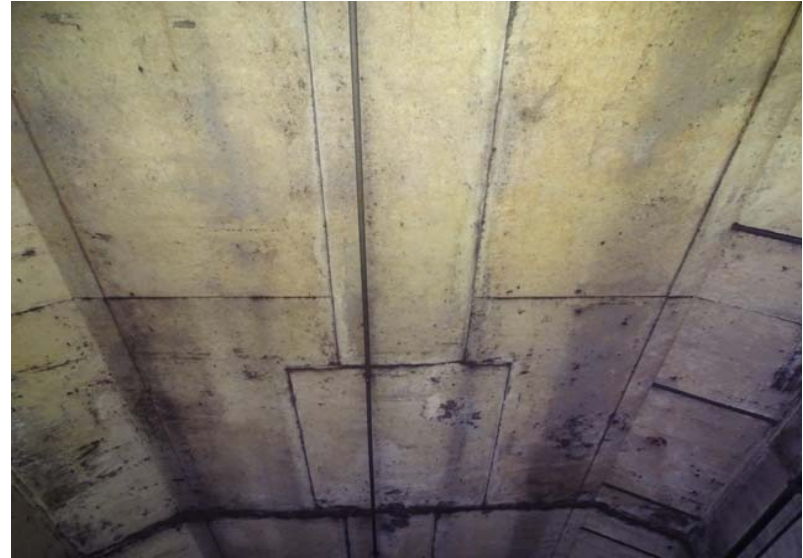
Photograph No. 253
Station 73+60 - cracks above east arch.

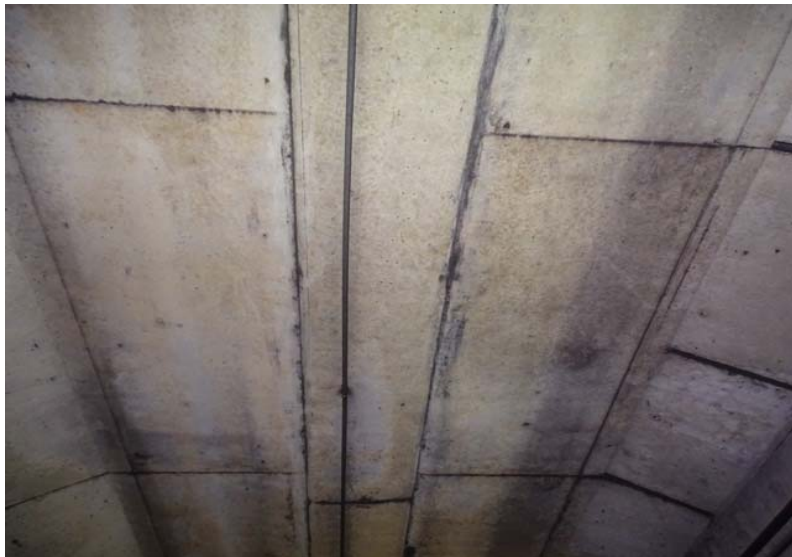
Photograph No. 264
Station 73+80 - cracks above east arch.

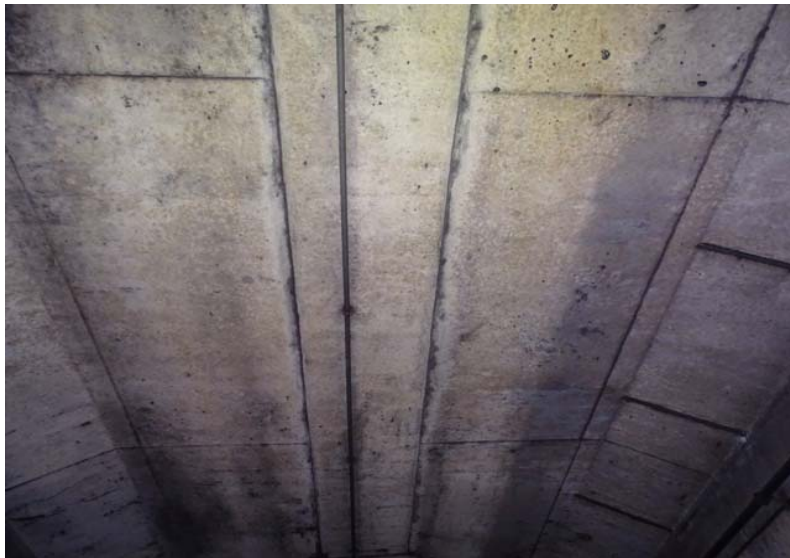
Photograph No. 283
Station 74+10, ceiling.

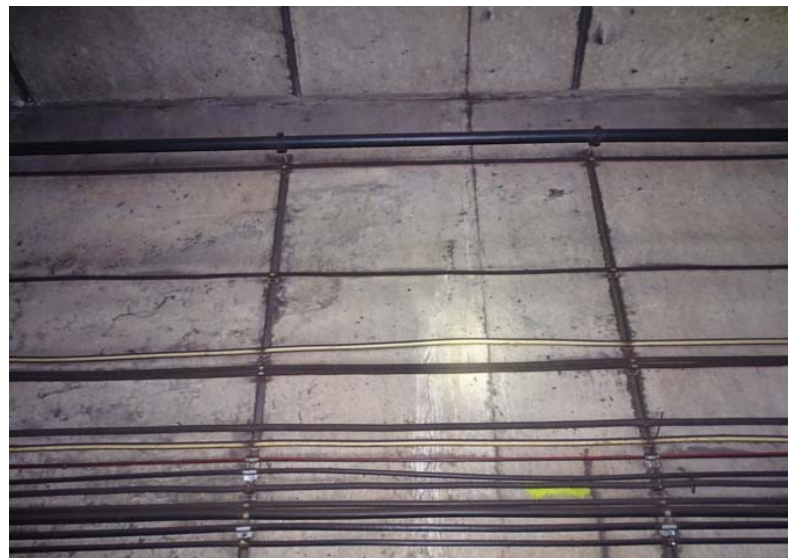
Photograph No. 286
Station 74+10 - crack and efflorescence on west wall.

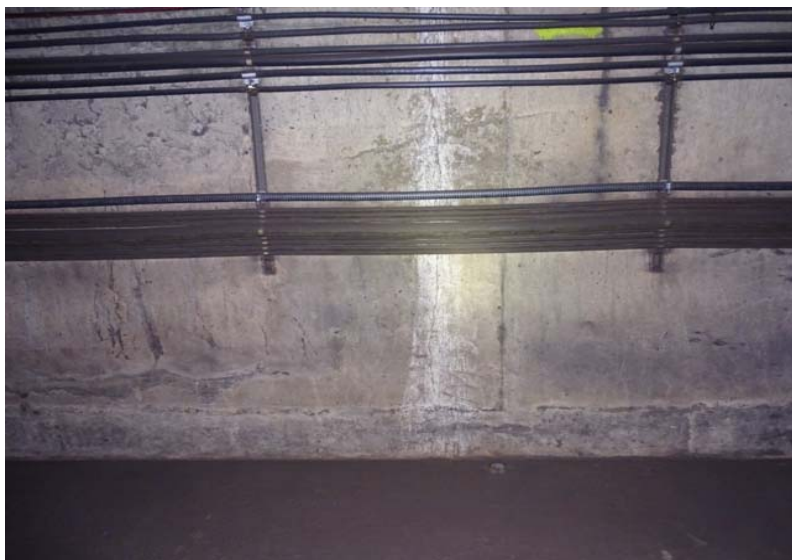
Photograph No. 287
Station 74+10 - crack and efflorescence on west wall.

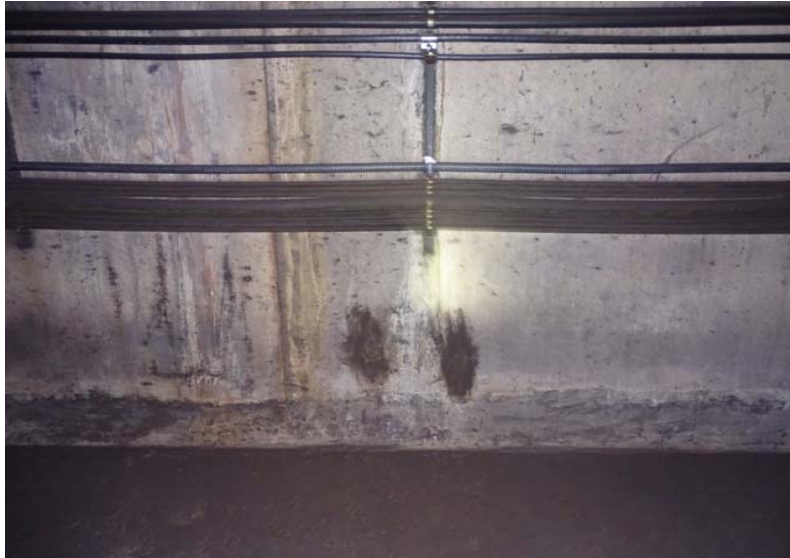
Photograph No. 293
Station 74+20 - stains and efflorescence on west wall.

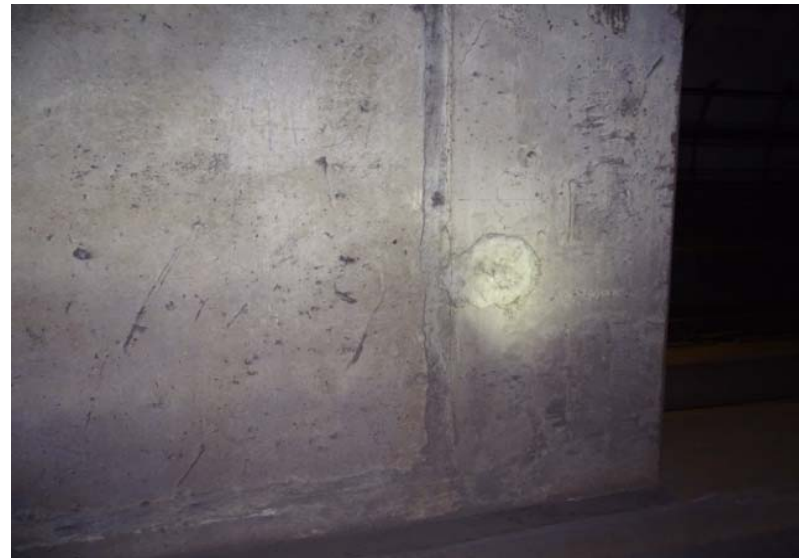
Photograph No. 296
Station 74+30 - previous concrete repair on east wall.

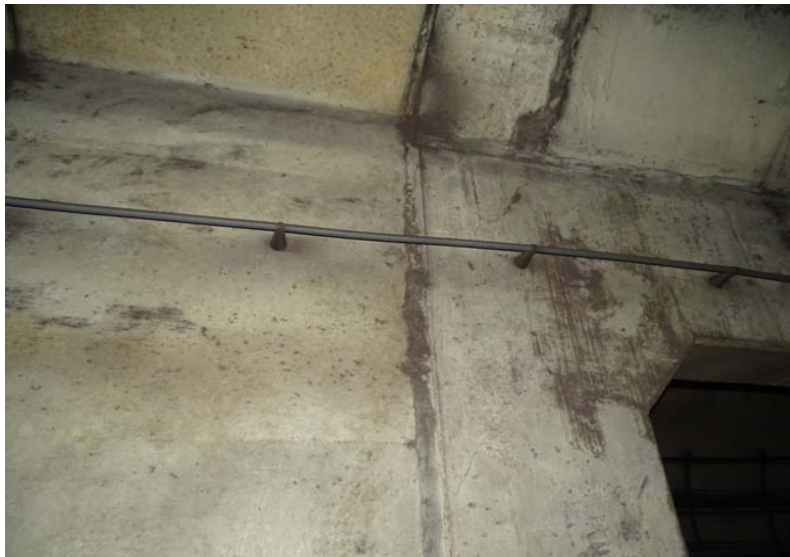
Photograph No. 297
Station 74+30 - crack on east wall.

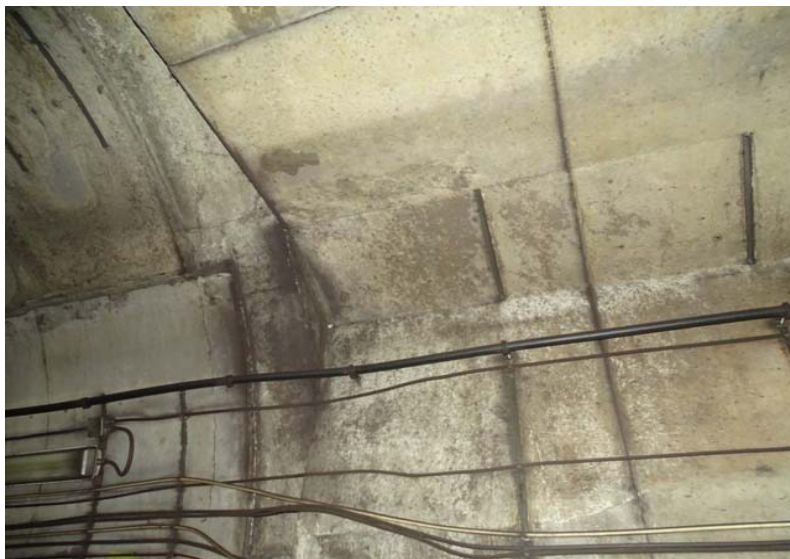
Photograph No. 299
Station 74+30, upper portion of west wall. Note the stains and efflorescence.

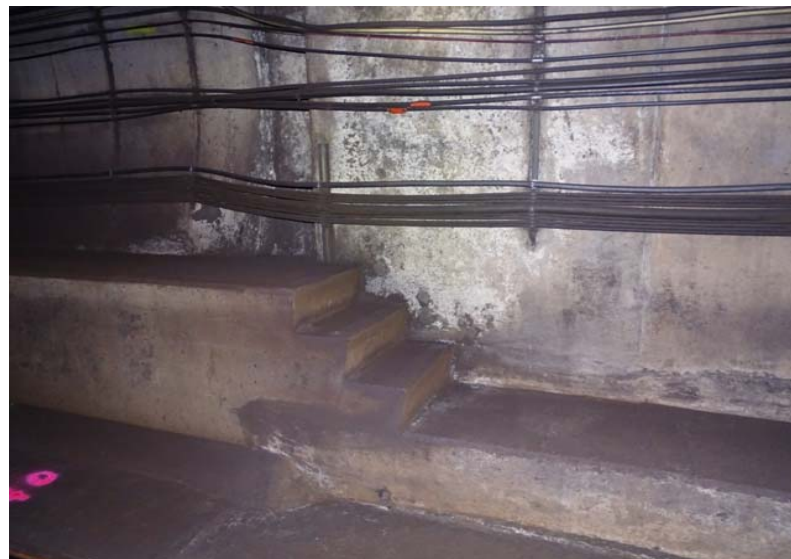
Photograph No. 300
Station 74+30, lower portion of west wall. Note the stains and efflorescence.
