**Report of Preconstruction Condition
Survey Services**

**ADJACENT PROPERTIES TO
THE WHARF – PHASE I
WASHINGTON, DC**

ECS PROJECT NO. 37:1306

OCTOBER 6, 2014

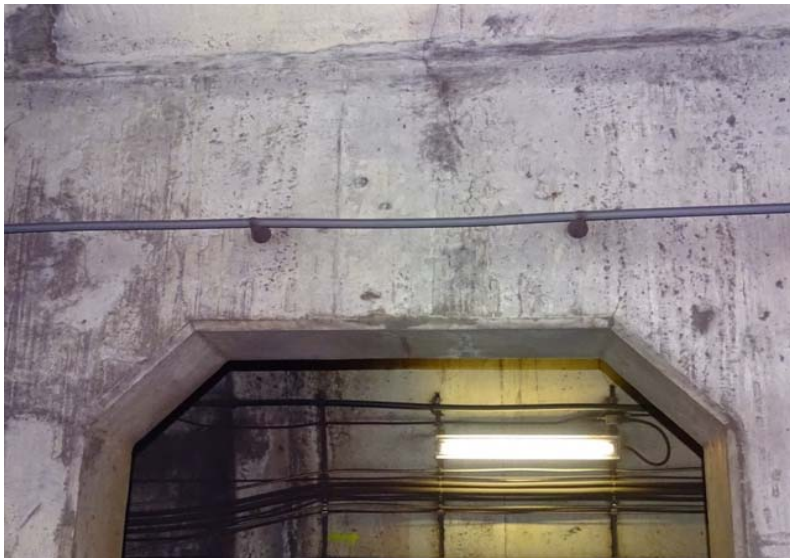
Photograph No. 303
Station 74+40 - cracks and stains above east arch.

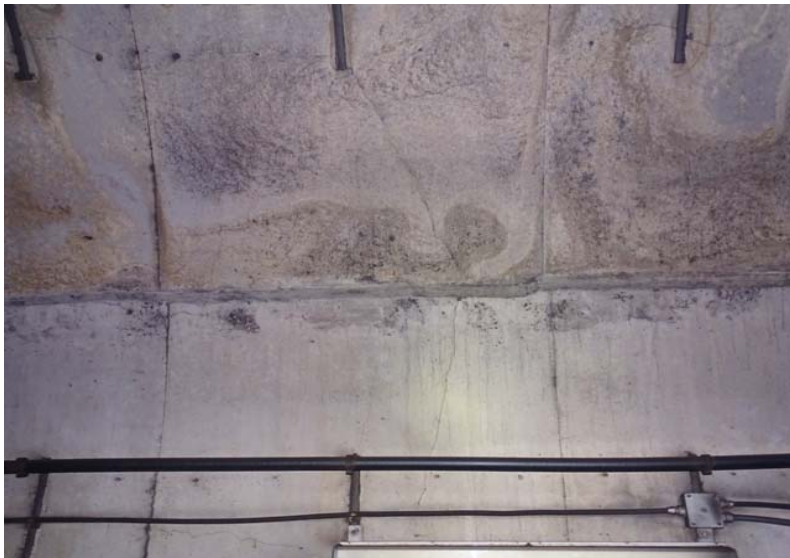
Photograph No. 307
Station 74+40 - crack on west wall.

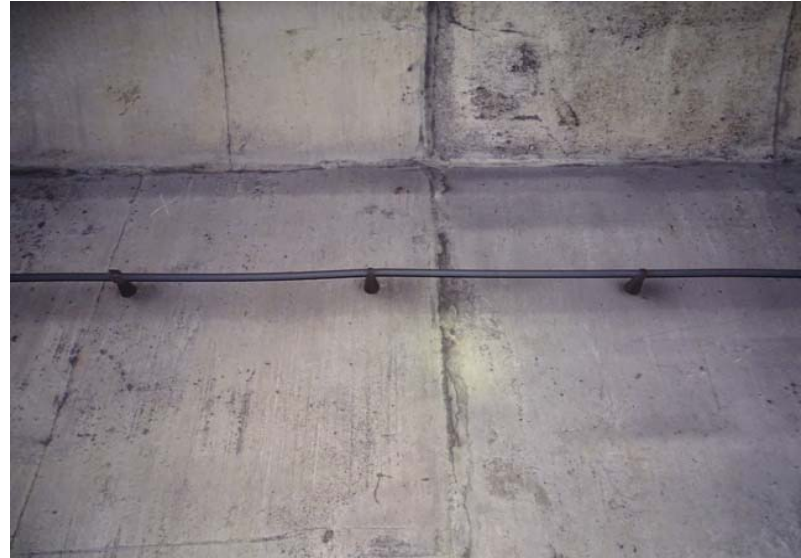
Photograph No. 310
Station 74+50 - crack on east wall.

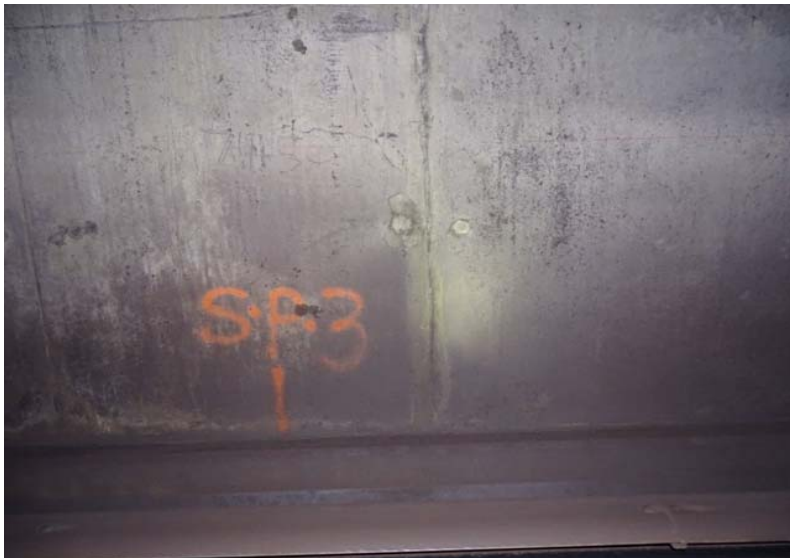
Photograph No. 311
Station 74+50 - crack on east wall.

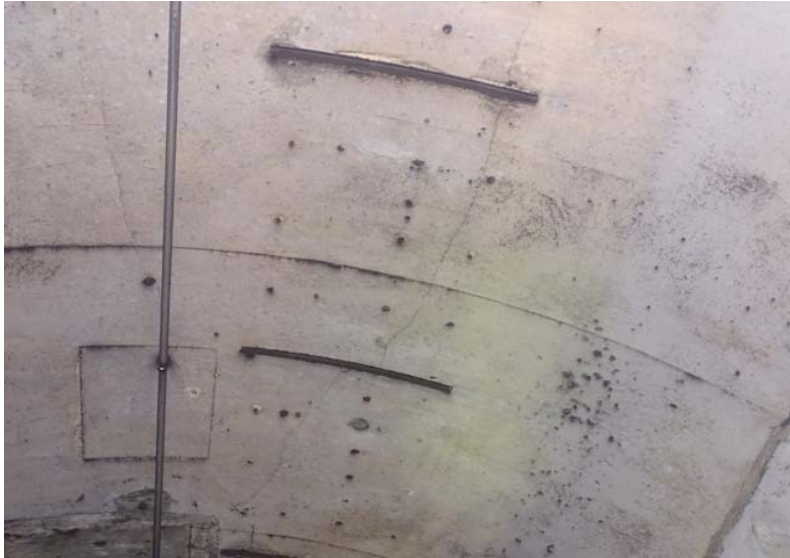
Photograph No. 313
Station 74+50 - crack on ceiling.

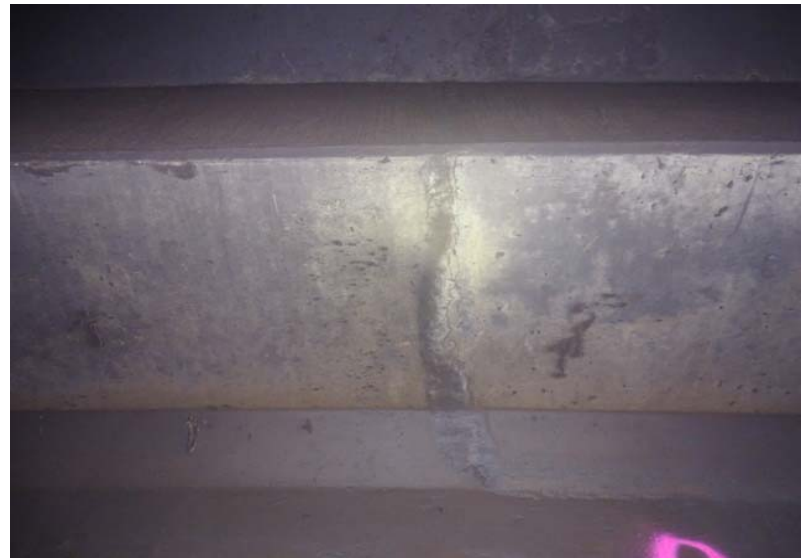
Photograph No. 316
Station 74+50 - crack on catwalk.

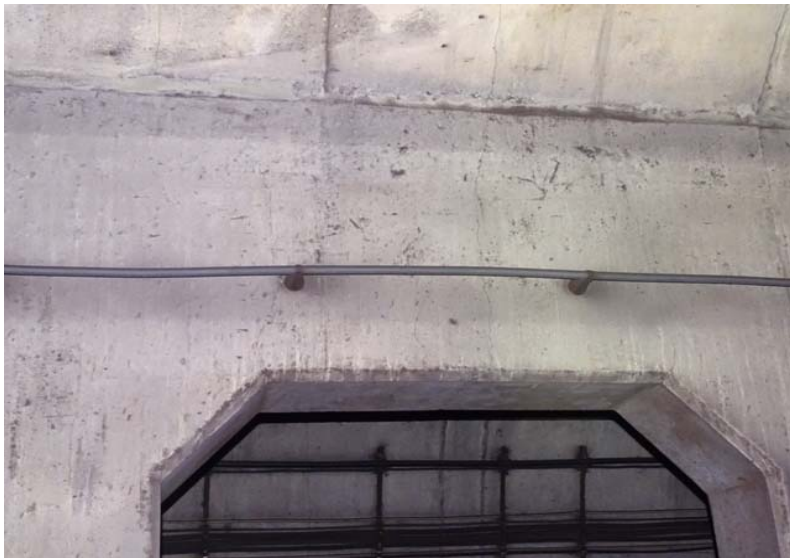
Photograph No. 319
Station 74+60 - cracks above east arch.

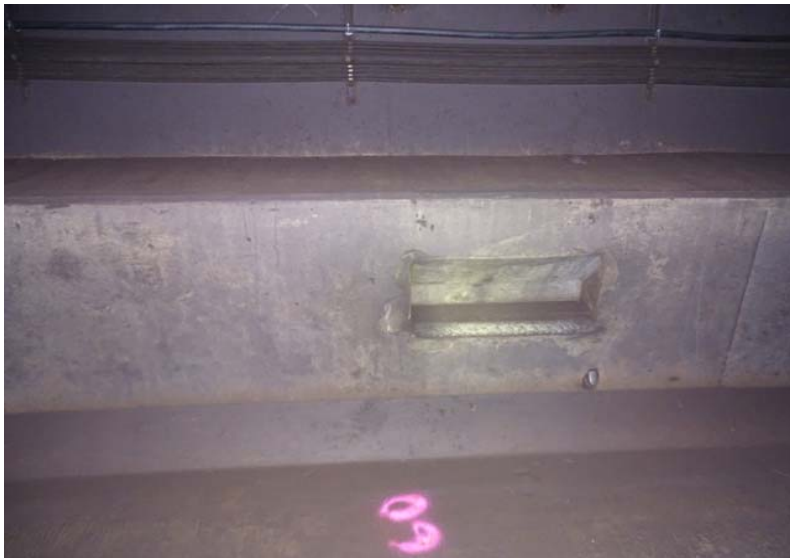
Photograph No. 323
Station 74+60 - typical foothold at side of catwalk.

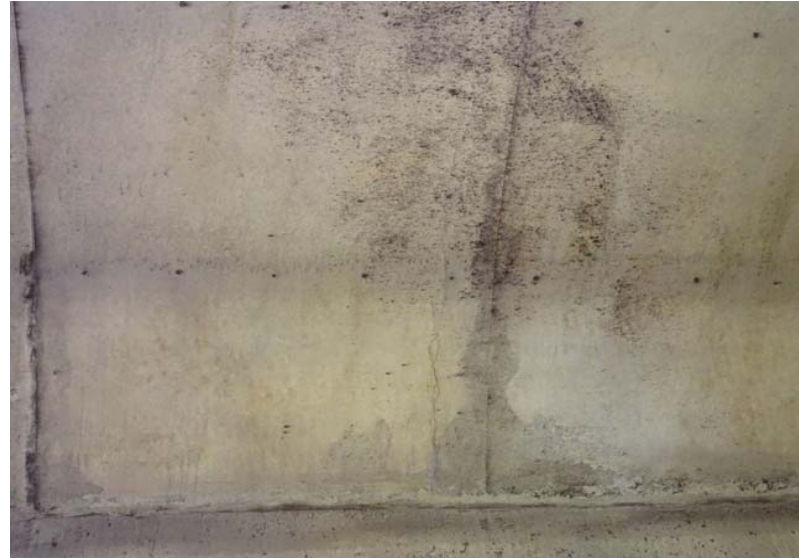
Photograph No. 326
Station 74+70 - crack and stains on ceiling, looking east.

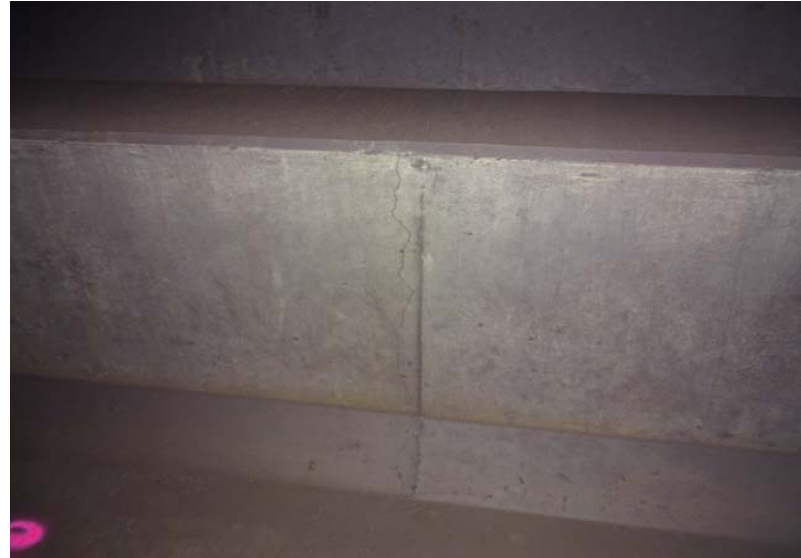
Photograph No. 330
Station 74+70 - crack on catwalk.

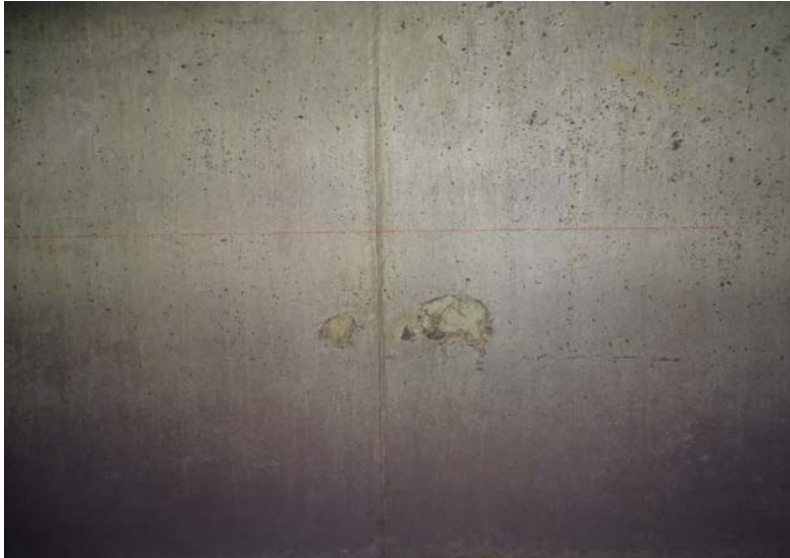
Photograph No. 333
Station 74+80 - previous concrete repair on east wall.

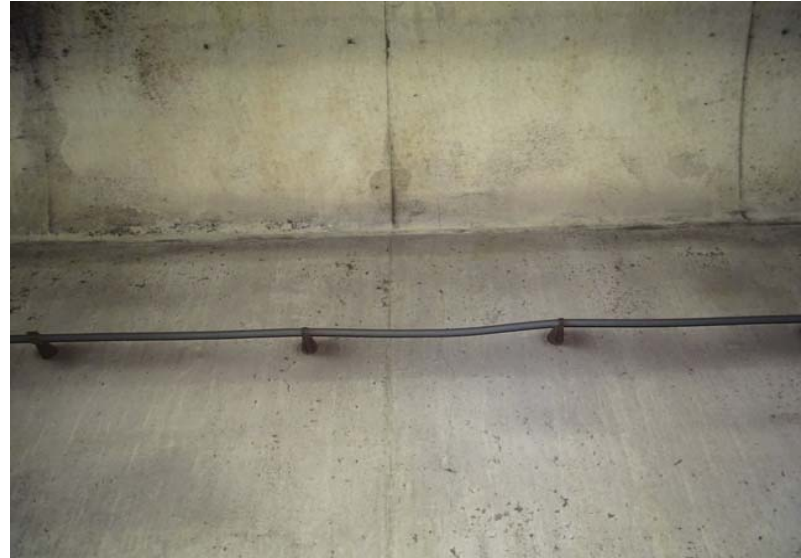
Photograph No. 334
Station 74+80 - crack on east wall.

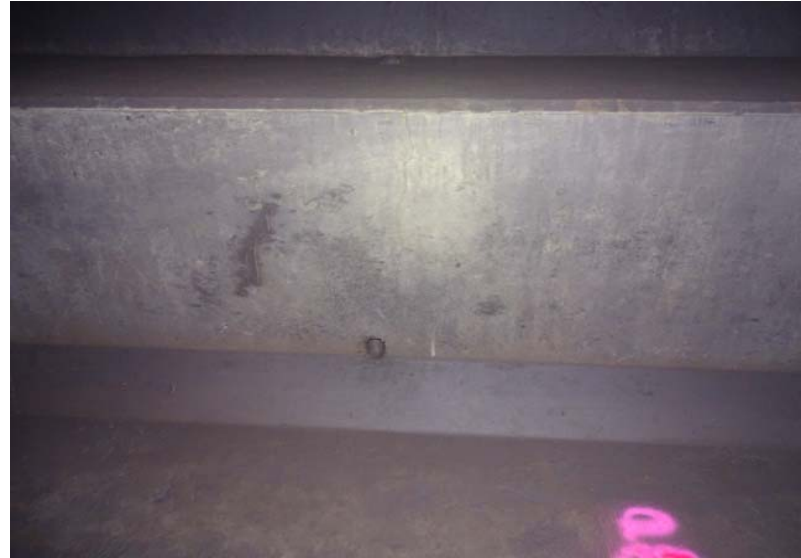
Photograph No. 338
Station 74+80 - crack on catwalk.

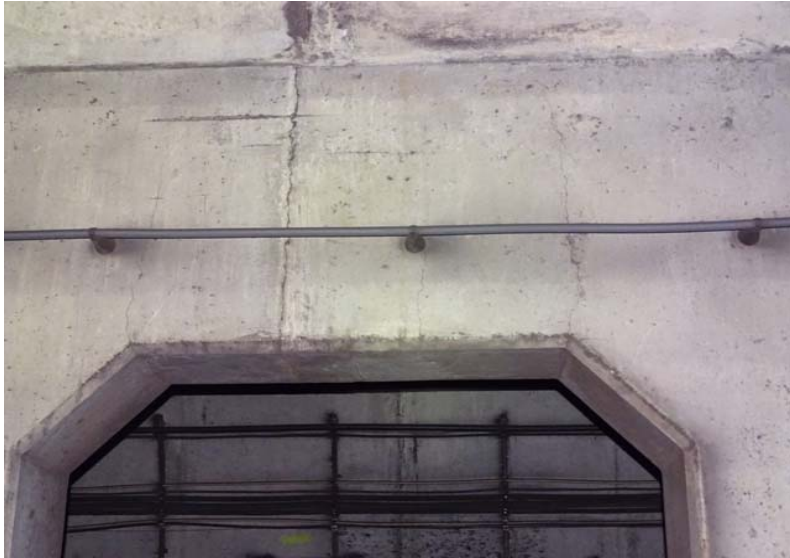
Photograph No. 341
Station 74+90 - cracks above east arch.

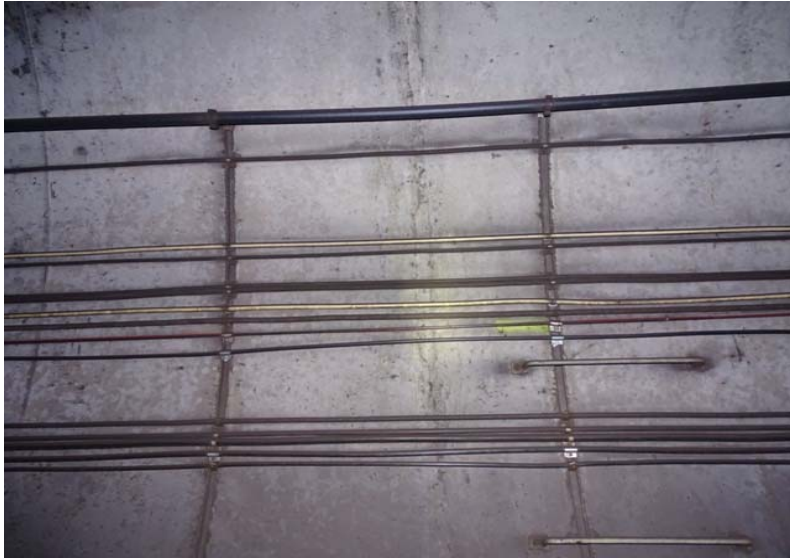
Photograph No. 345
Station 74+90 - crack on west wall.

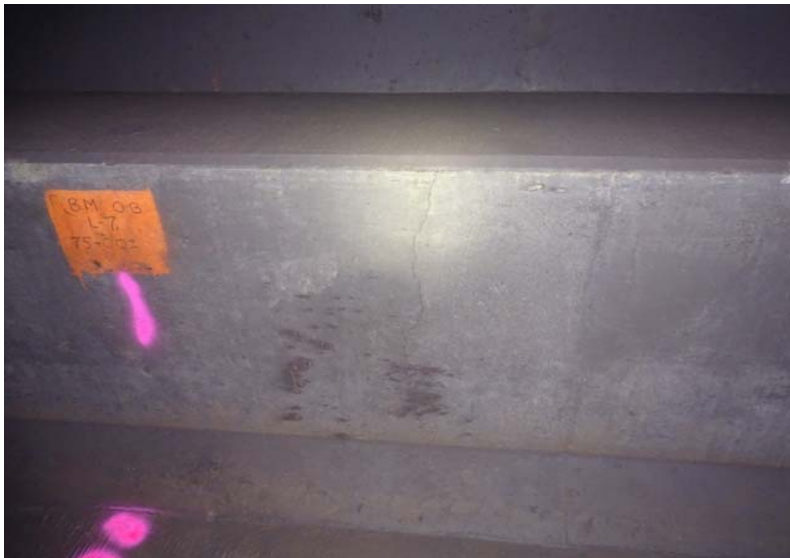
Photograph No. 347
Station 74+90 - crack on catwalk.

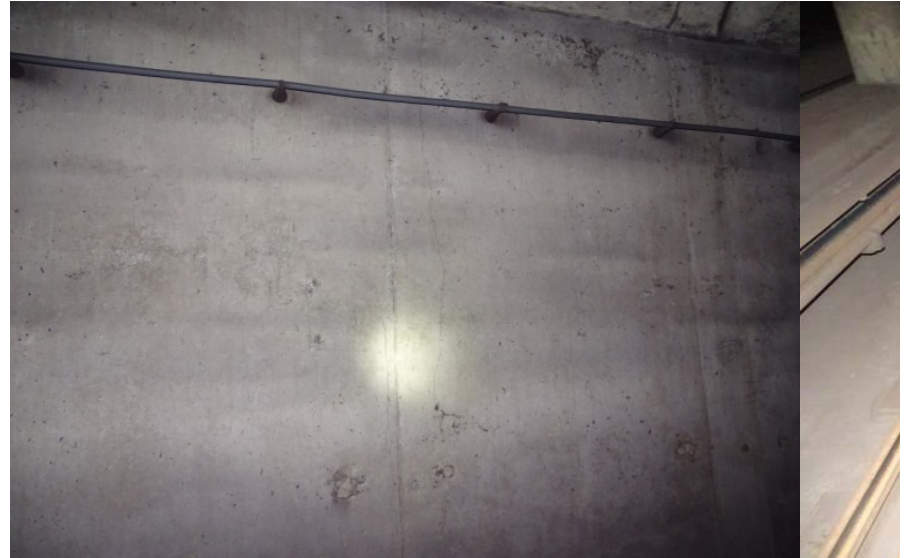
Photograph No. 350
Station 75+07 - vertical crack on east wall.

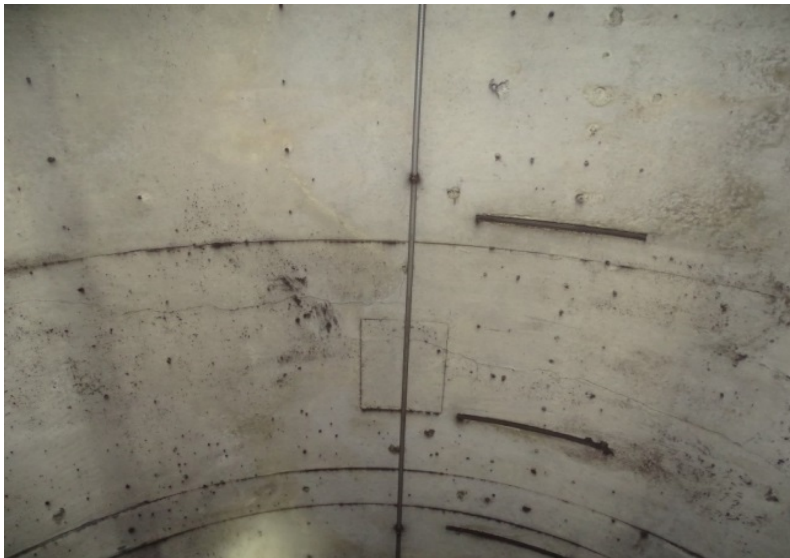
Photograph No. 355
Station 75+07 - crack on ceiling.

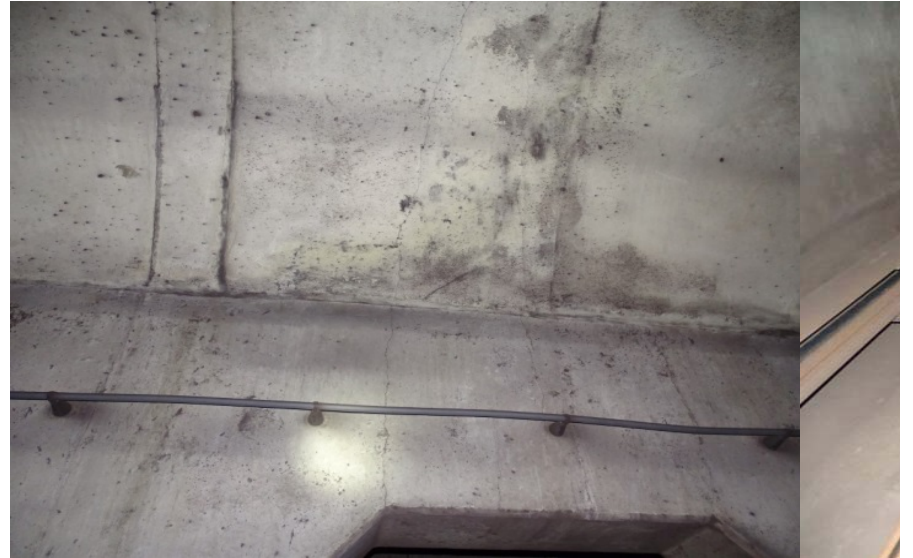
Photograph No. 362
Station 75+15 - vertical crack on east wall.

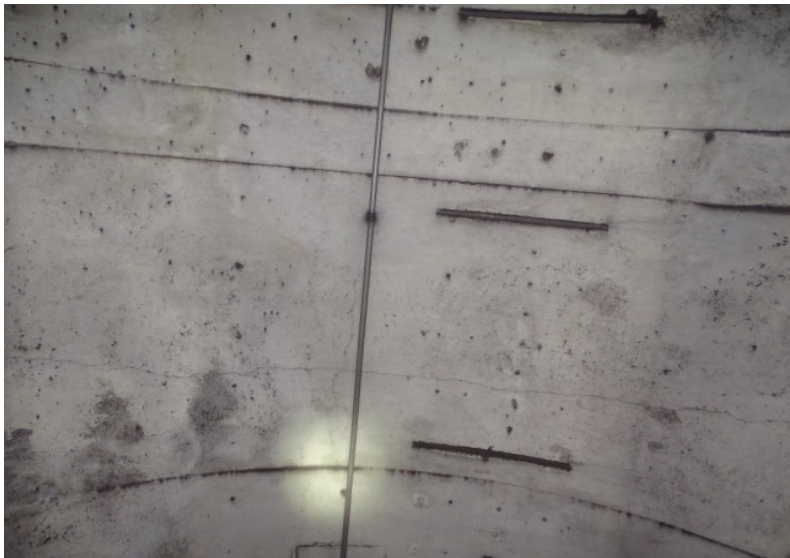
Photograph No. 363
Station 75+15 - crack in ceiling.

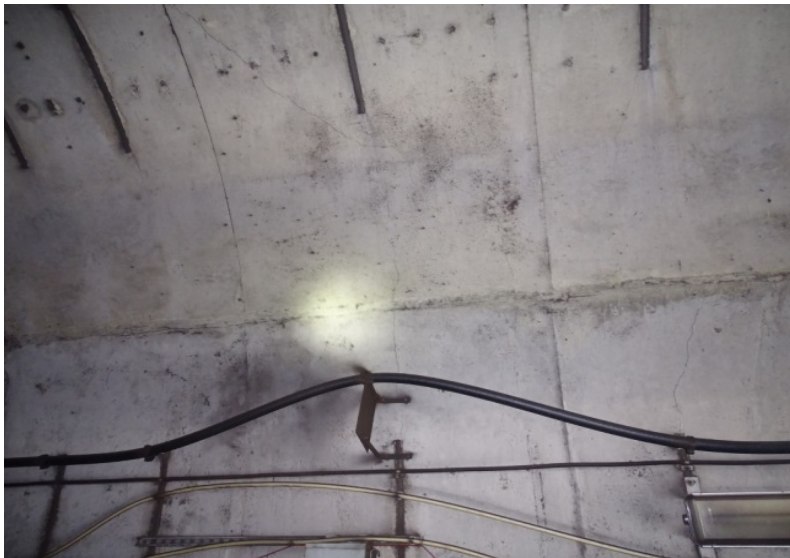
Photograph No. 370
Station 75+28 - cracks in ceiling.

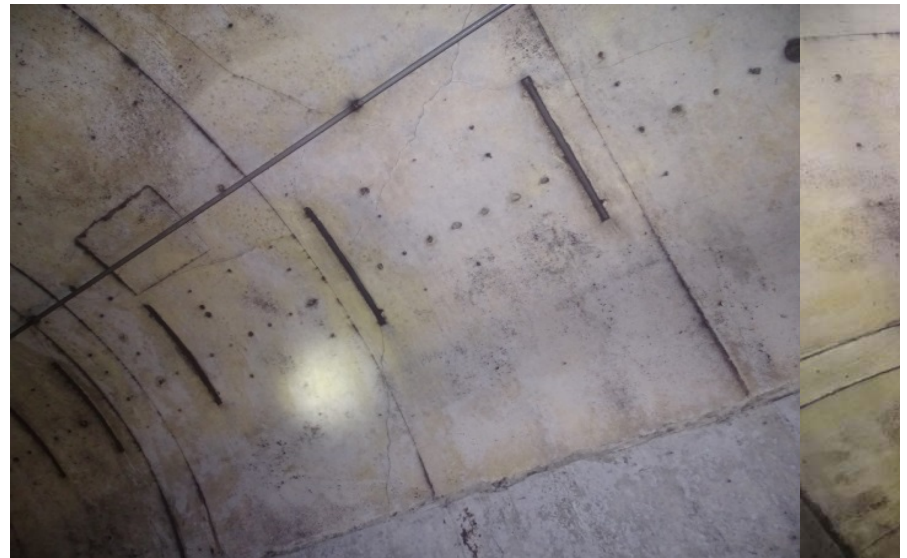
Photograph No. 383
Station 75+44 - vertical crack on east wall.

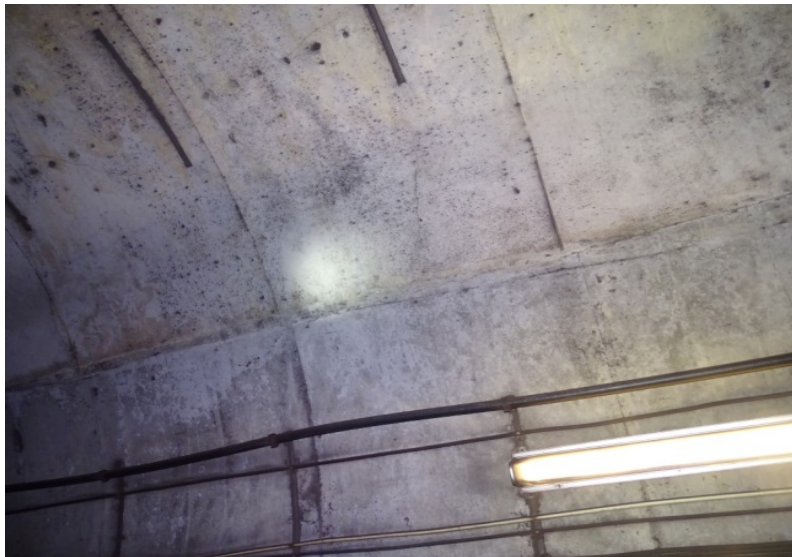
Photograph No. 396
Station 75+60 - crack in east portion of ceiling.

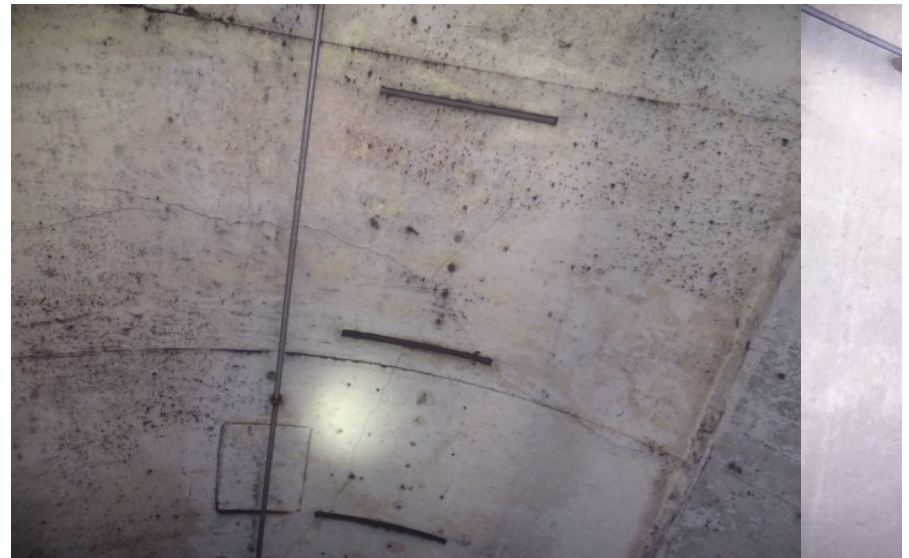
Photograph No. 403
Station 75+70 - vertical crack in east wall.

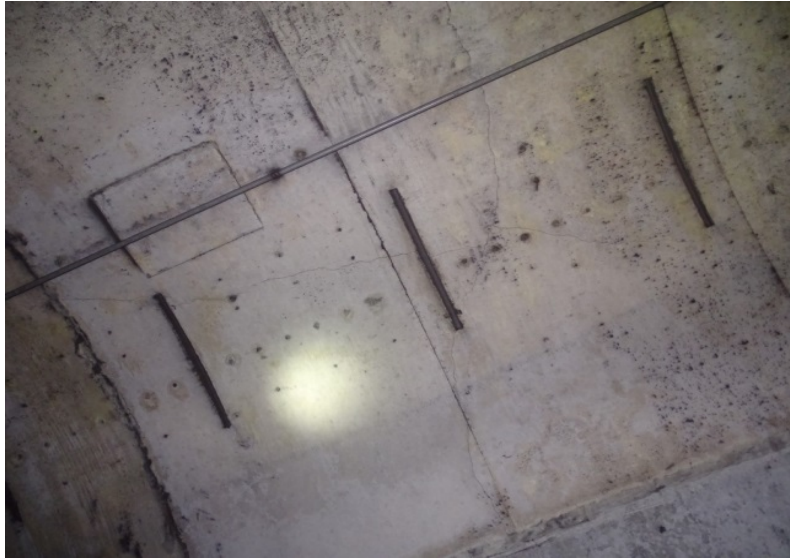
Photograph No. 404
Station 75+70 - cracks in ceiling.

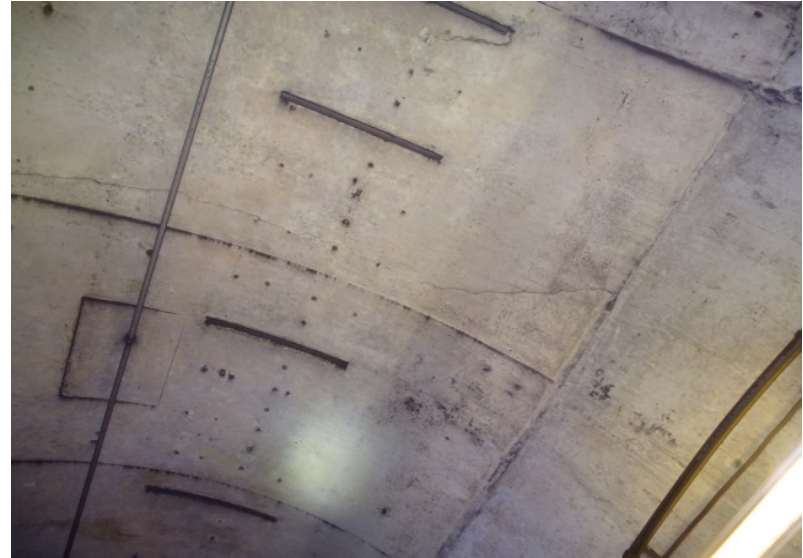
Photograph No. 425
Station 76+00 - crack in east portion of ceiling.

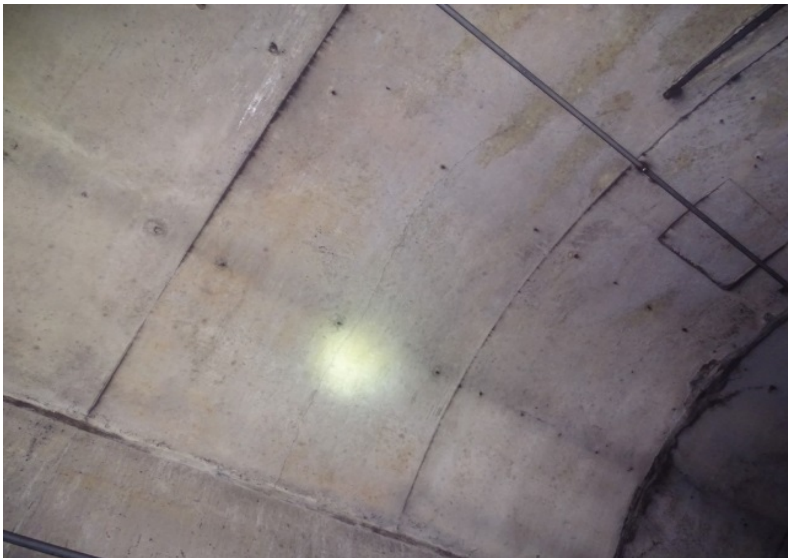
Photograph No. 426
Station 76+00 - crack in west portion of ceiling.

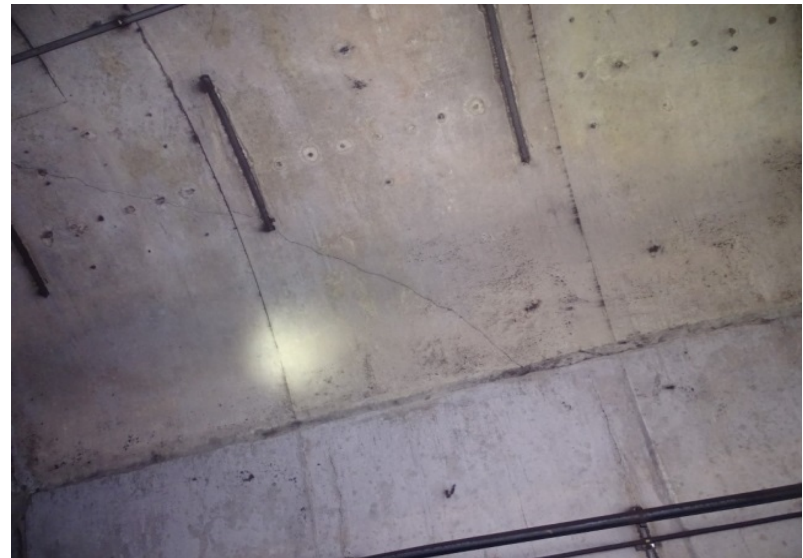
Photograph No. 427
Station 76+08 - crack in east portion of ceiling.

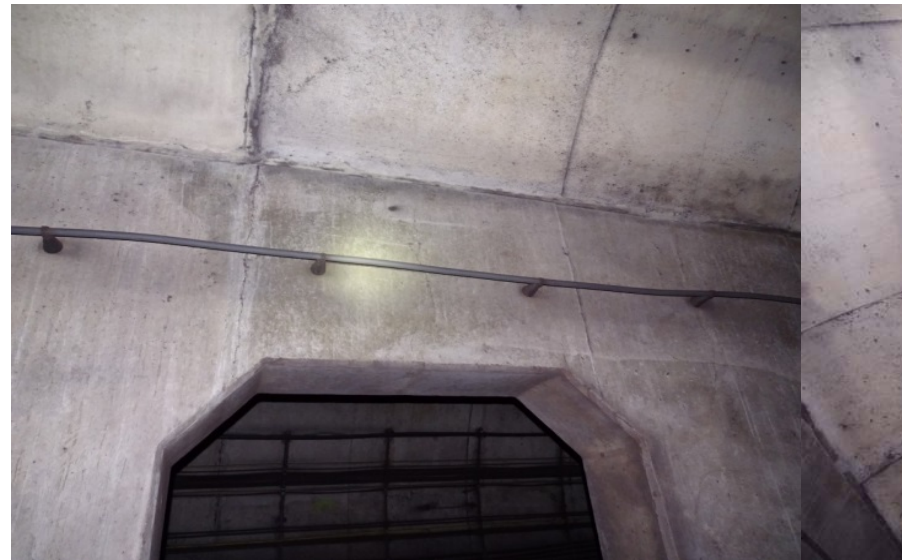
Photograph No. 435
Station 76+15 - crack in ceiling.

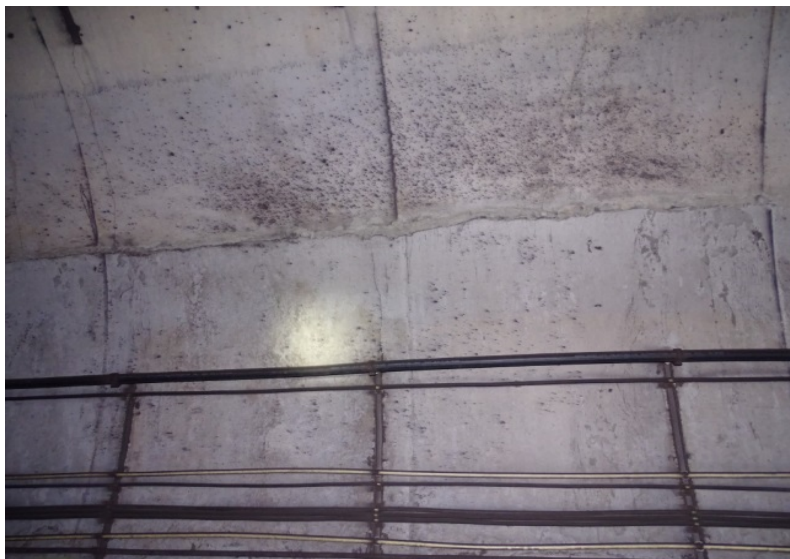
Photograph No. 442
Station 76+22 - vertical crack in east wall.

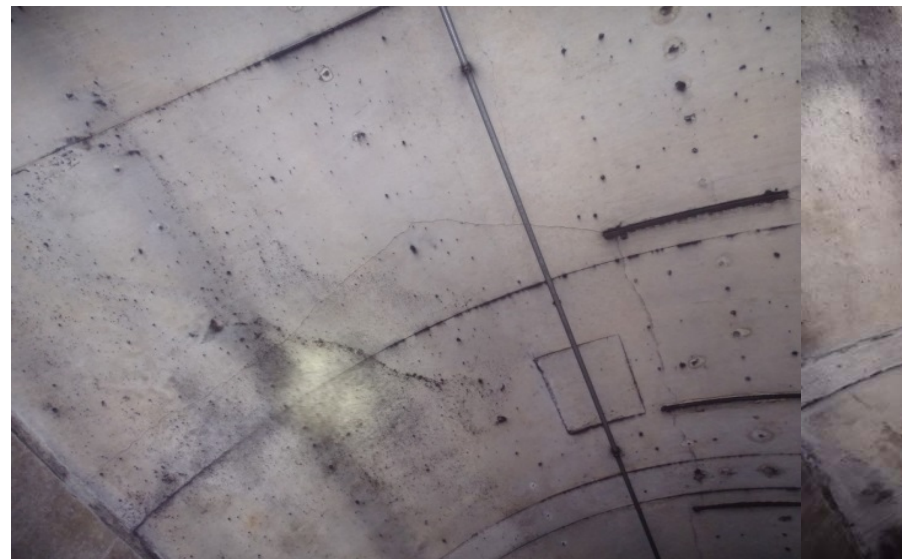
Photograph No. 443
Station 76+22 - vertical crack in west wall.

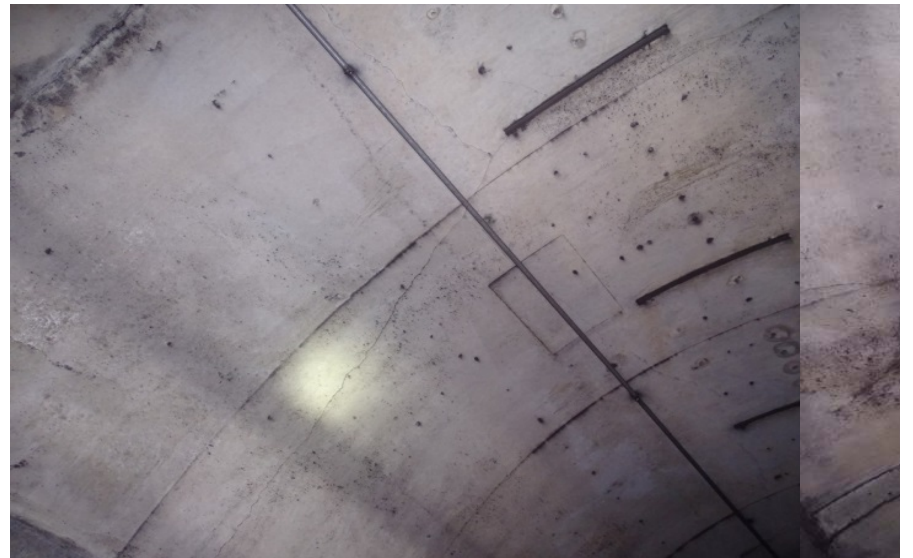
Photograph No. 467
Station 76+60 - crack in safety walkway.

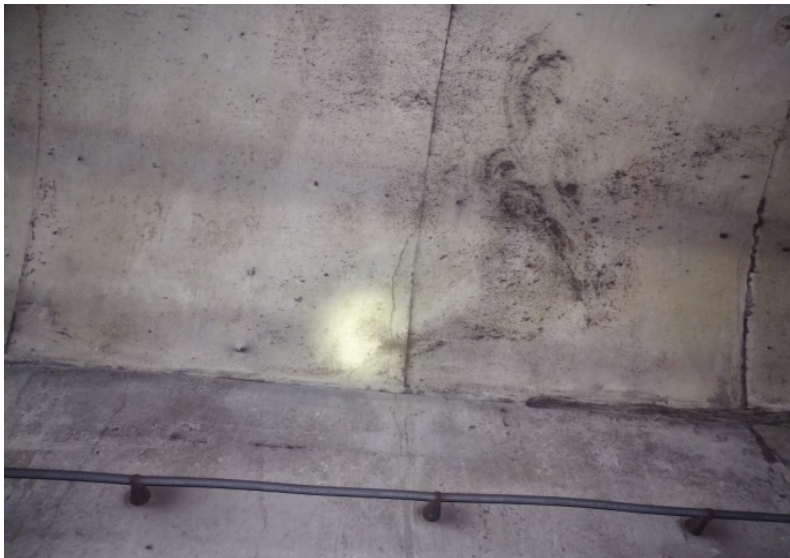
Photograph No. 474
Station 76+70 - vertical crack in east wall.

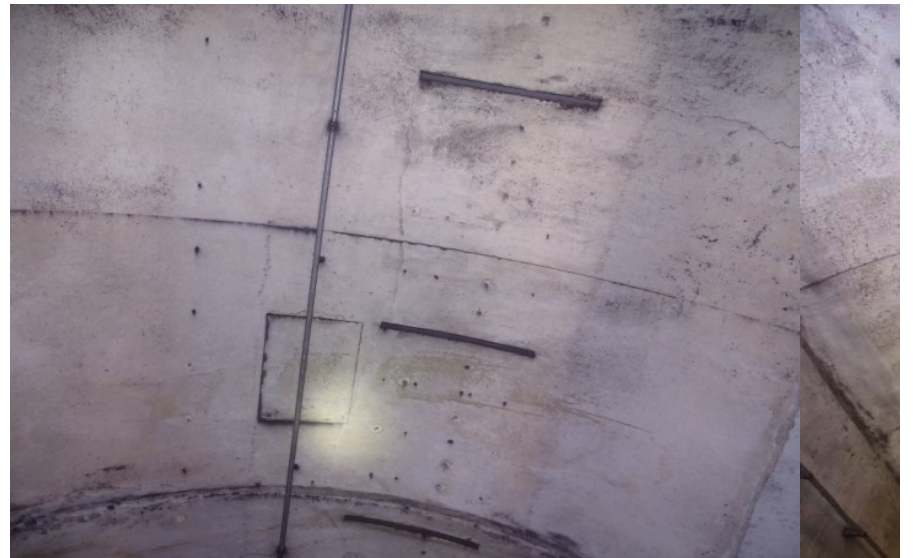
Photograph No. 488
Station 76+95 - crack in ceiling.

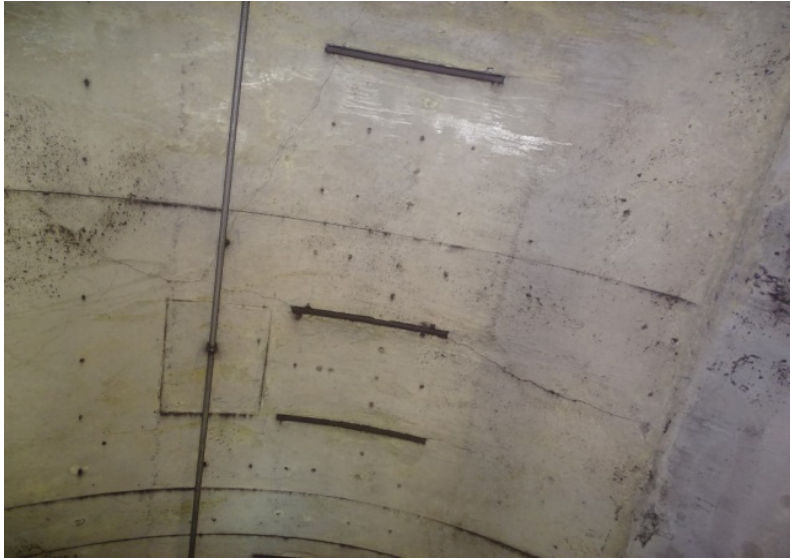
Photograph No. 500
Station 77+12 - vertical crack above east arch.

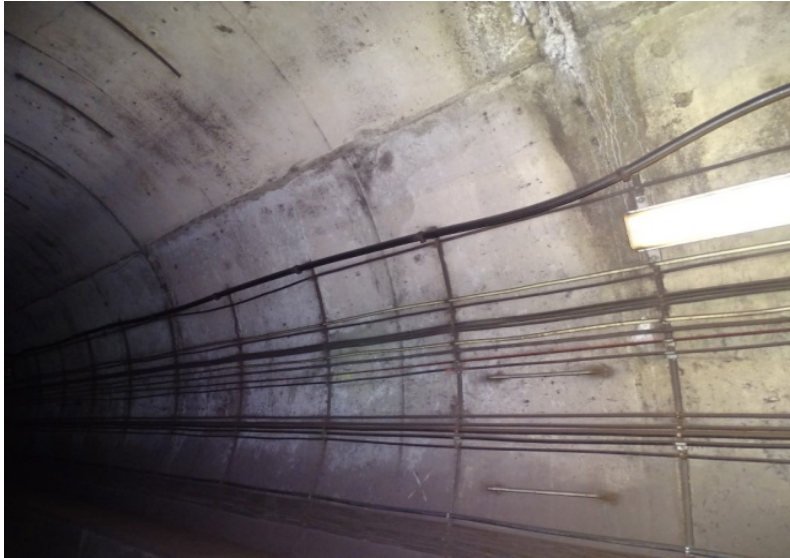
Photograph No. 504
Station 77+20, ceiling. Note cracks and stalagmites.

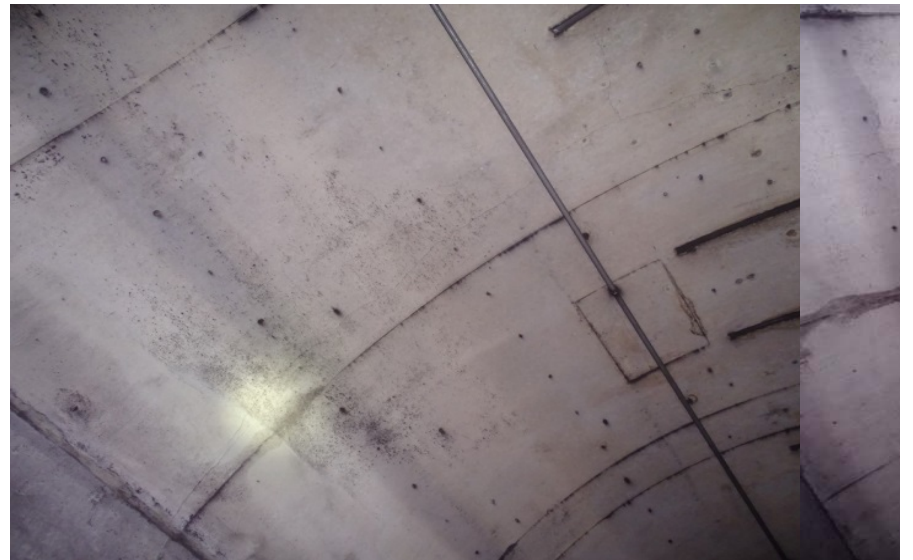
Photograph No. 523
Station 77+51 - crack in ceiling.

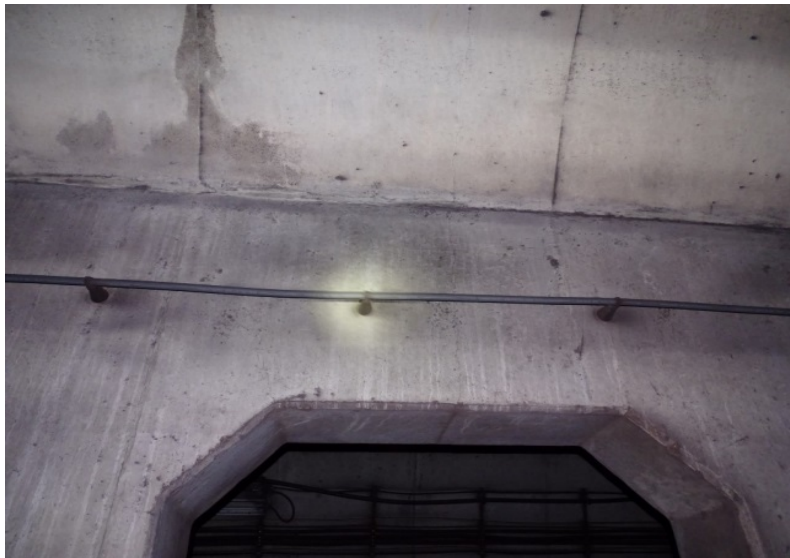
Photograph No. 530
Station 77+65 - transverse crack in ceiling.

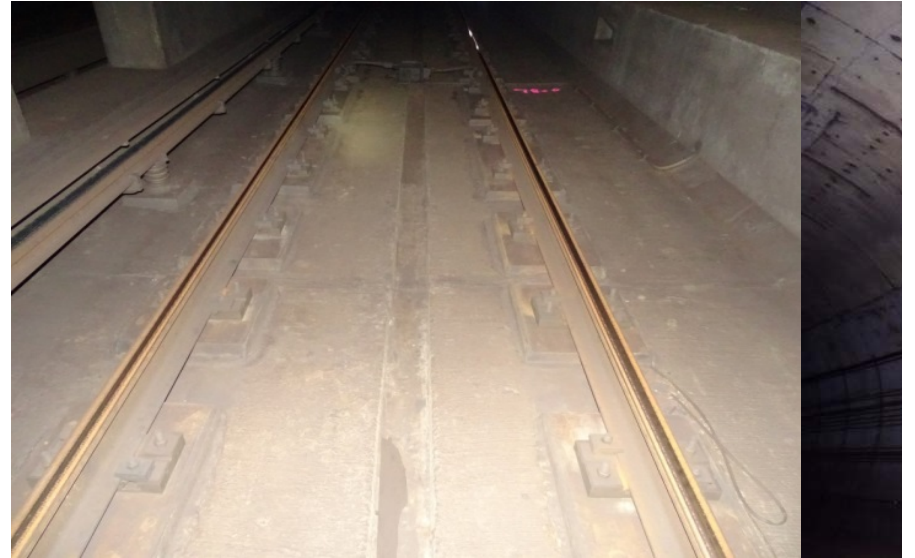
Photograph No. 537
Station 77+70 - crack in west walkway.

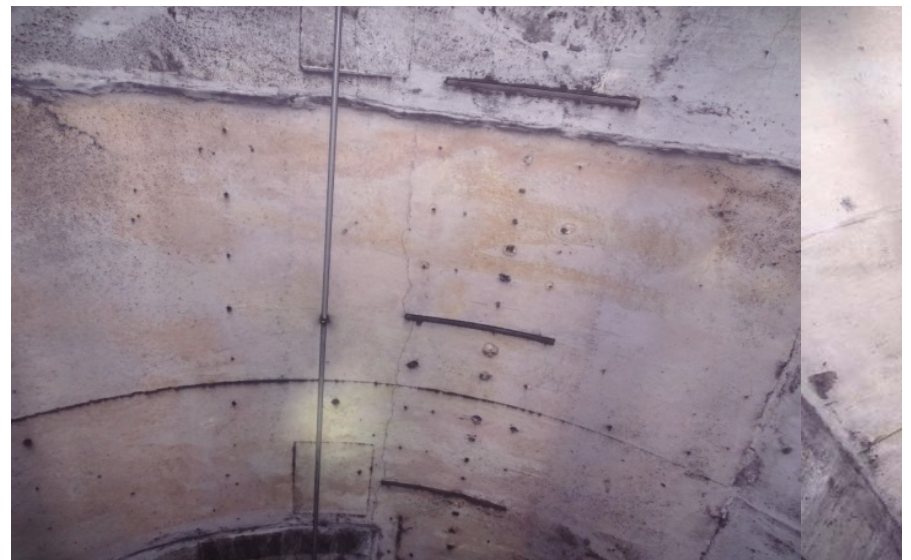
Photograph No. 543
Station 77+90 - vertical crack in east arch.

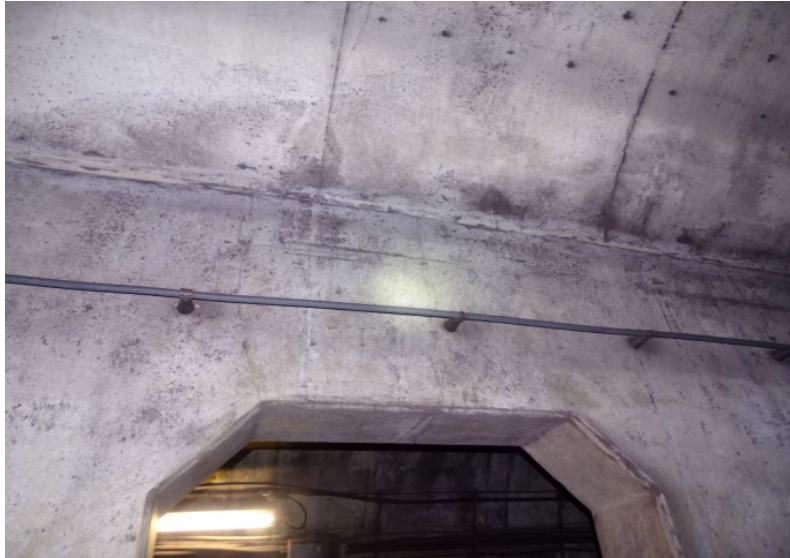
Photograph No. 556
Station 78+40 - crack in ceiling.

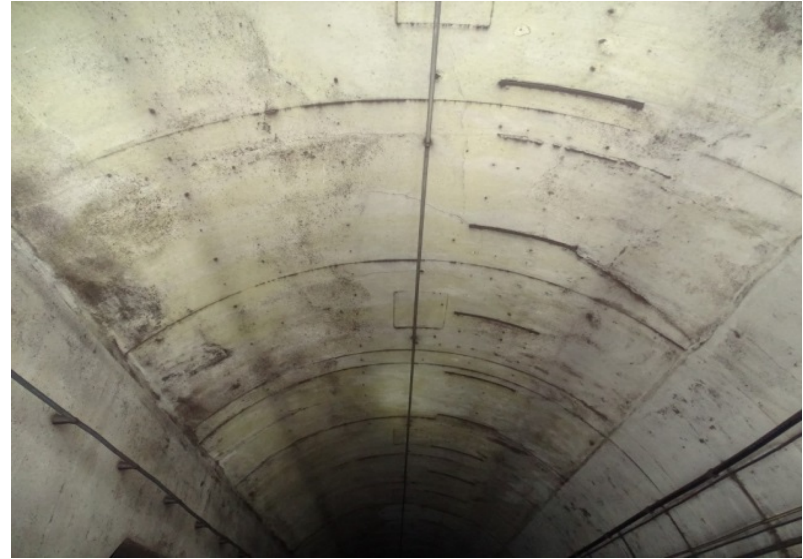
Photograph No. 565
Station 78+75 - vertical crack above east arch.

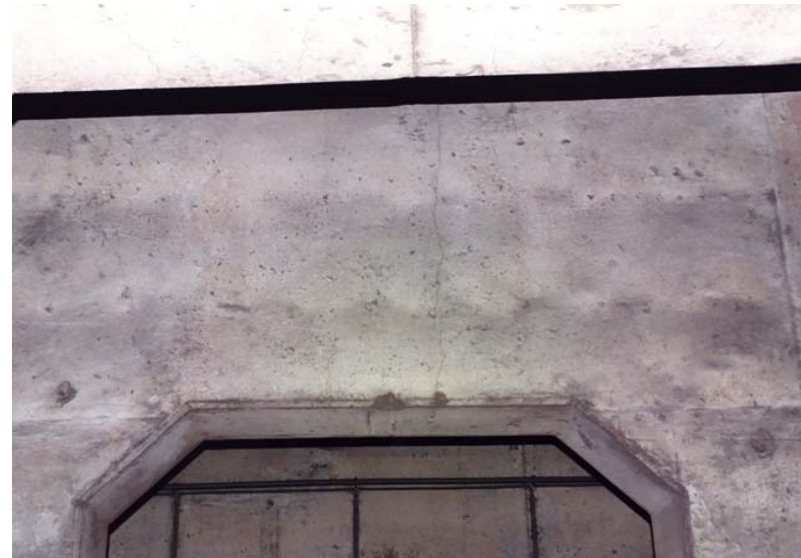
Photograph No. 16
Storage area, section 2, upper middle portion. Note the cracks.

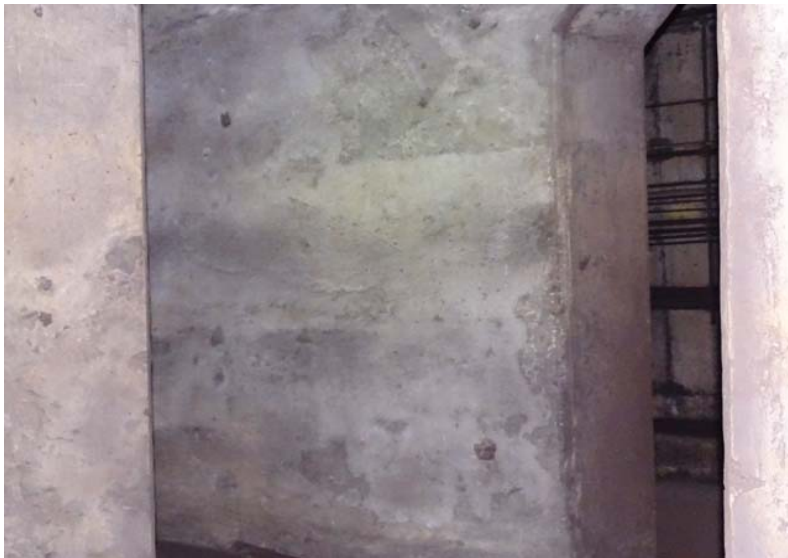
Photograph No. 31
Storage area, section 3. Close up of previous concrete repair.

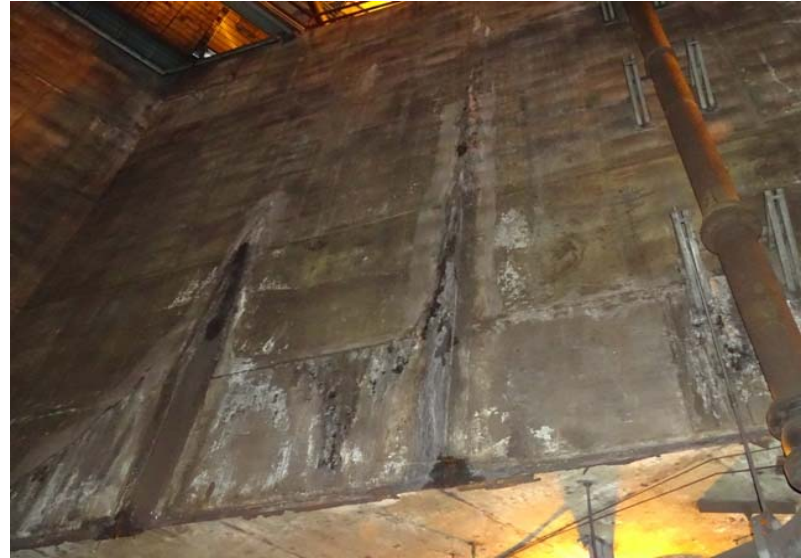
Photograph No. 34
Main room, southwest wall. Note the cracks, stains, and efflorescence.

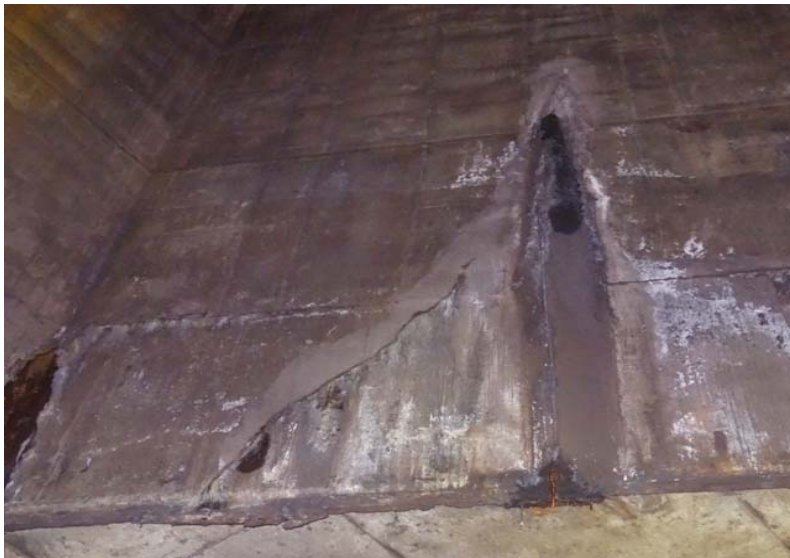
Photograph No. 35
Main room, southwest wall. Close up of the crack, stains, and efflorescence.

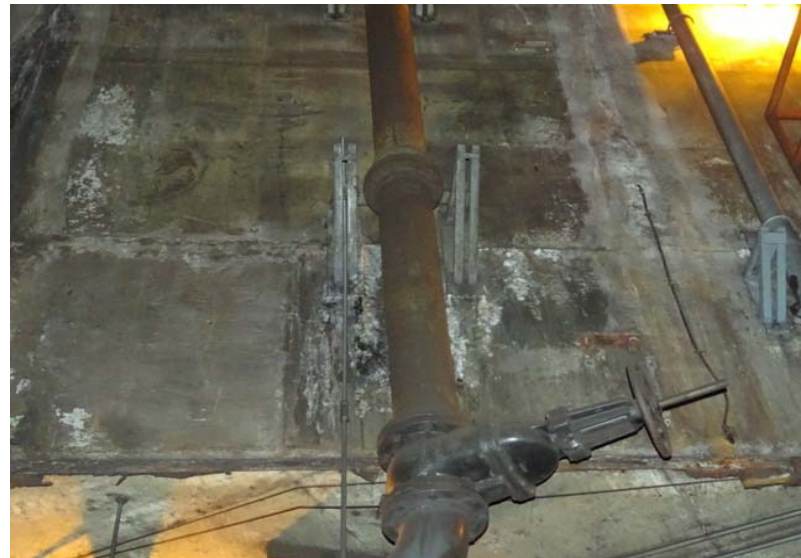
Photograph No. 36
Main room, southwest wall. Close up of the stains and efflorescence.

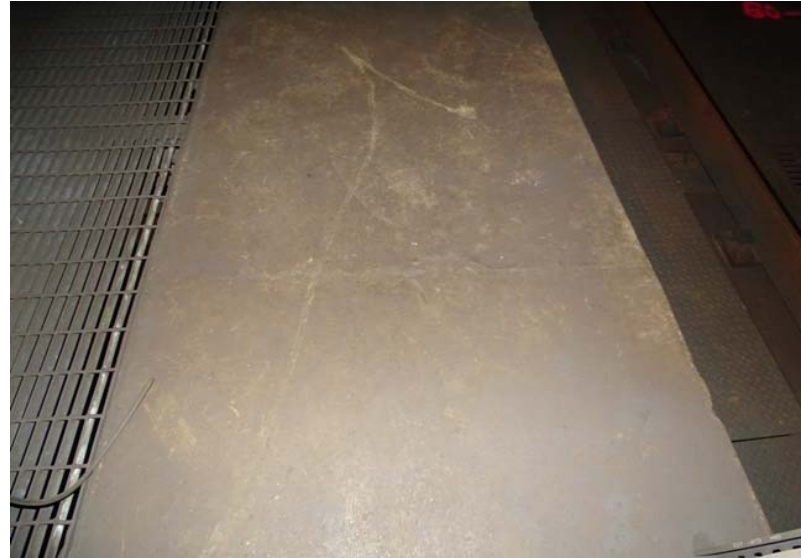
Photograph No. 46
Platform. Close up of condition of concrete.

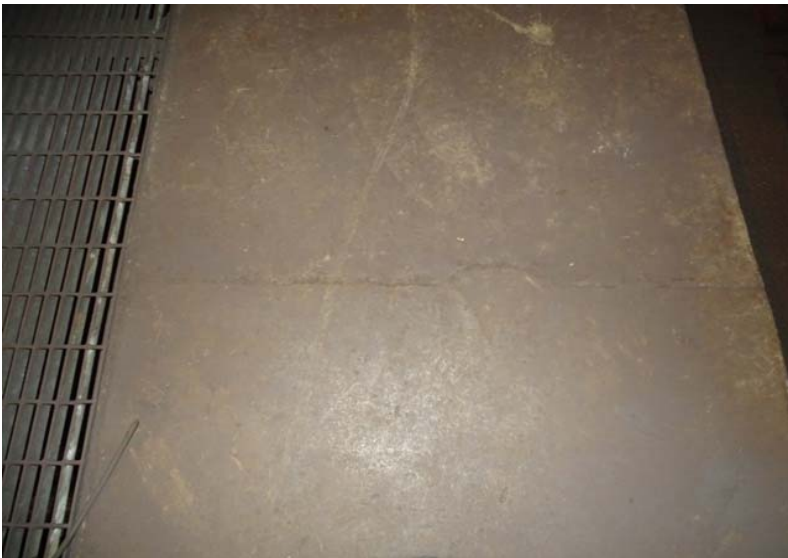
Photograph No. 47
Platform. Close up of condition of concrete.
