**Report of Preconstruction Condition
Survey Services**

**ADJACENT PROPERTIES TO
THE WHARF – PHASE I
WASHINGTON, DC**

ECS PROJECT NO. 37:1306

OCTOBER 6, 2014

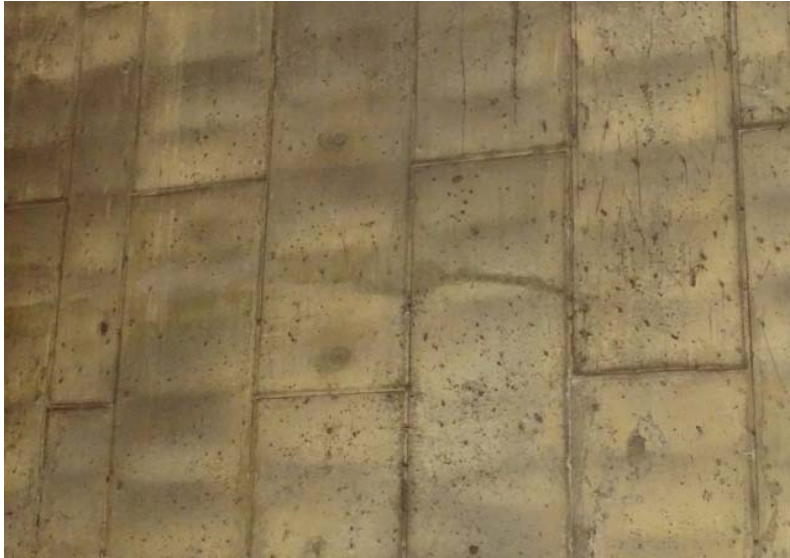
Photograph No. 65
Main room, east wall, close up of stain.

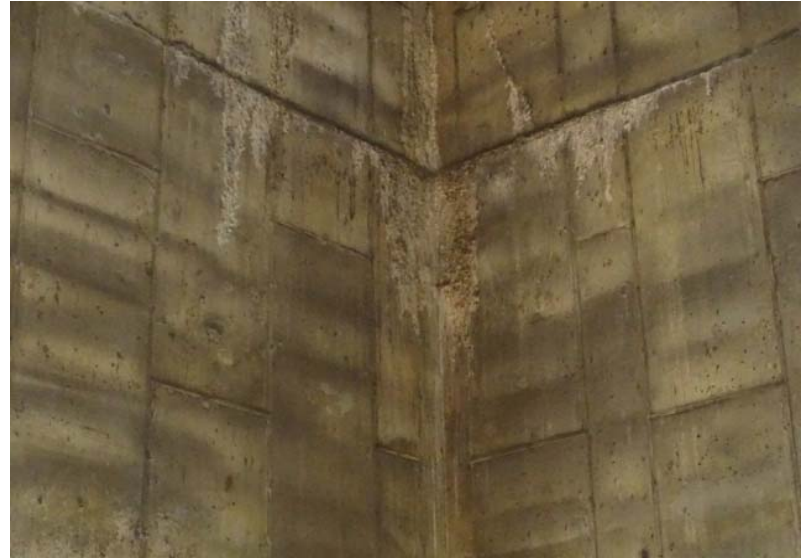
Photograph No. 66
Main room, northeast corner, close up of efflorescence.

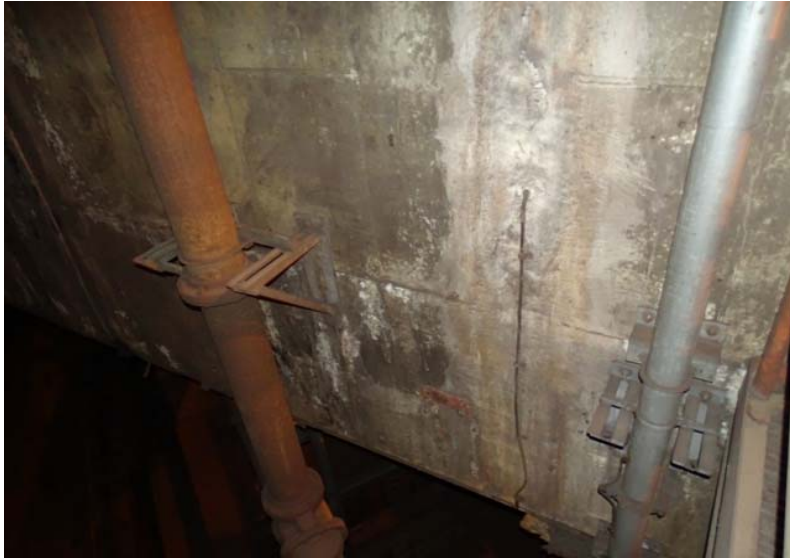
Photograph No. 73
Main room, west wall, close up of efflorescence.

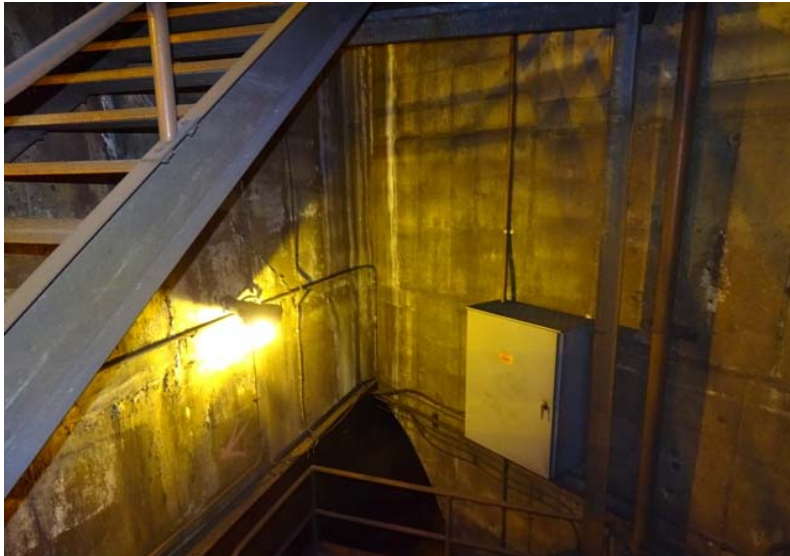
Photograph No. 75
Main room, northwest corner. Note the efflorescence.

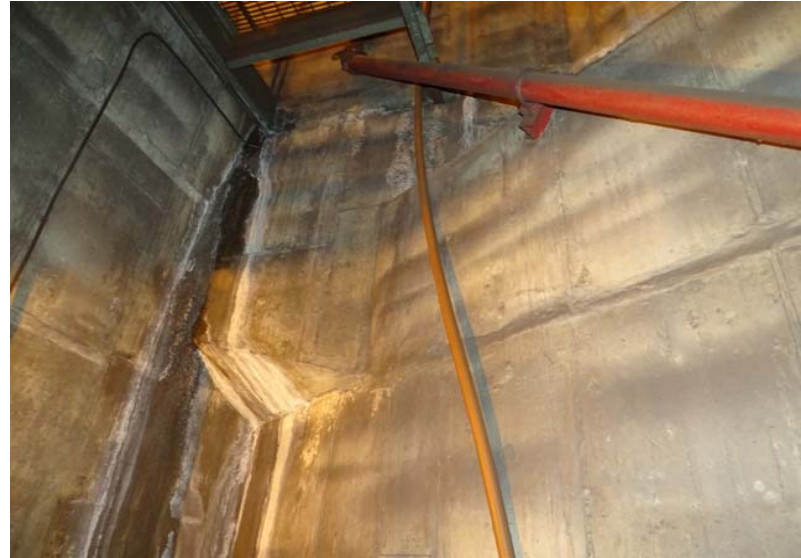
Photograph No. 78
Main room, northwest corner. Note the efflorescence.

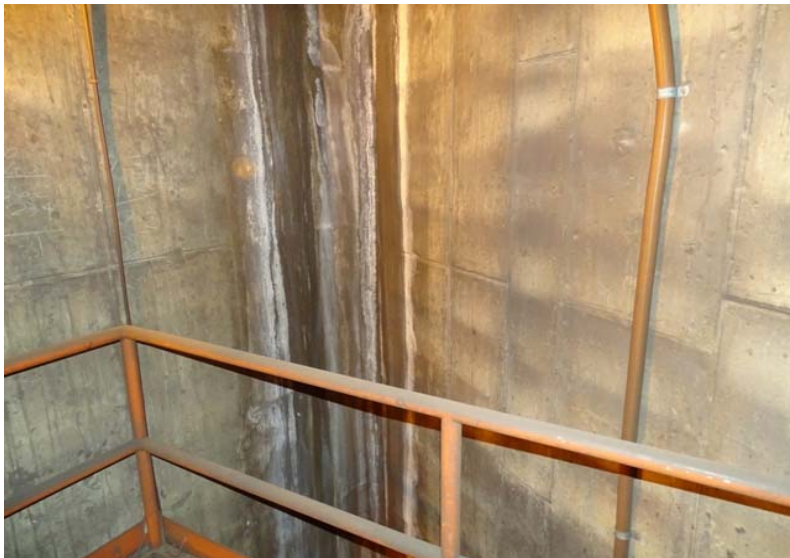
Photograph No. 79
Main room, northwest corner, close up of efflorescence.

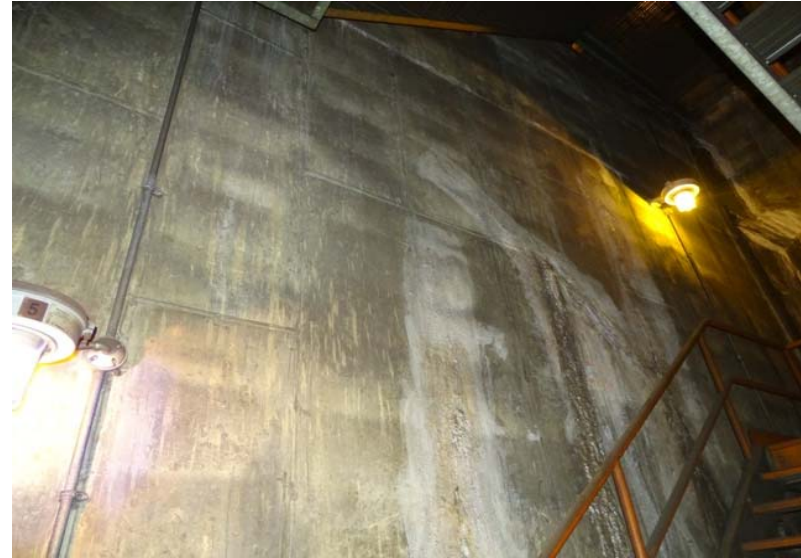
Photograph No. 82
Main room, west wall, top of the stair. Note the efflorescence.

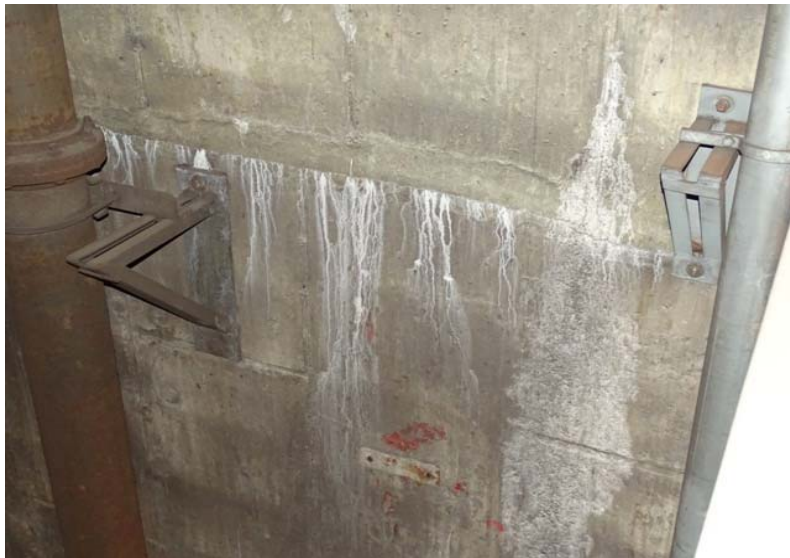
Photograph No. 99
Main room, upper portion, west wall at the stair, close up of efflorescence.

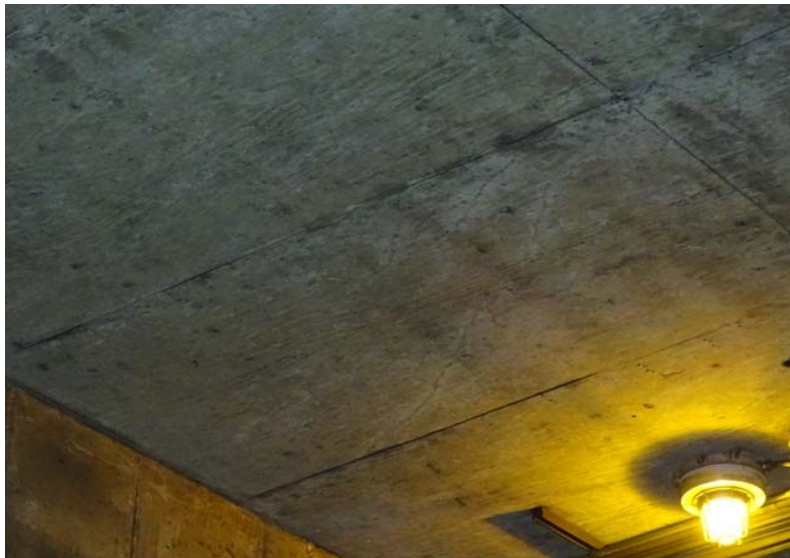
Photograph No. 107
Main room, ceiling, section 3, close up of cracks.

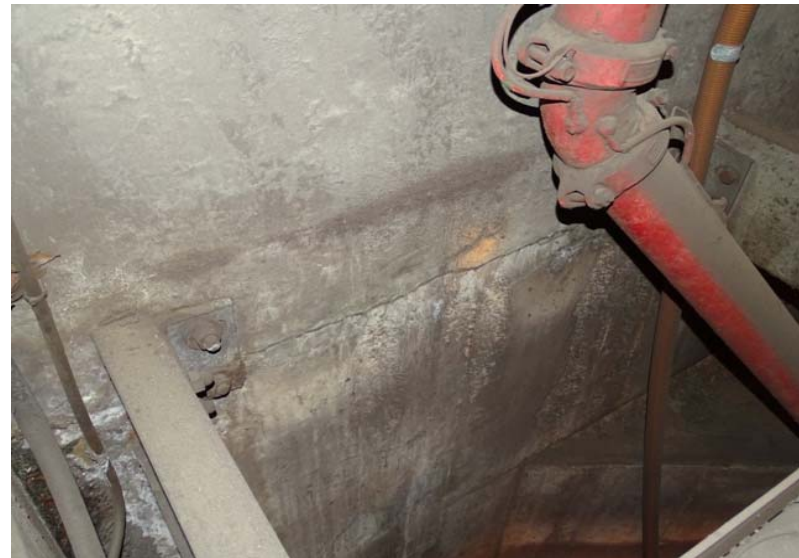
Photograph No. 115
Main room, upper level, north wall.

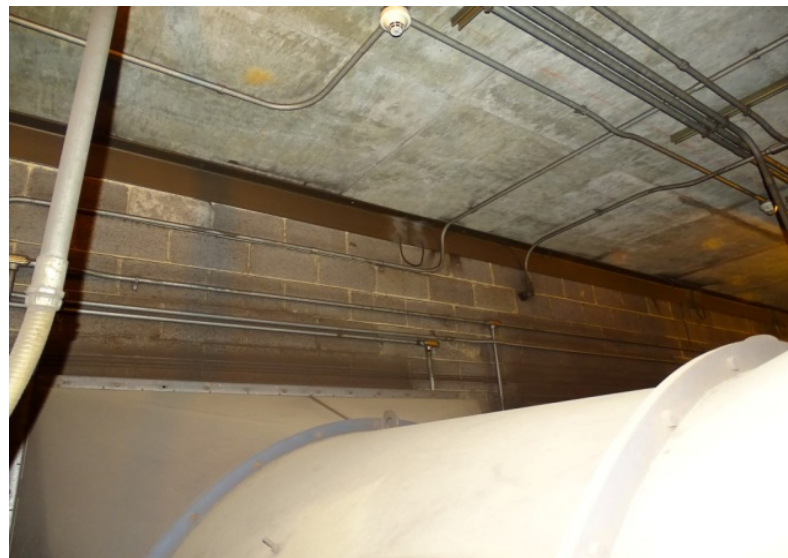
Photograph No. 121
Main room, upper level, west wall, south end.

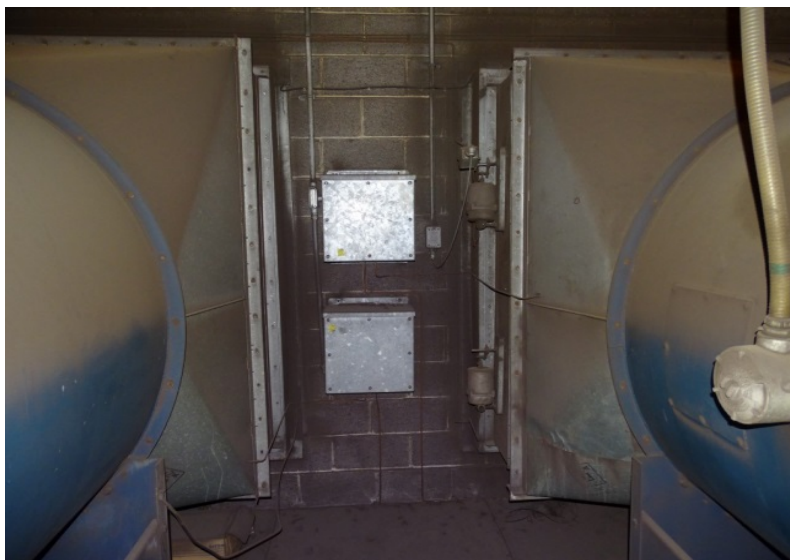
Photograph No. 122
Main room, upper level, west wall, above south fan unit.

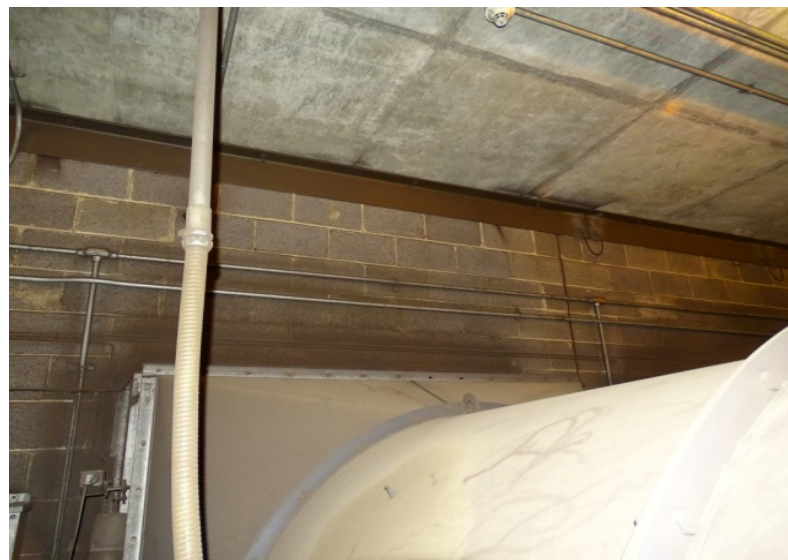
Photograph No. 123
Main room, upper level, west wall, between south and south-center fan units.

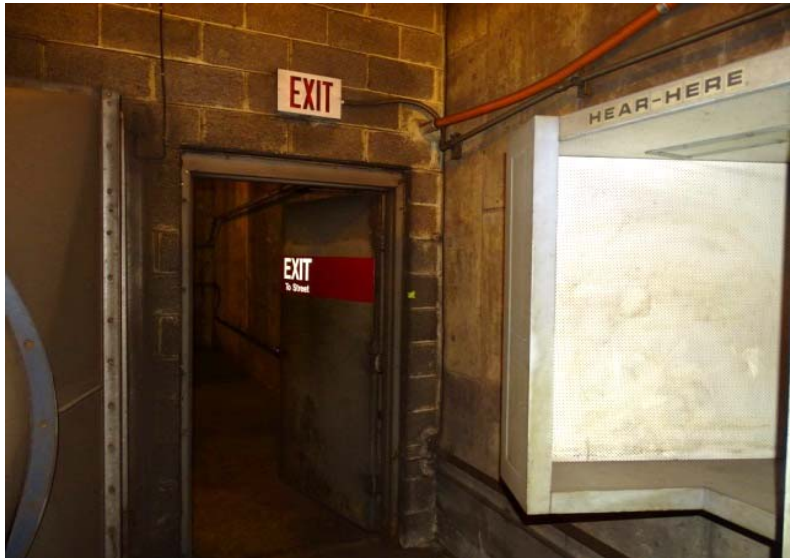
Photograph No. 128

Main room, upper level, west wall, above north fan unit.

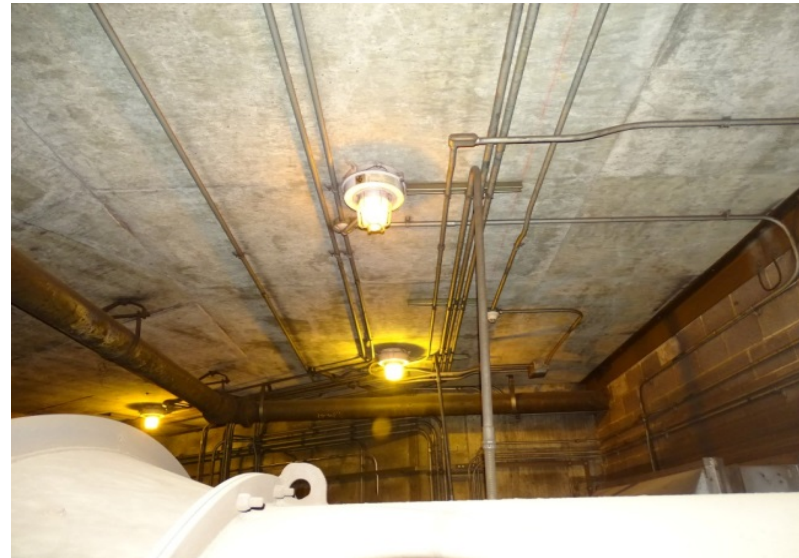
Photograph No. 129
Main room, upper level, west wall, north end.

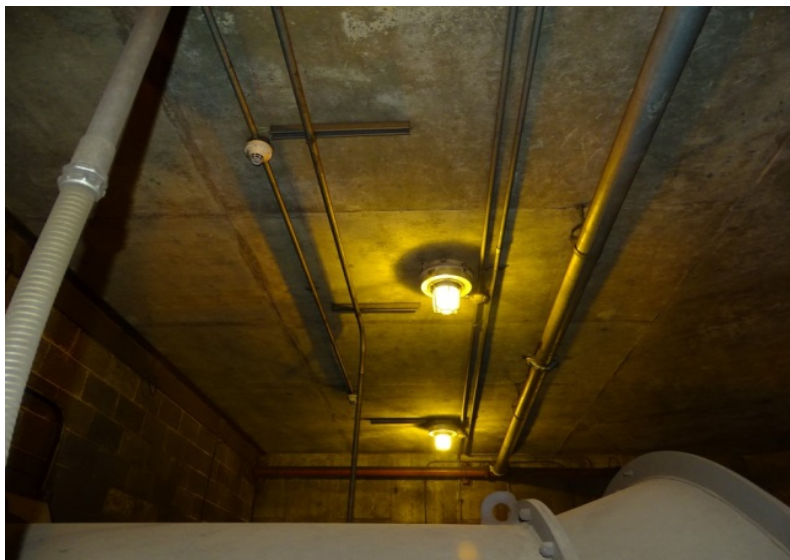
Photograph No. 130
Main room, upper level, southwest portion of ceiling.

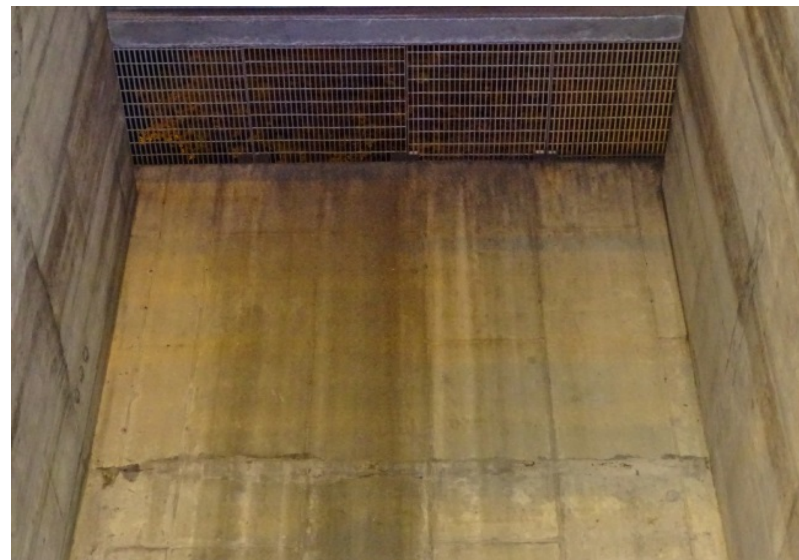
Photograph No. 131
Main room, upper level, northwest portion of ceiling.

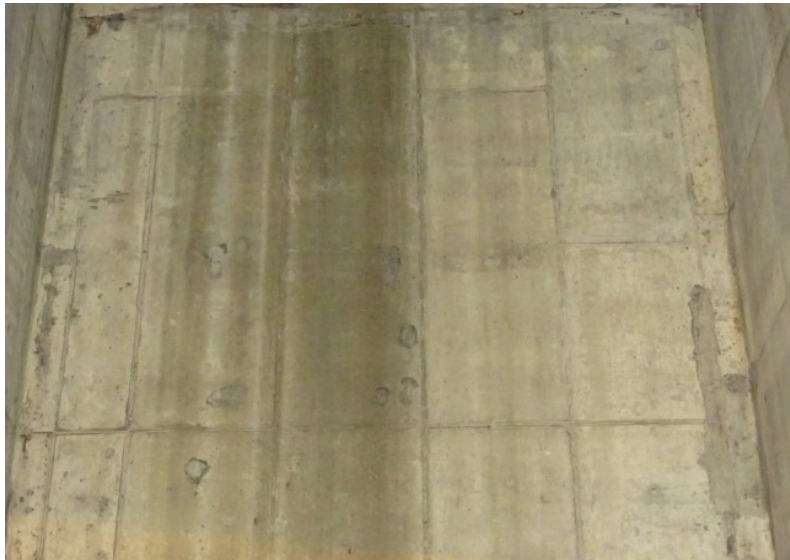
Photograph No. 132
Upper fan room, north wall, upper portion.

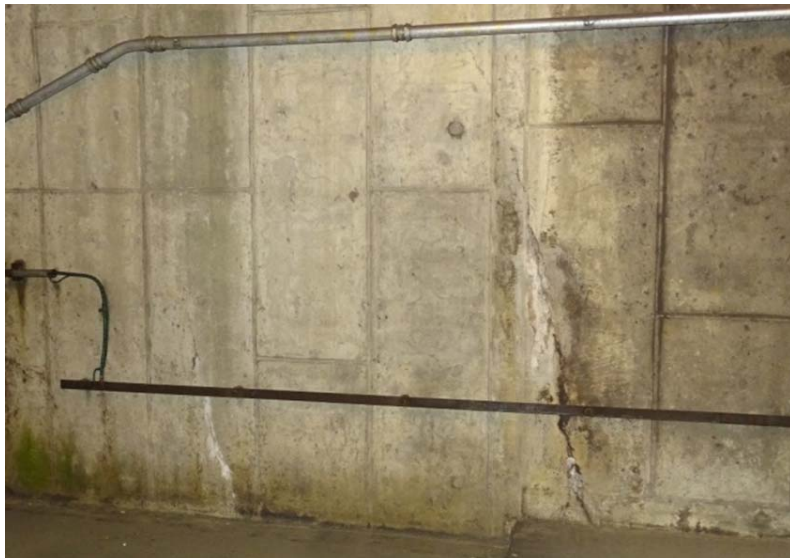
Photograph No. 134
Upper fan room, north wall, lower-west portion.

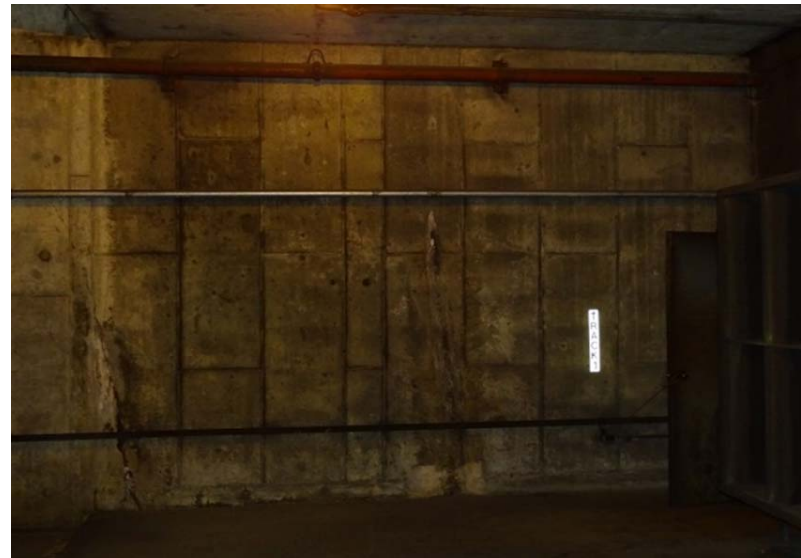
Photograph No. 135
Upper fan room, north wall, lower-west portion - vertical cracks and efflorescence.

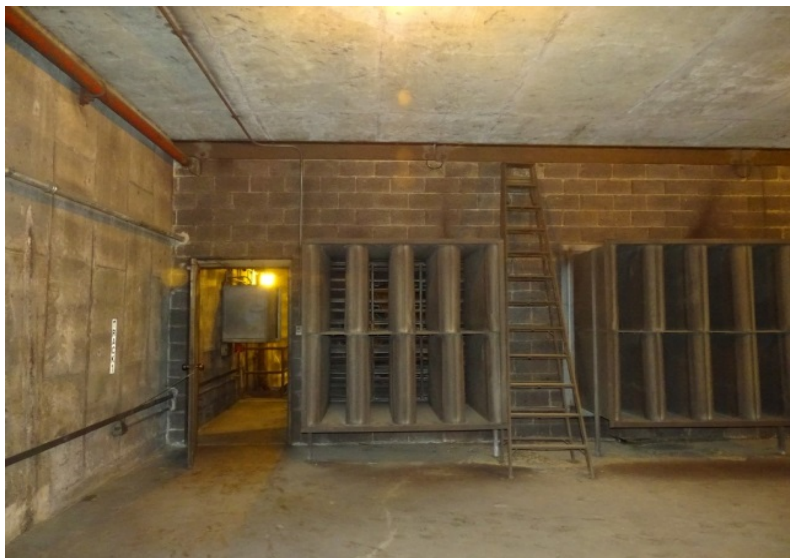
Photograph No. 140

Upper fan room, east wall, north end, middle-lower portion.

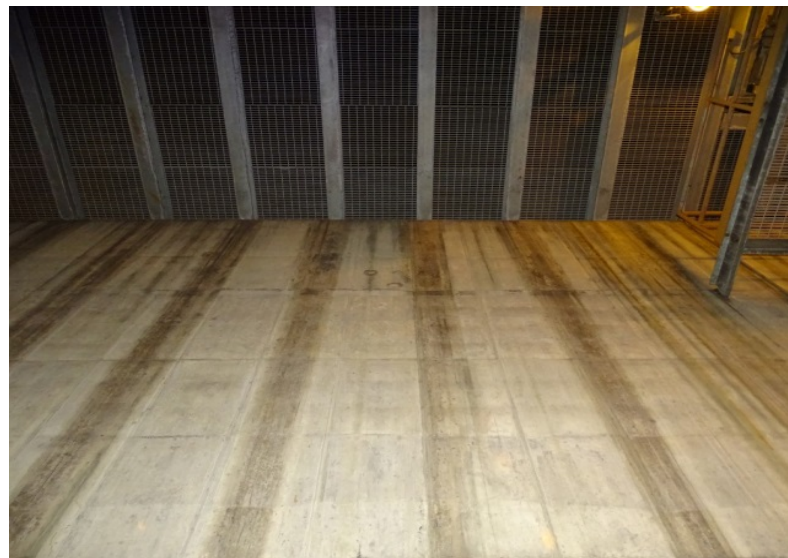
Photograph No. 141
Upper fan room, east wall, north end, lower portion.

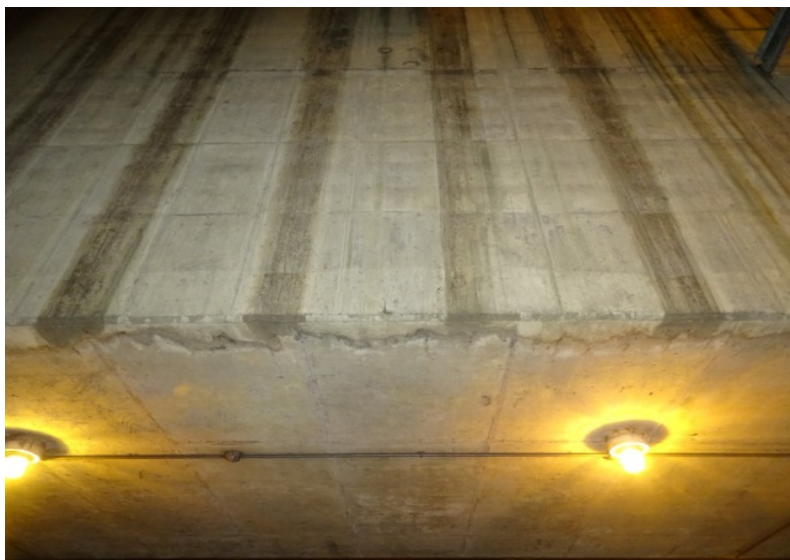
Photograph No. 142
Upper fan room, east wall, north-center section, upper portion.

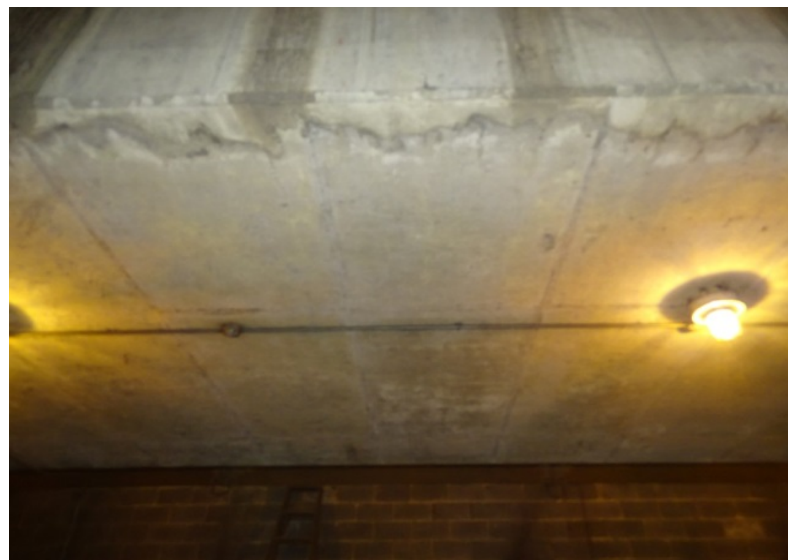
Photograph No. 143
Upper fan room, east wall, north-center section, middle-upper portion.

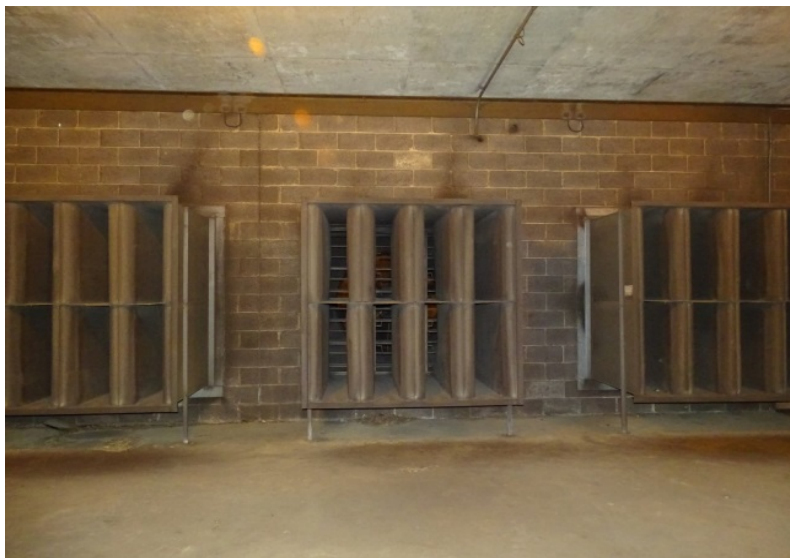
Photograph No. 148

Upper fan room, east wall, south-center section, middle-lower portion.

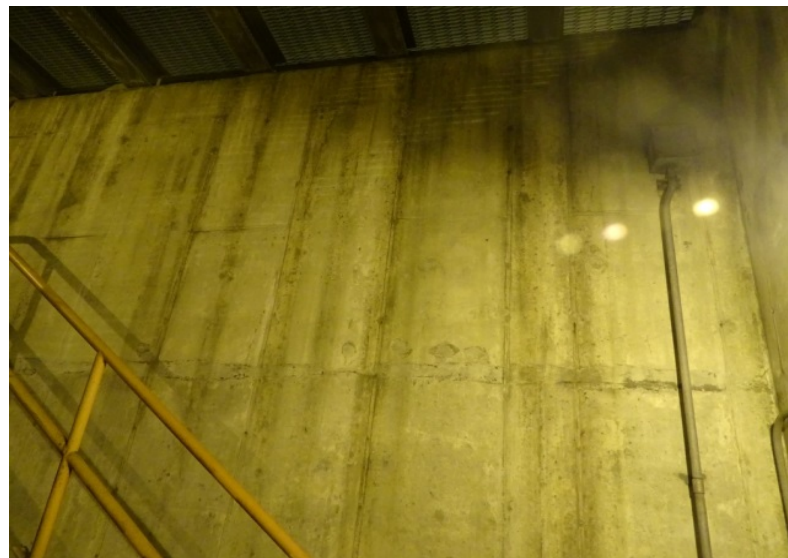
Photograph No. 149
Upper fan room, east wall, south-center section, lower portion.

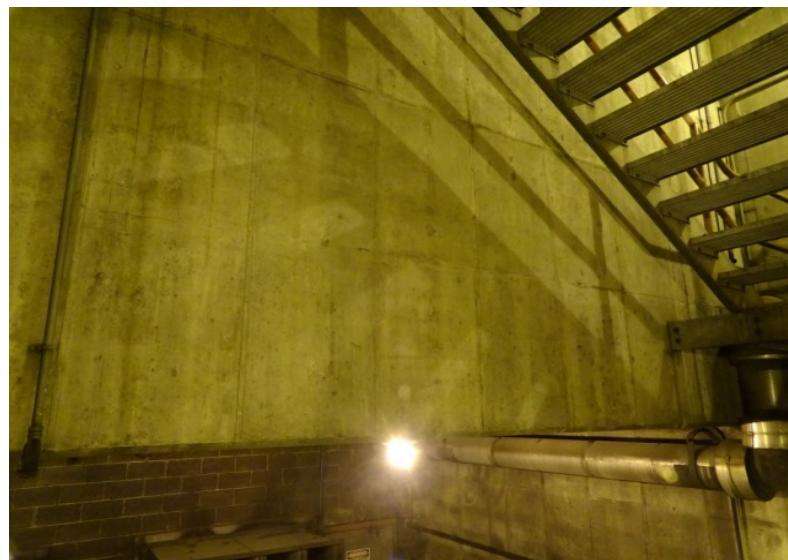
Photograph No. 151
Upper fan room, east wall, south end, middle-upper portion.

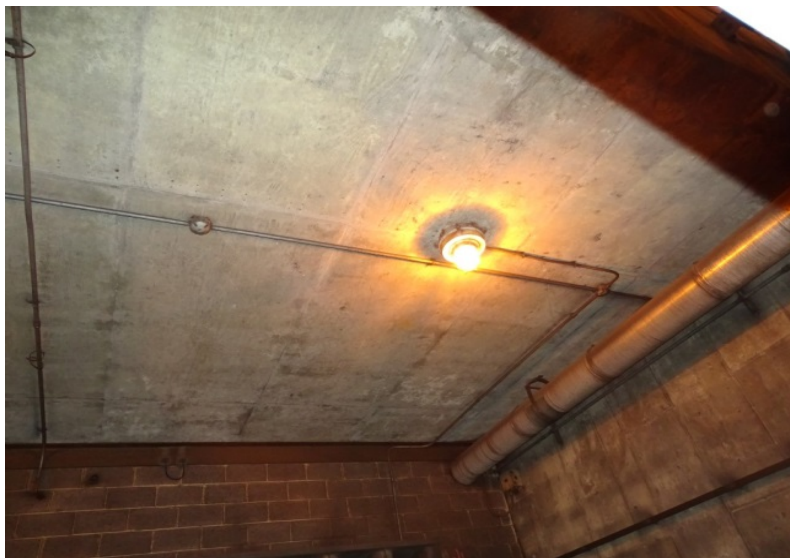
Photograph No. 152
Upper fan room, east wall, south end, middle portion.

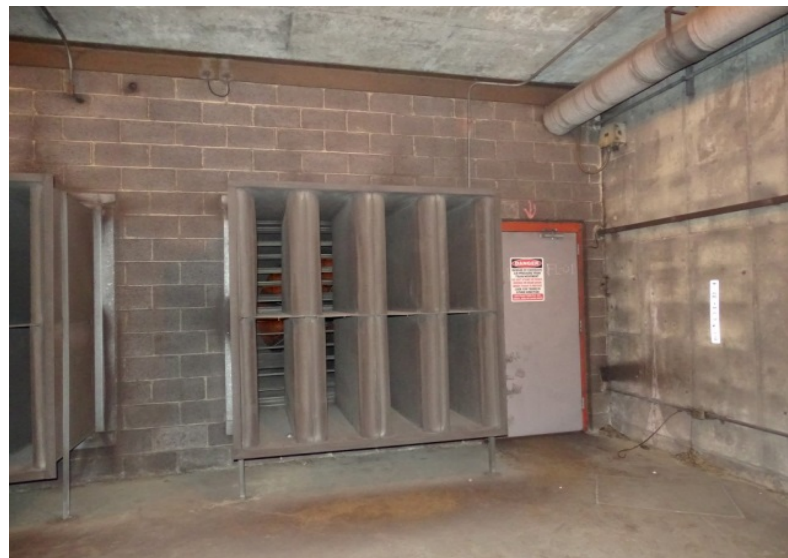
Photograph No. 153
Upper fan room, east wall, south end, middle-lower portion.

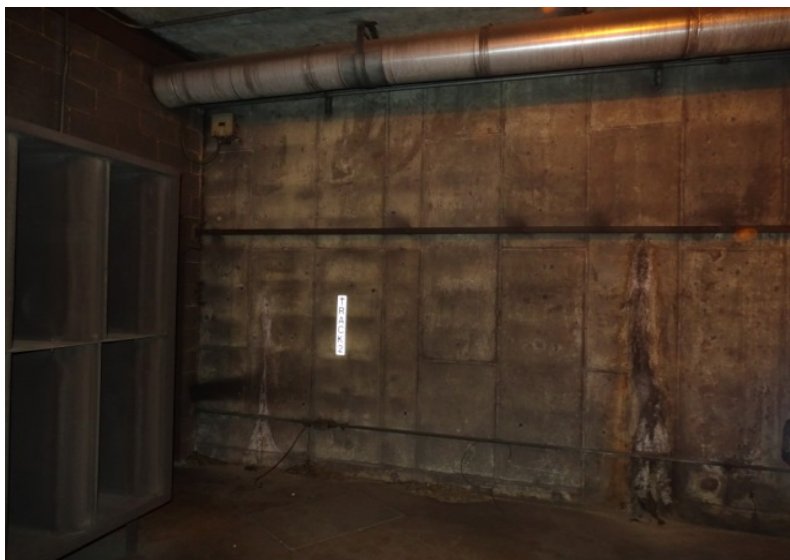
Photograph No. 154
Upper fan room, east wall, south end, lower portion.

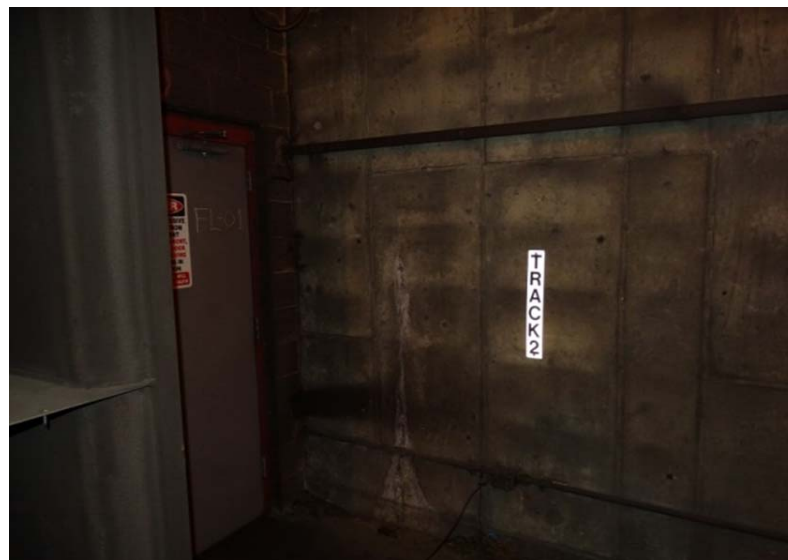
Photograph No. 155
Upper fan room, south wall, lower-east portion.

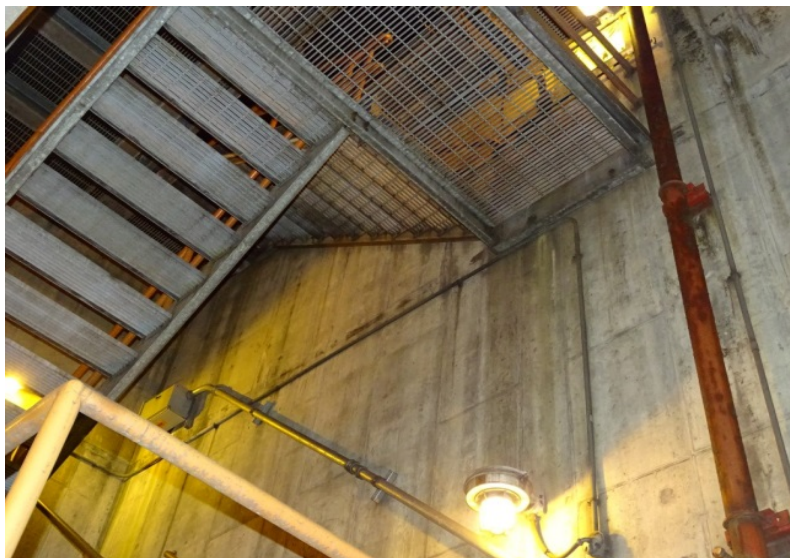
Photograph No. 160

Upper fan room, west wall, south section, lower portion.

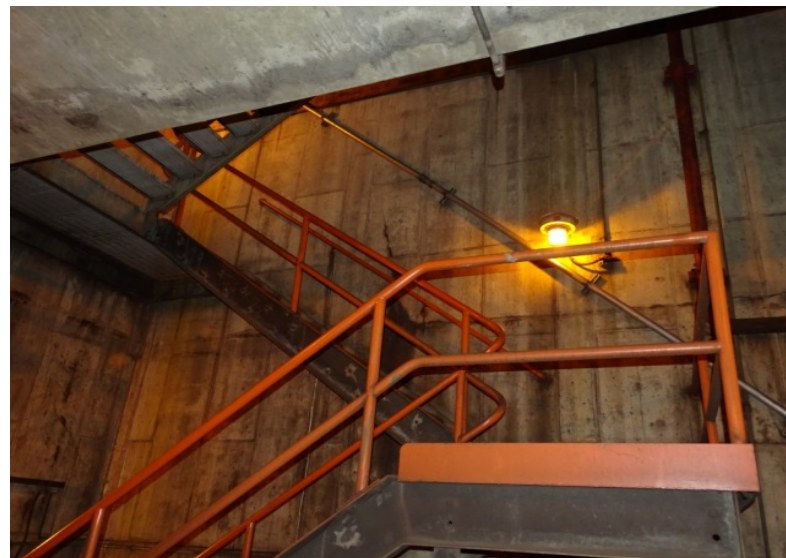
Photograph No. 161
Upper fan room, west wall, south section, upper portion.

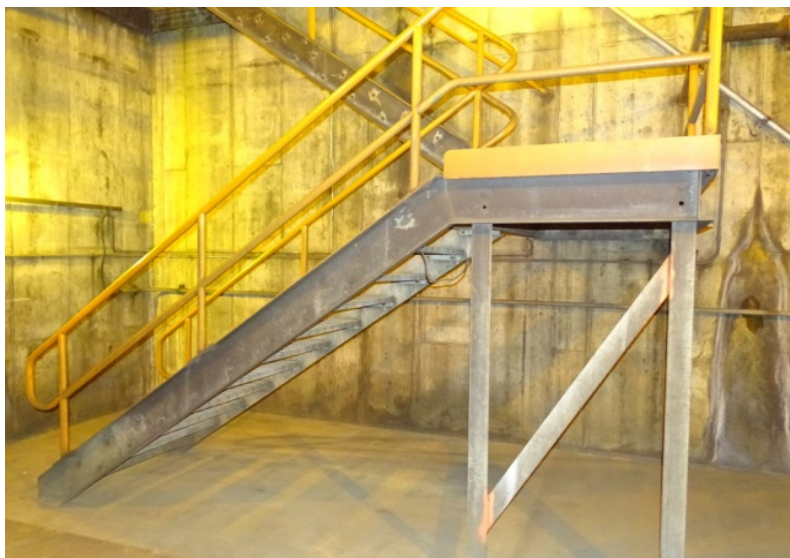
Photograph No. 162
Upper fan room, west wall, south section, middle portion.

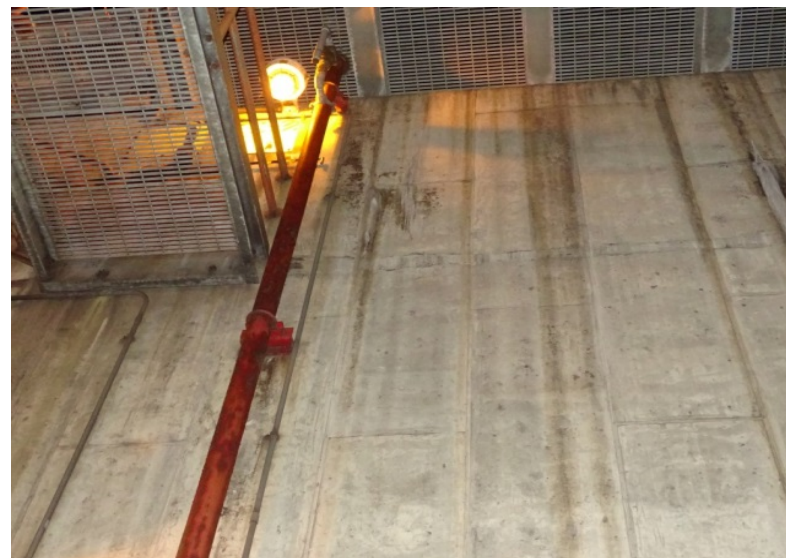
Photograph No. 163
Upper fan room, west wall, south section, lower portion.

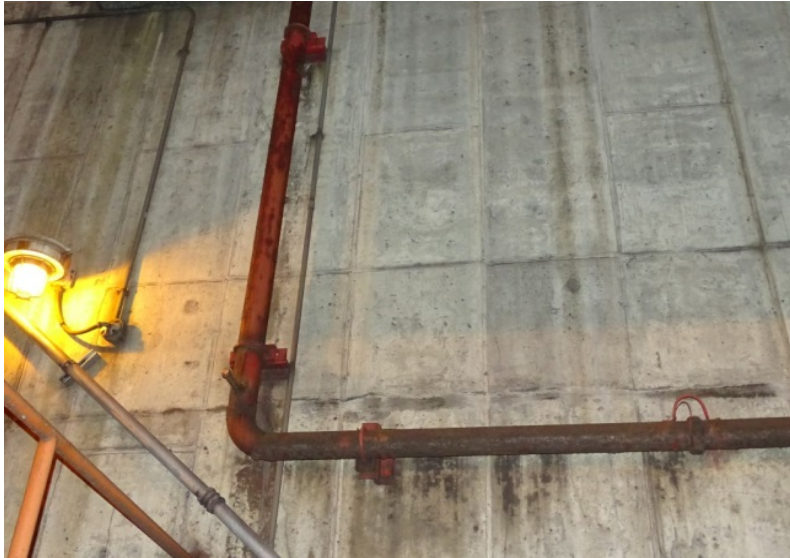
Photograph No. 164
Upper fan room, west wall, middle-north section, upper portion.

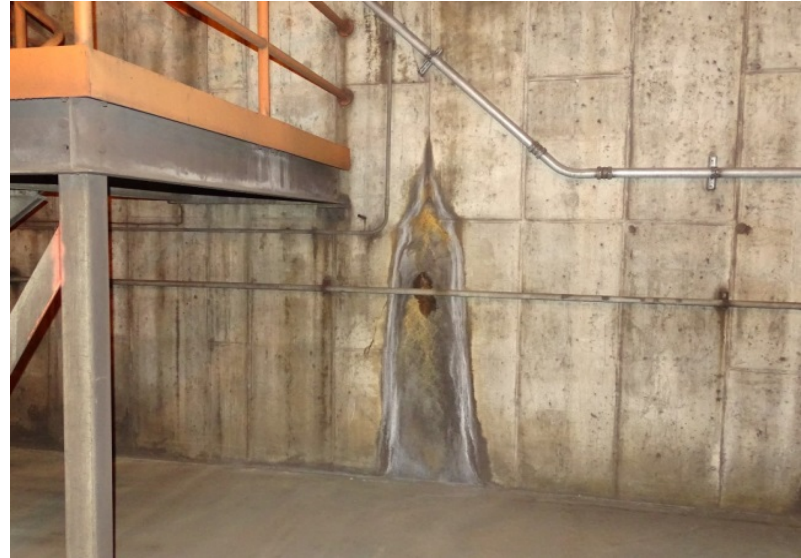
Photograph No. 165
Upper fan room, west wall, middle-north section, middle portion.

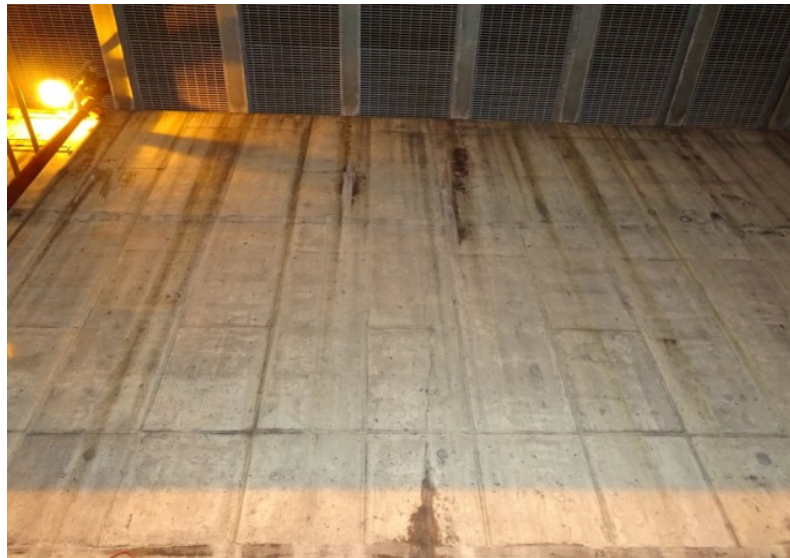
Photograph No. 166
Upper fan room, west wall, middle-north section, lower portion. Note efflorescence.

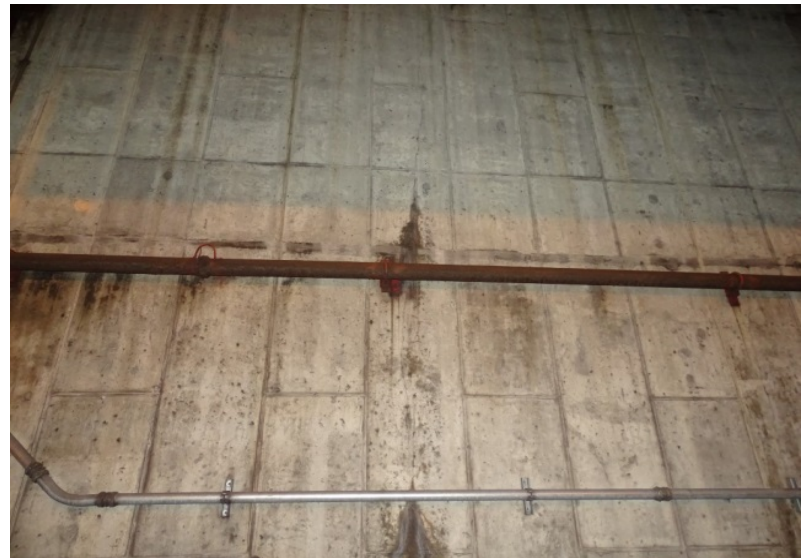
Photograph No. 167
Upper fan room, west wall, middle-south section, upper portion.

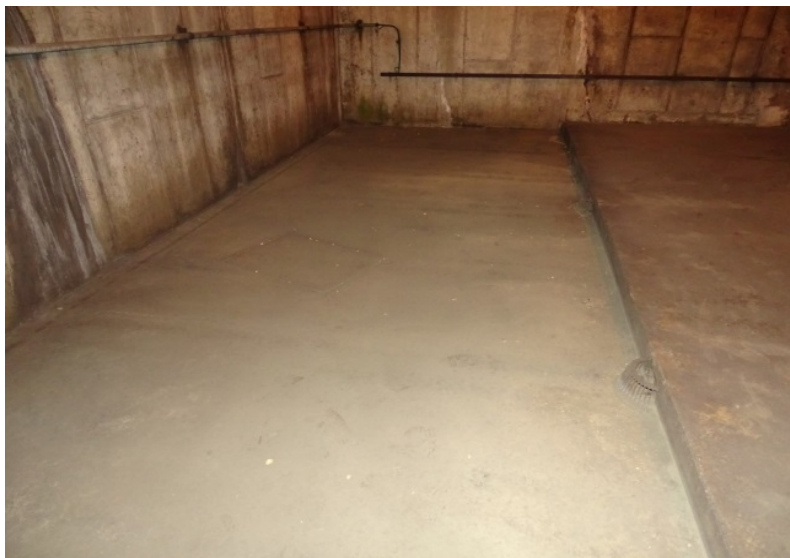
Photograph No. 172

Upper fan room, west wall, south end, lower portion.

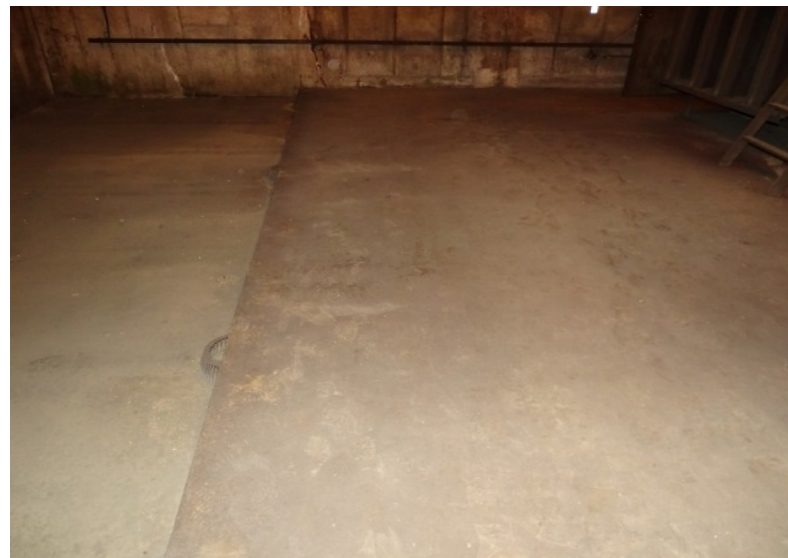
Photograph No. 173
Upper fan room floor, north section, west end.

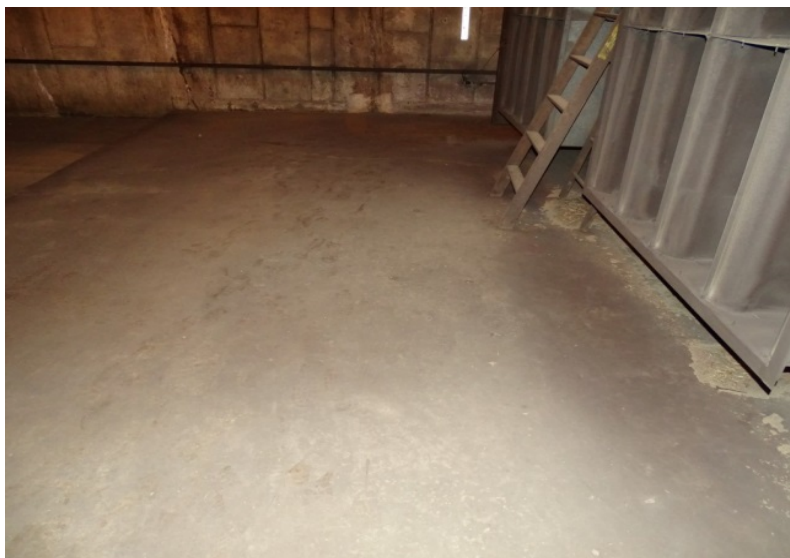
Photograph No. 174
Upper fan room floor, north section, center portion.

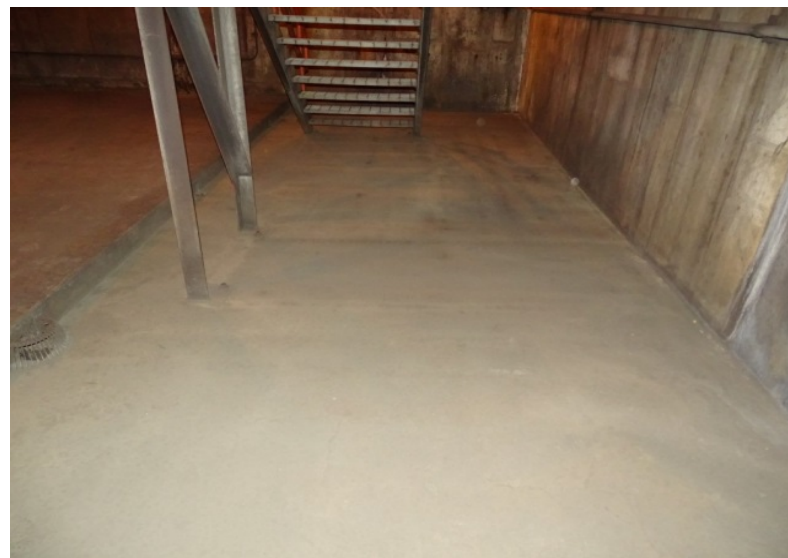
Photograph No. 175
Upper fan room floor, north section, east end.

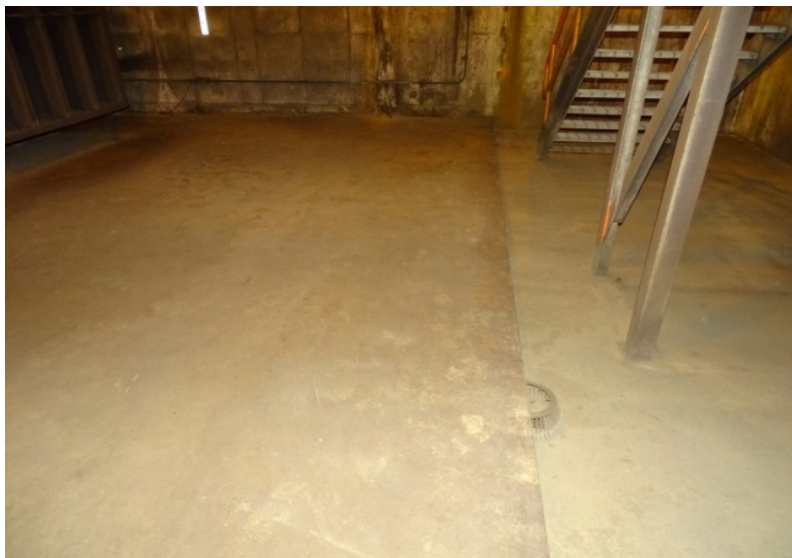
Photograph No. 176
Upper fan room floor, south section, west end.

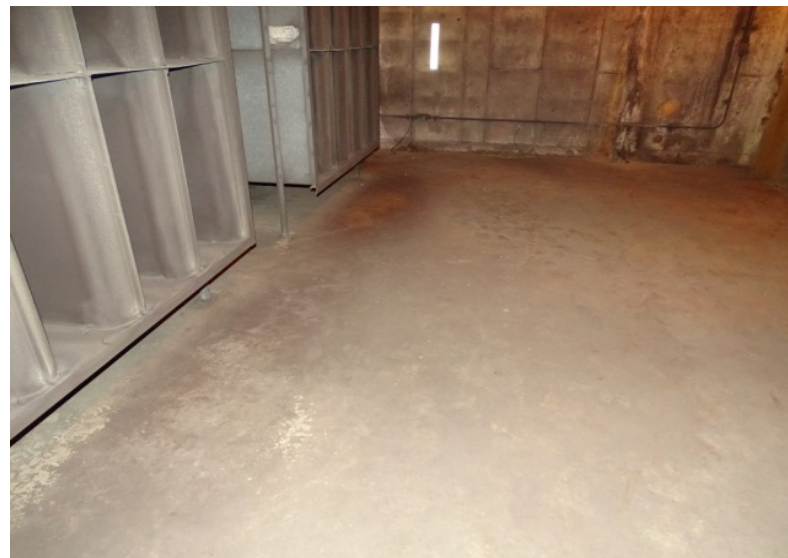
Photograph No. 177
Upper fan room floor, south section, center portion.

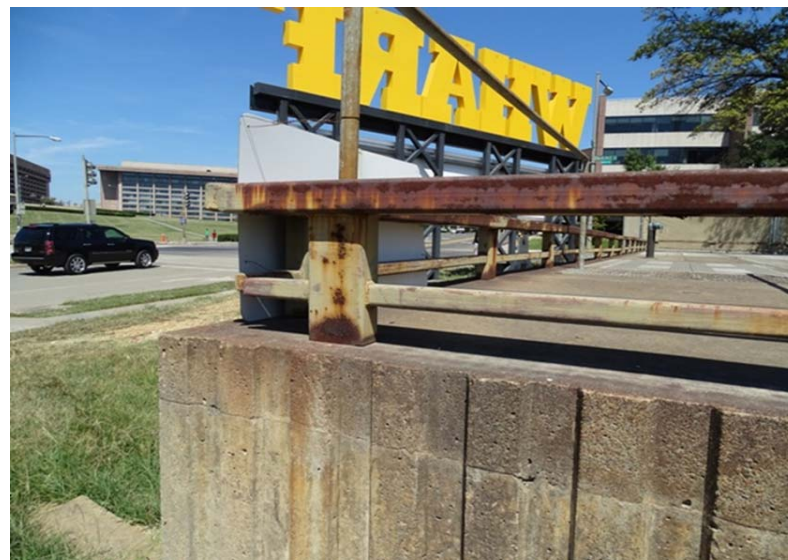
Photograph No. 179
Exterior of main vent shaft, south wall.

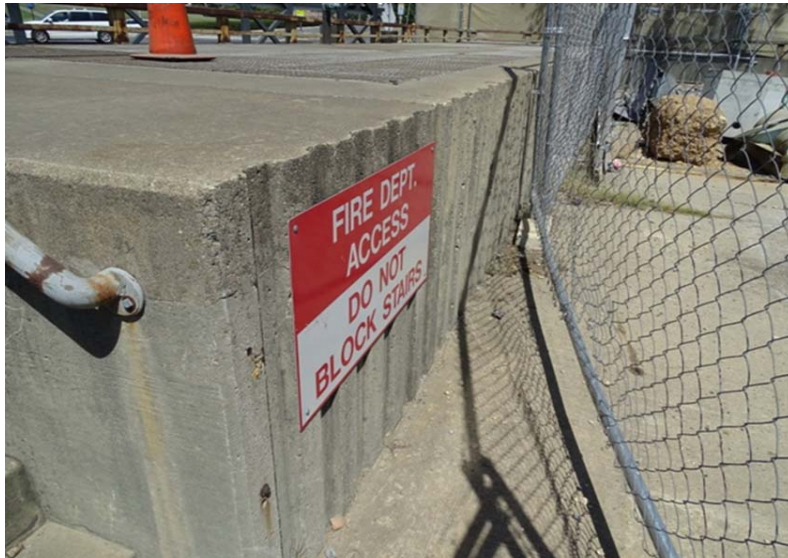
Photograph No. 184

Vent shaft exterior, southeast side.

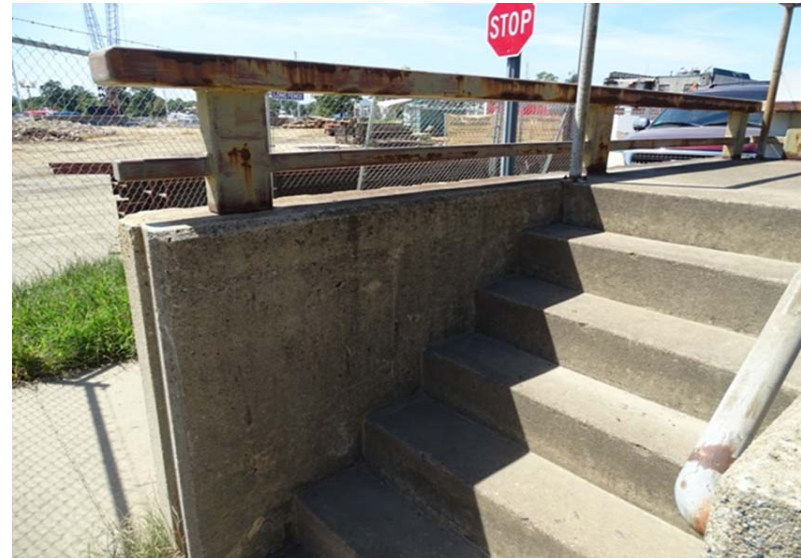
Photograph No. 185
Vent shaft exterior, close up of southeast side.

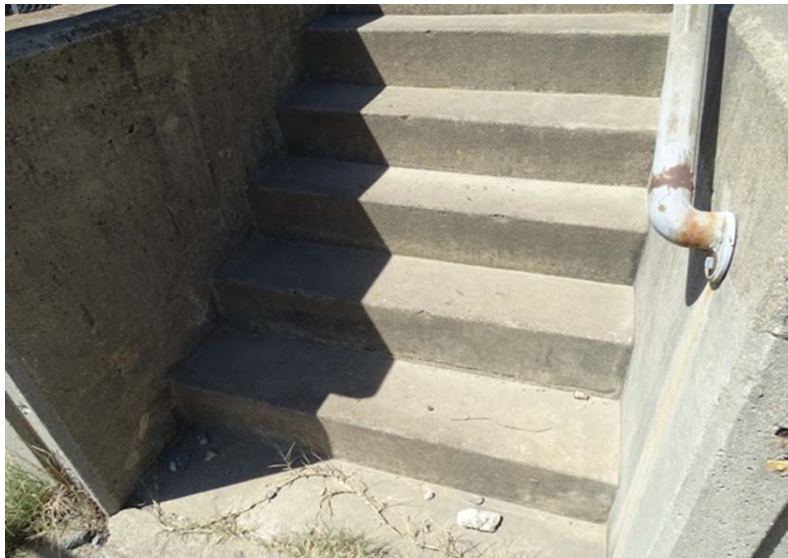
Photograph No. 186
Vent shaft exterior, steps at the south corner.

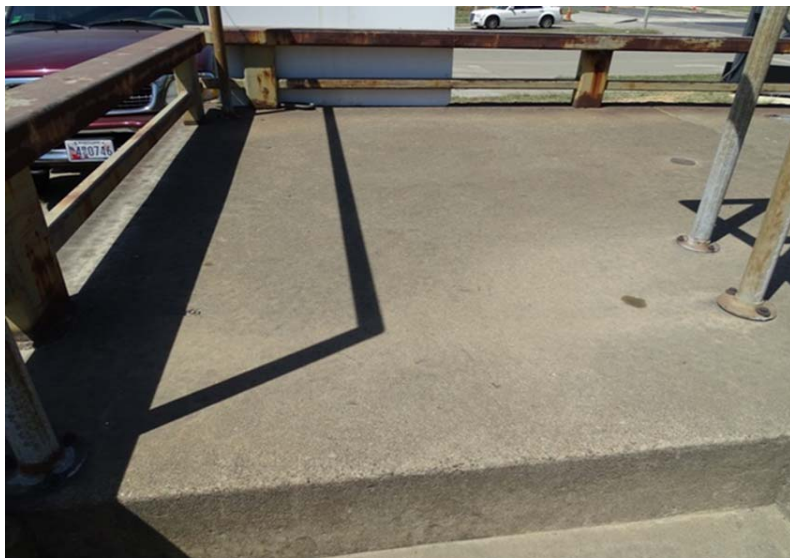
Photograph No. 188
Vent shaft exterior, steps at the south corner.
