**Report of Preconstruction Condition
Survey Services**

**ADJACENT PROPERTIES TO
THE WHARF – PHASE I
WASHINGTON, DC**

ECS PROJECT NO. 37:1306

OCTOBER 6, 2014

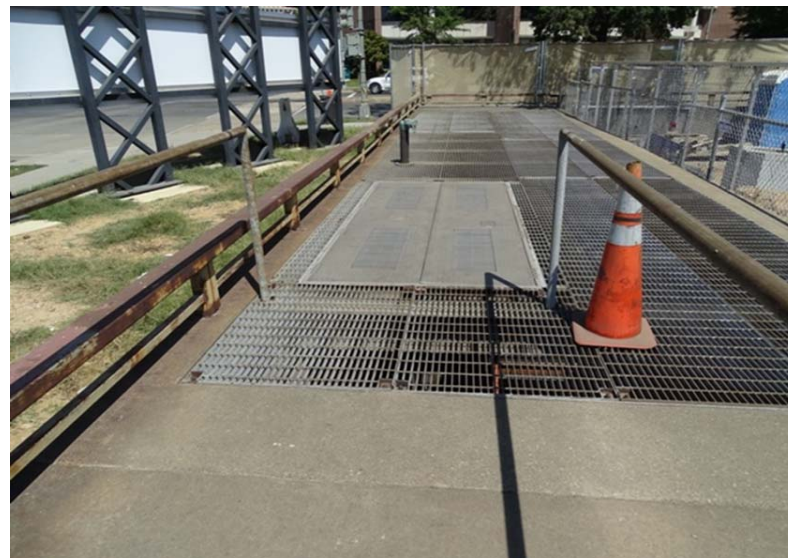
Photograph No. 189
Vent shaft exterior, south end of deck.

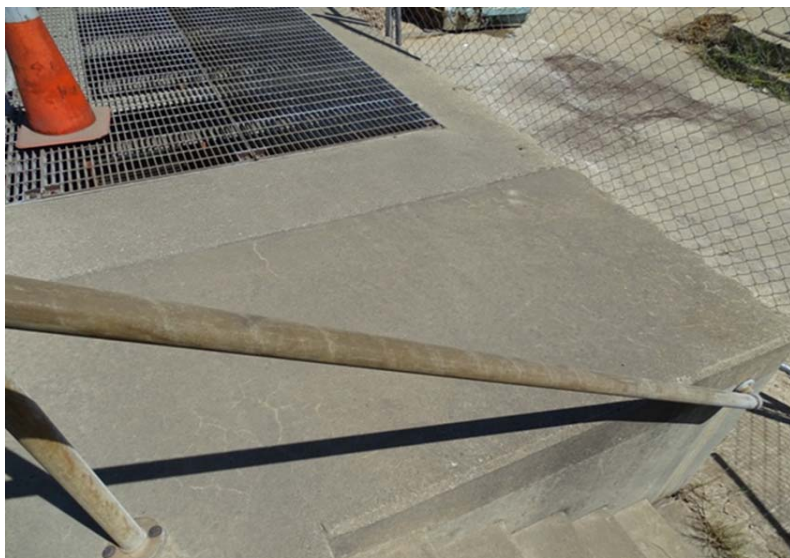
Photograph No. 190
Vent shaft exterior, looking northeast at deck.

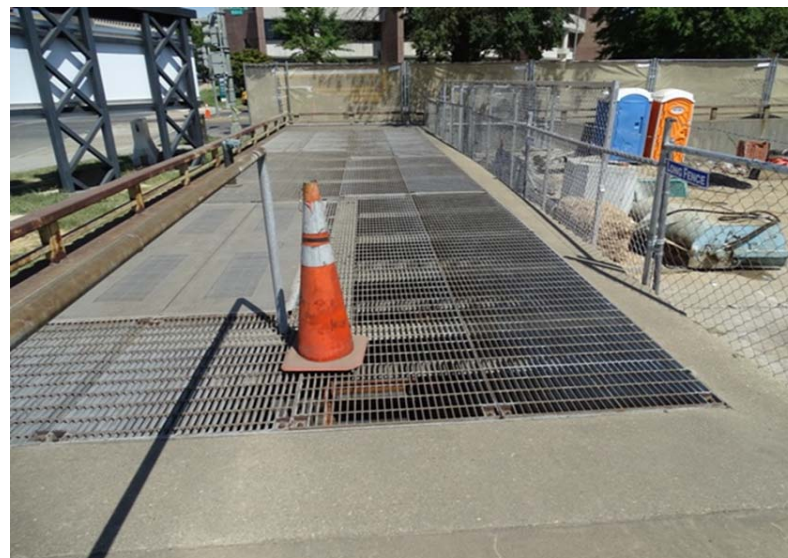
Photograph No. 191
Vent shaft exterior, south corner of deck.

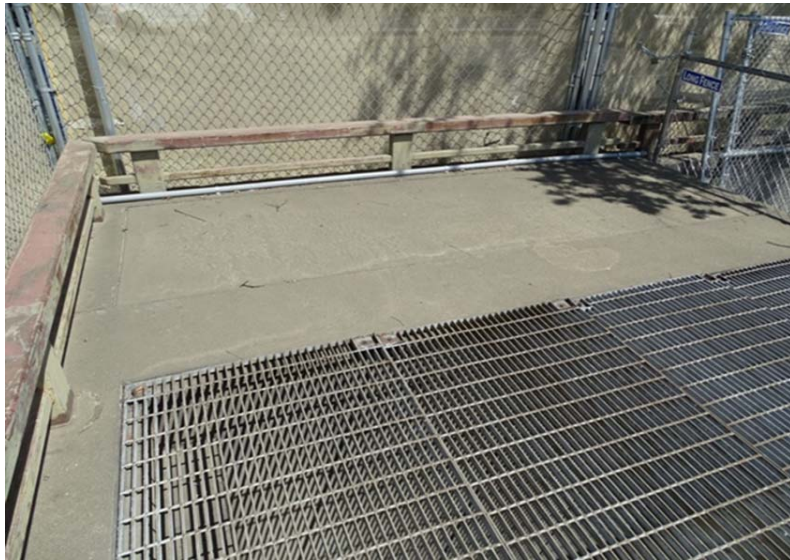
Photograph No. 192
Vent shaft exterior, looking northeast at deck.

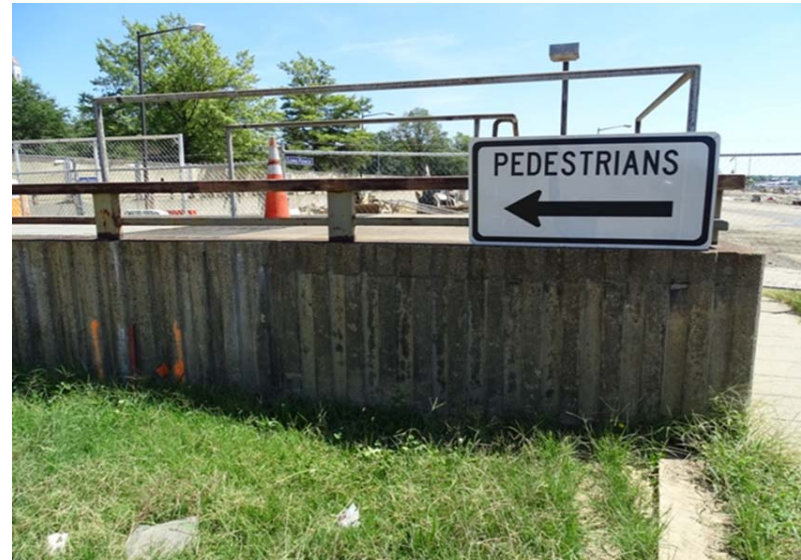
Photograph No. 193
Vent shaft exterior, north end of deck.

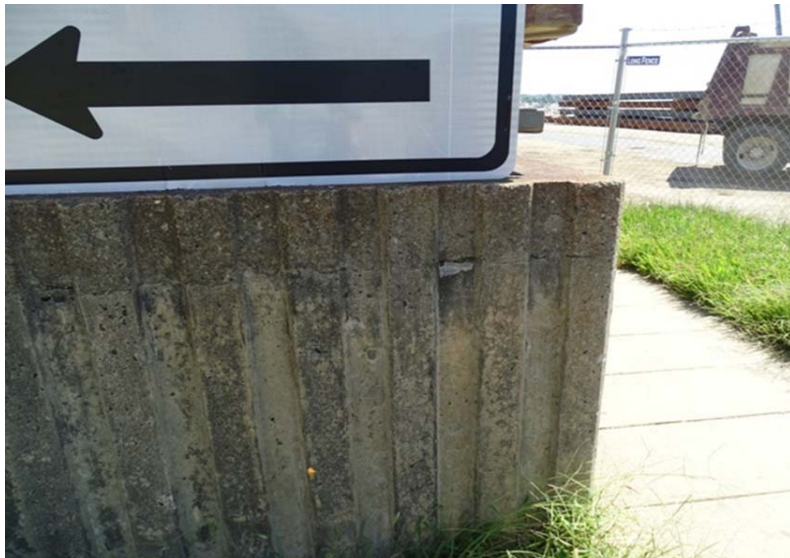
Photograph No. 194
Vent shaft exterior, northwest side, section 1.

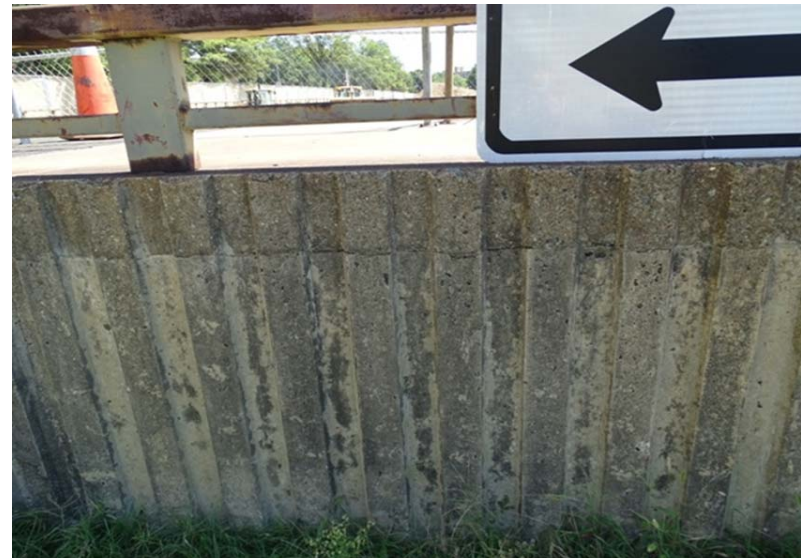
Photograph No. 195
Vent shaft exterior, northwest side, close up of separation.
