NATIONAL TRANSPORTATION SAFETY BOARD
Investigative Hearing

Washington Metropolitan Area Transit Authority Metrorail train 302 that encountered heavy smoke in the tunnel between the L'Enfant Plaza Station and the Potomac River Bridge on January 12, 2015

GROUP	C
EXHIBIT	
3

Summary Report For PSRS Adjustments at One Judiciary Square

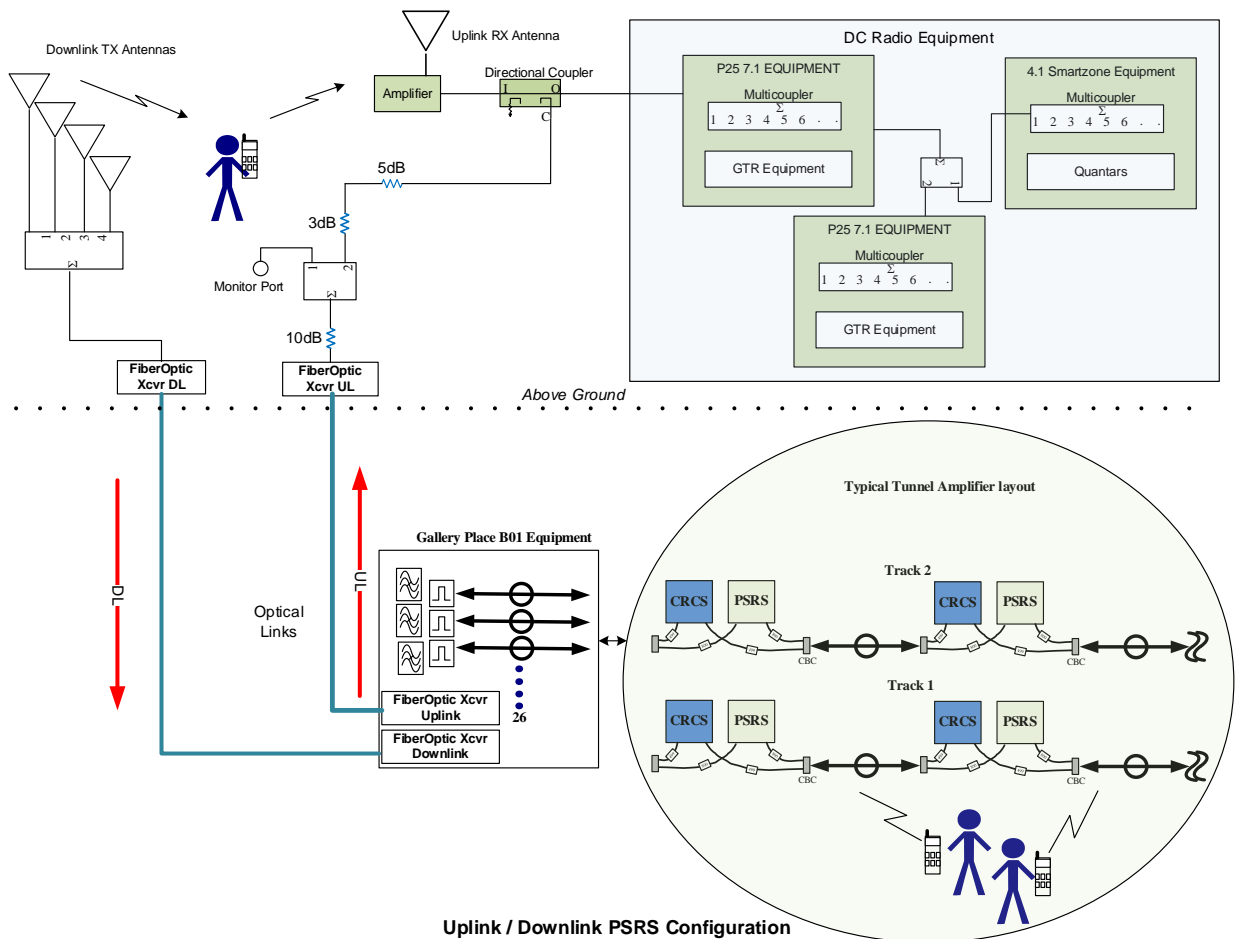
Typical PSRS configuration

The DC Public Safety Radio System (PSRS) operates in the below ground at 800 MHz to support EMS and DC fire. In the current mode of operation, all communication from the bellow Ground segments are combined at galley Place Station (room B01). Signals are converted from RF to optical and linked to DC's COMM room at One Judiciary square. At the penthouse COMM room, DC's radio equipment is installed and operated. This is also an antenna site for subscriber units operating above ground. See diagram below
