**NATIONAL TRANSPORTATION SAFETY BOARD
Office of Research and Engineering
Vehicle Recorder Division
Washington, DC 20594**

**GROUP CHAIRMAN'S FACTUAL REPORT OF INVESTIGATION
External Imagery Factual Report
DCA15MA019**

Location: Koehn Dry Lake, CA
Date: October 31, 2014
Vehicle: Model 339 SpaceShipTwo
Registration: N339SS
Operator: Scaled Composites, LLC.
NTSB Number: DCA15MA019

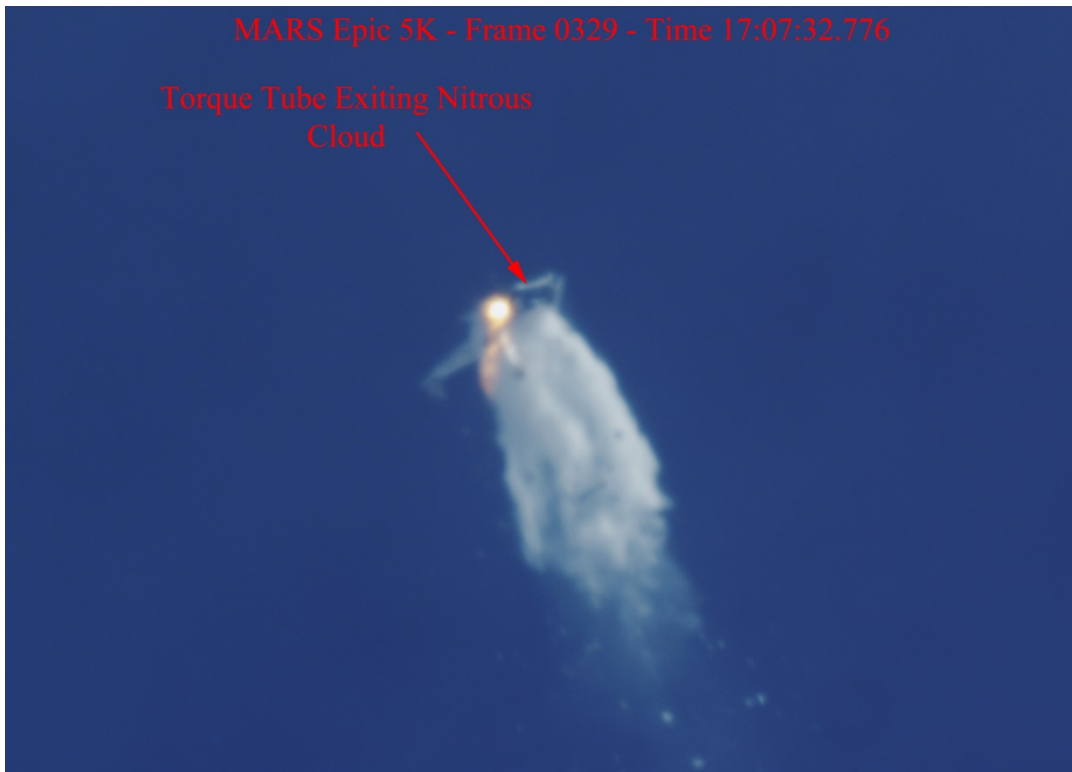
Figure 19.

Figure 19 shows evidence of the torque tube detaching from the vehicle and exiting the cloud of nitrous.

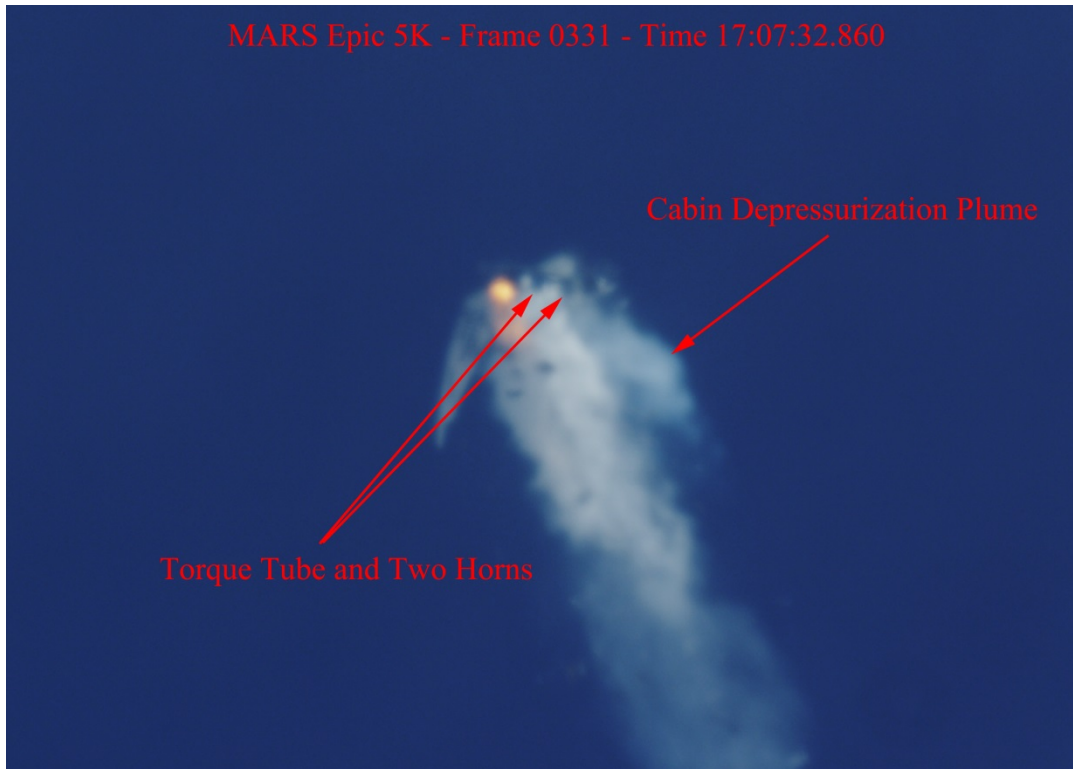
Figure 21.

Figure 21 shows additional evidence of the torque tube departing from the vehicle. The two feather actuator horns are visible and indicated in the graphic with two red arrows. The cabin depressurization has become more developed.

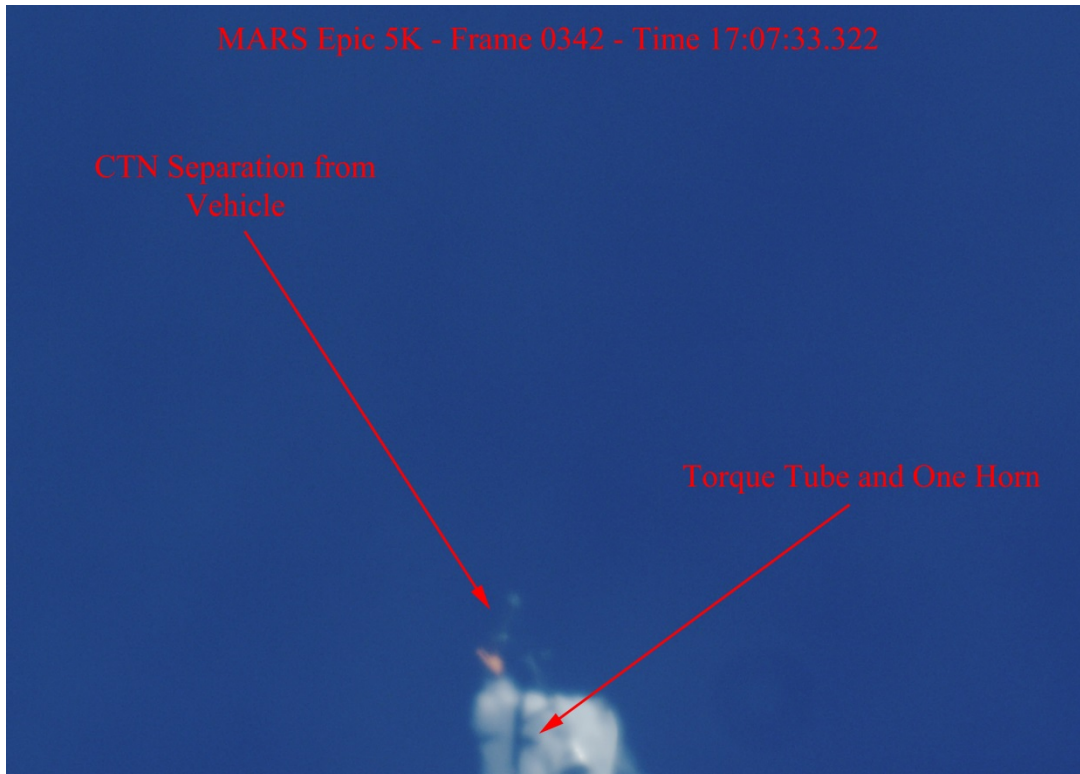
Figure 22.

Figure 22 shows evidence of the Case Throat Nozzle Assembly (CTN) separating from the vehicle, a flame still visible near the nozzle end. The torque tube is seen detached from the vehicle and only one feather actuator horn is visible in the camera's frame. The main fuselage is surrounded by a cloud of nitrous.

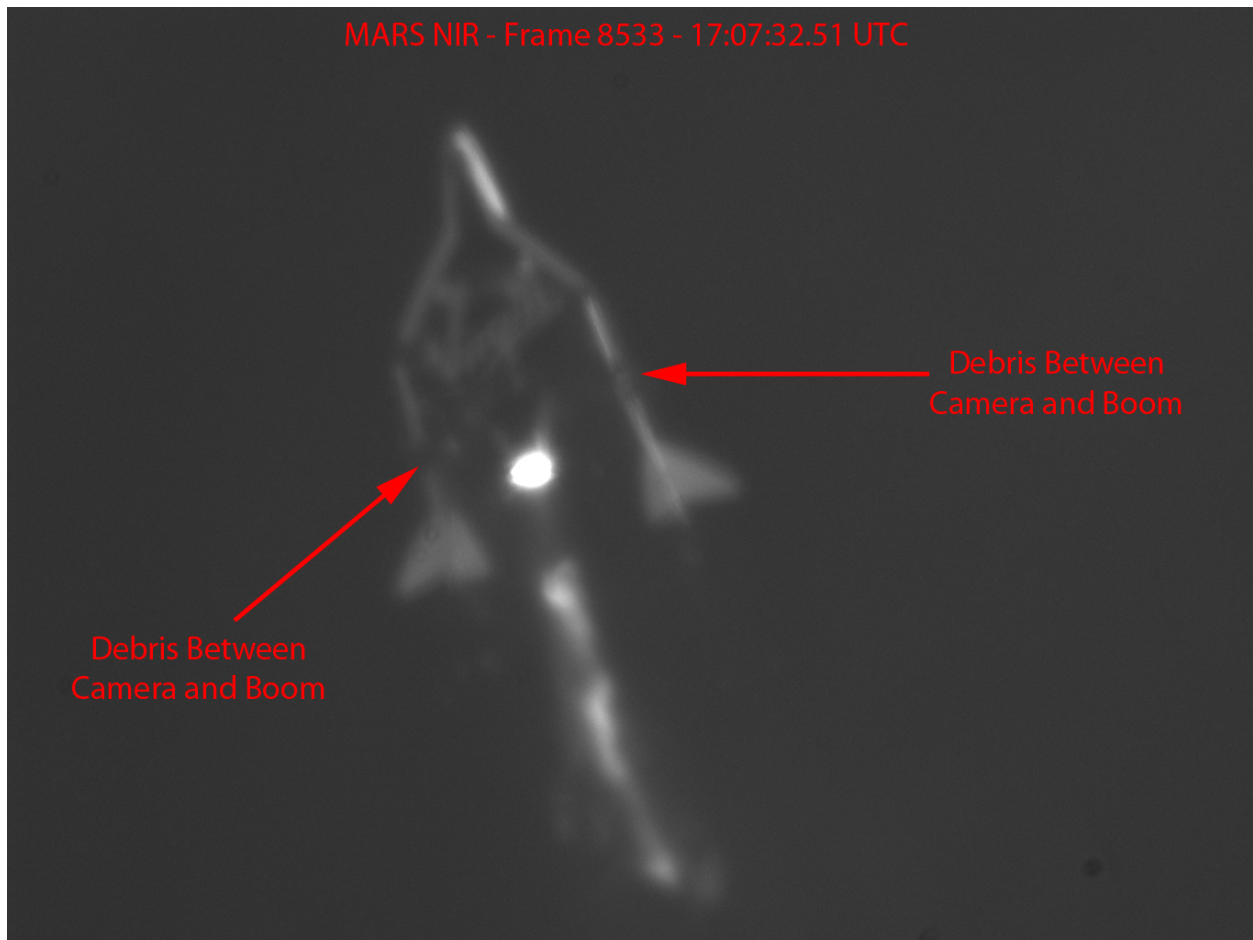
Figure 23.

Figure 23 shows the time of first evidence of debris separating from the vehicle. Unidentified objects obscure the imager's view of the left and right booms.

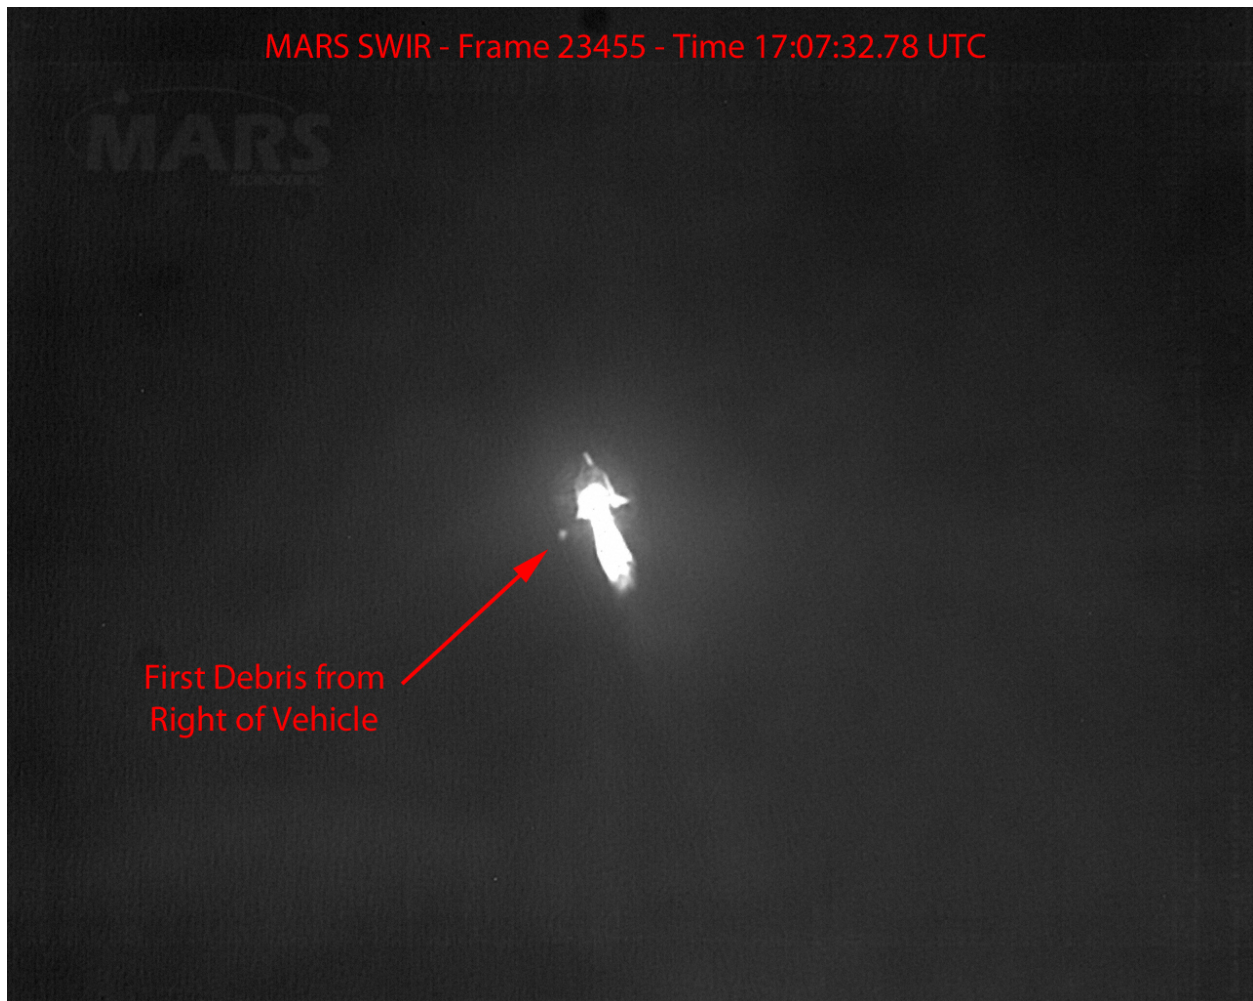
Figure 33. MARS Enhanced.

Figure 33 shows the first identifiable moment of debris separation from the right side of the vehicle.

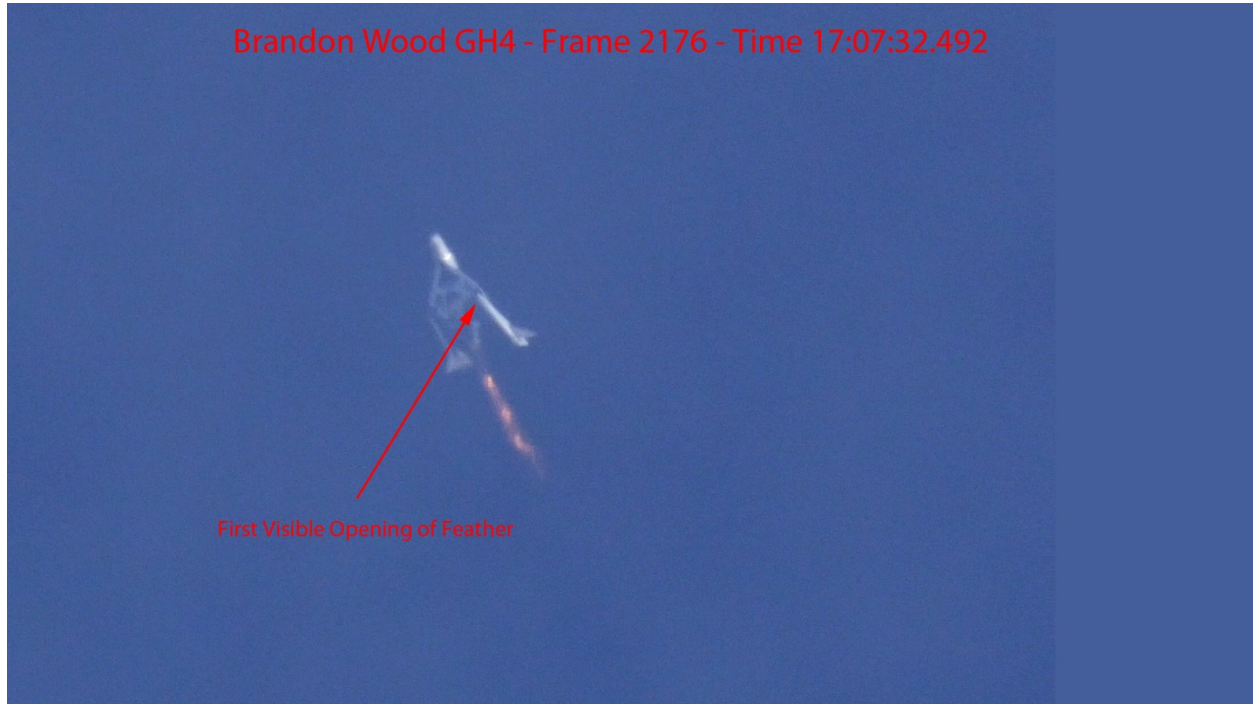
Figure 39.

Figure 39 shows the first visible evidence of the feather opening. The feather tusk region is clearly disjointed from the main wing area on the left side of the vehicle.

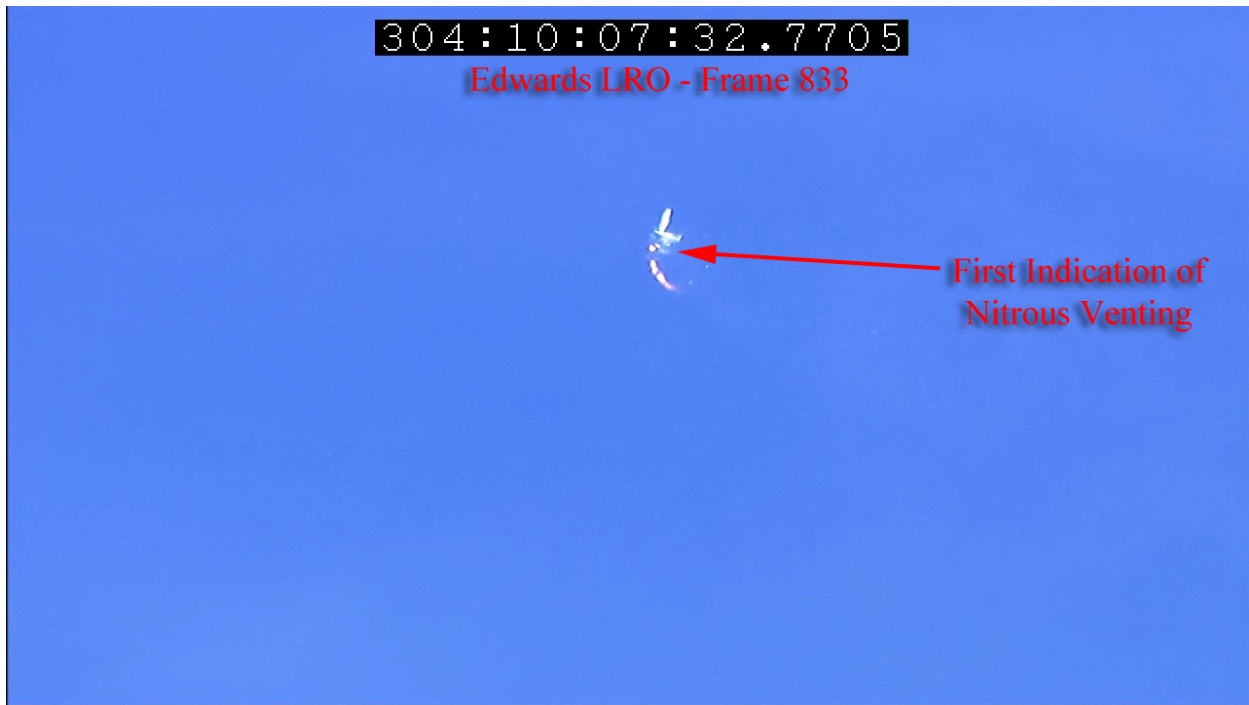
Figure 53.

Figure 53 shows the first visible evidence of nitrous venting.

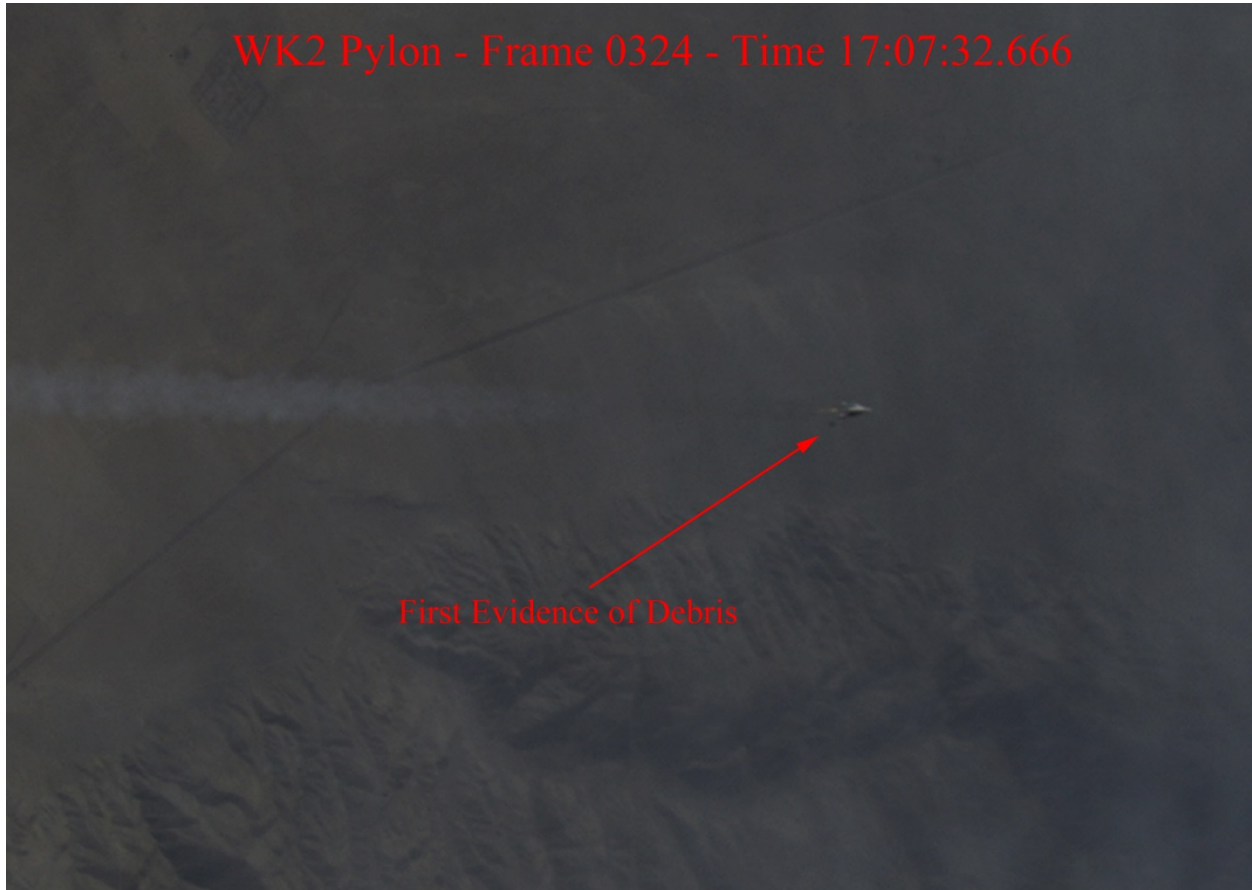
Figure 58.

Figure 58 shows the first evidence of debris.

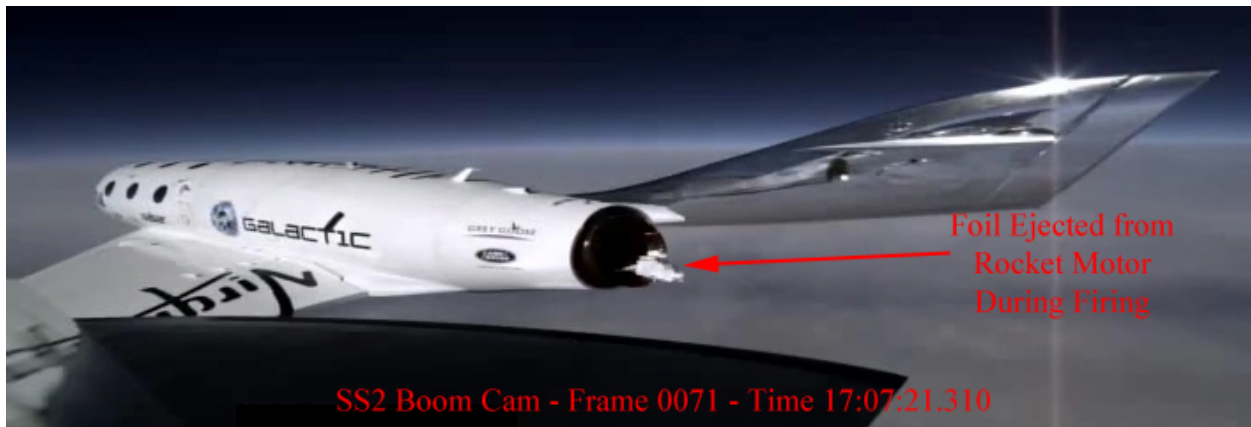
Figure 61.

Figure 61 shows a foil covering from the rocket motor being ejected from the nozzle near the moment of firing as expected.

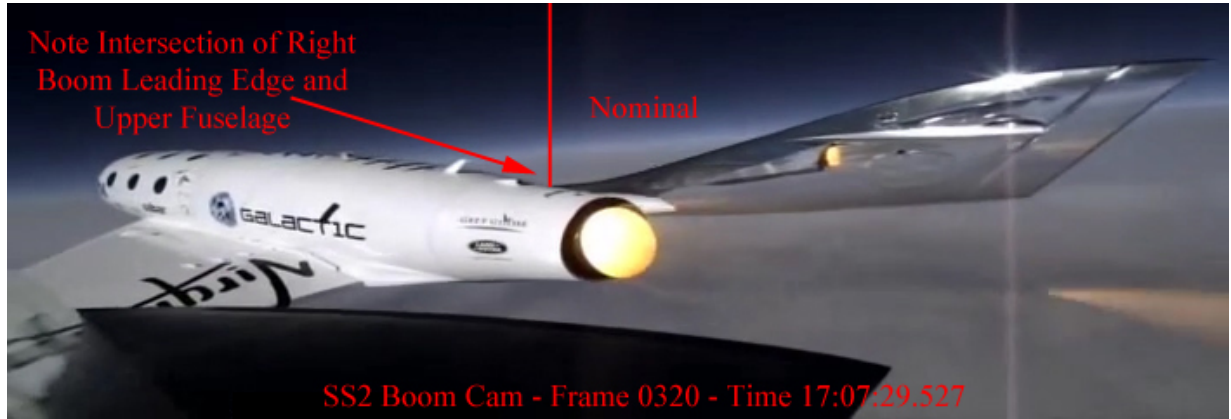
Figure 62.

Figure 62 is the last frame exported from the recording that shows the feather in a undeployed and nominal position. A vertical line was drawn at the intersection of the right boom's leading edge and the contour of the upper fuselage structure to illustrate the feather's relative position. In every frame prior to this, the feather position is nominal. By figure 62 and forward, the exported images show positive feather movement indicated by the incongruity between the vertical line and the relative position of the right boom's leading edge and the contour of the fuselage.

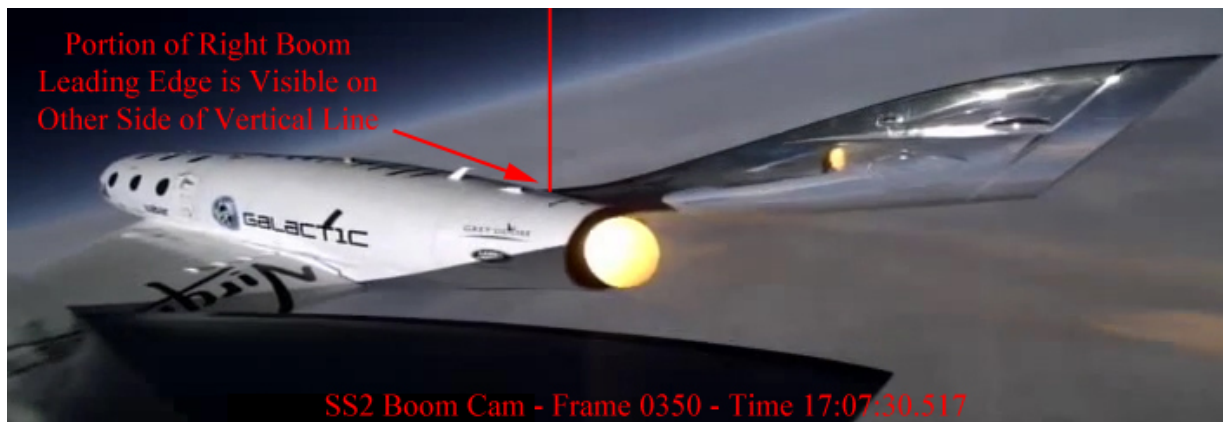
Figure 64.

Figure 64 shows a portion of the right boom leading edge is visible to the left of the transposed vertical line applied from the previous figures. By this frame, movement of the feather is apparent when compared to figures 62 and 63.

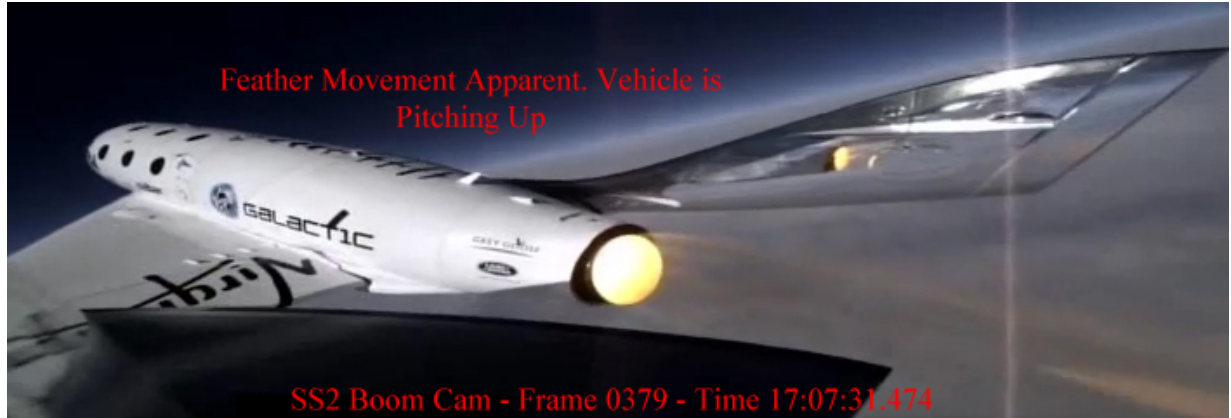
Figure 65.

Figure 65 shows an increase in feather movement. The vehicle continues to pitch upward.

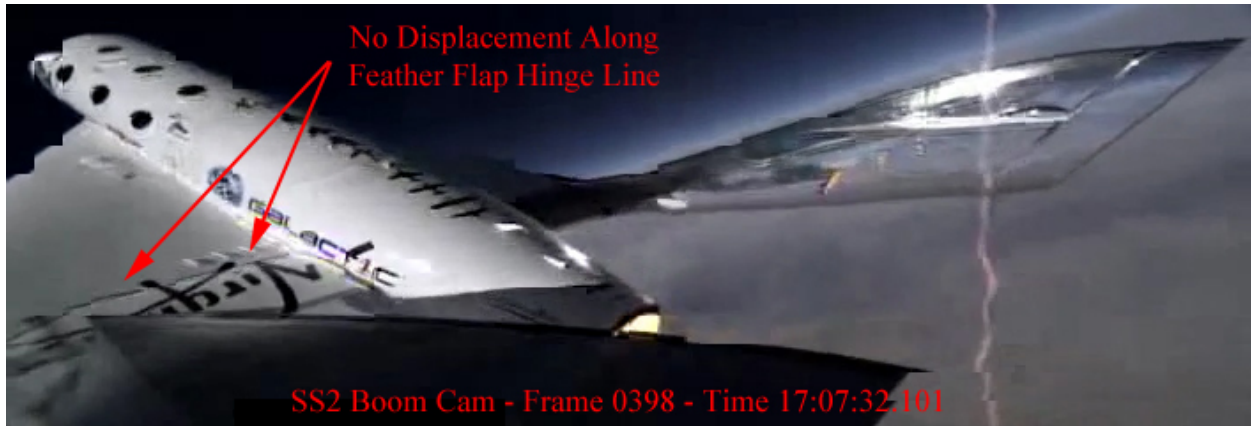
Figure 67a.

Figure 67a shows the last frame in the series of exported images where the feather flap hinge line does not exhibit displacement. The feather flap hinge line in this image appears nominal.

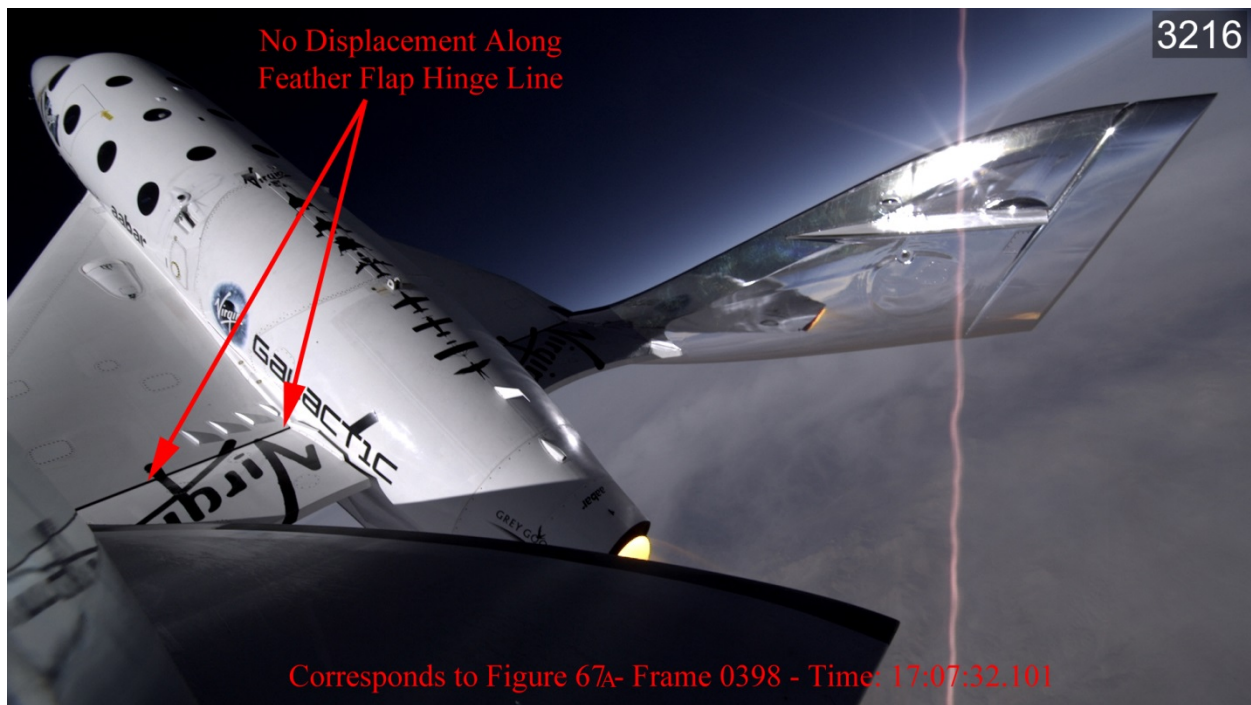
Figure 67b.

Figure 67b is the corresponding still frame exported from the boom camera hard drive containing high definition imagery.

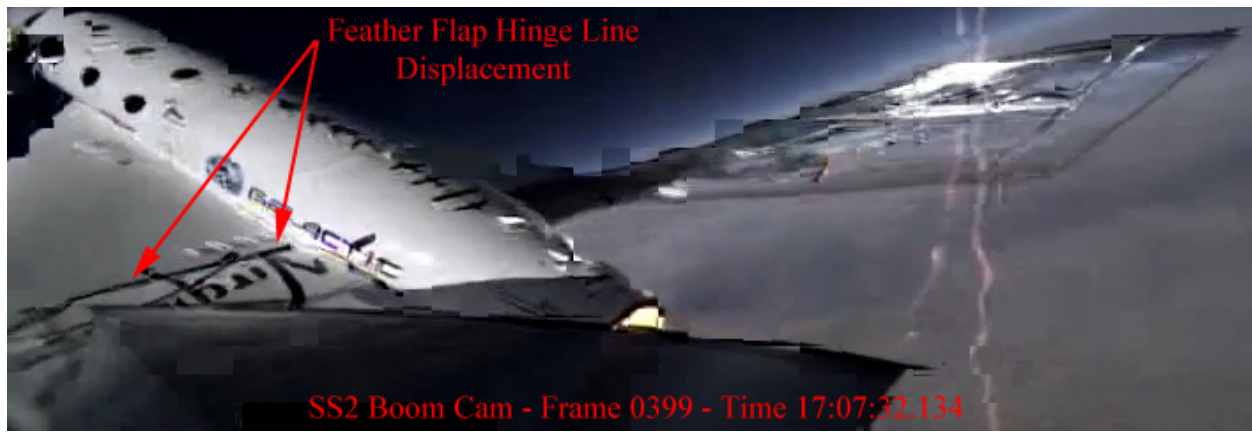
Figure 68a.

Figure 68a shows the first frame in the series of exported images where a displacement is exhibited along the feather flap hinge line. From this moment forward, the feather structure appears to become further displaced from the main structure of the vehicle.

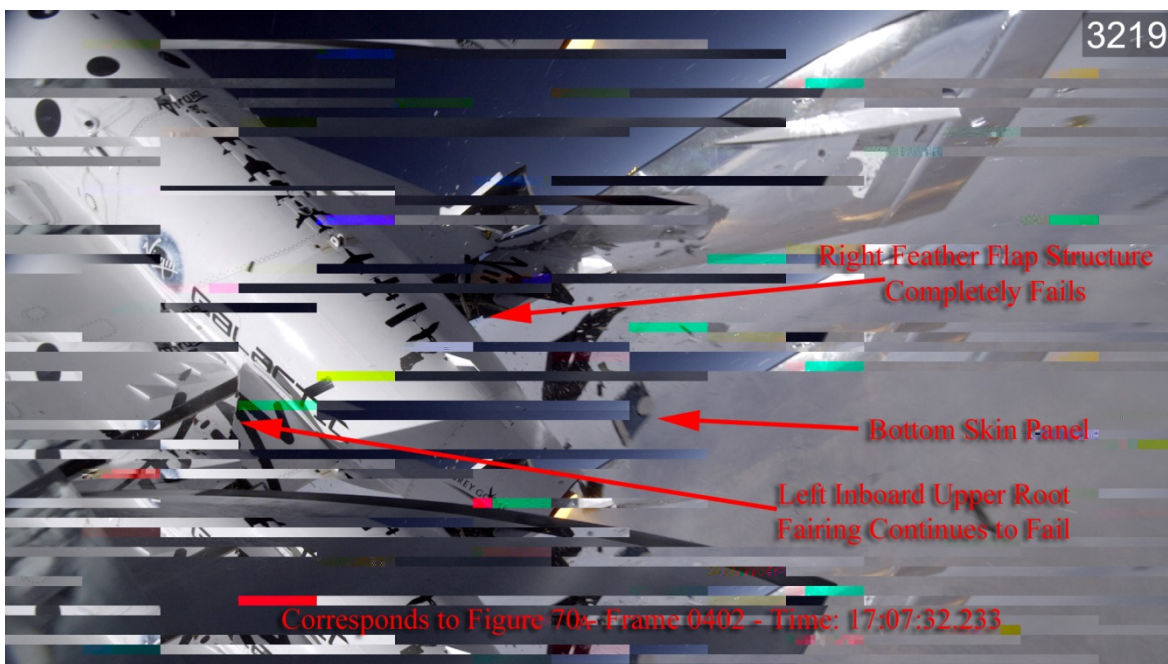
Figure 70b.

Figure 70b is the corresponding still frame exported from the boom camera hard drive containing high definition imagery. The high definition file shows the right feather flap structure completely failing. A skin panel from the bottom surface of the vehicle is seen removed from the structure and the left inboard upper root fairing structure is continuing to fail. Figure 70b is the last usable high definition file recovered from the boom camera hard drive. All subsequent recovered imagery contained heavy digital artifacting.

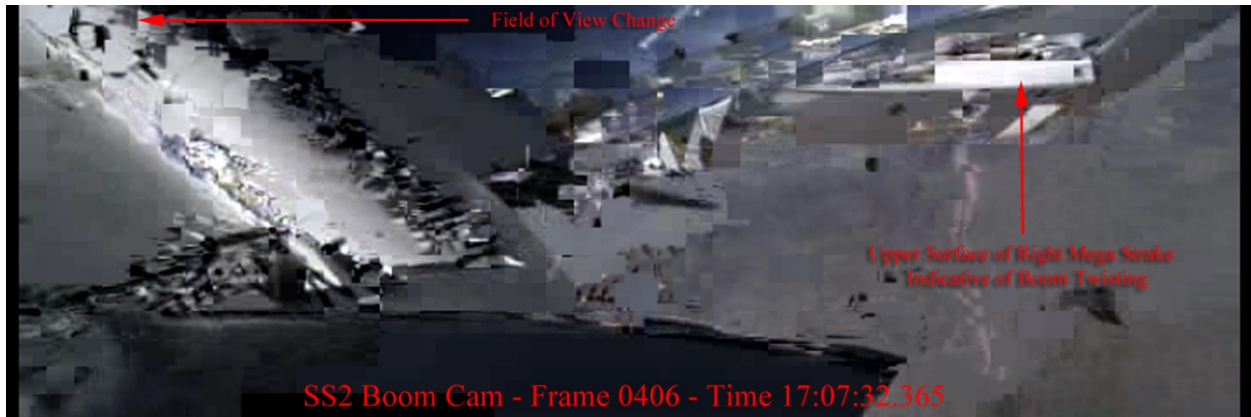
Figure 71.

Figure 71 shows the upper surface of the right mega strake becoming visible to the camera's field of view. This indicates the right boom has begun to rotate inboard toward the centerline of the vehicle.

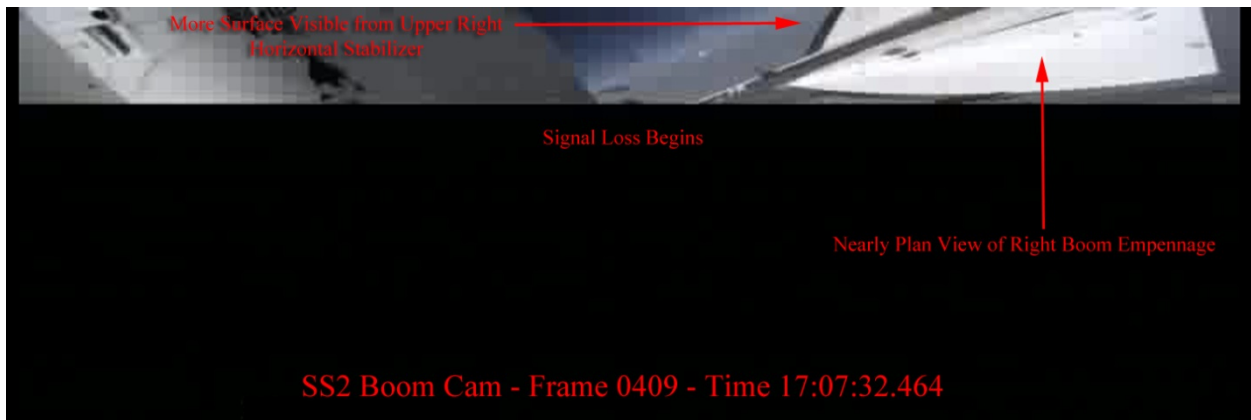
Figure 74.

Figure 74 shows the camera has begun to power down and the recorded image is rapidly losing fidelity. The upper surface of the right mega strake is more apparent, indicating a continued roll inboard toward the center line of the vehicle. The “Virgin DNA” graphic on the upper portion of the main fuselage is in close view, indicating a significant change in displacement between the camera and the main fuselage.

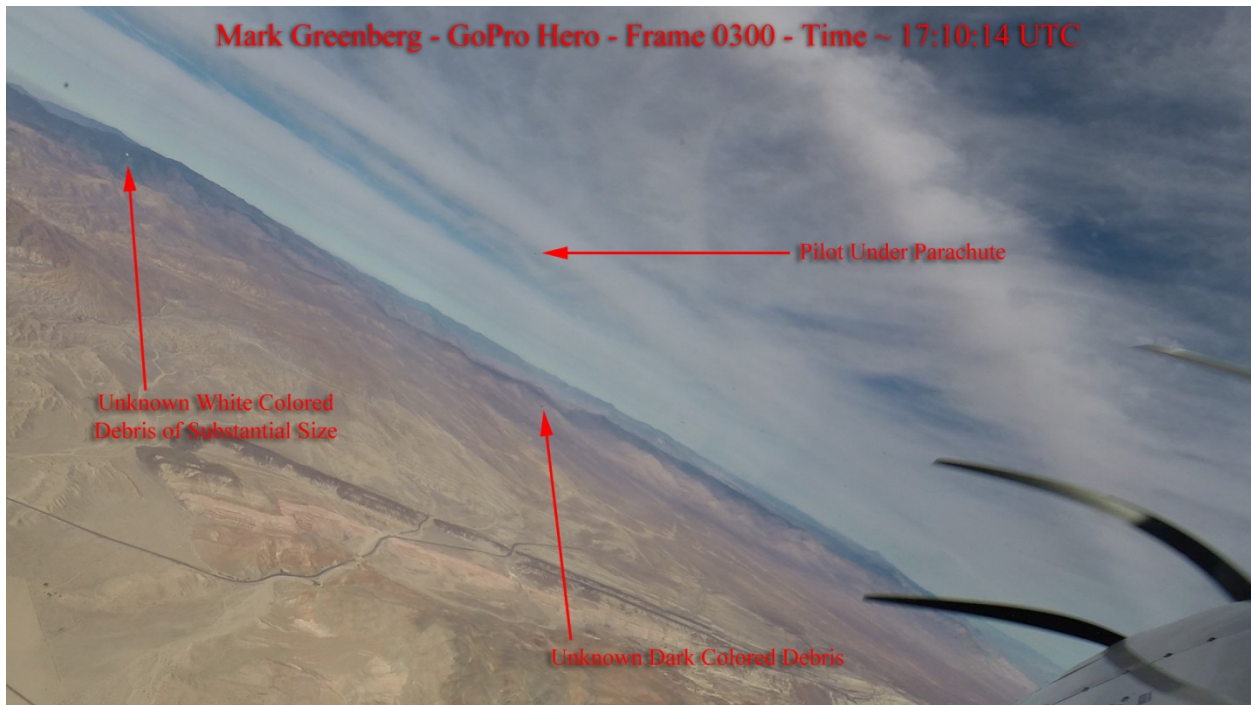
Figure 78.

Figure 78 shows the pilot under parachute near the center of the frame. Additionally, some medium to large size falling debris is near the center and left hand portions of the frame.
