FAA Inspector Report – Mr. Wesley Dollahite, Denver FSDO

On Friday July 12, 2019 I drove from Denver to Sidney, Ne, to help with an accident involving Queen Air, N62069, S/N 62-3866 that during departure had a left hand wing explosion. Met with a team from Bemidji Aviation including the Director of Maintenance and Director of Ops, as I walked into the FBO they taxied onto the ramp.

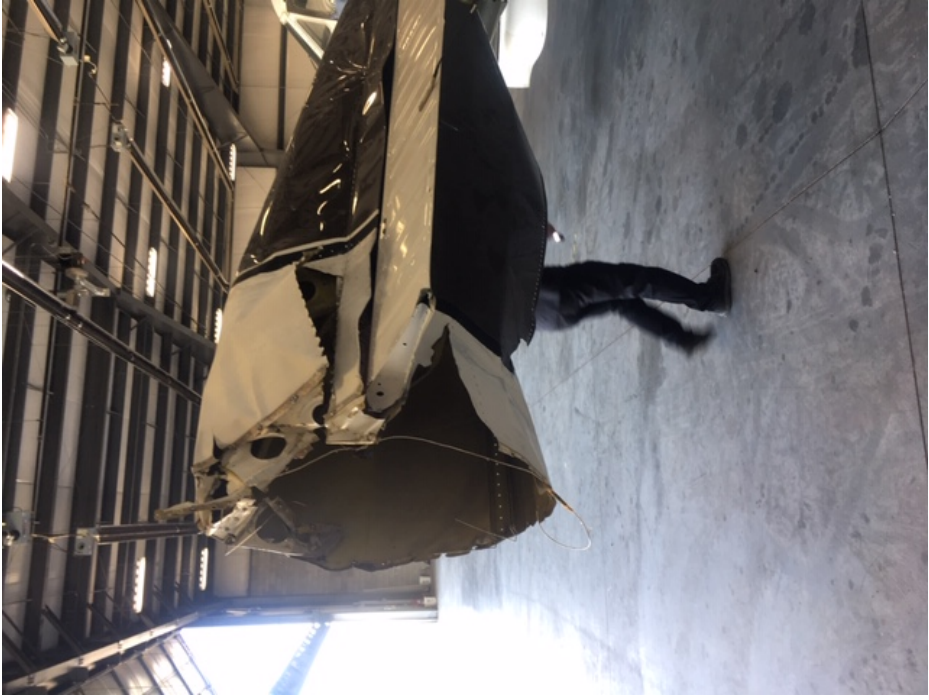
So between the fuel leaking from the sending unit and the wiring being pinched and arcing the cheese seemed to line up. Flames from the inboard fire ignited the vapors in the wing causing the wing tip to explode.
