U.S. Department
of Transportation
**Federal Aviation
Administration**

Damage Report - Incident Number ERA13IA313

MARC CABIBBO ASI FSDO-AEA-11 Accident June 30, 2013 @ 12:15 EDT
FAA IIC Marc H. Cabibbo received a call from AEA-RO communications center reporting a helicopter down on the Hudson River near 79 street boat basin New York, NY. FAA Inspectors Marc Cabibbo and James Ciccone responded and were present at the accident site at 1335 hours EDT. The aircraft was at that time secured at the 79street dock, stable on its emergency pop out floats. There were no injuries in connections with this event. The circumstances are as follows:

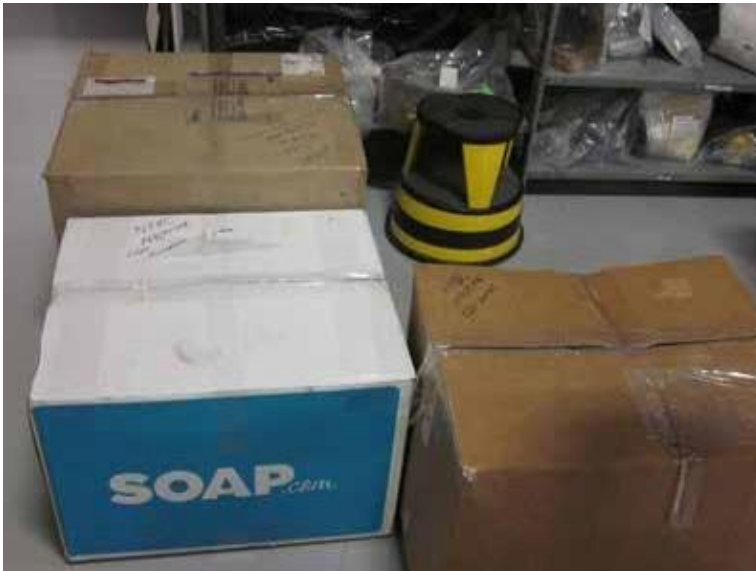
The owner/operator brought the power plant to Keystone Turbines, LLC (KTS), for disassembly. The power plant was separated into three modules, prior to arriving at KTS. The power plant was separated into the Turbine, Compressor and the Gearbox. The three modules were in cardboard boxes when they arrived at the facility (Figure 1). No damage from shipping was noted.

Figure 1, Power plant Modules, as received and delivered by Owner on 7/11/13

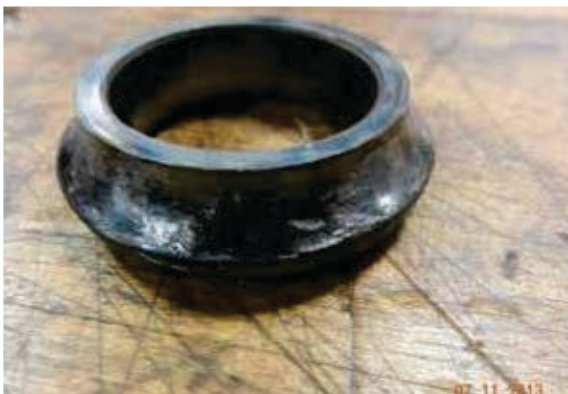
The compressor module was the first removed from the shipping container and reviewed. The #2 bearing in the compressor was noted at the operator's maintenance facility as being seized. During an inspection of the #2 bearing there was a noted lack of oil and high temperature signatures (Figures 2, 4 & 5). The bearing had debris on it, the ball bearings were damaged, showed coking, no cracks noted. The bearing appeared to have more heat damage on the forward side of the bearing (Figure 4) compared to the aft side (Figure 5). The races showed signs of high temperature as well (Figures 3 & 5). The

Figure 6, fwd Race #2 Bearing

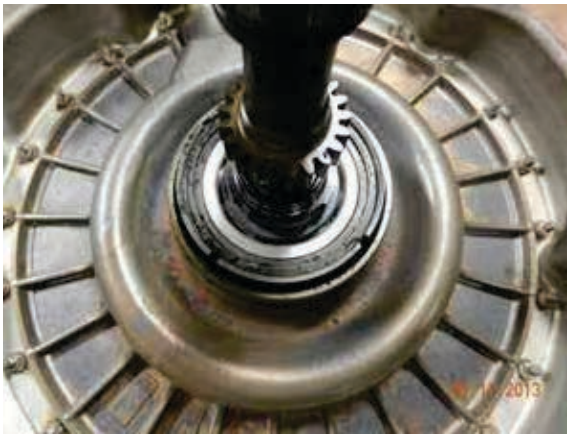
The Impeller was also inspected. During the tear down to get to the Impeller, it was difficult to separate the Impeller from the housing. The housing showed signs of high temperature, most evident in the 12 and 6 o'clock positions (Figures 8, 9, 10, 11, 12, 13 & 14). Once the Impeller was removed, there was evidence that the Impeller had rubbed on the housing (Figure 12).

Figure 13, Compressor, aft view

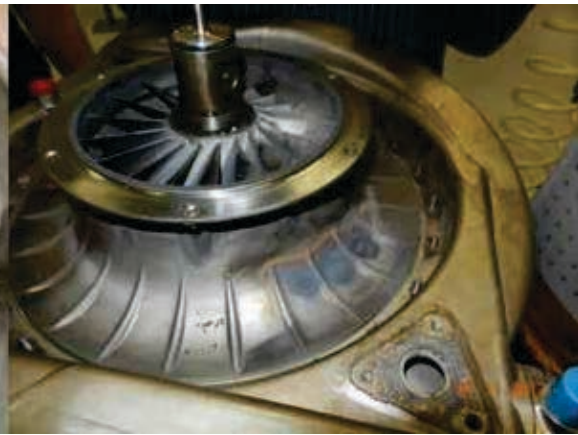
Figure 14, Compressor, fwd view

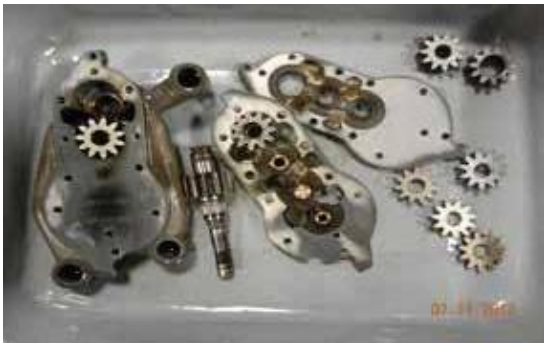
The oil pump was disassembled. The pump was able to spin by hand and did not show signs of damage (Figure 21).

Figure 21, Oil Pump, disassembled

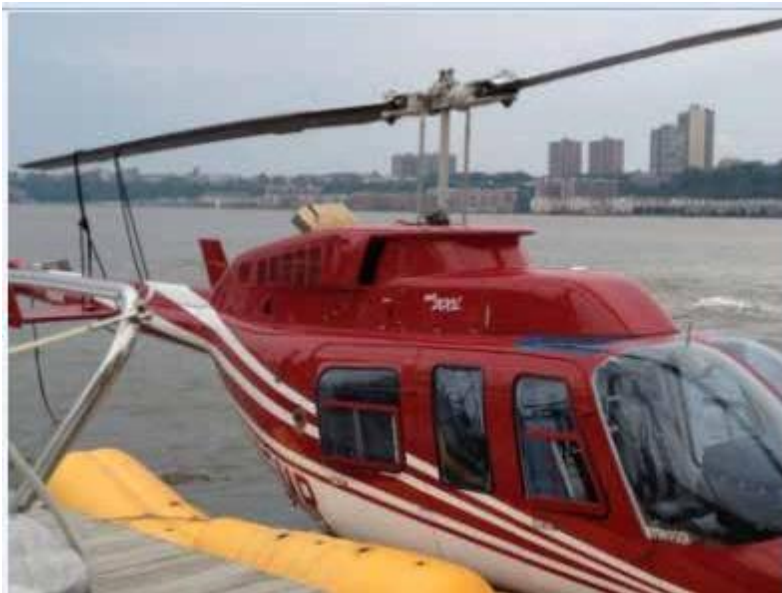
Photo 0734 – N405MR at 13:30 hours after being towed to the 79 St Marina NYC

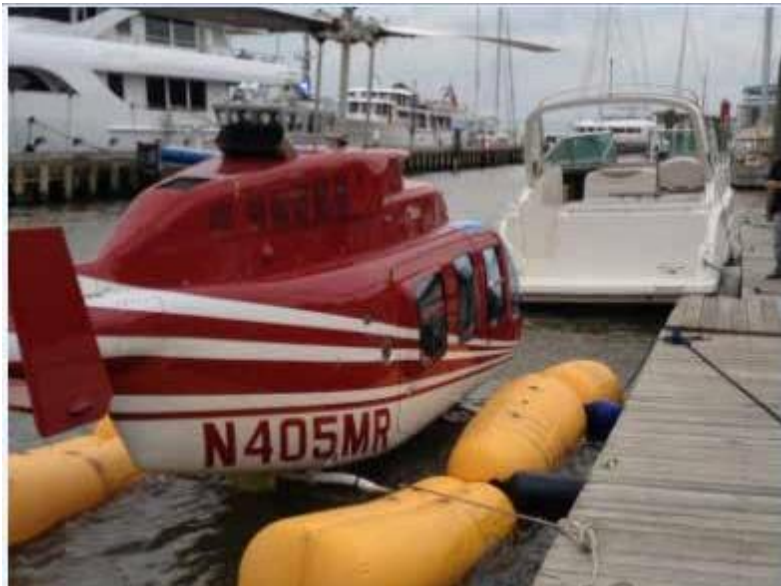
Photo 0736 – N405MR at 13:30 hours after being towed to the 79 St Marina

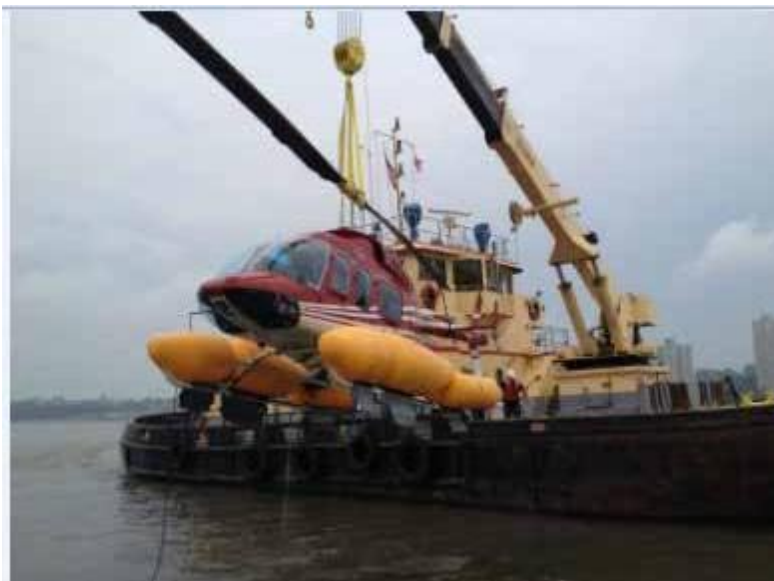
Photo 0744 – N405MR at 15:49 hours –Recovered by Army Corp - DCV Hayward

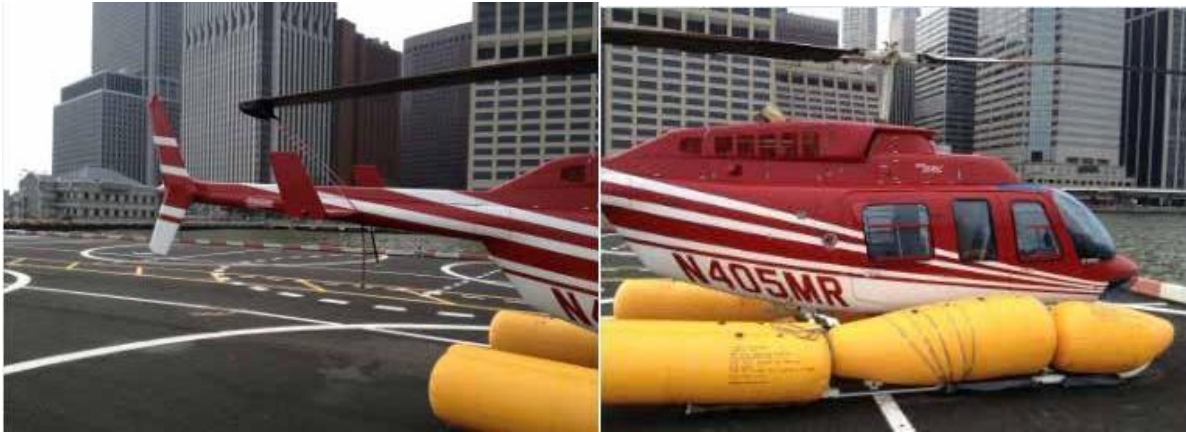
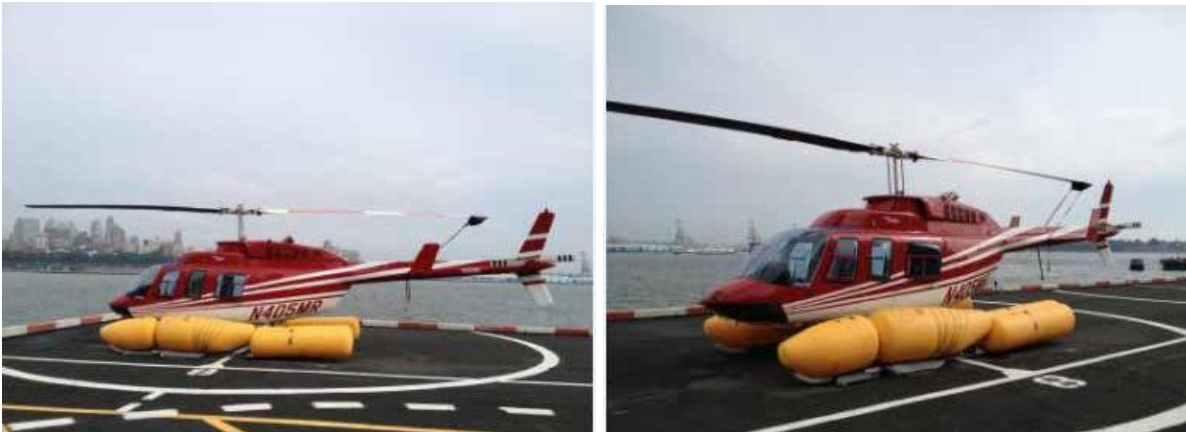
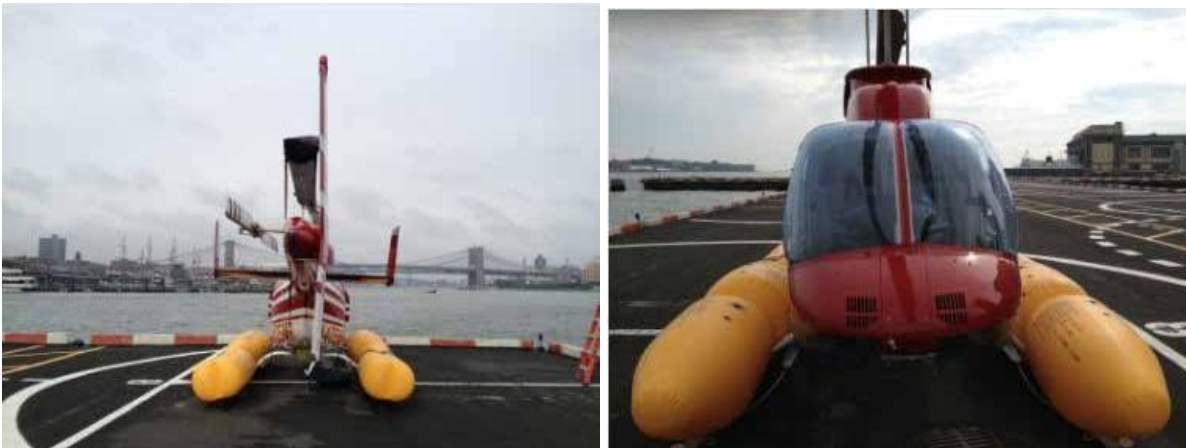
Photos 0758 - 0763 – N405MR at 17:35 hours –Relocated to Downtown Heliport by Army Corp DCV Hayward- Cardinal Points

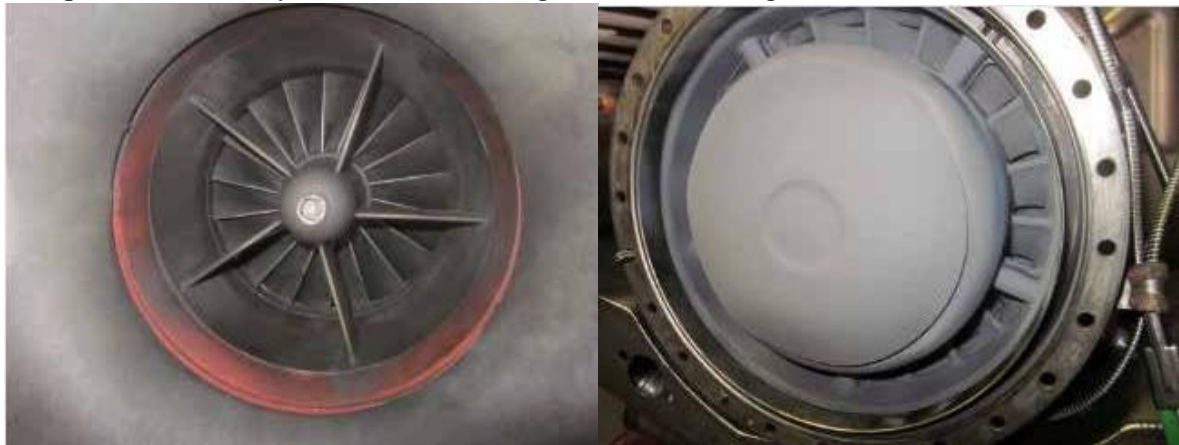
1. With power applied to the Battery Bus the ENG CHIP light was illuminated
2. Motored engine but starter would not turn engine. (N1 Locked)
3. Turned first stage compressor by hand, hard to turn.
4. Inspected compressor inlet- normal no damage or evidence of FOD
5. Removed both engine chip plug, caked with carbon and small metal specks.
6. Removed Scavenge oil filter removed , small metal flacks and carbon.
7. Removed Turbine section from Accessory Gearbox-Turbine and N2 shafts turned freely
8. N1 shaft when installed into Accessory Gearbox very hard to turn –suspected No.2 bearing
9. The combustor housing and liner was removed with no defects noted
10. The first stage nozzle and wheel was inspected with no defects noted

Compressor Inlet July 2, 2013 – First Stage turbine nozzle guide vanes

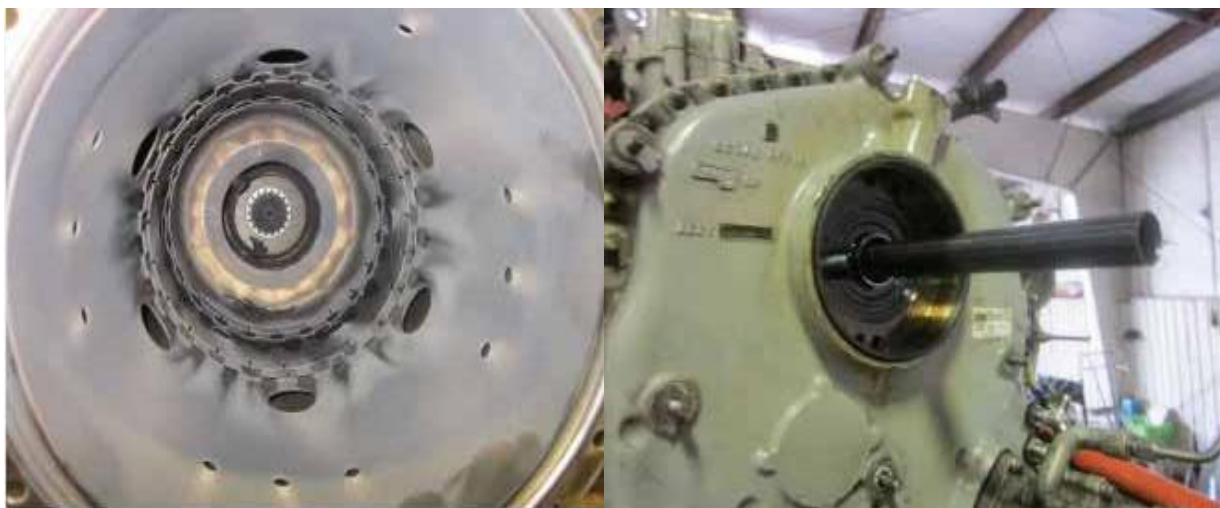
This module was able to spin freely and did not show major signs of damage. The combustion liner had a rough coating that was not normal (Figure 15). It was not disassembled. Over haul was conducted by KTS during 11/2012. In preparation for overhaul the turbine module was separated by the owner/operator and shipped to KTS. The gearbox and compressor modules were not sent to KTS at that time.

Combustor Liner with Fuel Nozzle/ AGB with N1 Coupling Shaft- July 2, 2013

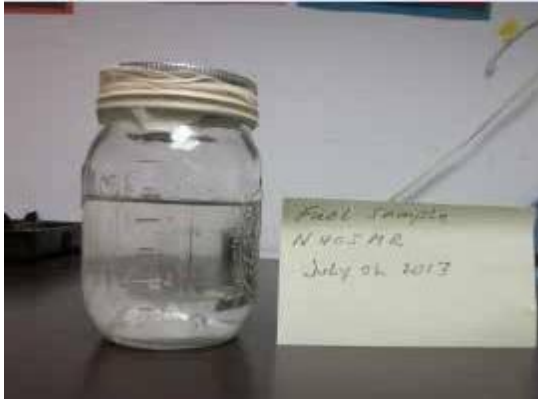
The aircraft fuel gauge read 525 lbs with power applied (June 30th). An aircraft fuel sample was obtained on July 2, 2013 under control conditions and appeared normal, clear and bright. This sample was taken from the electrically operated fuel sump valve. A visual check through the filler cap revealed no anomalies (June 30th). The Fuel Facility (Kearny Heliport 65NJ) which fueled the aircraft just prior to the engine failure was audited on June 30th, the fuel was found to be clear and bright and a free water test was conducted and found to be within Specification.

Fuel Samples N405MR left-7/2/2013

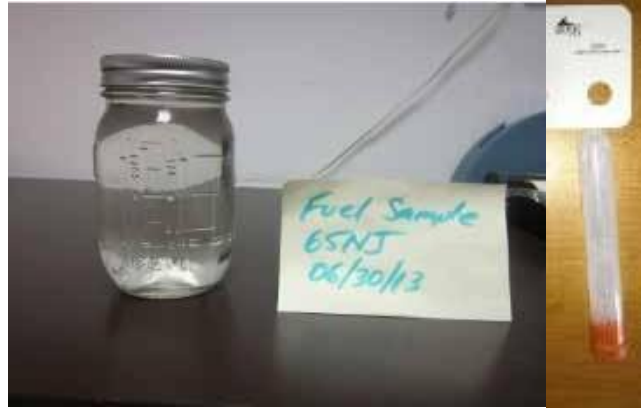
Fuel Storage 65NJ Right 6/30/2103 w/free water test
