**Submission to the
National Transportation Safety Board**

Ravn Connect Flight 3153 Accident
Cessna 208B; N208SD
Togiak, Alaska; October 2, 2016

Case No. ANC17MA001; *Ravn Connect Flight 3153*;

NTSB Aircraft Accident Investigation Case No. ANC17MA001
Ravn Connect Flight 3153; October 2, 2016; Togiak, Alaska

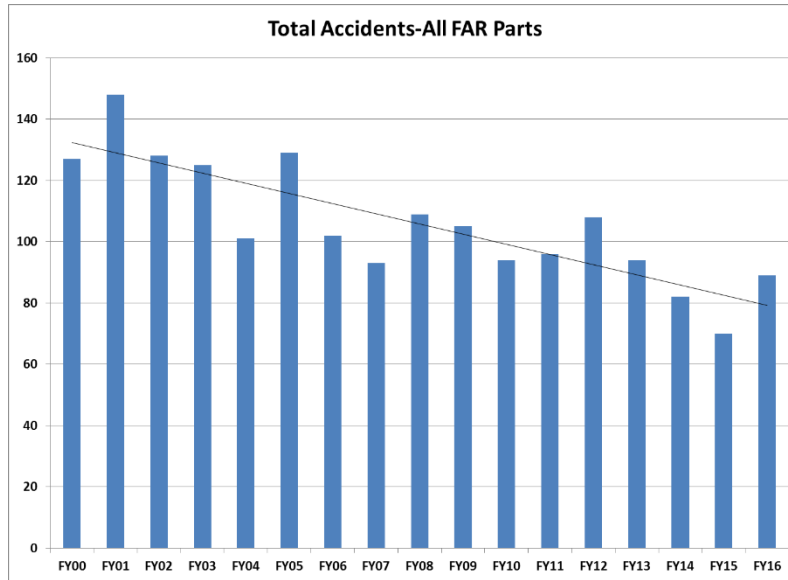
Total Aviation Accidents in Alaska

(Includes all Fatal and Non-fatal Accidents - in All FAR Types of Operations)

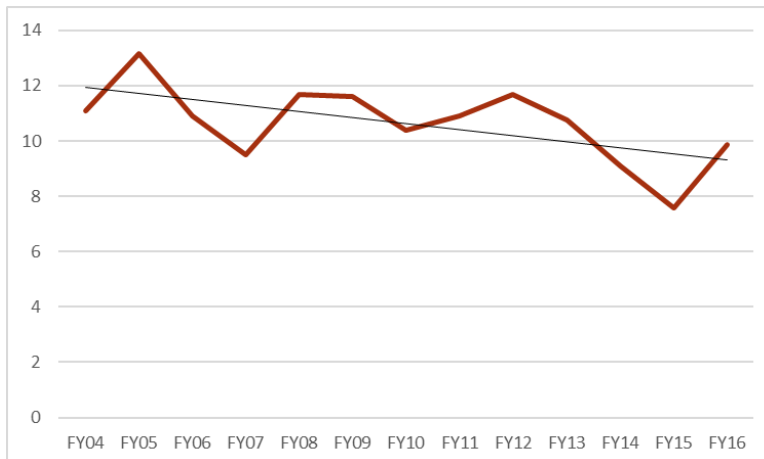
Aviation Accident Rate in Alaska

Even more remarkable, the overall *rate* of accidents in Alaska is on the decline, as shown in the next plot below. This rate is calculated with the use of data from the FAA's annual Air Carrier and GA Survey, which calculates the total number of flight hours flown each year in Alaska, and strives for 100 percent sampling of *all* pilots and operators in Alaska.

(Includes all Fatal and Non-fatal Accidents - in All FAR Types of Operations)

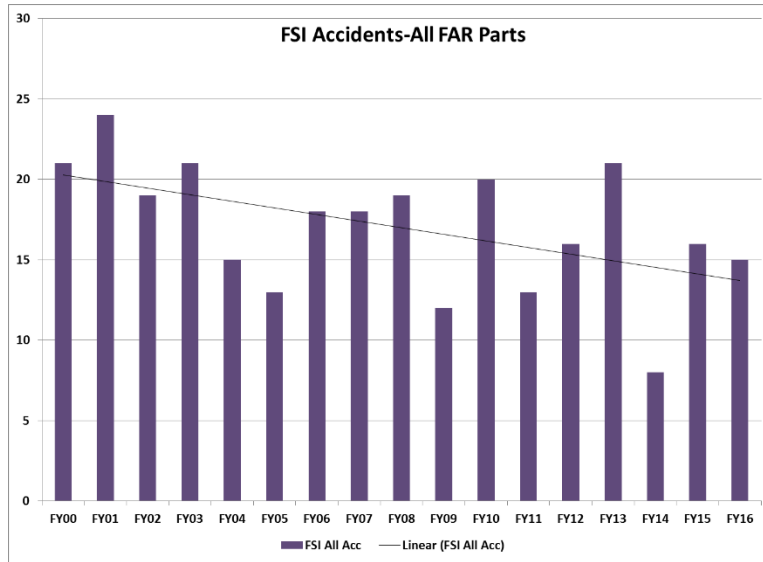
Total *Fatal & Serious Injury* Alaska Accidents
(Includes All FAR Types of Operations)

Since 2000, the trend of fatal and serious injury accidents in Alaska, or “FSIs”, has also been decreasing, as depicted in the plot below. Note that FY14 had the lowest number of FSI’s – eight -- since FAA began keeping records of this metric.

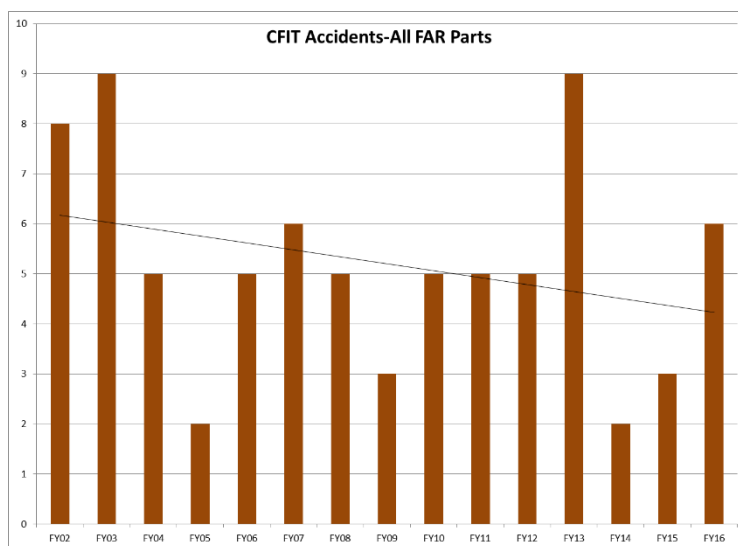
Total *CFIT* Accidents in Alaska
(Includes all Fatal and Non-fatal Accidents - in All FAR Types of Operations)

The next plot below illustrates the downward trend in the total number of *all CFIT accidents* in Alaska, both commercial and private operations since FY02. While there was a momentary increase in CFIT accidents from 2014-2016, the trend has normalized since.

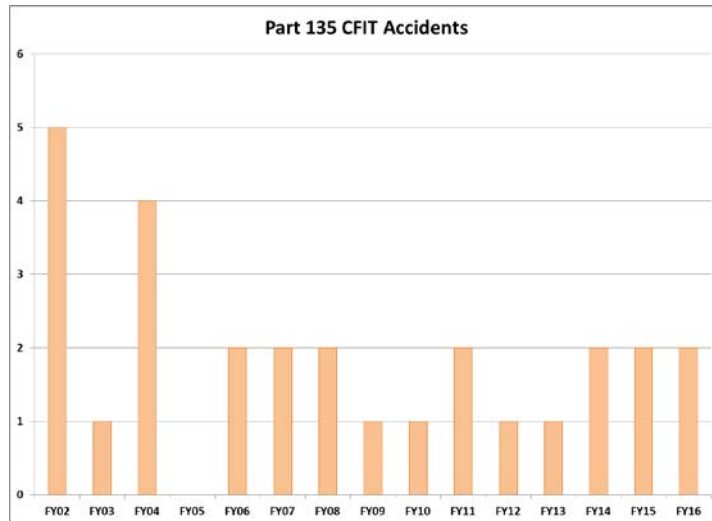
Total Part 135 CFIT Accidents in Alaska
(Includes all Fatal and Non-fatal Accidents - FAR 135 only)

Additionally, as shown in the next chart below, the total number of CFIT accidents *involving only Part 135 commercial operators* --- fatal and non-fatal -- has also decreased since FY02, but has since remained relatively flat for the past decade with one or two occurring each year. As stated previously, any accident is one too many, and the FAA continues to aggressively pursue accident prevention efforts in Alaska for further reductions in CFIT accidents.

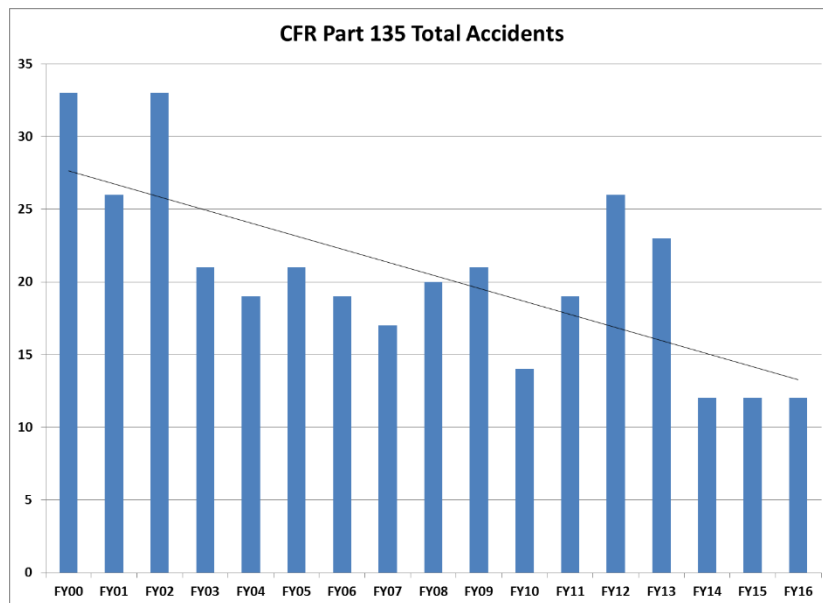
Total Part 135 Accidents in Alaska:
(Includes all Fatal and Non-fatal Accidents – for all accident types)

This next chart below indicates that when all the other types of Part 135 commercial accidents in Alaska are considered - in addition to CFIT accidents – a dramatic reduction since FY 2000 becomes evident.

The above chart depicts a validation of the efficacy of the risk controls initiated by the FAA and industry in Alaska to reduce accidents. When compared to the previous chart, it can be seen that Part 135 CFIT accidents made up only one-sixth of all Part 135 accidents in the FY 14, 15, and 16 timeframe.

Finding 10: The total number, and the rate, of fatal and non-fatal accidents in Alaska – including CFIT and Part 135 accidents --have been on the decline over the past two decades. Aviation safety in Alaska continues to experience significant improvement.
