**NATIONAL TRANSPORTATION SAFETY BOARD
OFFICE OF HIGHWAY SAFETY
WASHINGTON, D.C.**

FACTUAL REPORT OF INVESTIGATION

Vehicle #2: 2017 Navya Arma Transit Shuttle

NTSB #: **HWY18 F H001**

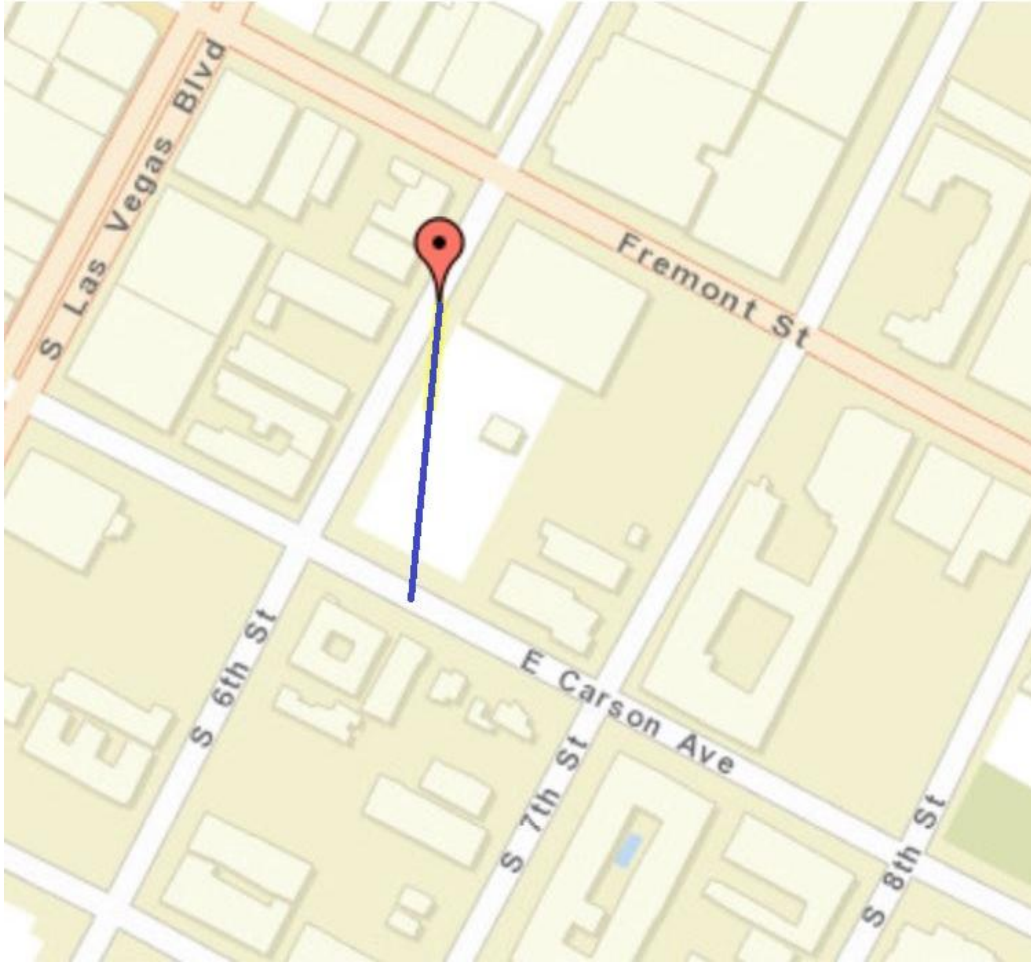
Figure 6. Graphic Representation of Sun Position

The position of the sun is depicted graphically in Figure 6. The location of the collision is shown with a red balloon; the direction of the sun is indicated by the blue line:
