**FACTUAL REPORT OF INVESTIGATION
TESLA MODEL X RUN-OFF THE ROADWAY AND COLLISION
WITH PRIVATE HOME RESULTING IN POST CRASH FIRE**

Lake Forest, CA

HWY17FH013

**NATIONAL TRANSPORTATION SAFETY BOARD
OFFICE OF HIGHWAY SAFETY
WASHINGTON, D.C.**

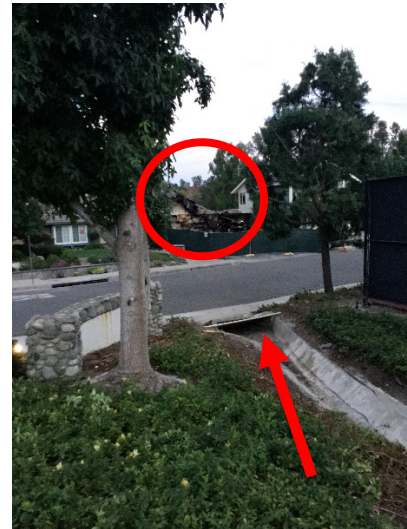
Figure 3: Drainage Culvert

Figure 2 provides a view from the top of Normandale Drive approaching Countryside Drive. The left hand curve in which the Tesla departed the roadway is indicated with a red arrow, and the residence is indicated with a red circle. Figure 3 provides a view of the drainage culvert struck by the Tesla (indicated with a red arrow), and the residence (indicated with a red circle).

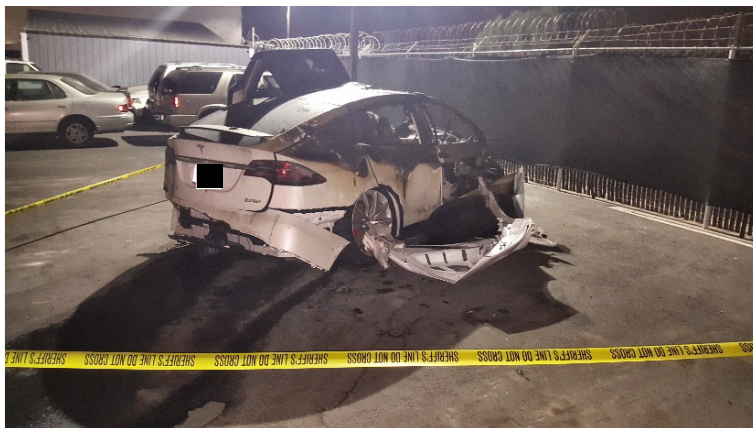
Figure 5: Tesla storage position at Southside Towing (Source: Southside Towing)

The 2016 Tesla Model X had Vehicle Identification Number (VIN) 5YJXCBE49GFXXXXXX.¹ The Tesla was stored in a paved lot at Southside Towing, 25101 Front St., Lake Forest California, as shown in figure 5. The tow yard was advised to leave as much space around the vehicle as possible as a precaution in case of re-ignition. The vehicle was placed outside on a paved lot with approximately 6 feet of distance to a fence on one side, approximately 15 feet from other vehicles on another side, and then at least 40 feet from objects on two other sides.

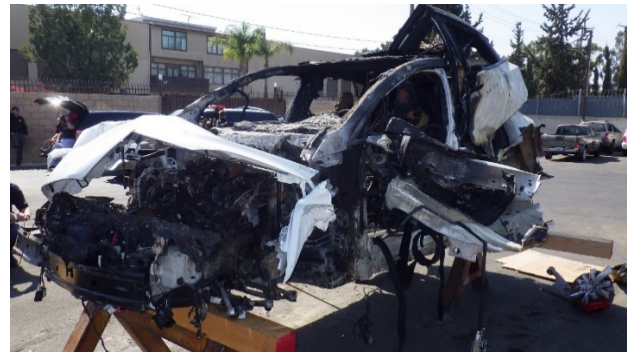
Figure 9: Left Front View of the Tesla

The exterior body panels of the front passenger door were displaced and hanging from the door structure, which remained on the hinges, as shown in figure 8. The driver door was found open and severely deformed with the exterior panel displaced, as shown in figure 9. The right rear passenger door was closed and mostly intact, but with the main glass panel missing. The exterior handle was missing. The left rear door was a partially open. The right rear passenger door had extensive thermal damage at the front extending about the width of the door handle. The right rear exterior door handle was missing. The paint on the rest of the door was intact.
