RE: DCA97MA055, Fedex Pilots Association Submission

Federal Express Flight 14, McDonnell Douglas MD-11 N611FE
Newark International Airport, Newark, NJ
July 31, 1997, 0131 EDT
DCA97MA055

Fedex Pilots Association
Submission

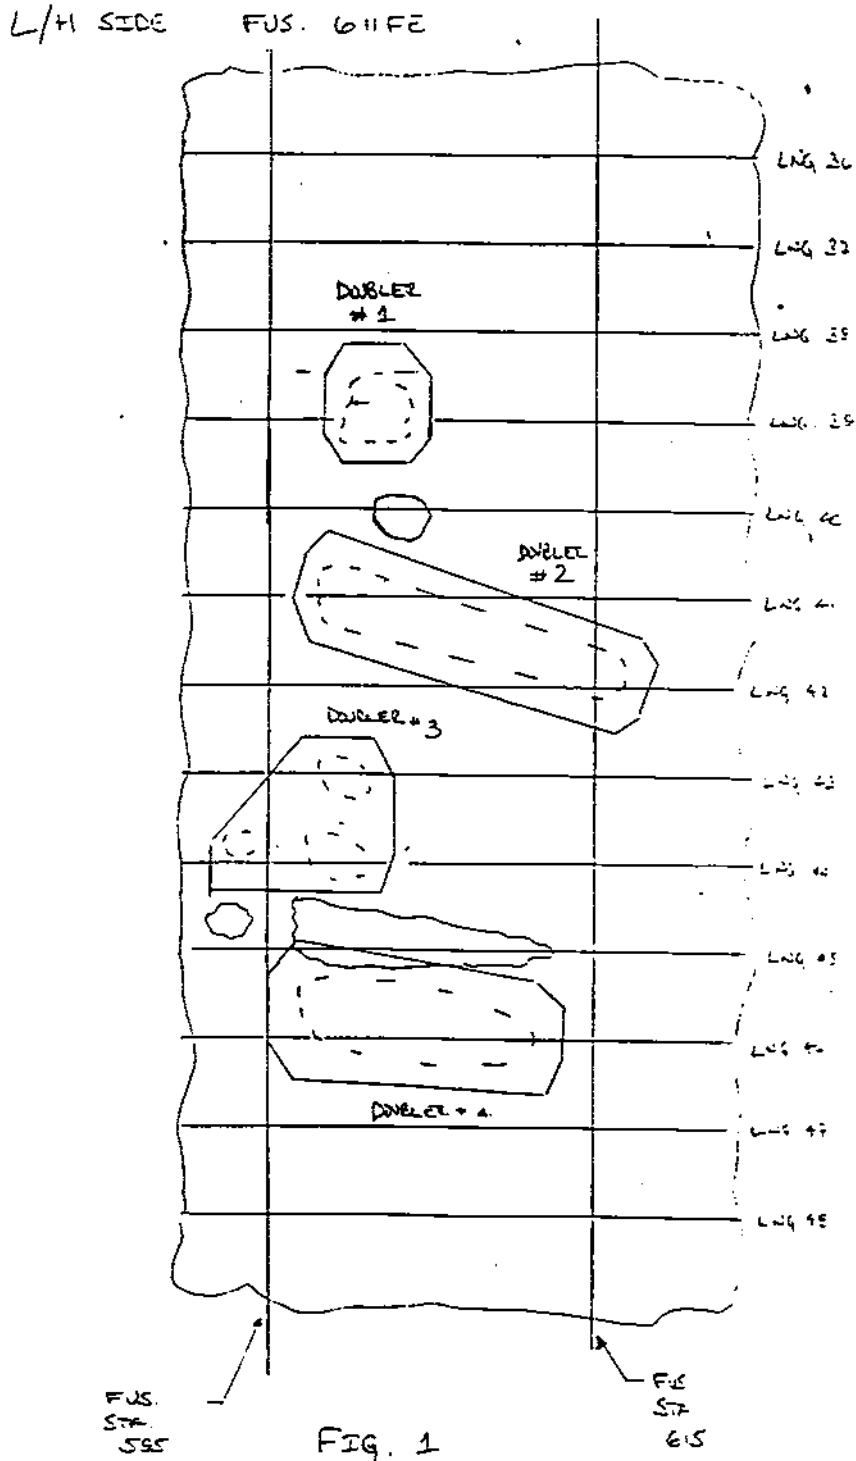
Fig. 1
Showing Boron Doublet Repair

THIS E.A. GIVES INSTRUCTIONS FOR THE APPLICATION OF THE BORON DOUBLERS ON THE L/H SIDE OF A/C 611. THE DOUBLERS WILL BE APPLIED OVER THE SKIN WRINKLES FOUND FROM FUS. STA. Y =595 TO Y = 615, FROM LONGERON 36 TO LONGERON 48. REFERENCE FIG. 1 AS WELL AS THE ACTUAL SIZE MAPPING OF THE DAMAGE AND DOUBLERS.

NOTE, THESE INSTRUCTIONS REFER TO THE APPLICATION OF DOUBLERS #2 AND #4 ONLY (REF. FIG.1), HOWEVER, WITH TIME PERMITTING DOUBLER #1 MAY ALSO BE INSTALLED.

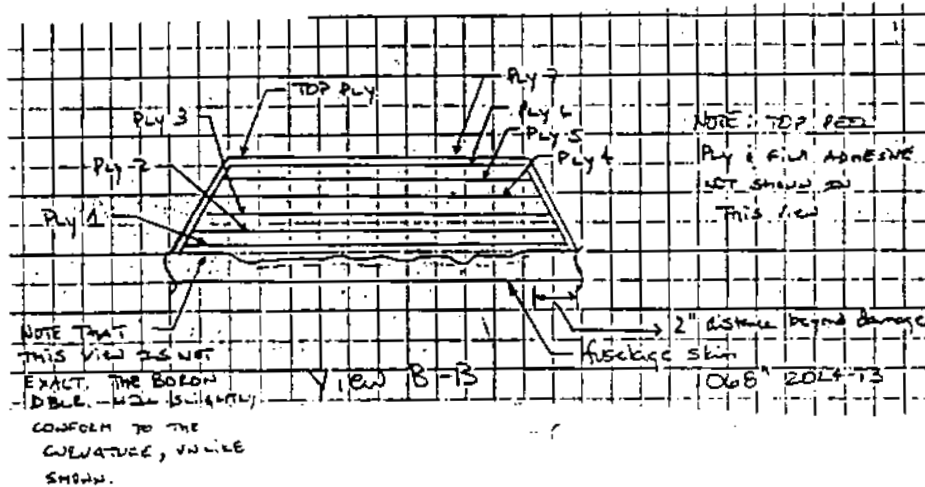
Fig. 2

INSTRUCTIONS: (Continued)	MECHANIC	CHECK BY
INSPECT FOR GROWTH OF DELAMINATION FOUND ON DBLR. #2. DELAMINATION FOUND WAS AT THE UPPER LEFT HAND CORNER (LOOKING INBD.). THE DELAMINATION WAS 5.3" X 5.9" (SEE FIG. 2).	TAI 67262 AUG 25 1995	N/A FC-04

<p>19. VERIFY THE DIRECTION OF THE PLY LAY-UP AS SHOWN IN FIG. 2. NOTE THAT THE "0" DIRECTION WILL BE APPLIED IN THE HOOP DIRECTION (RUNNING CIRCUMFRENCIALLY).</p>	RMG 99513	E-23
