## **Factual Report Figures**

Aaron McCarter Air Safety Investigator Eastern Region Aviation

May 1, 2019

Subject: ERA18FA120- Figures for Factual Report

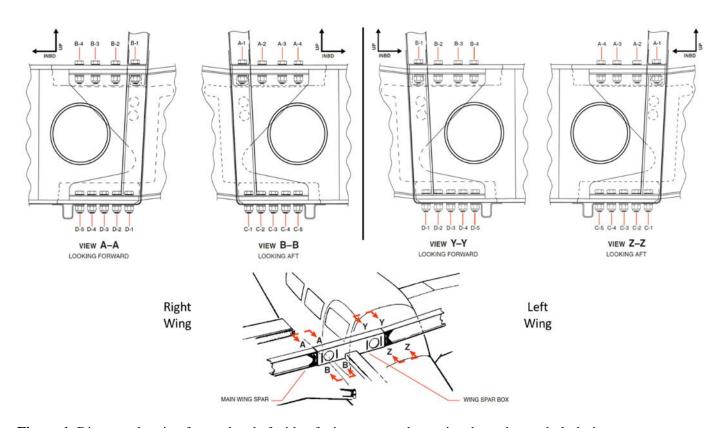
**Figure 1**. Diagram showing forward and aft side of wing spars and associated attachment bolt designator map. Courtesy of Piper Aircraft, Inc. Arrow Wing Installation Drawings
