Building Explosion and Fire
Silver Spring, Maryland
August 10, 2016

Accident Report

NTSB/PAR-19/01
PB2019-100722

Pipeline Accident Report

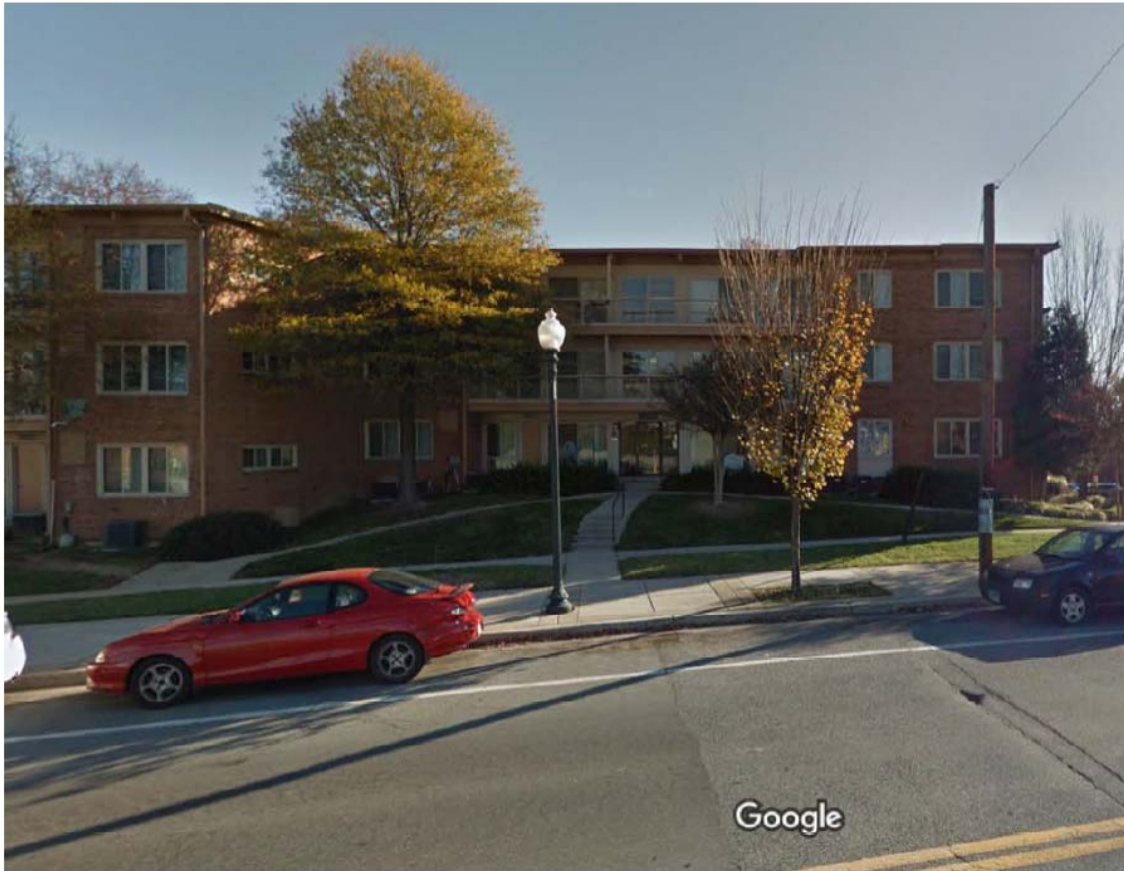
Figure 1. The accident location, 8701 Arliss Street, before the August 10, 2016, explosion. (Photograph from Google Earth, dated November 2015.)

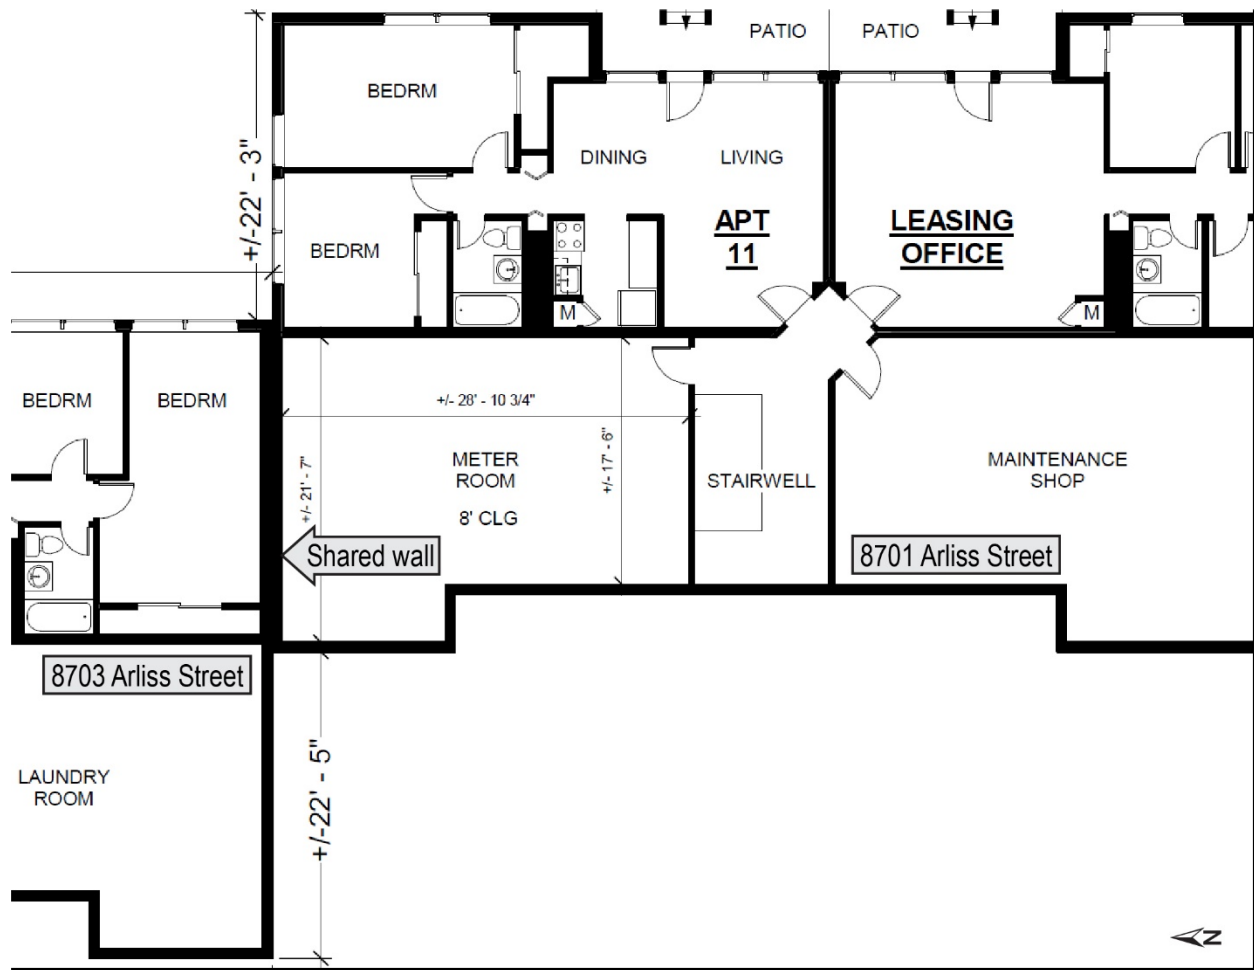
Building 8701 Arliss Street was a four-level structure with a basement and three floors. Four apartments were located on each of the upper three levels. The basement/terrace level consisted of one apartment, a meter room, a storage room, and a property management and rental office. (See figure 4.)

Figure 4. A plan for the basement/terrace floor for 8701 Arliss Street and the shared-wall portion of 8703 Arliss Street. (Graphic provided by Kay Management.)

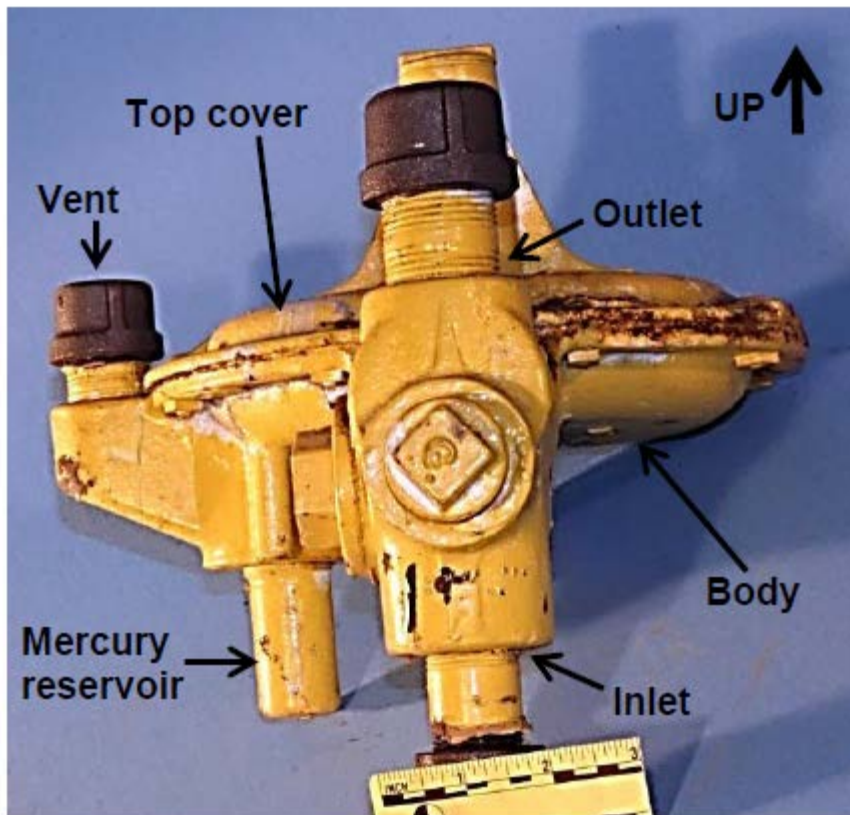
Figure 8. Exemplar mercury service regulator taken from a nearby Flower Branch apartment building.
