Collision of BNSF Coal Train With the Rear End of Standing
BNSF Maintenance-of-Way Equipment Train
Red Oak, Iowa
April 17, 2011

NTSB/RAR-12/02
PB2012-916302

Railroad Accident Report

Abstract: On April 17, 2011, about 6:55 a.m. central daylight time, eastbound BNSF Railway coal train C-BTMCNM0-26, BNSF 9159 East, travelling about 23 mph, collided with the rear end of standing BNSF Railway maintenance-of-way equipment train U-BRGCRI-15, BNSF 9470 East, near Red Oak, Iowa. The accident occurred near milepost 448.3 on main track number two on the Creston Subdivision of the BNSF Railway Nebraska Division. The collision resulted in the derailment of 2 locomotives and 12 cars. As a result of collision forces, the lead locomotive's modular crew cab was detached, partially crushed, and involved in a subsequent diesel fuel fire. Both crewmembers on the striking train were fatally injured. Damage was in excess of \$8.7 million.

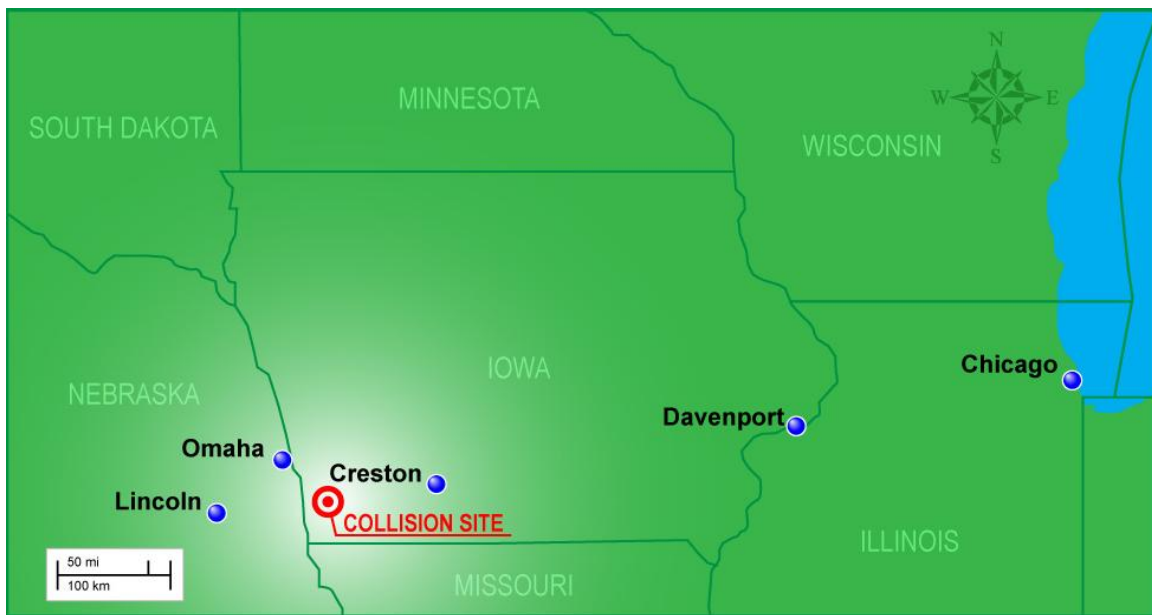
Figure 1. Accident location.

On April 17, 2011, about 6:55¹ a.m. central daylight time, eastbound BNSF Railway² (BNSF) coal train C-BTMCNM0-26, BNSF 9159 East, collided with the rear end of standing BNSF maintenance-of-way (MOW) equipment train U-BRGCRI-15, BNSF 9470 East, near Red Oak, Iowa. (See figure 1.) The accident occurred on a curve near milepost (MP) 448.3 on main track number two (track two) on the Creston Subdivision of the BNSF Nebraska Division. The striking coal train was travelling about 23 mph when it struck the standing MOW equipment train.

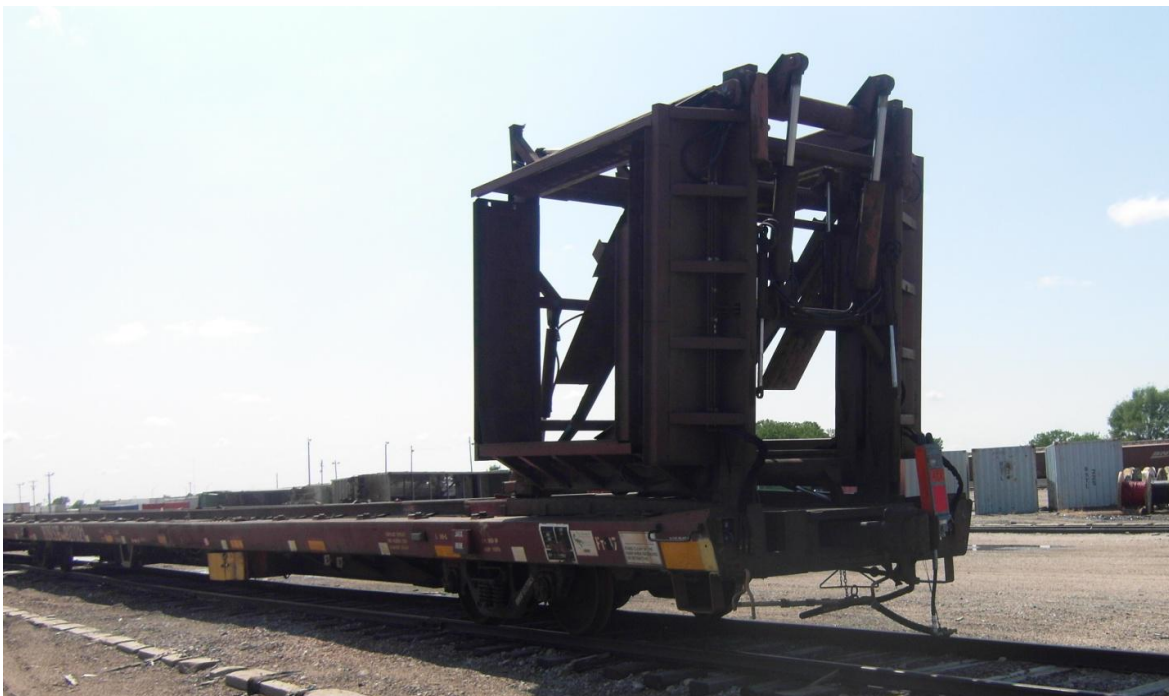
Figure 17. Exemplar scorpion-equipped flatcar.

The second to the last car in the struck train was BNSF 927022. This was a scorpion car: an 89-foot flatcar with a folding loading ramp attached to the end of the car. (See figure 17.) The scorpion ramp was composed of six segments tied together with pin joints and hydraulic rams. The ramp unfolds so that MOW equipment can roll on and off the flatcar. When the ramp is fully open and extended, it is 52 feet 8 inches long. The ramp is powered by a diesel engine and has an 11.5-gallon fuel tank. The hydraulic fluid tank had a 25-gallon capacity. This car weighed 155,400 pounds.
