National Transportation Safety Board

Alagasco Natural Gas Release with Ignition, Birmingham, Alabama

Operations Group Factual Report

DCA-14-MP-001

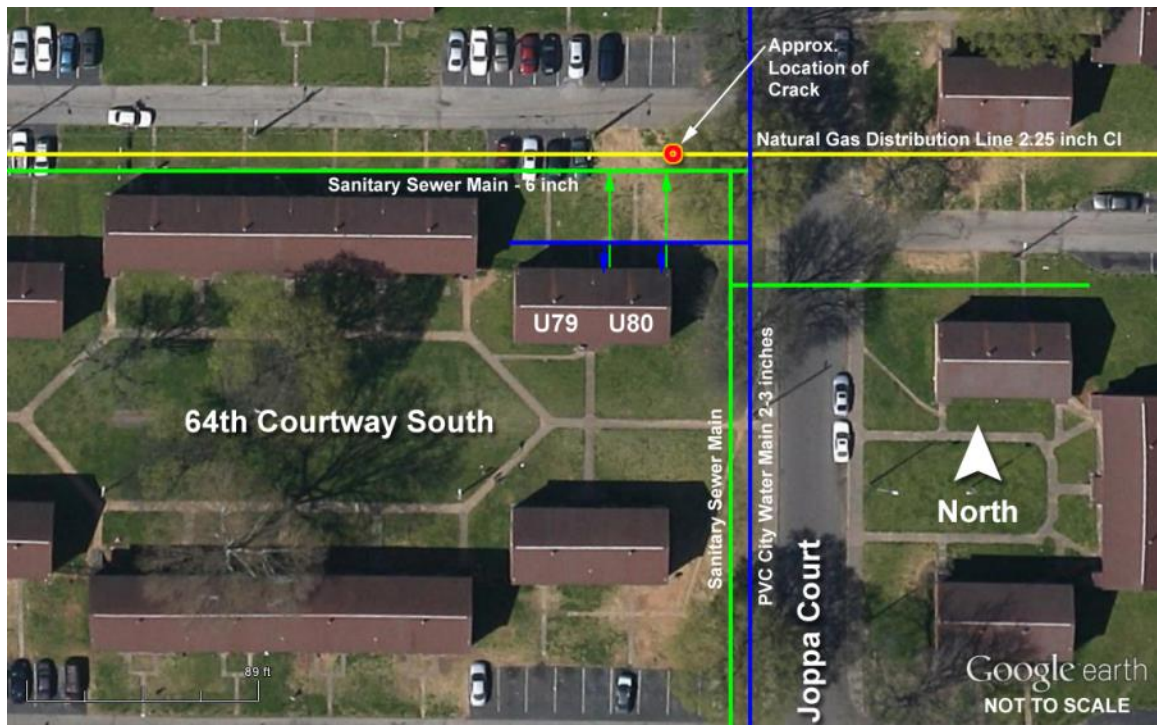
Two 4-inch cast iron sanitary sewer penetrations entered the north foundation wall of the property below the slab. Each of the connections made a 90 degree vertical turn beneath the slab and penetrated into the dwelling. These penetrations were about 29 feet apart and about 32 inches below the slab as depicted in Figure 2. Investigators observed gaps around the sanitary sewer pipe where it entered the building.

Figure 2: Aerial view showing utilities near Unit 80 in Gate City. Source: NTSB formatted

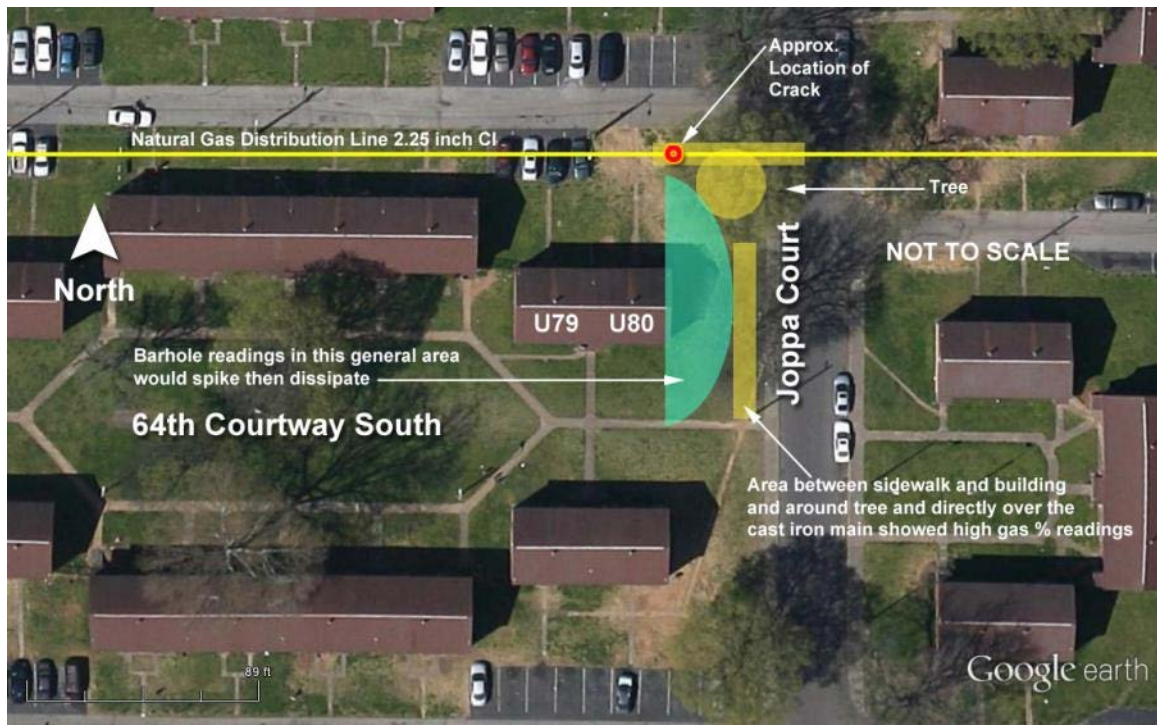
Figure 4: Bar hole test locations conducted during the emergency response. Source: NTSB formatted.

After the riser fire was extinguished, Alagasco construction crews conducted bar hole tests to locate the source of the gas leak and continued to search for the service line as shown in Figure 4. This involved checking for the presence of gas in the soil around the perimeter of the

accident scene. Crews noticed bubbles near the road curb on the northeast side of the apartment. Digging revealed a 2-1/4-inch circumferential cracked cast iron distribution main.³³
