Highway-Railroad Grade Crossing Collision
Commerce Street
Valhalla, New York
February 3, 2015

NTSB/RAR-17/01
PB2017-102658

Railroad Accident Report

Abstract: On February 3, 2015, at 6:26 p.m., a vehicle driven by a 49-year-old woman, traveled northwest on Commerce Street in Valhalla, New York, toward a highway-railroad grade crossing. The driver entered the boundary of the grade crossing and stopped. The driver then moved beyond the boundary and stopped adjacent to the railroad tracks. The grade crossing warning system activated and the gate came down, striking the rear of the vehicle. She exited her vehicle, examined the gate, then returned to her vehicle and moved forward on to the tracks. Meanwhile, a Metro-North Railroad train approached the grade crossing. The engineer activated the emergency brakes and collided with the vehicle at 51 mph. The train and the vehicle continued north, damaging the electrified third rail which pierced the vehicle and penetrated the lead railcar. Five passengers died and nine passengers and the engineer were injured, all in the lead railcar. The driver of the vehicle also died. The NTSB made new recommendations to the Federal Transit Administrat

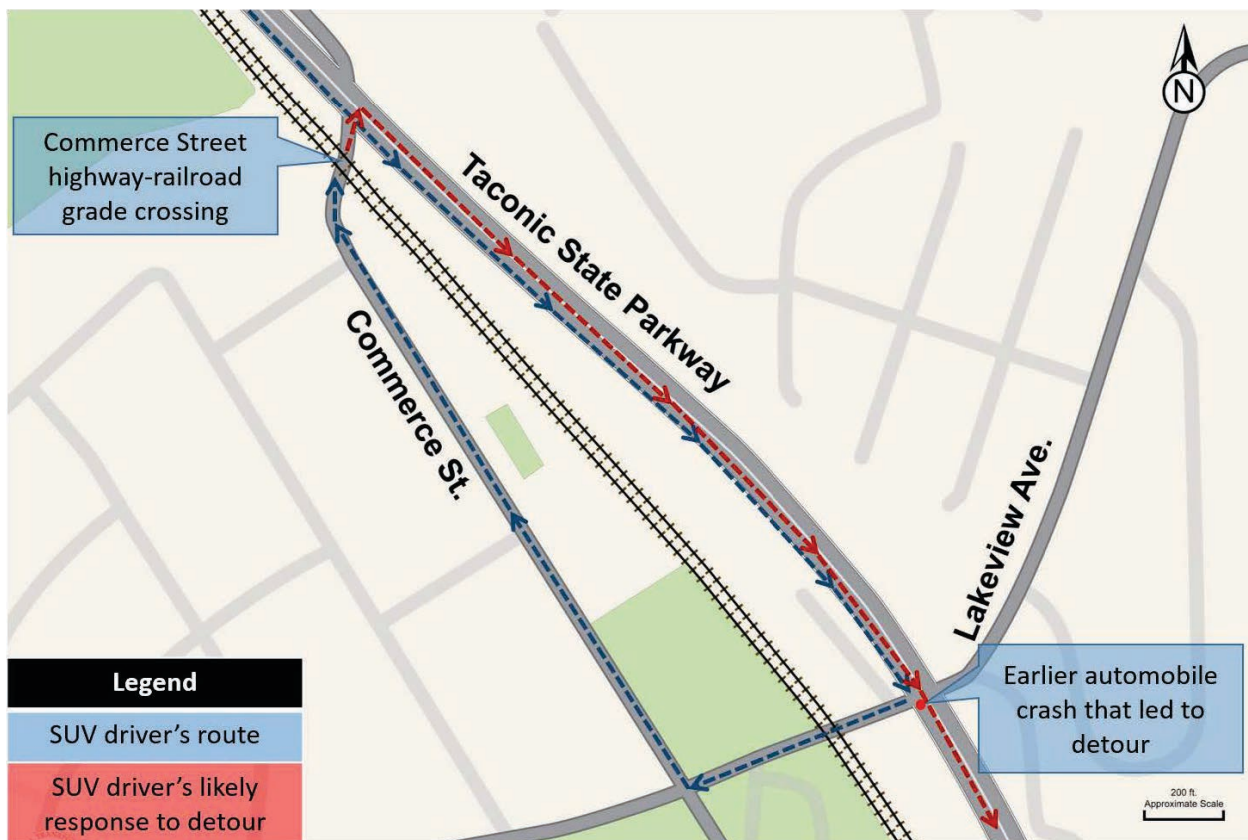
Figure 4. Map of the driver's route. (Source: Google Maps.)

The driver likely had been detoured on to Commerce Street because of an automobile crash that occurred at the intersection of Taconic State Parkway and Lakeview Avenue at 5:25 p.m. on the day of the accident. (See figure 4.) Lakeview Avenue is located about 0.4-mile southeast of the intersection of Commerce Street and Taconic State Parkway. The earlier crash was in the process of being cleared and the right southbound lane of Taconic State Parkway was being detoured on to Lakeview Avenue.⁴

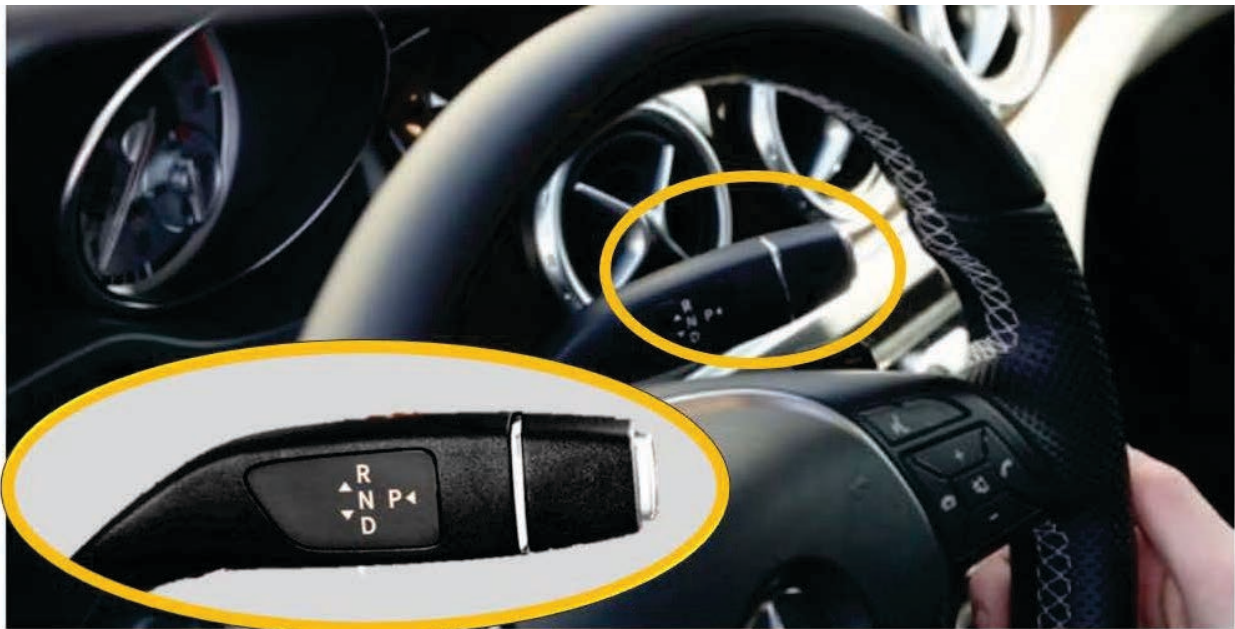
Figure 6. 2011 Mercedes Benz ML350 electronic gear-selection lever.

Investigators obtained and examined an exemplar 2011 Mercedes Benz ML350. The gear-selection lever is electronically operated, and etching on the lever indicates the movements required to make gearshift selections. A driver must depress the brake pedal and move the lever up or down to select the desired vehicle direction (forward or reverse). The button at the end of the gear-selection lever puts the vehicle into park. (See figure 6.)

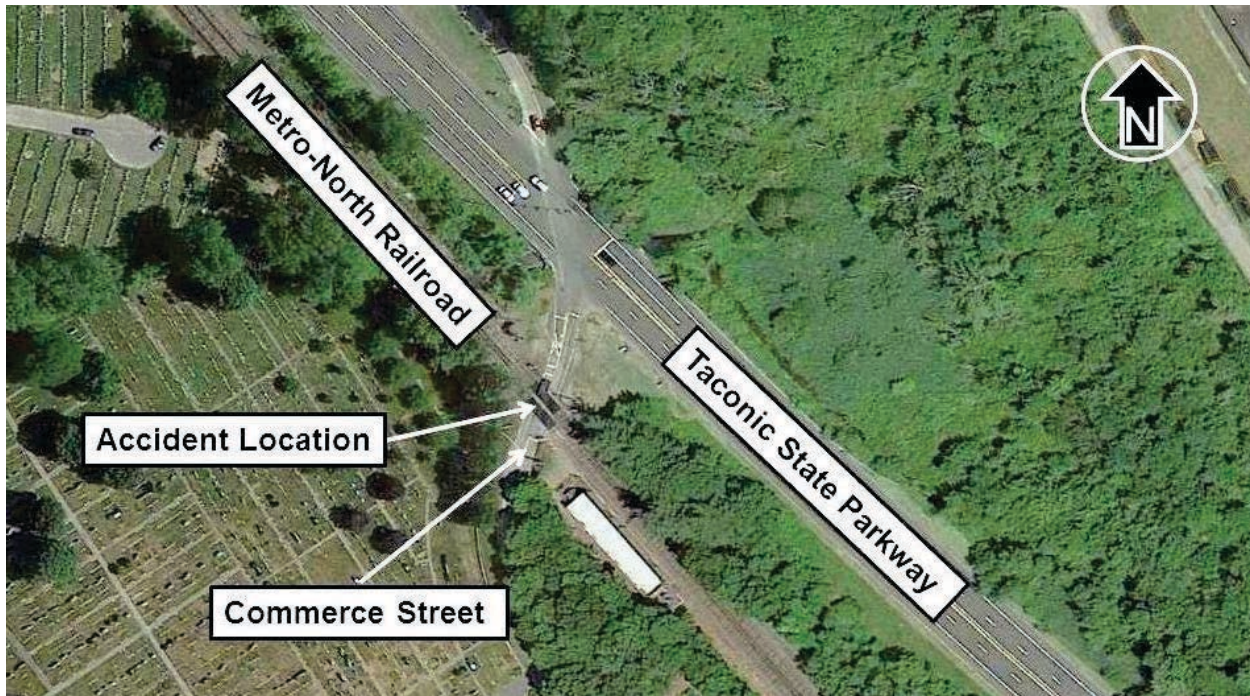
Figure 7. Accident location. (Modified from Google Earth.)

Commerce Street is a northwest-southeast, two-lane asphalt road that turns slightly northeast and crosses the railroad tracks at milepost 26.6 and then intersects with the Taconic State Parkway. The Taconic State Parkway is a restricted four-lane divided principal and limited access parkway for passenger car vehicles only, while Commerce Street is an unrestricted two-lane undivided minor arterial. (See figure 7.)

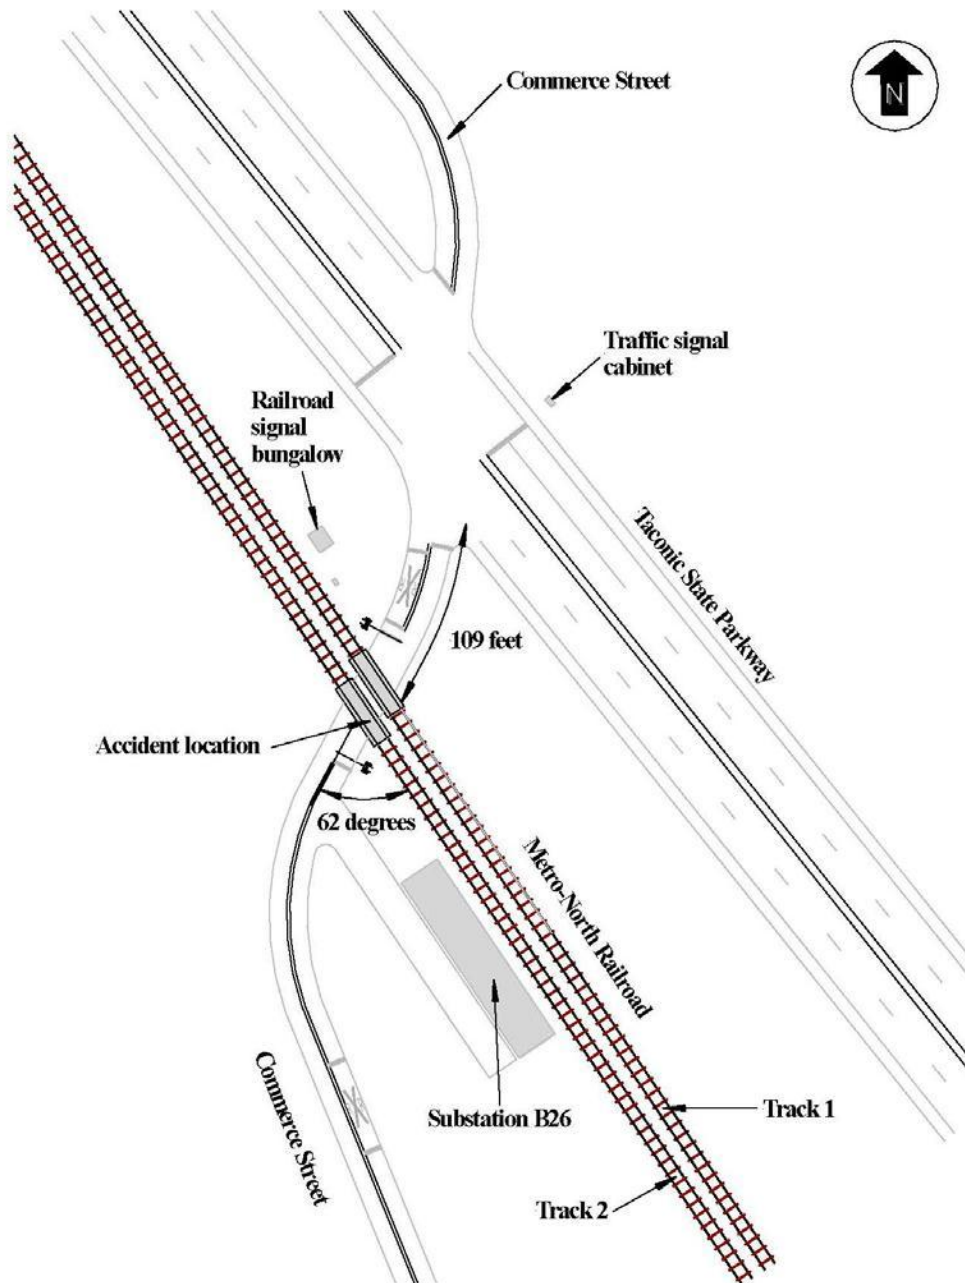
Figure 8. Accident site. (Not to scale.)

Solid yellow double lines that were each 6 inches-wide separated the through lanes of Commerce Street. An edge line separated the through lane and shoulder. The edge line consisted of a 6-inch-wide solid white line. The total width of the two-lane cross section was 18 feet-wide southwest of the grade crossing and 20 feet-wide northeast of the grade crossing. The grade crossing at Commerce Street and the Metro-North tracks formed about a 62° angle. The distance from the farthest eastern rail to the western edge line of the intersection of Commerce Street and Taconic State Parkway was 109 feet. (See figure 8.)

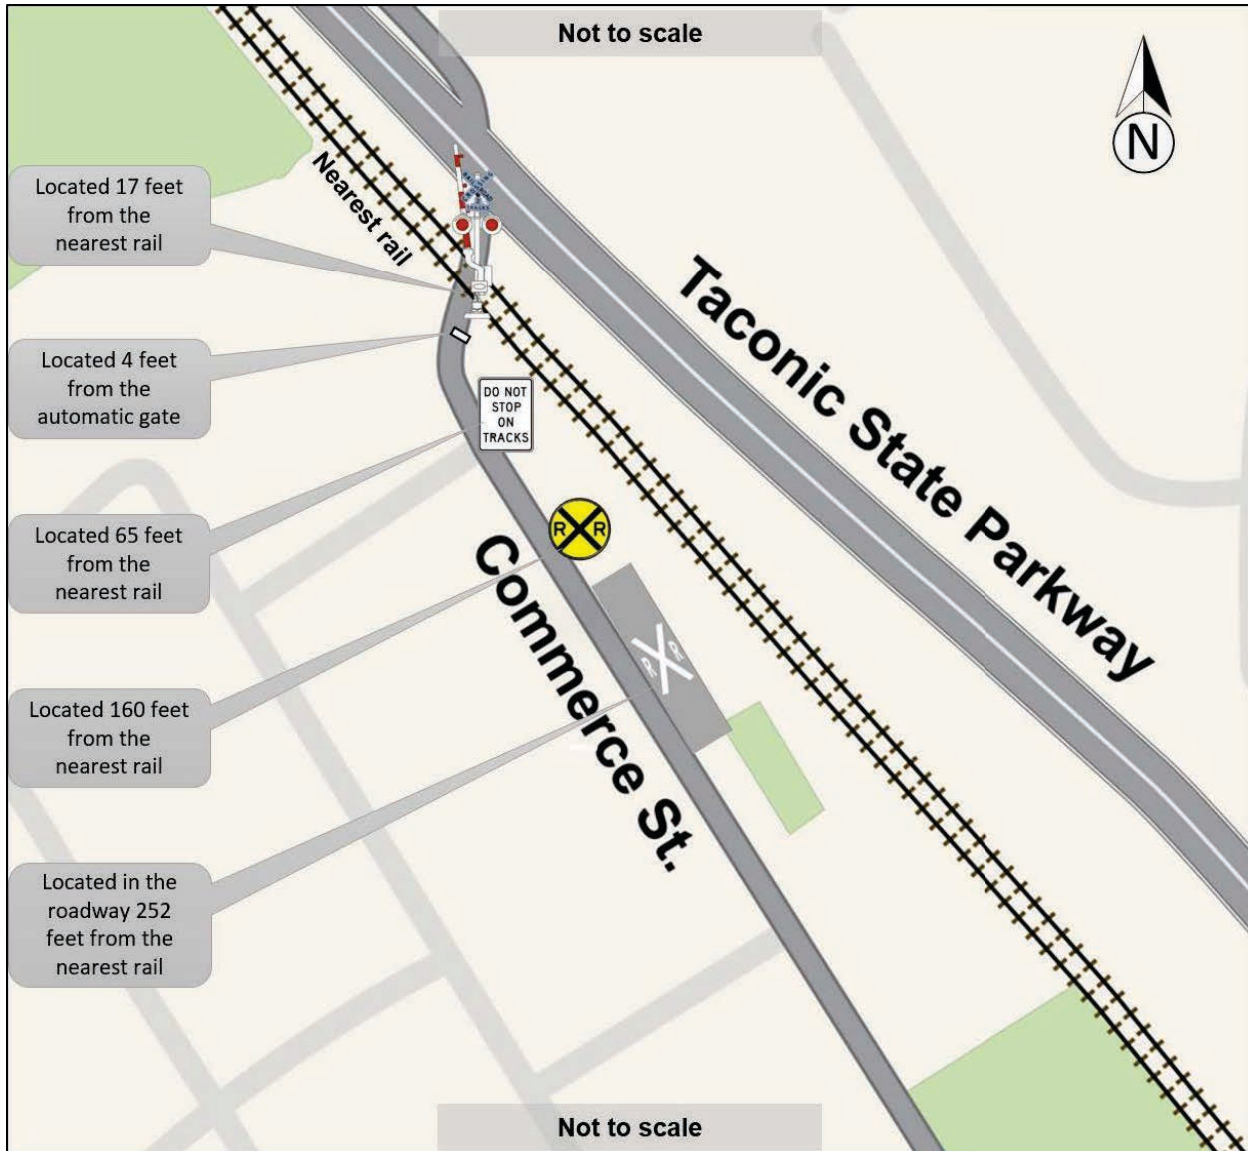
Figure 9. Warning sign locations on the approach to the Commerce Street grade crossing.

the nearest rail. A grade crossing advance warning symbol (yellow warning sign) was located about 160 feet from the nearest rail. A “Do Not Stop on Tracks” sign was located about 65 feet from the nearest rail and a grade crossing warning crossbuck indicating two tracks was 17 feet before the nearest rail.¹⁰ A reflectorized white stop line, measuring 16 inches wide and 10 feet long, was located about 4 feet from the automatic gate. (See figure 9.)

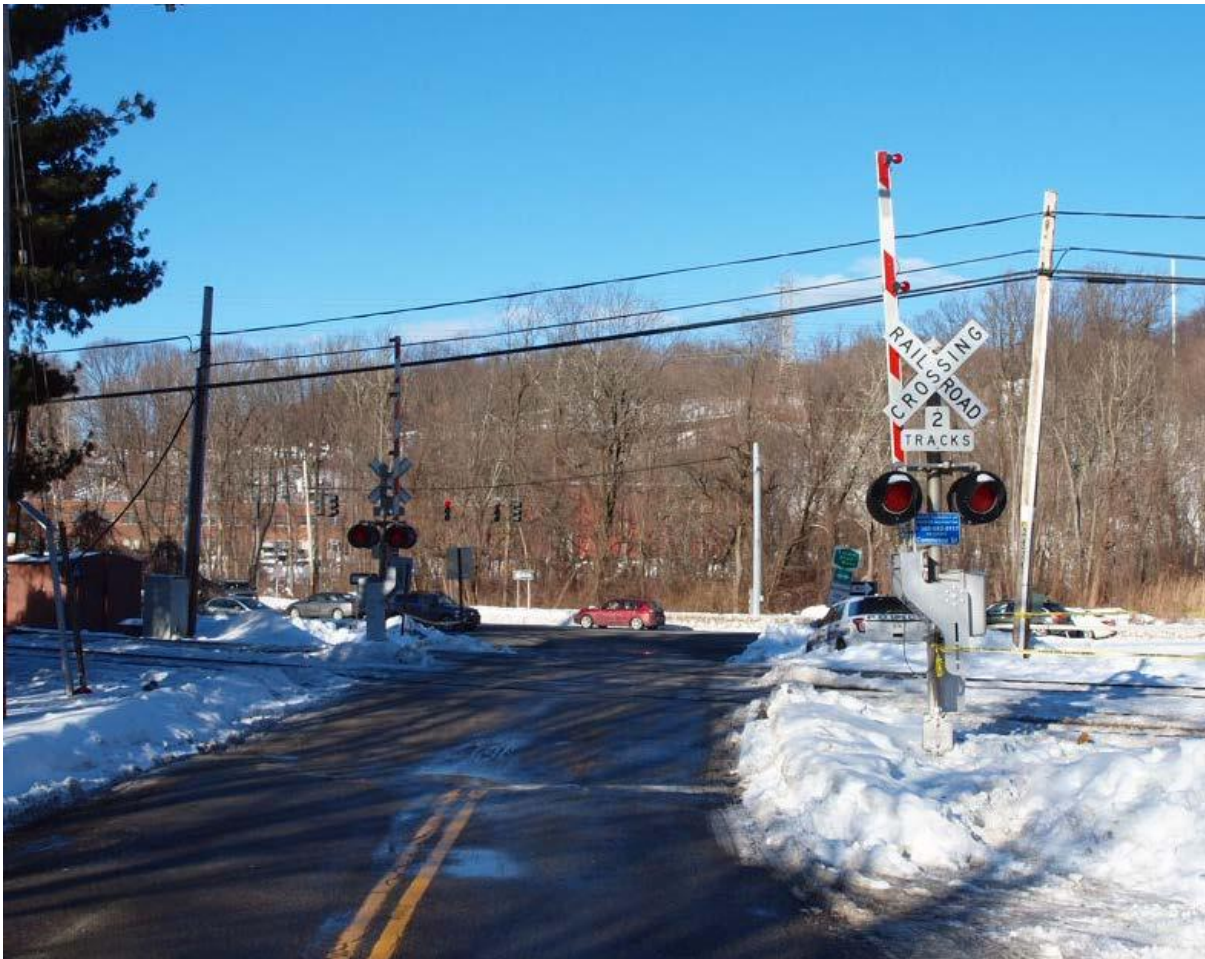
Figure 10. Approach of the Commerce Street grade crossing, facing northeast.

The warning system at the Commerce Street grade crossing consisted of reflectorized flashing lights and gates, including eight 12-inch diameter flashing light-emitting diode (LED) light units configured for bidirectional operation, and two gate arms mounted on two signal masts; however, it did not have bells.¹¹ This system provided warning for both directions of traffic on Commerce Street. One gate arm extended across one lane for the northeast direction of Commerce Street and a second gate arm extended across the southwest lane. Each aluminum and fiberglass gate arm had alternating red and white reflective striping and was equipped with three 3-inch LED light units mounted along the top. (See figure 10.)

Postaccident testing confirmed that when the warning system activated, the light unit mounted at the tip of the gate arms remained lit, while the other two light units flashed alternately. Both signal masts had signs affixed with a toll-free telephone number to report emergencies.

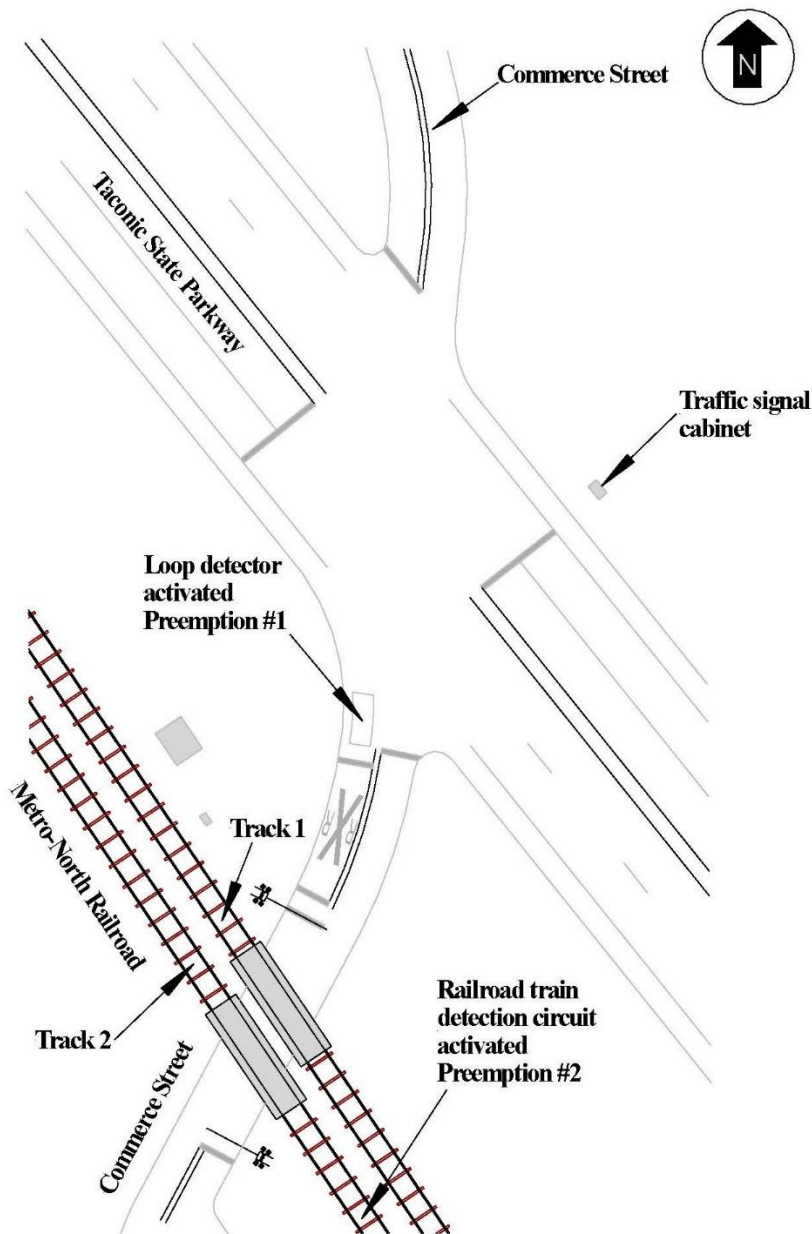
Figure 11. Traffic signal preemption at accident site. (Not to scale.)

The traffic signal at the Commerce Street and Taconic State Parkway intersection was designed with two preemptions. A loop detector in the pavement of the southwest approach of the Commerce Street grade crossing for southbound vehicles turning from Taconic State Parkway on to Commerce Street toward the grade crossing activated preemption #1.¹⁶ (See figure 11.)

Preemption #1, when activated, allowed vehicles to clear the Taconic State Parkway and Commerce Street intersection before any additional vehicles could turn or travel through the intersection, avoiding the potential of trapping vehicles in the intersection of Commerce Street and Taconic State Parkway.

The railroad train detection circuit, shown in Figure 11, is designed to activate Preemption #2 to provide green signal time for highway vehicles traveling northeast on Commerce Street to clear the queue. When Preemption #2 activates, the traffic signal for north and southbound traffic on the Taconic State Parkway terminates the active green phase, activates the corresponding

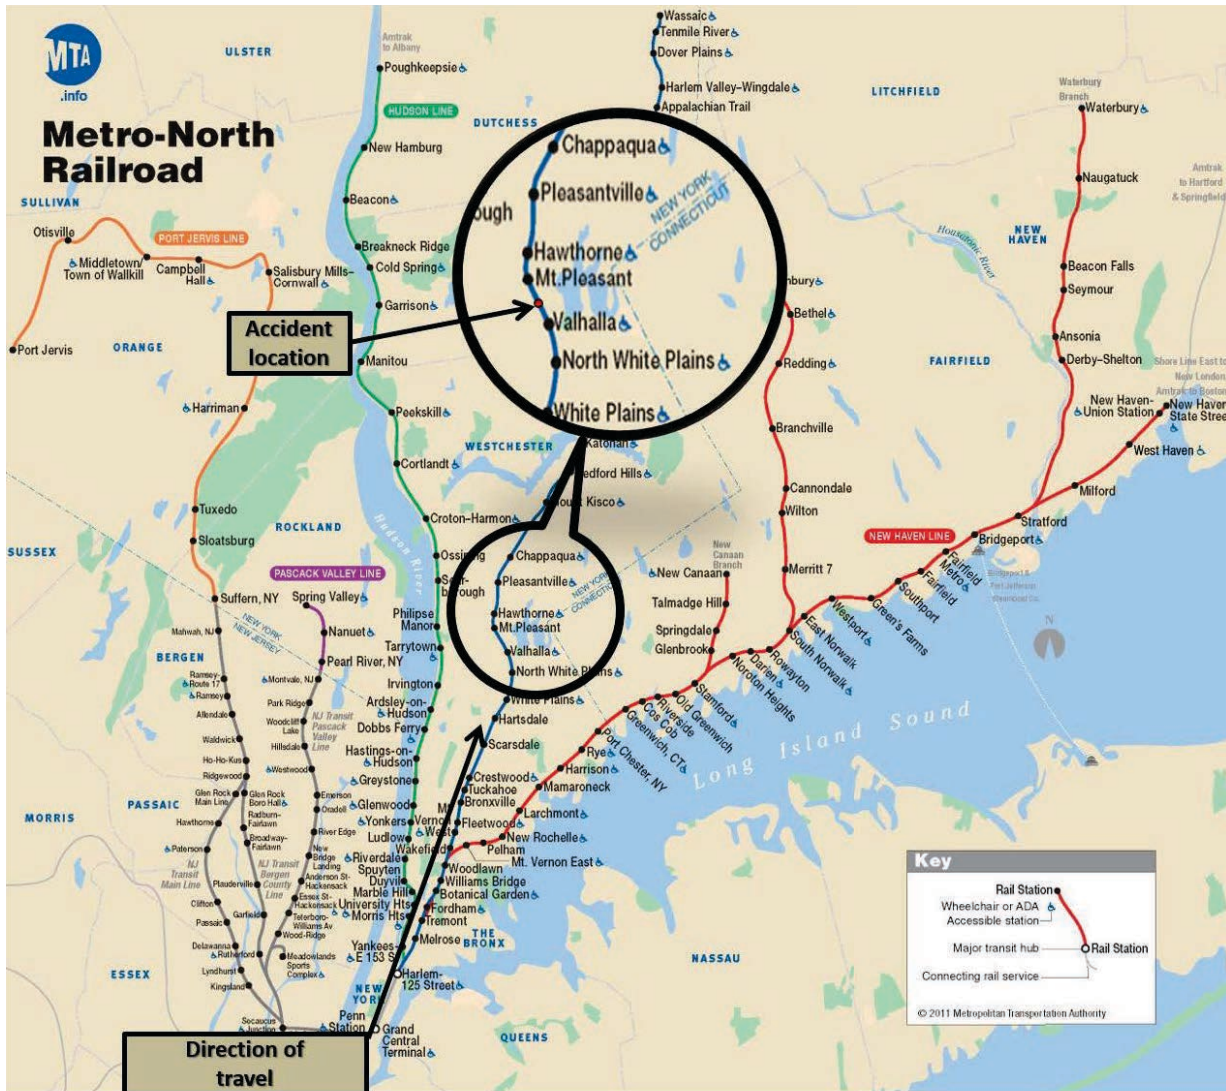
Figure 12. Metro-North system map highlighting the accident location. (Source: Metropolitan Transportation Authority.)

Train 659's first scheduled stop was Chappaqua, New York, which was north of the accident location. (See figure 12.) The train passed North White Plains Station on time, at about 6:22 p.m. The train proceeded within the maximum authorized speed until the accident.

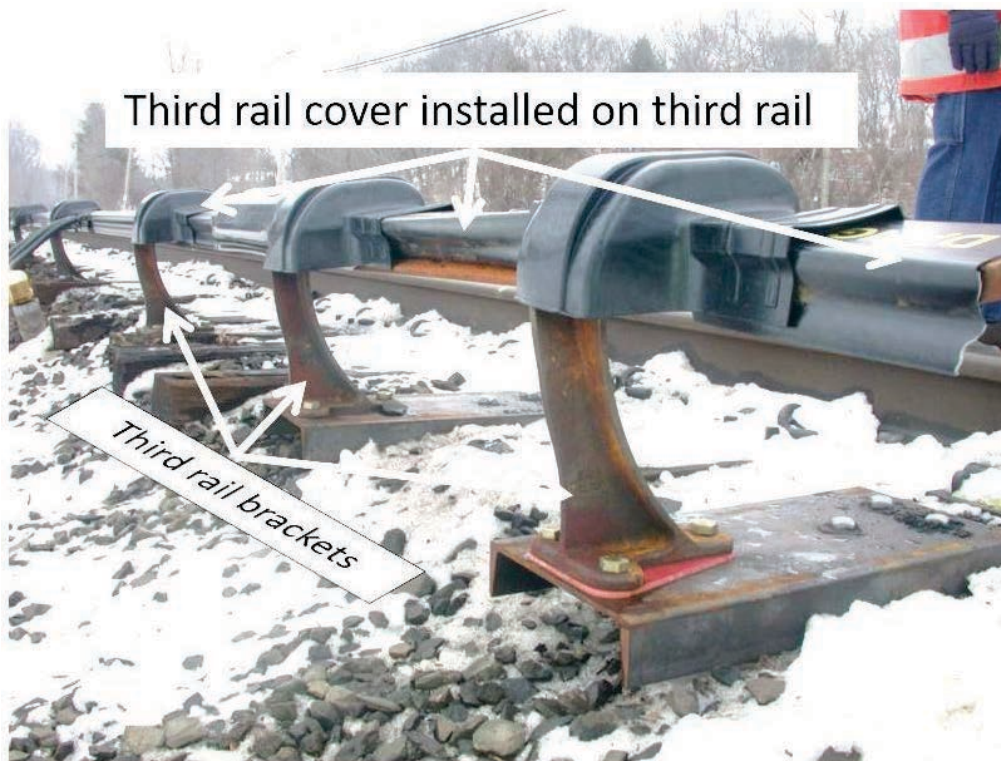
Figure 13. Metro-North's third rail configuration.

power to operate from the bottom side of the rail. The third rail has a protective cover. (See figure 13.)
