NATIONAL TRANSPORTATION SAFETY BOARD

FIRE GROUP FACTUAL REPORT

Report No. 15-058

NTSB #: **DCA15MR006**

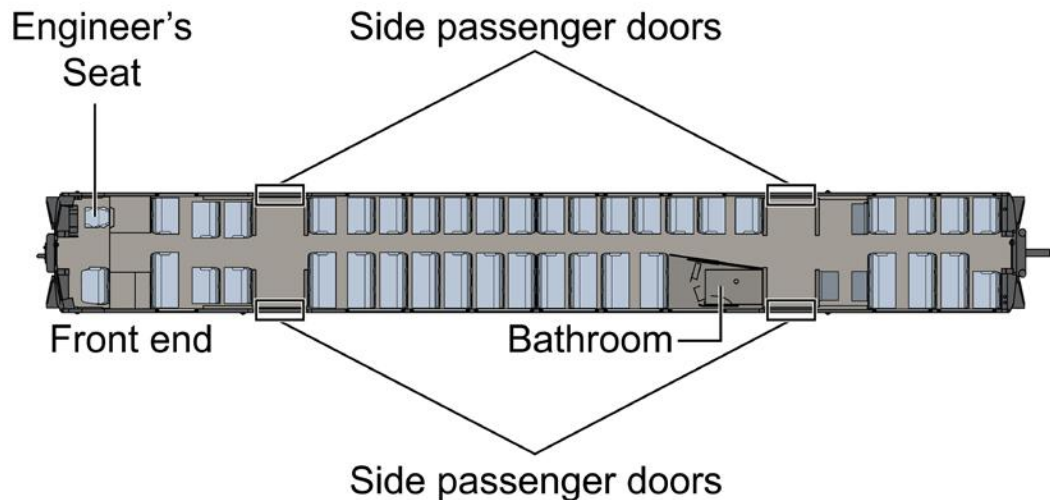
Figure 15. Floorplan of "B"-car (MN 4333).

An overall floorplan of the rail car is showing in Figure 15. The interior of the Operator's and passenger compartments exhibited significant fire damage. The damage to the passenger compartment is shown in Figures 16-17.
