**NATIONAL TRANSPORTATION SAFETY BOARD  
WASHINGTON, D.C.**

**FIRE AND EXPLOSION GROUP FACTUAL REPORT**

**DCA-96-MA-070**

Location : East Moriches, New York  
Date : July 17, 1996  
Time : 2031 Eastern Daylight Time (EDT)  
Aircraft : Boeing 747-131, N93119,

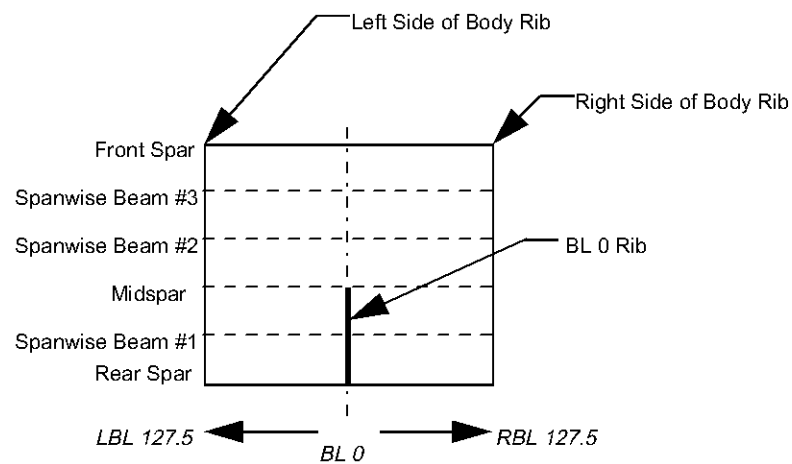
Plan (Top) View of  
the Center Wing  
Section

The following sketch shows the center tank support structure. The forward section of the WCS is a dry bay (no fuel) that is bounded by the front spar and spanwise beam 3.
