**NATIONAL TRANSPORTATION SAFETY BOARD
WASHINGTON, D.C.**

FIRE AND EXPLOSION GROUPS FACTUAL REPORT

**Appendix III
(Tests and Study)
(81 pages)**

TWA FLIGHT 800 ACCIDENT INVESTIGATION

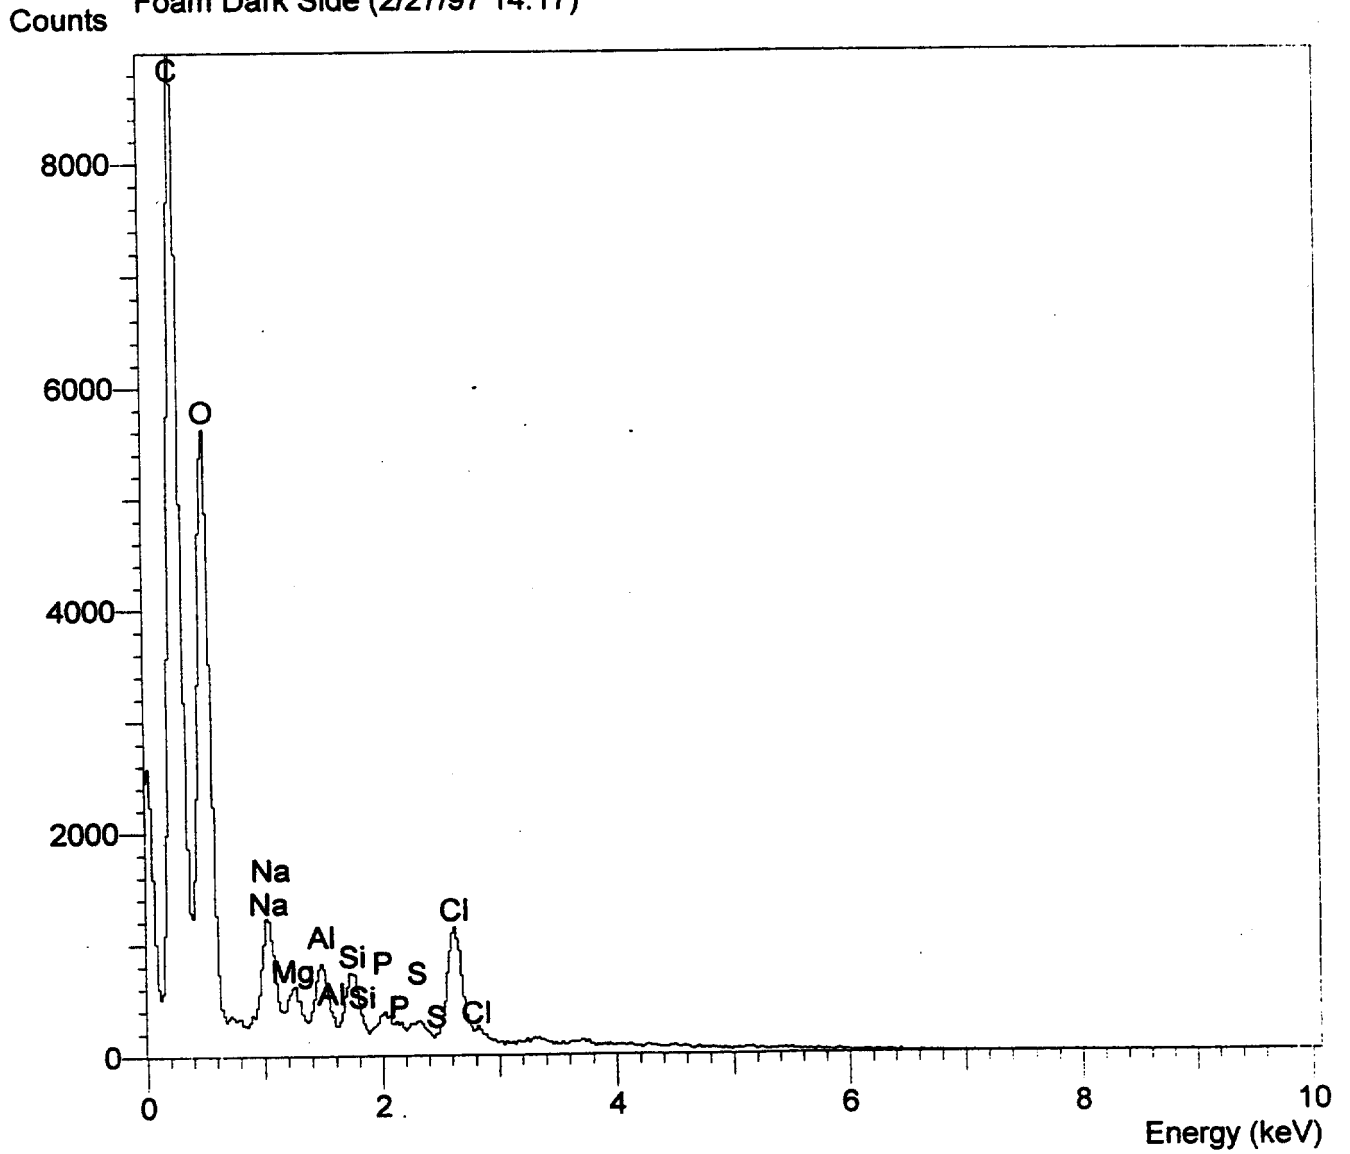
FIGURE 4. DARKER SIDE

- 4.3 An EDS analysis of the surface of the outer side (Refer to Figure 1) shows high concentrations of chlorine, moderate amounts of oxygen, silicon and carbon with minor amounts of sulfur, sodium, magnesium, aluminum, potassium, calcium, barium, iron and zinc. The EDS chart of these results is provided in Figure 4.

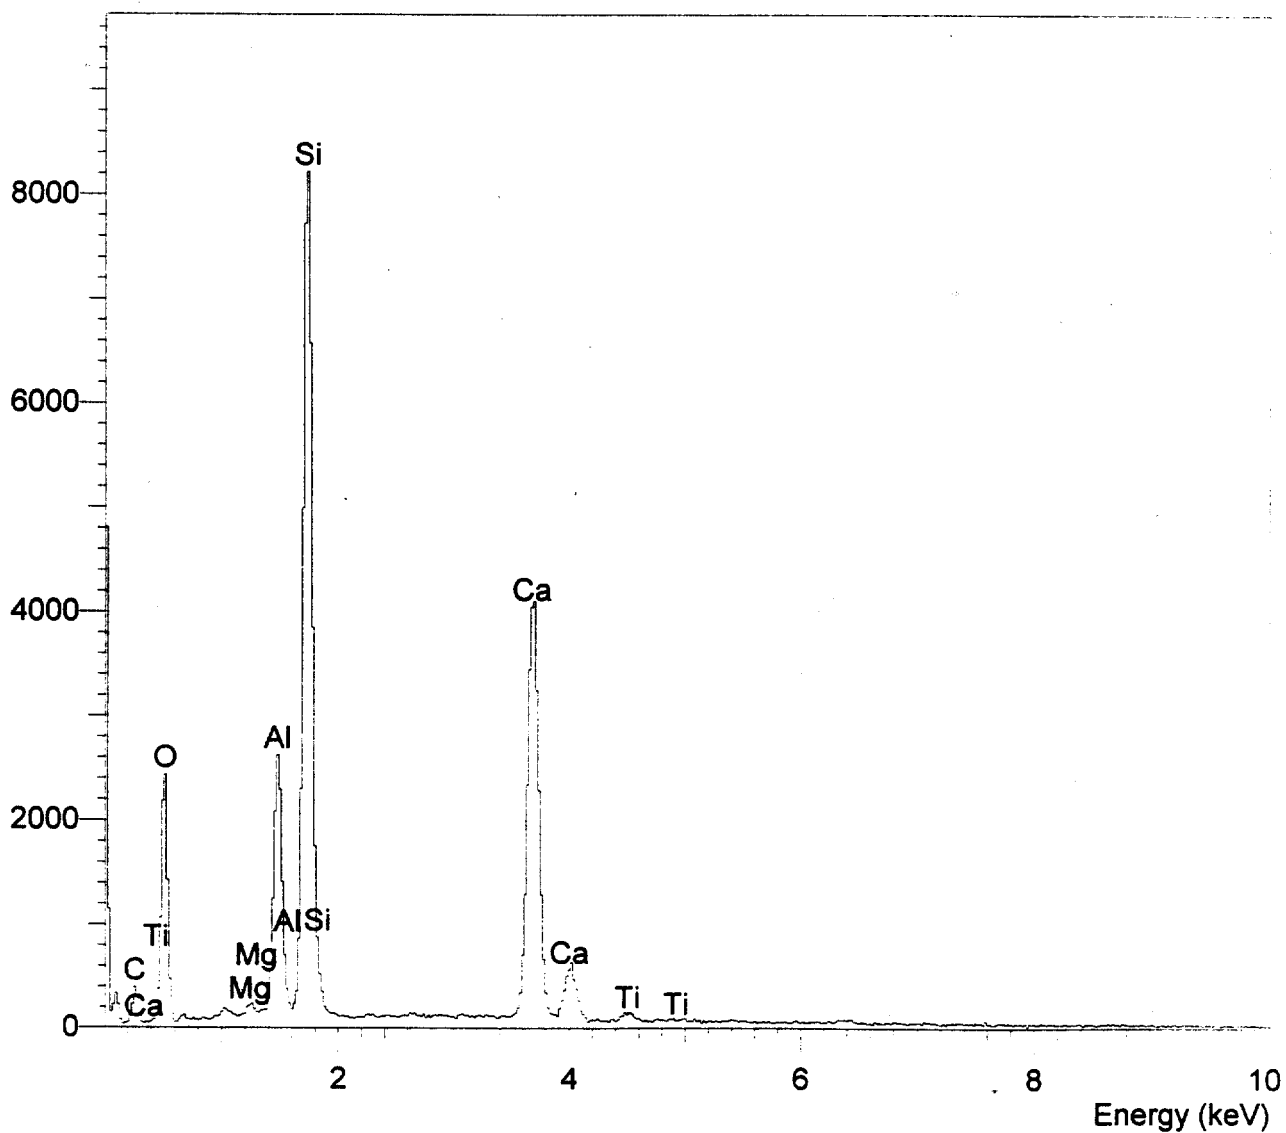
FIGURE 3. EDS OF FIBER.

- 4.2 EDS analysis of an isolated fiber, indicates high concentrations of silicon, moderate amounts of calcium, aluminum and oxygen, with trace amounts of carbon, magnesium and titanium also present. The EDS chart is provided as Figure 3.

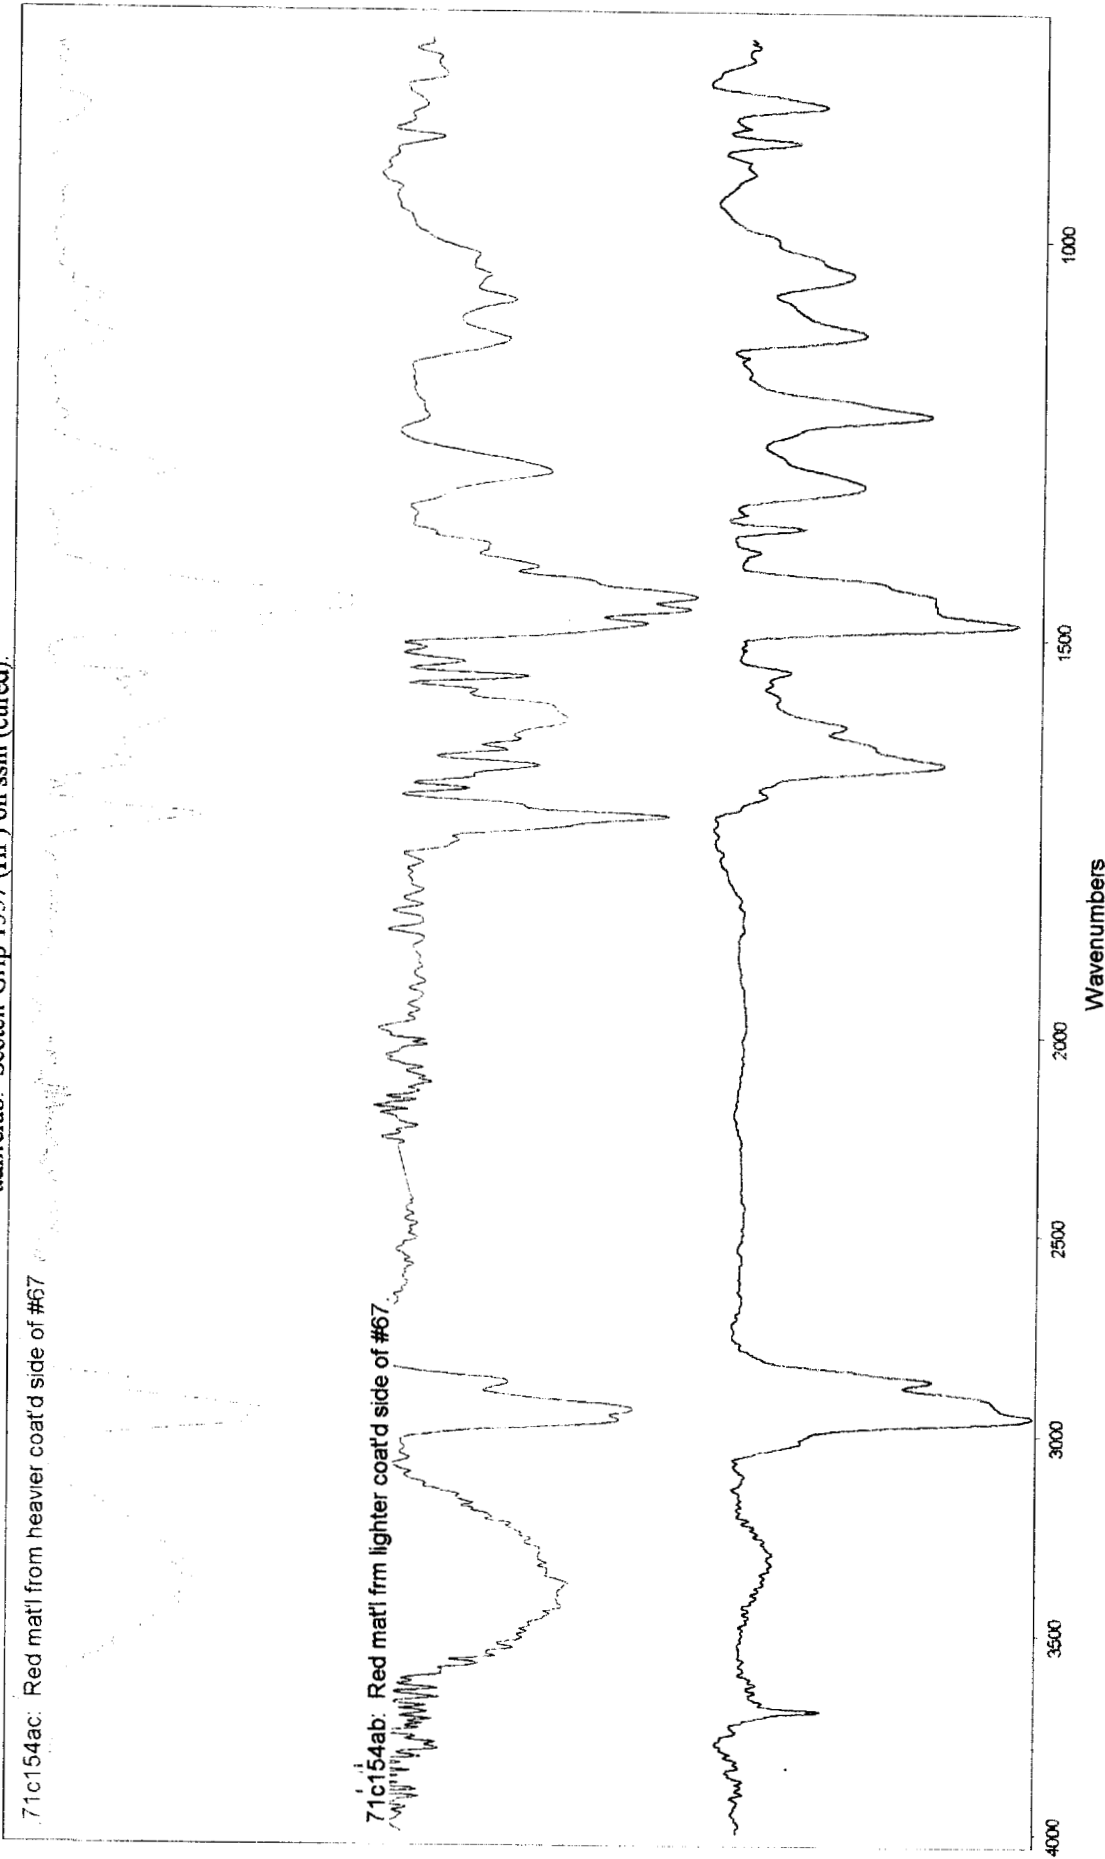
Figure 6. Spectral comparison with adhesive reference material.

- 3.2 Sample #67, Row 19, Seat 2 appeared to be a foam material. A red material was present on both sides with one side more heavily coated than the other (Figure 1). FTIR spectra for the foam material and the red material were independently generated and analyzed. The spectrum for each is provided at Figures 2, 3 and 4 respectively. The spectrum for the 3M reference adhesive (Figure 4) was compared to the spectra of the red material. The spectra for the comparison of the red material to the reference product is provided as Figure 6.

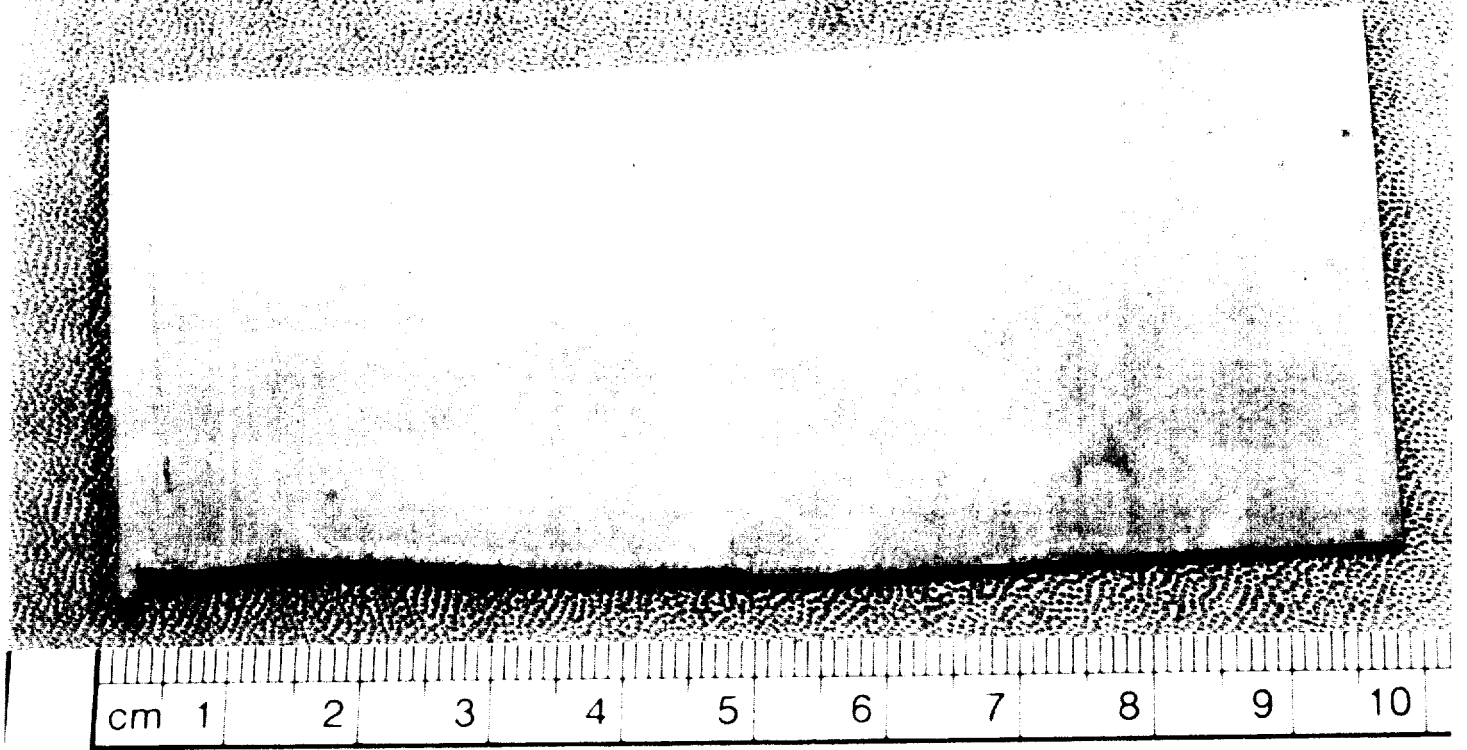
Figure 7. Sample #70, Row #17, Seat #8.

- 3.3 Sample #70, Row 17, Seat 8 (Figure 7) appeared to be a plastic or vinyl material with some of the unknown red material on one side. For the purposes of this discussion, the side which contained none of the suspected adhesive material will be referred to as the clean or non-contaminated side and the side which did contain some of the suspected adhesive material will be referred to as the contaminated side. FTIR spectra was generated for the clean side and for the contaminated side, the spectra of which are provided as Figure 8 and Figure 9 respectively. The spectrum of the reference adhesive was compared to the spectrum of the unknown red material. The spectral comparison is provided in Figure 10 and a spectral overlay in Figure 11.

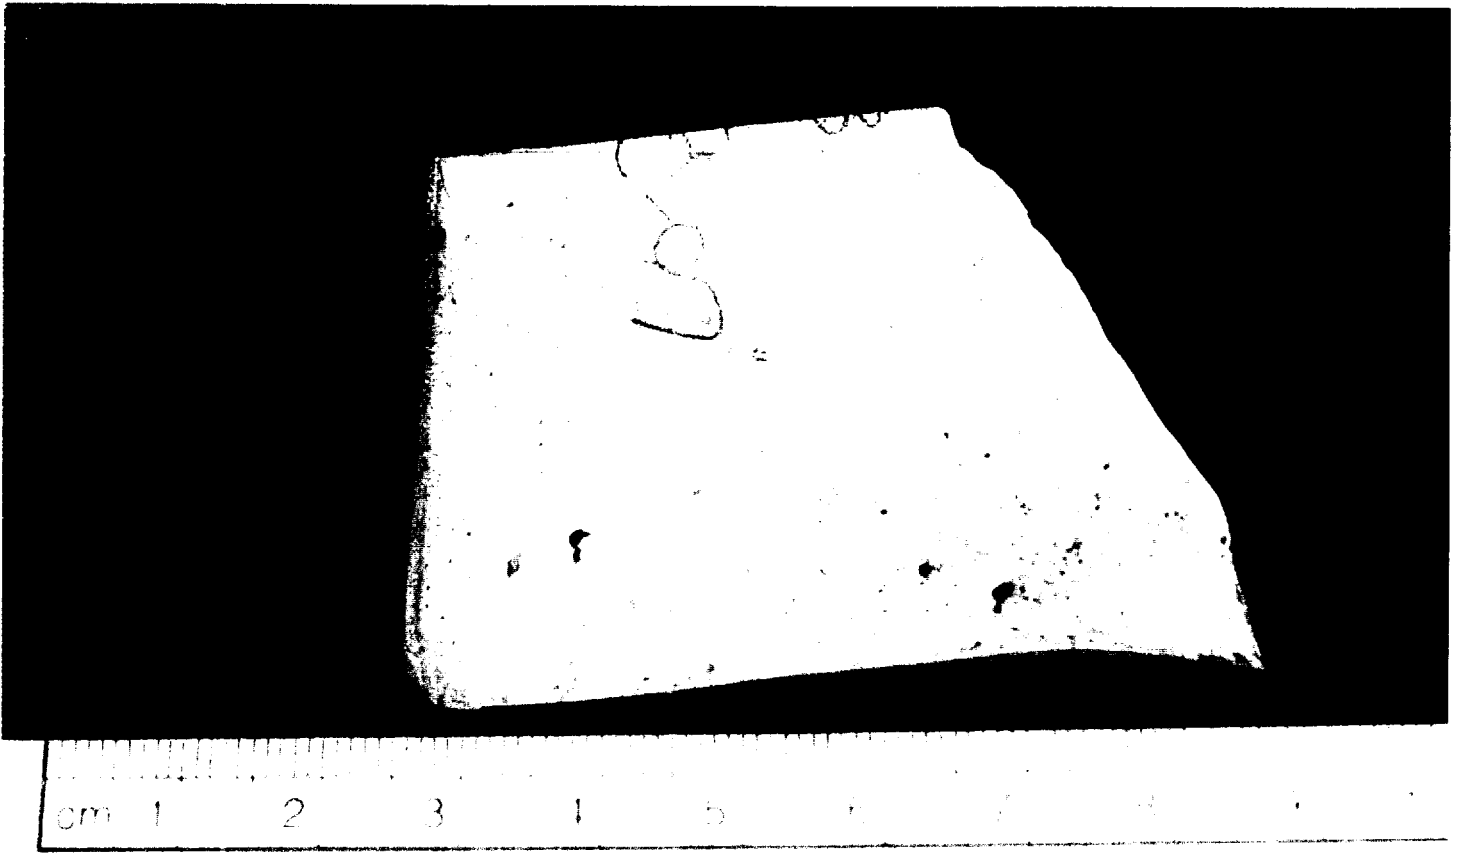
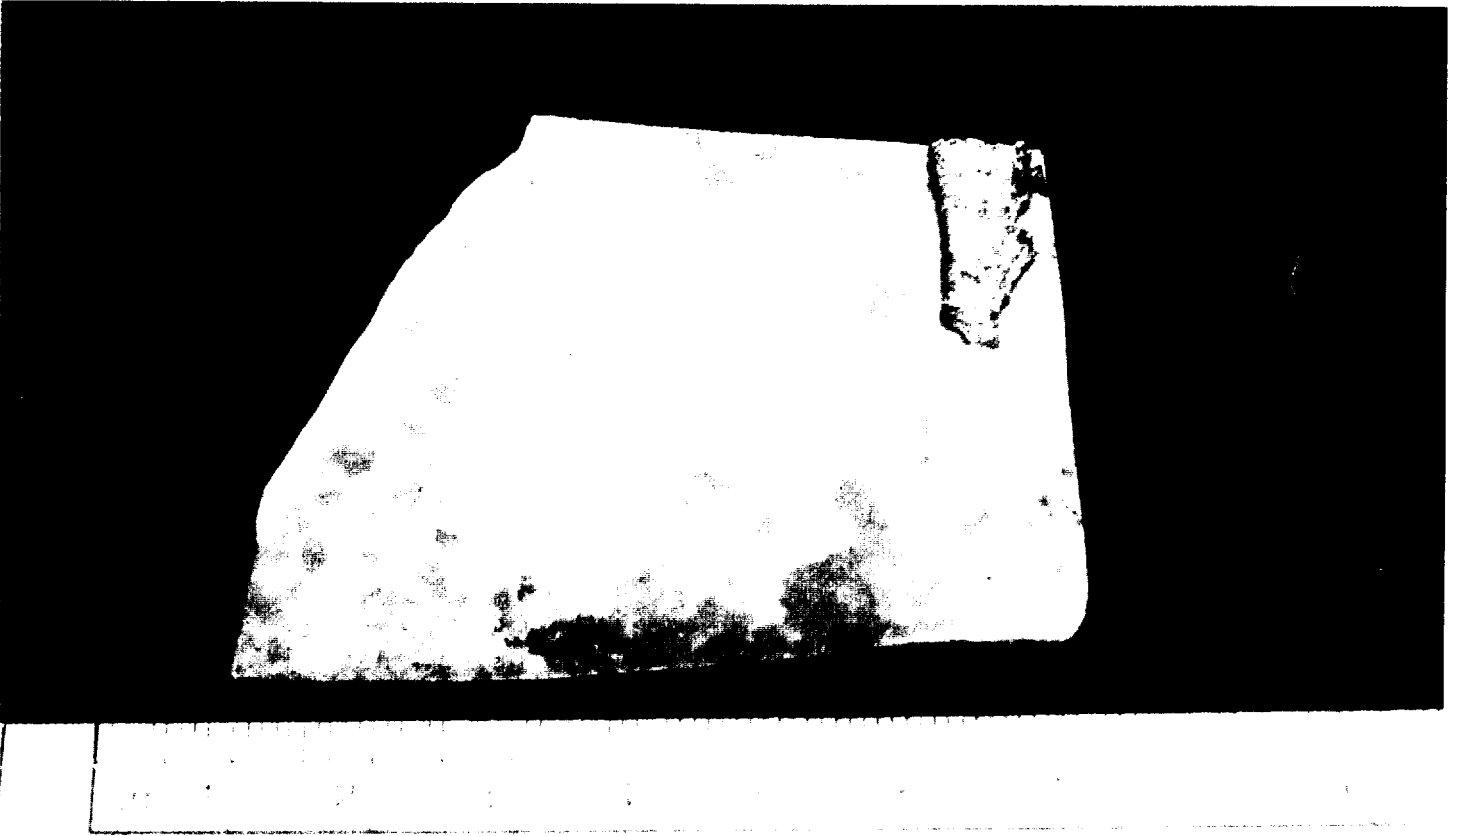
Figure 12. Sample #73, Row #27, Seat #2

- 3.4 The plastic or vinyl material from sample #73, Row 27, Seat 2 (Figure 12) was contorted much like the deformation which occurs when exposed to heat, whereas the material of sample #70 was smooth and exhibited no such altered conformation. Additionally, the unknown material which was attached to one side of sample #73 was tan or reddish-brown, whereas the contaminated side of sample #70 was red. The spectrum for the clean side of sample #73 is provided in Figure 13 and the spectrum for the contaminated side of the sample is provided in Figure 14. A spectral comparison of the reference adhesive and the red-brown material is provided in Figure 15 and a spectral overlay in Figure 16.

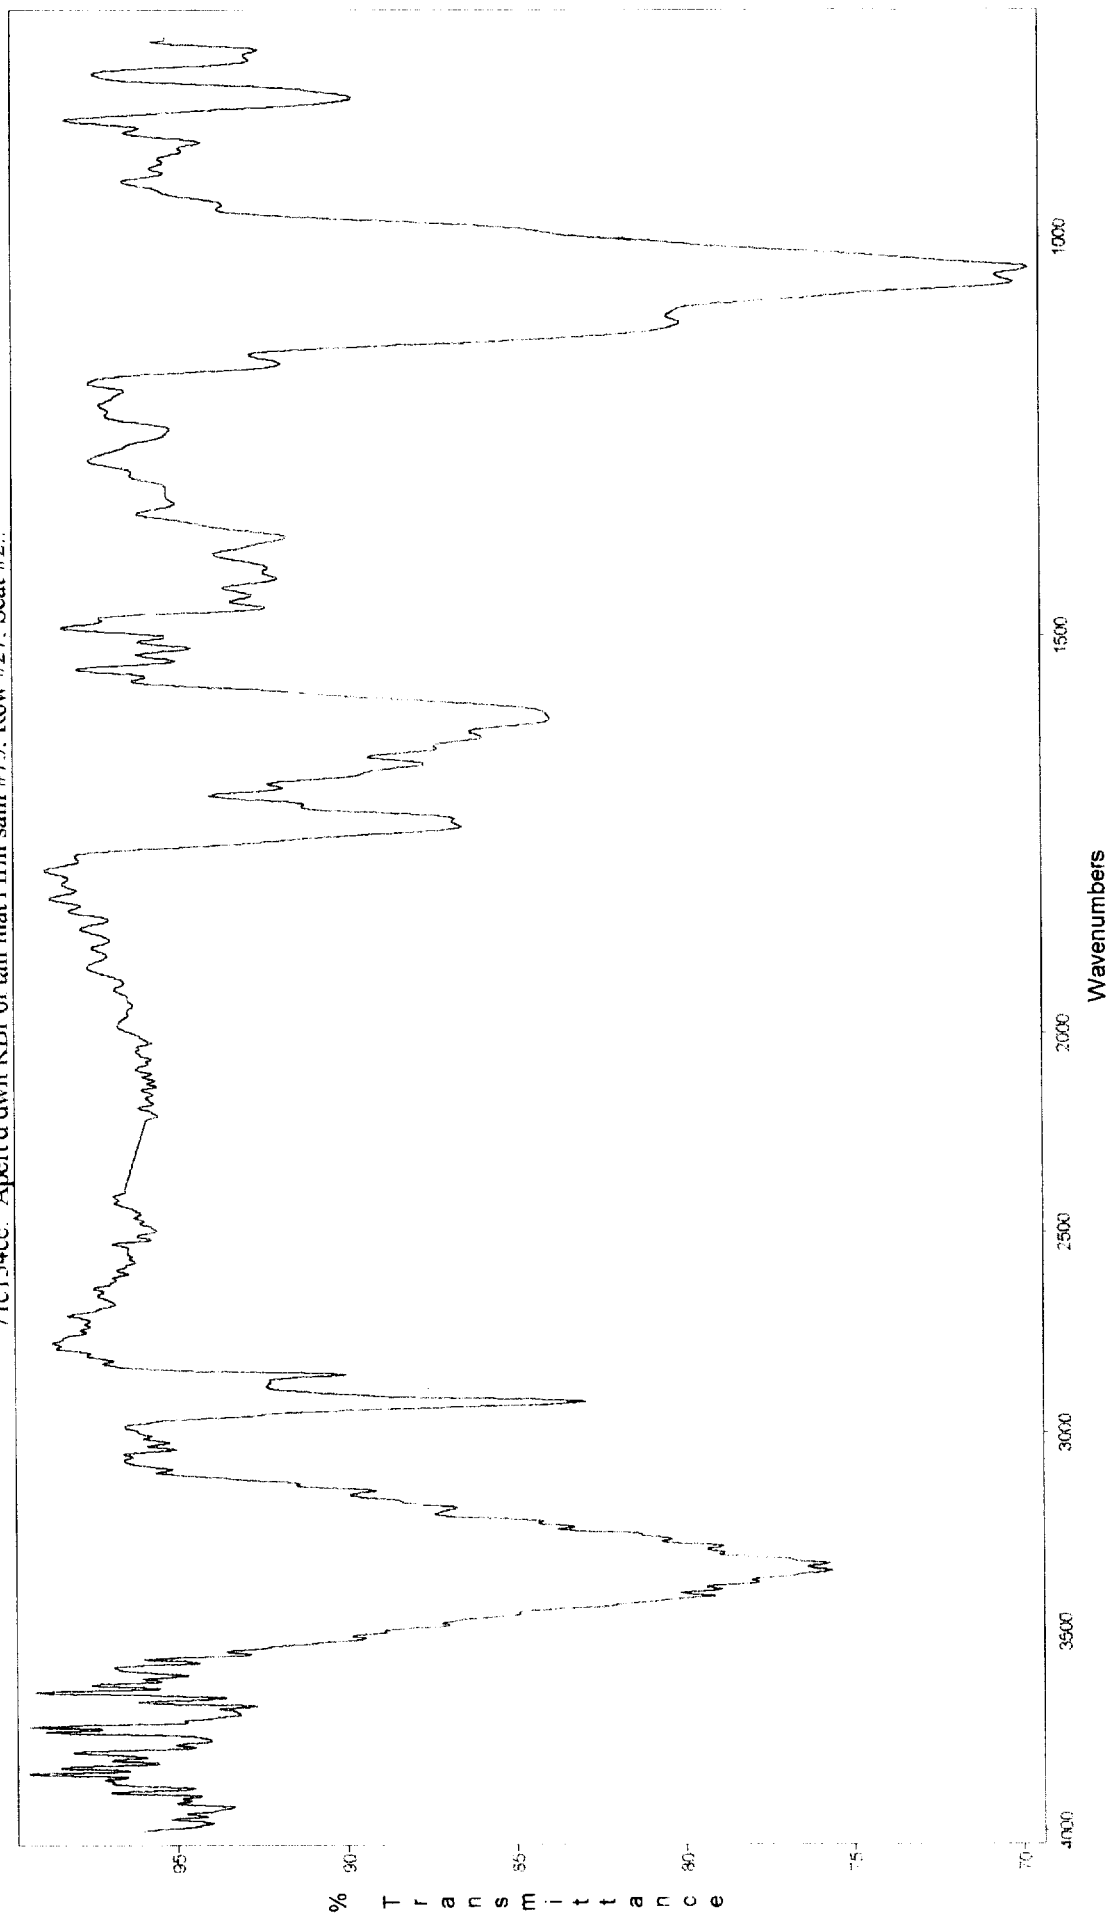
Figure 14. IR spectrum of contaminated side of sample #73, Row #27, Seat #2.

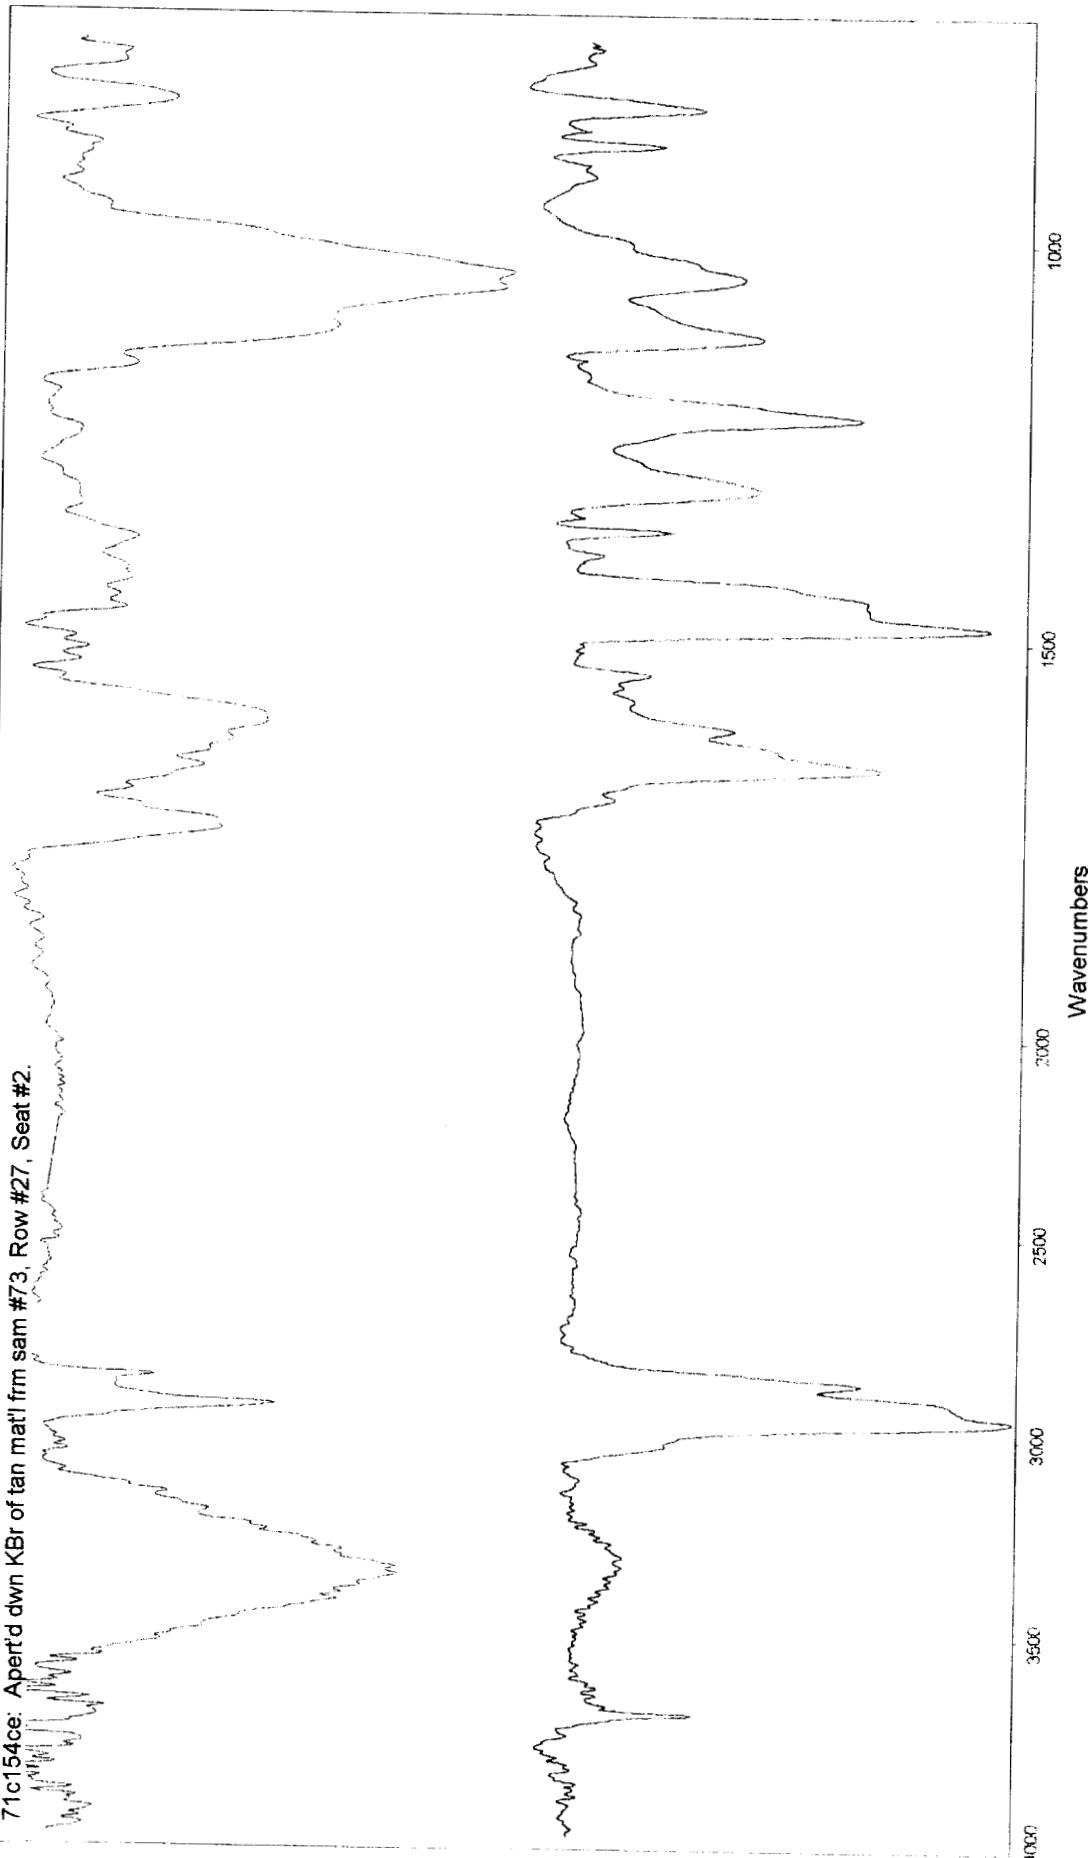
Figure 15. Spectral comparison of adhesive reference with contaminant of sample #73.

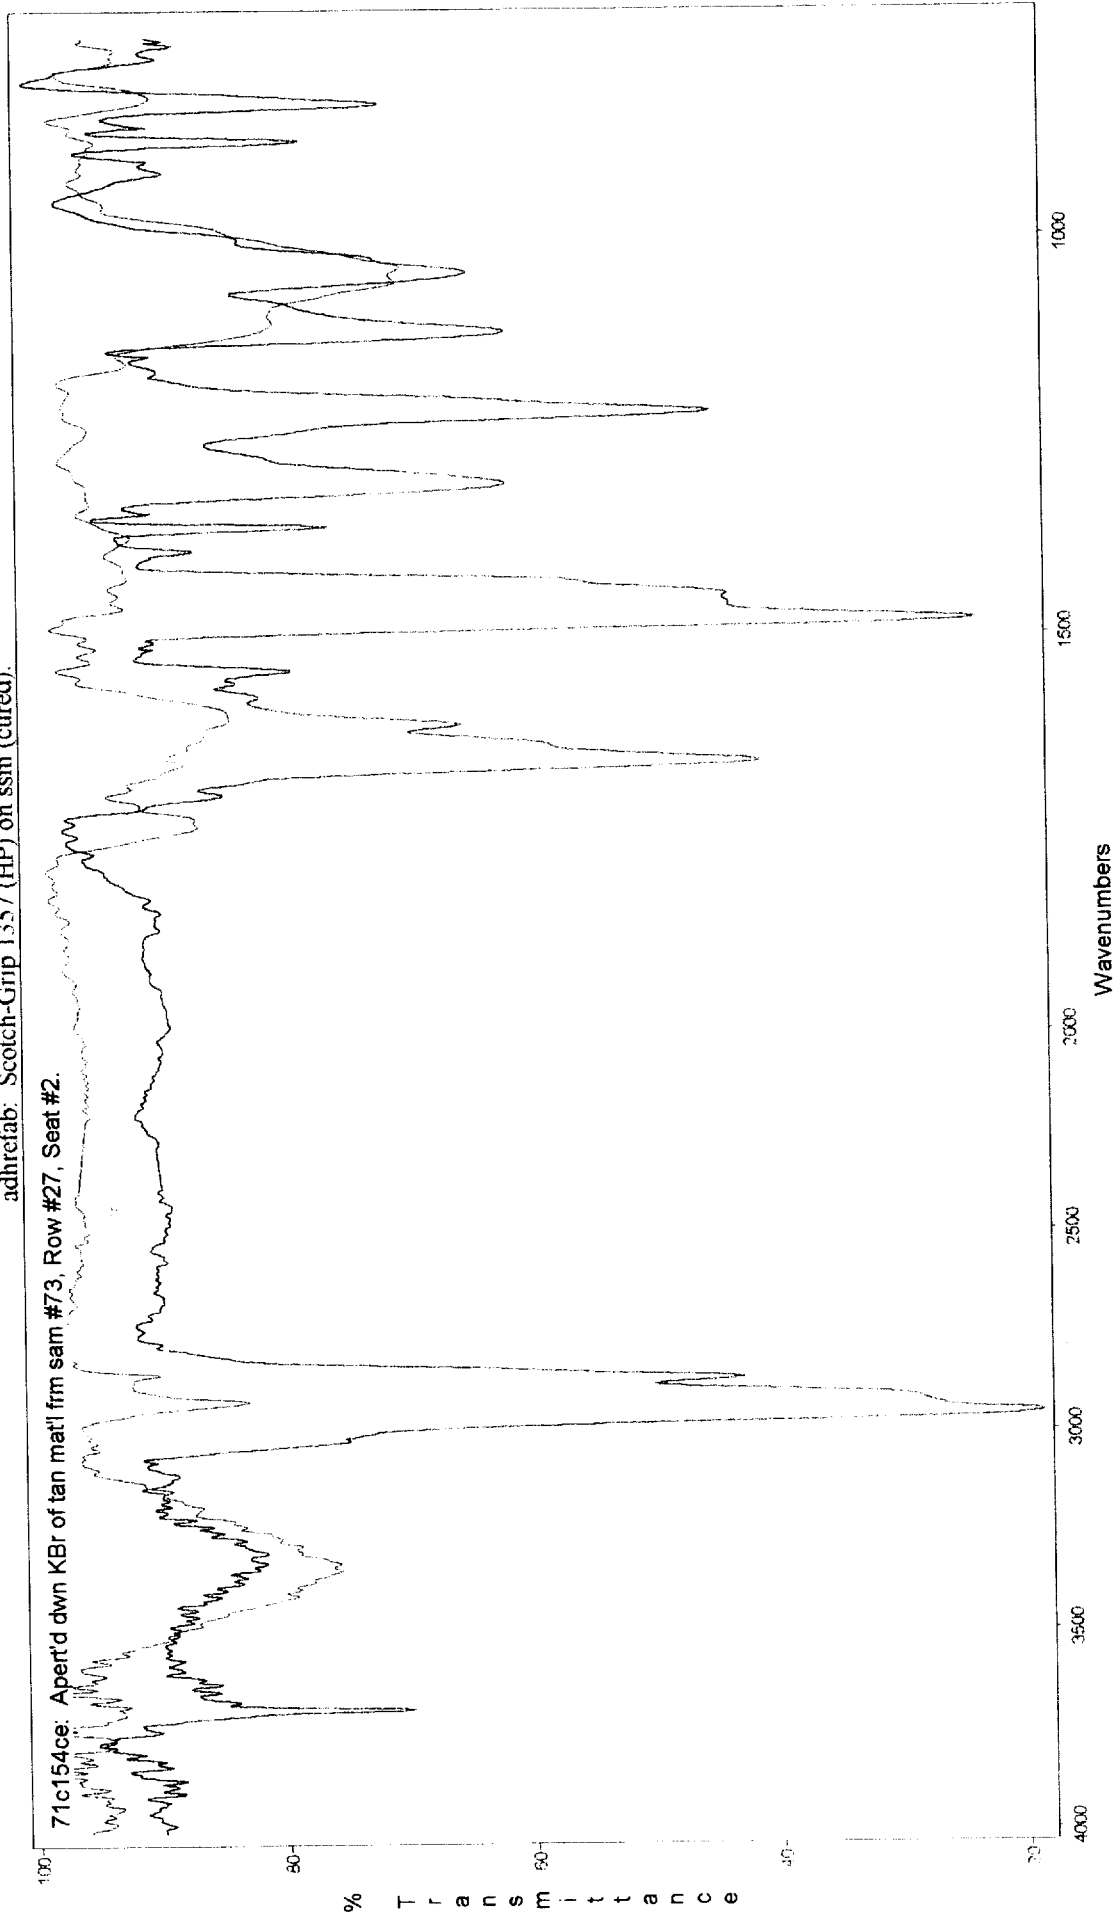
Figure 16. Spectral overlay of adhesive with contaminant.

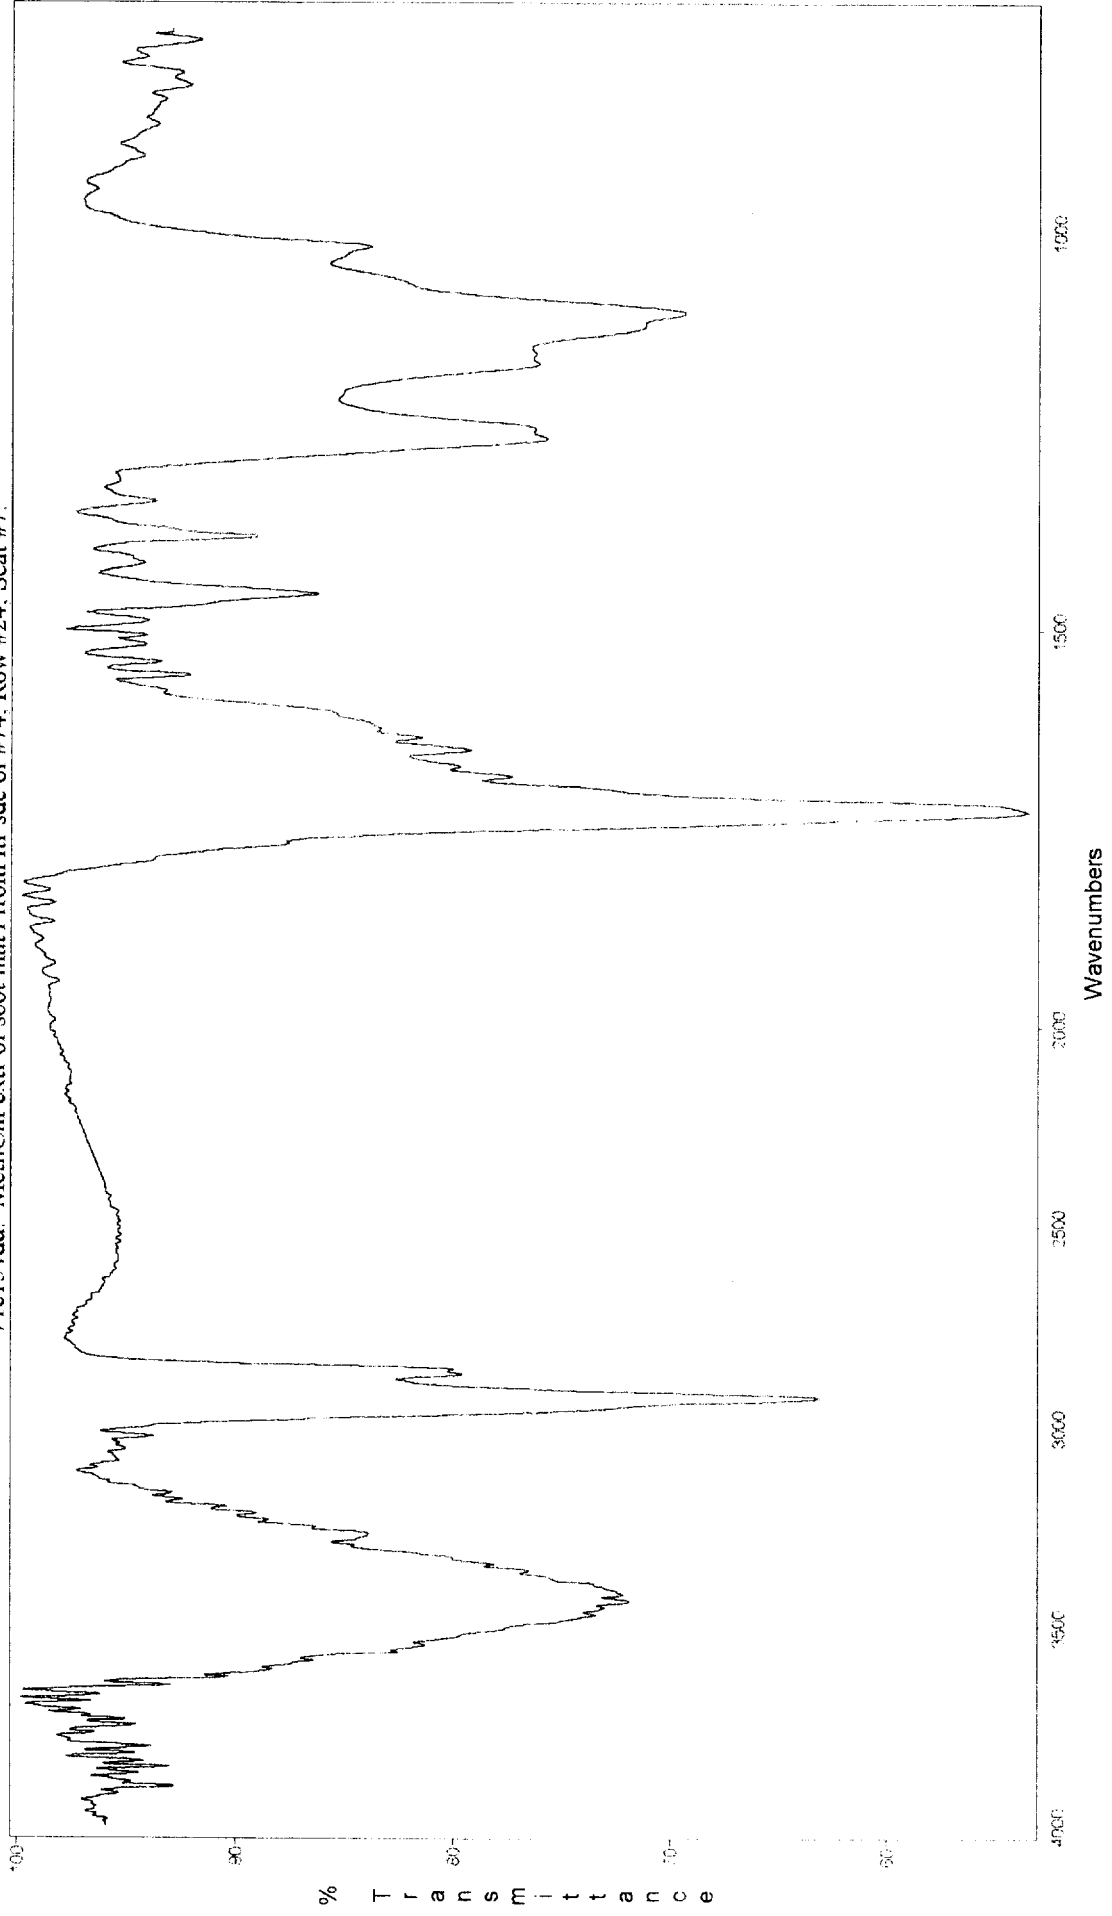
- 3.5 Sample #74, Row 24, Seat 7 (Figure 17) appeared to be a metal alloy (probably aluminum) and was characterized by charred material on both sides. Material from each side was removed and FTIR spectra generated. For the purposes of this discussion, the terms "darker side" and "lighter side" will be used to differentiate between the two sides. A gold colored glazed and a black organic appearing material were removed from the darker side and spectra generated. The FTIR spectra for each is provided in Figure 18 and Figure 19 respectively. From the lighter side, a "soot" looking material was extracted with an organic solvent and a spectrum generated. The spectrum is provided in Figure 20.

Figure 20. Extraction of "sooty" material from lighter side of sample #74.
