ARTECH TESTING L.L.C.
FINAL REPORT

TWA FLIGHT 800 WRECKAGE EXAMINATION

**Prepared for
PERKINS COIE LLP,
KREINDLER & KREINDLER,
and
NATIONAL TRANSPORTATION SAFETY BOARD**

**ARTECH Testing, LLC
Project No. M90127
December 22, 1999**

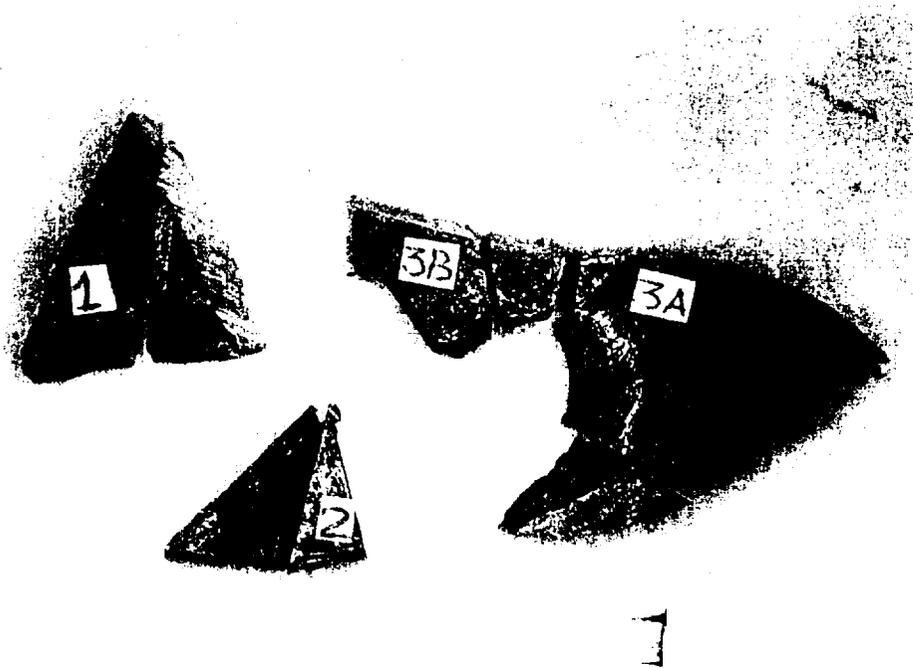
One transverse section through the fracture face was cut from each of Sections CW236 - 1, CW236 - 2, CW236 - 3A, CW236 - 3B, and CW238. The section locations are shown in figures 18 and 19. These sections were prepared for metallographic analysis. The fracture faces of the polished and etched sections were examined at various magnifications to characterize the direction of grain flow. Photomicrographs of the sections are presented in figures 20-24. Grain flow in these photomicrographs clearly indicates stretching of grains from the inside surface of the tank to the outside surface.

Figure 18: Photograph of the transverse section cut for metallographic analysis of Section CW236

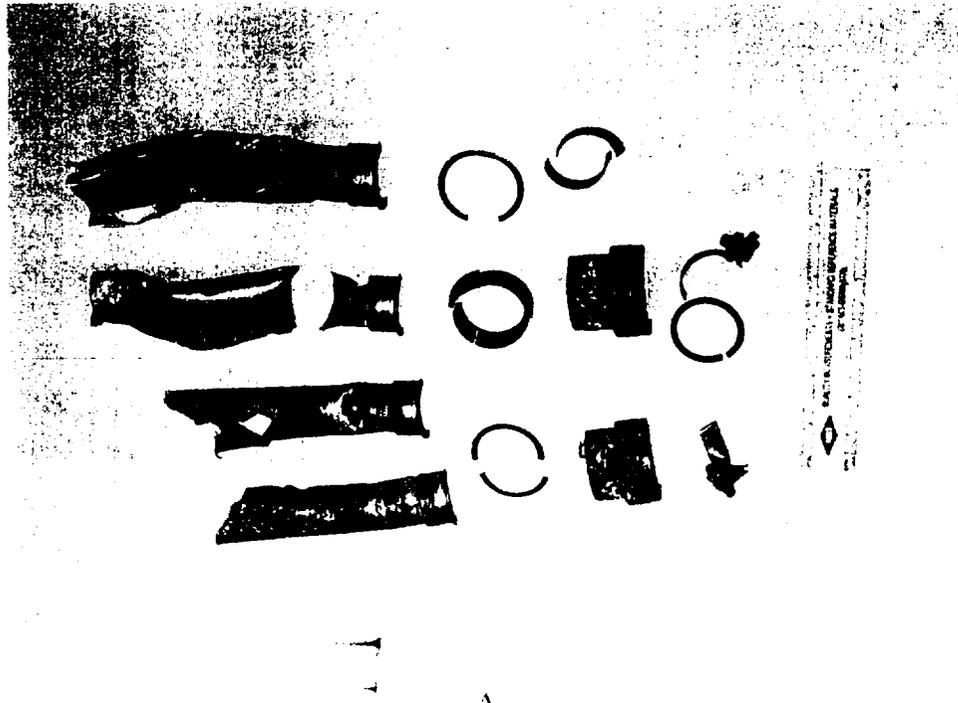
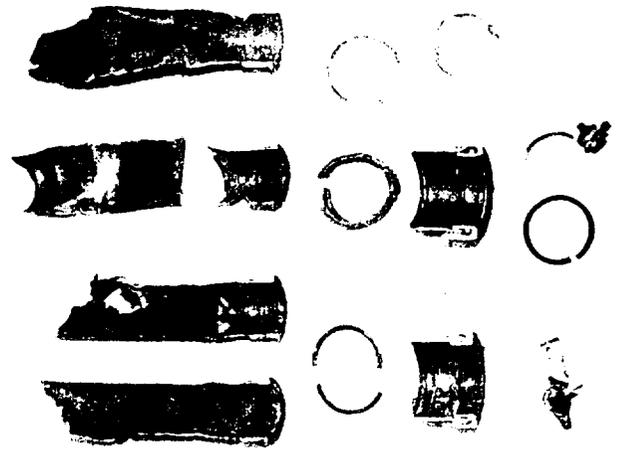
Pieces of the scavenge pump inlet tube are shown in figure 25. Tube sections, which had been cut longitudinally in half, were identified as 65B and S3052 (figure 26).

Figure 25. Photographs show the outside and inside surfaces of the pieces of the scavenge pump in the tube. The top two valves and the plunger valve are identical as 85B and the bottom two valves are 85A.

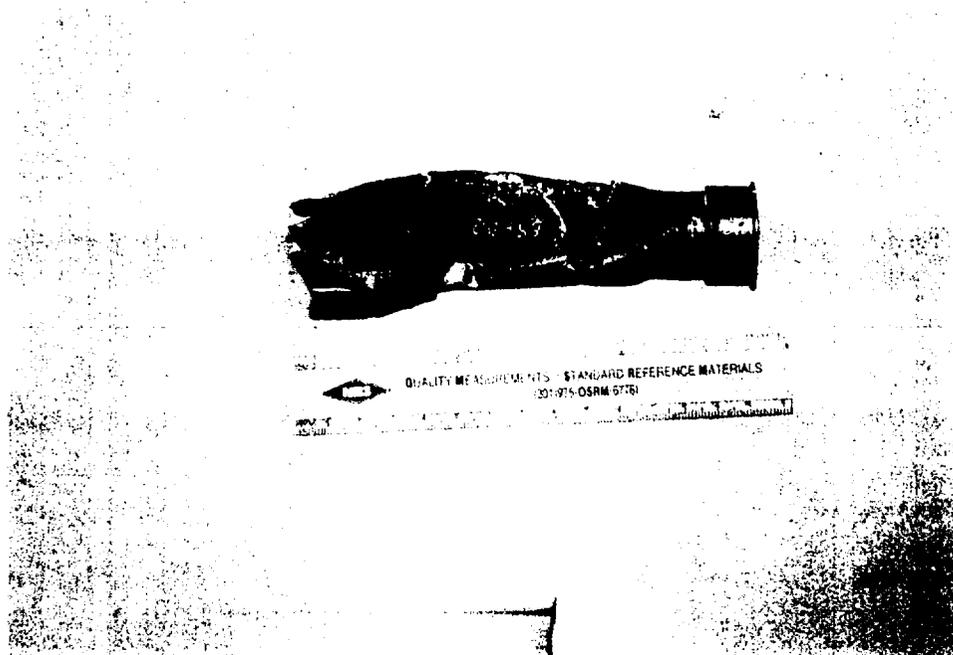
Figure 26. Identifications of the tube pieces shown in figure 25 are exhibited clearly in these photographs.

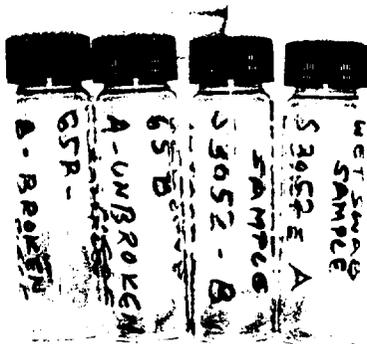
Figure 28. Wet swab samples are shown in this photograph
