Waterman Peak Site Exam
N530RL, S/N 0602FF

WATERMAN PEAK SITE EXAM 3-8-2011
N530RL, S/N 0602 FF

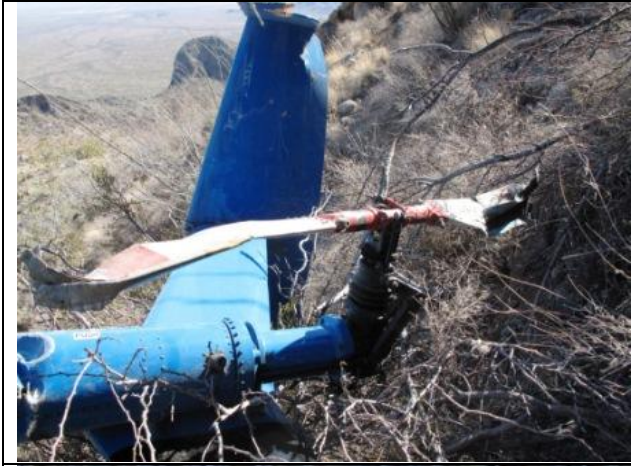
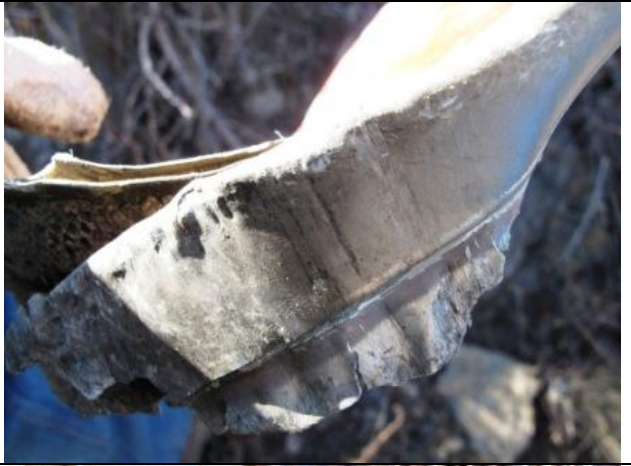
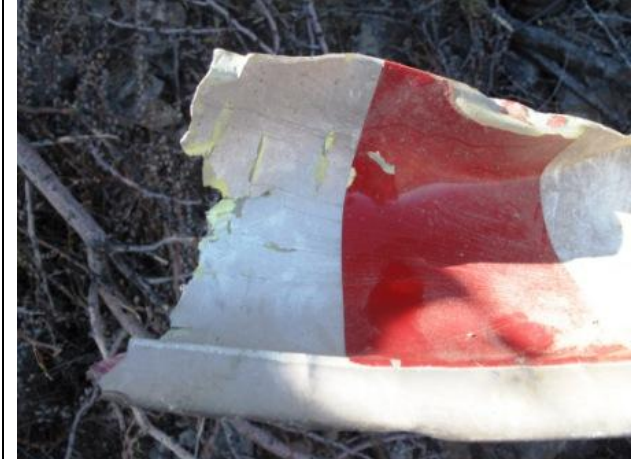
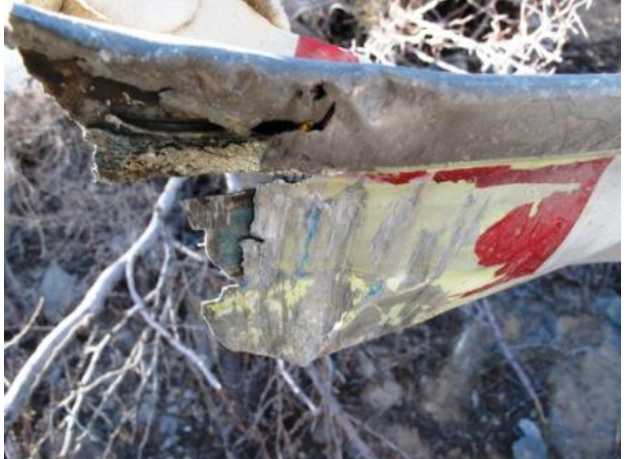
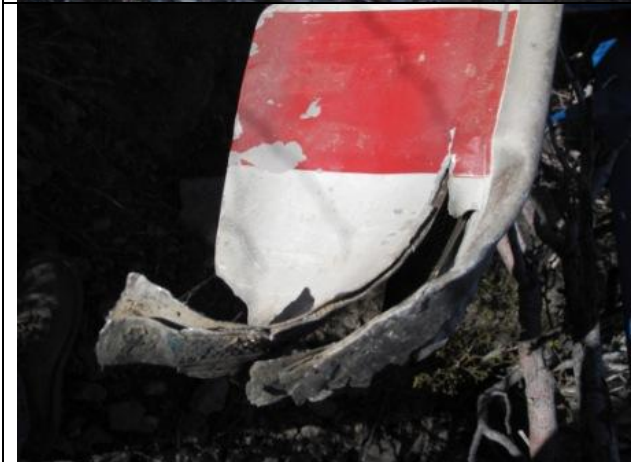
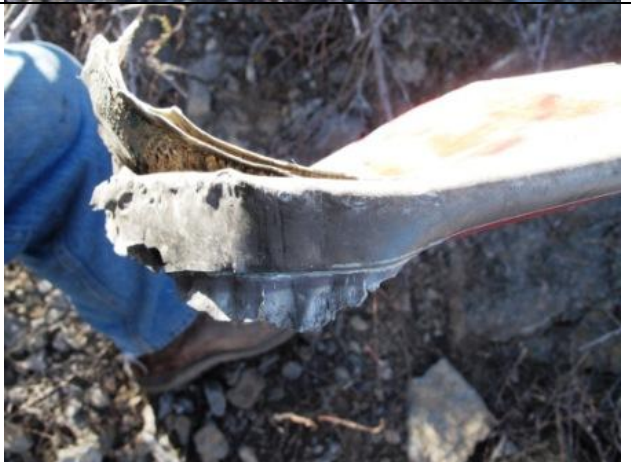
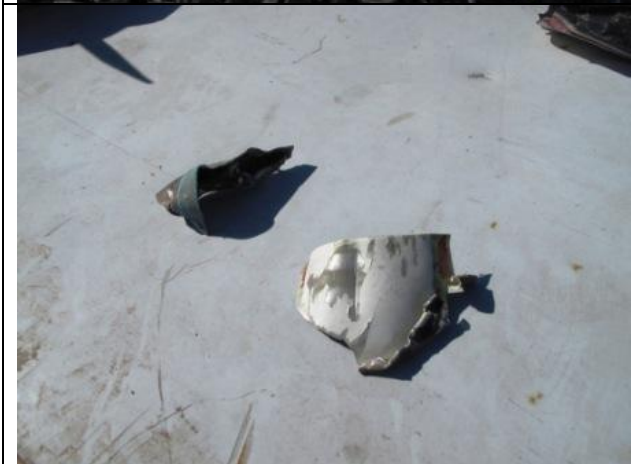
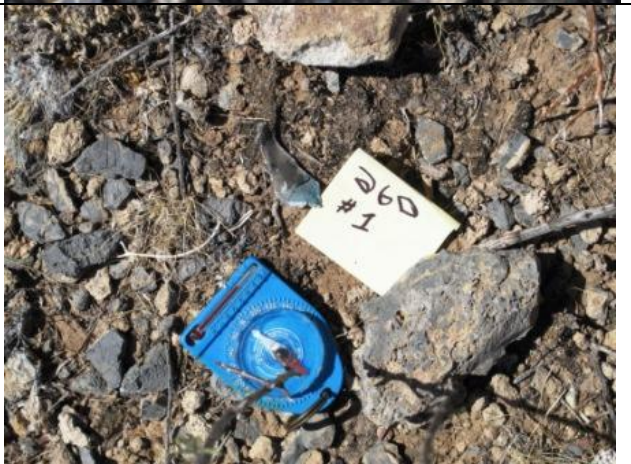
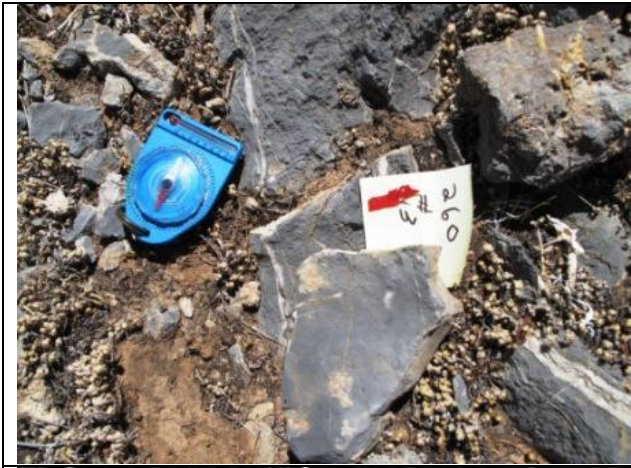
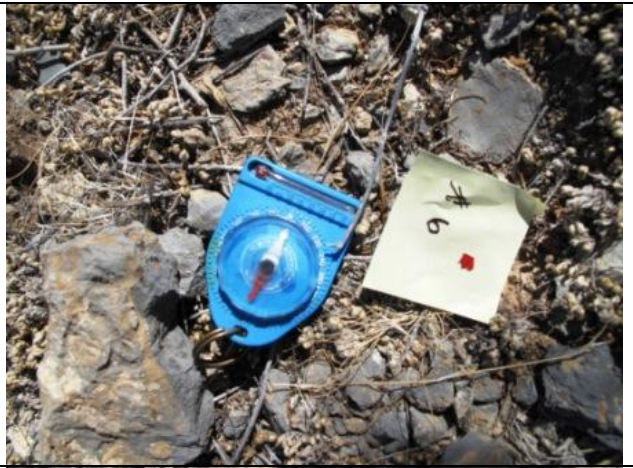
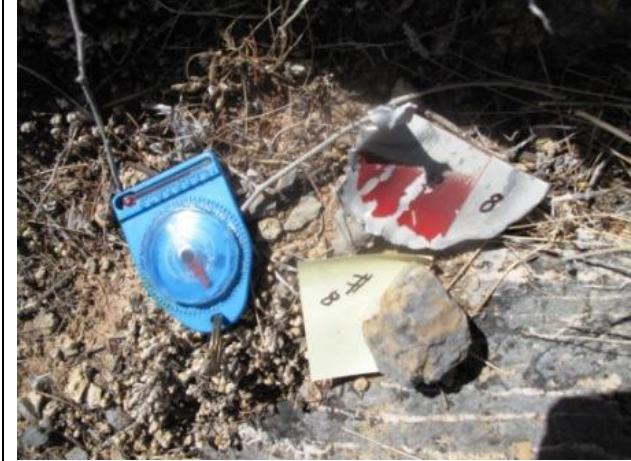
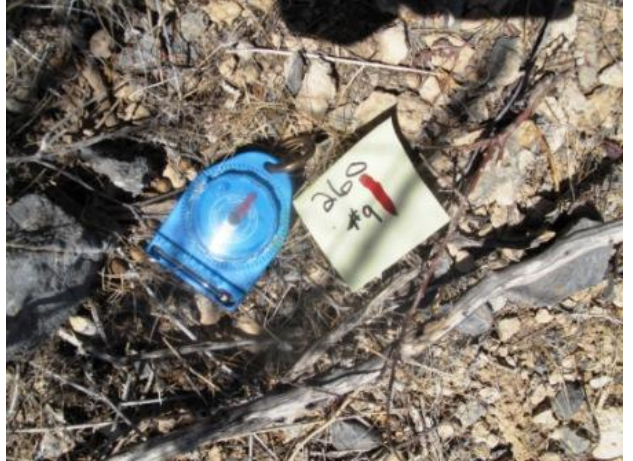
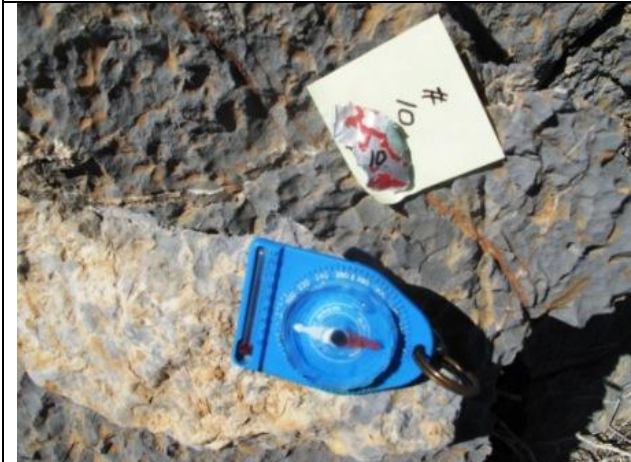
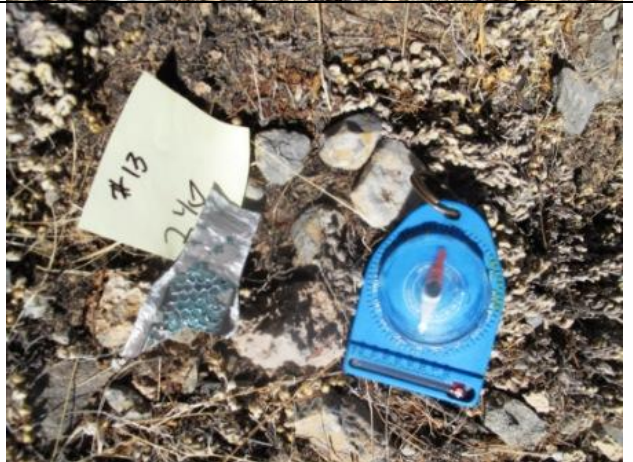
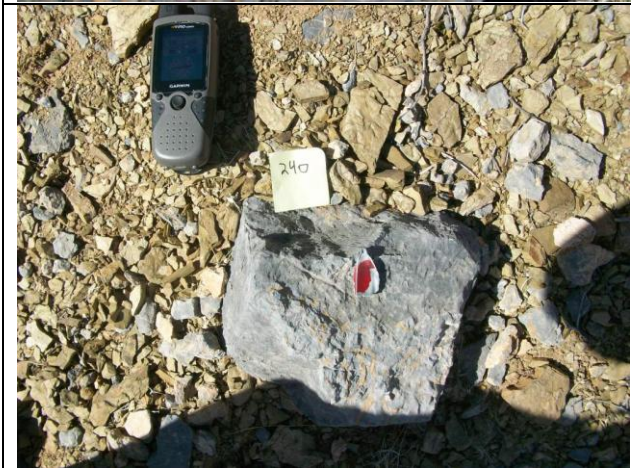
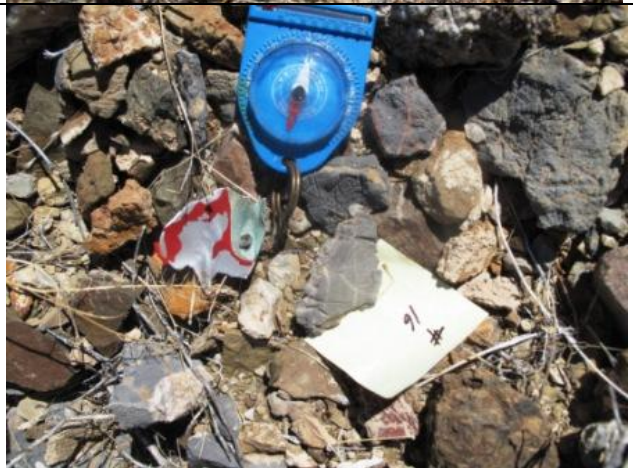
The accident site exam found pieces from the tail rotor blades on the pinnacle landing area in one general debris field. The pieces found were identified and numbered and the relative locations are shown on the attached map. The ground is rocky providing little evidence of ground scarring as verified by the limited rock scarring where known main rotor blade strikes occurred. A location on the ground or rocks where a tail rotor strike occurred was not determined. Pieces from the tail rotor blades are hi-lighted in yellow. A blue colored adhesive is used in the tail rotor blade bonded skin joints and red colored adhesive is used in the main rotor blade bonded skin joints (except for the tip weight). The red paint pieces are consistent with the paint stripes on the tail rotor blades. Since both the main and tail rotor utilize honeycomb, no determination of origin was made to these pieces. The parts recovered were retained by the FAA, Ken Fenning.

<u>Item Number</u>	<u>Description</u>
#1	T/R blade skin with some red paint and blue adhesive. Located approx. 57 feet south of rock out cropping where helicopter main rotor blades made contact

#2	Piece of honeycomb, approx. 6 feet east of Item #1
#3	Piece of red paint, approx. 28 feet to the north east of Item #1
#4	Piece of main rotor blade tip with yellow paint, approx. 25 feet to the north east of Item #1

#15	Piece of main rotor blade tip weight fractured through threaded area
#16	Piece of tail rotor tip skin with red paint, blue adhesive and rivet for the dog leg abrasion strip
