National Transportation Safety Board

Airport Factual Report

Location:	Macon, Georgia
Date:	September 18, 2012
Aircraft:	Beech 400
Registration:	N428JD
Operator:	Private
NTSB Number:	ERA12FA567

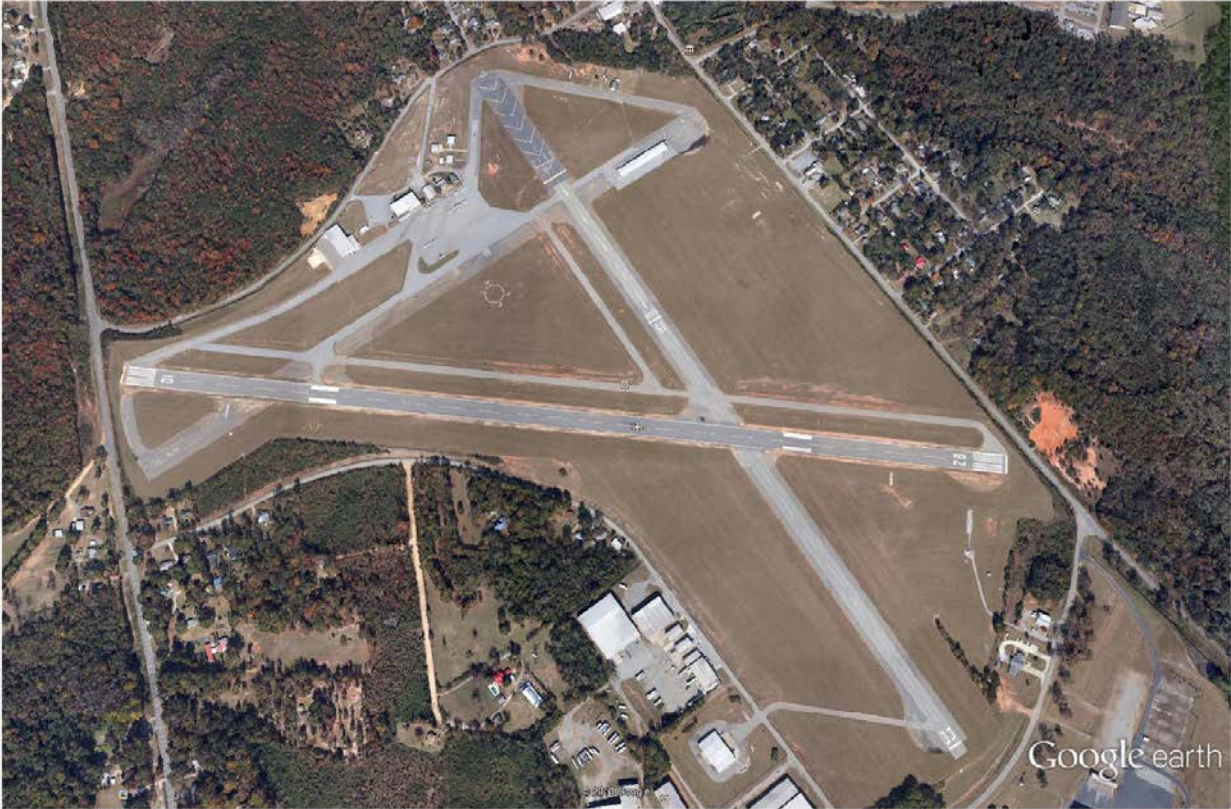
Photo 1: Google Earth Picture of MAC

Macon Downtown Airport (MAC) was located about 3 miles southeast of the city of Macon at an elevation of 437 feet above mean sea level. The airport had two runways designated as 10/28 and 15/33, as shown in photo 1. MAC was a federally funded airport and was obligated, as when a project is funded by a Federal Airport Improvement Program grant agreement, to meet
