NATIONAL TRANSPORTATION SAFETY BOARD - **Public Hearing**

Conrail Derailment in Paulsboro, NJ with Vinyl Chloride Release

## NTSB Hazardous Materials Group Chairman's Factual Report

Carrier: Consolidated Rail Corporation (Conrail)  
Train No.: FC4230  
Location: Paulsboro, New Jersey  
Date/Time: November 30, 2012, at 6:59 a.m. EST  
NTSB No.: DCA-13-MR-002

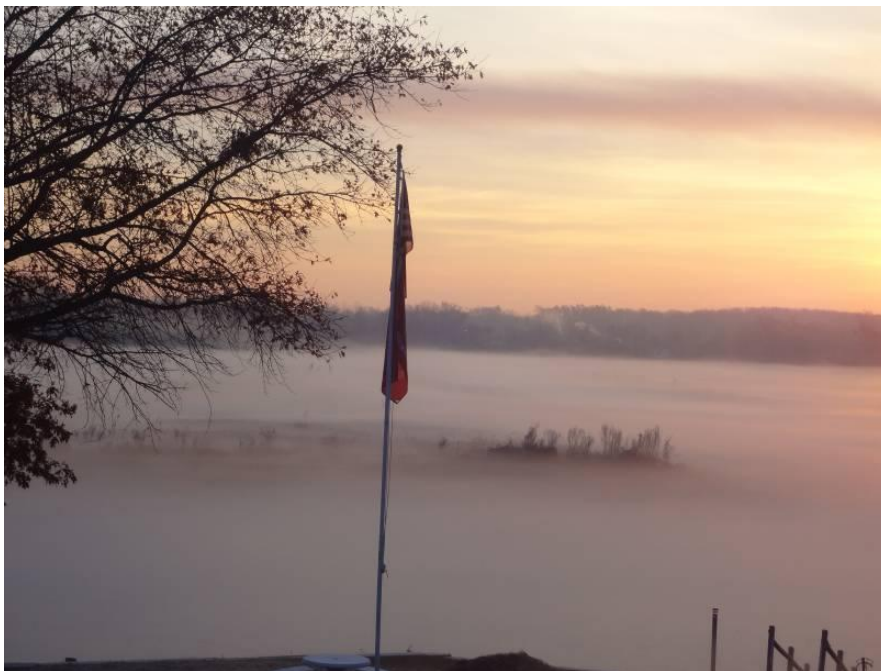
*Figure 5 – Eastward view of dense, low lying cloud or fog over Mantua Creek at approximately 7:13 a.m. on November 30, 2012.<sup>20</sup> (Photograph courtesy of the wife of the Paulsboro Assistant Fire Chief)*

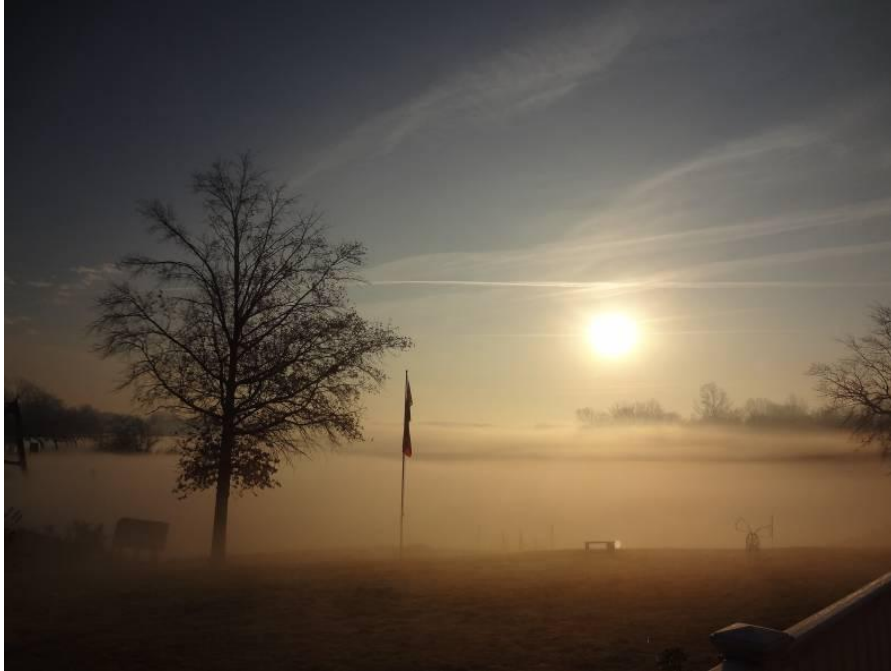
*Figure 6 – Eastward view of dense, low lying cloud or fog over Mantua Creek taken at approximately 8:00 a.m. on November 30, 2012. <sup>21</sup> (Photograph courtesy of the wife of the Paulsboro Assistant Fire Chief)*

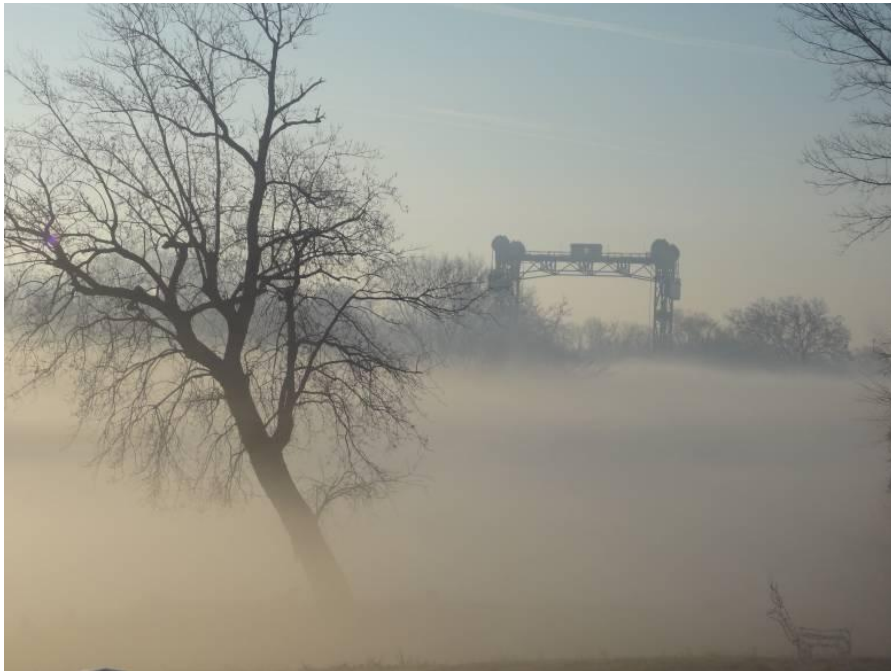
*Figure 7 – Southward view of dense, low lying cloud or fog over Mantua Creek and Route 44 Bridge at 8:01 a.m. on November 30, 2012. <sup>22</sup> (Photograph courtesy of the wife of the Paulsboro Assistant Fire Chief)*

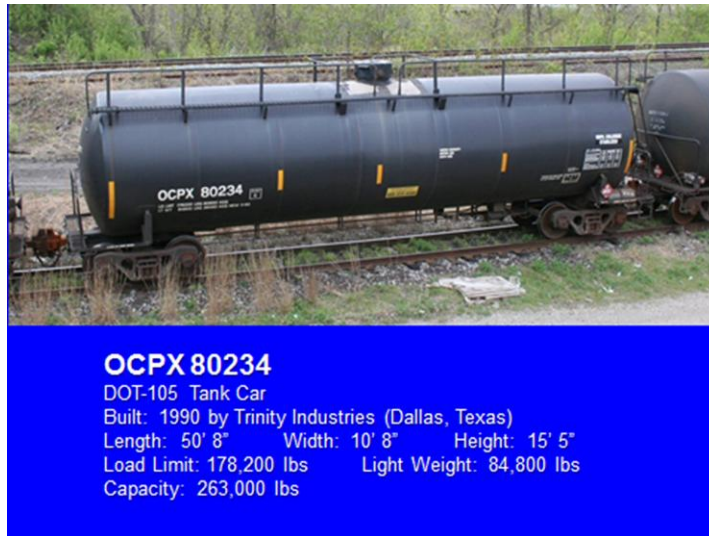
*Figure 14 – Image of OCPX 80234 prior to the November 30, 2012, accident. (Photograph courtesy of the USCG)*

Tank car OCPX 80234 was manufactured on November 1, 1990. The car had a capacity of 24,650 gallons and a load limit of 178,200 pounds. The tank shell and heads were constructed of 9/16-inch Association of American Railroads (AAR) TC-128 Grade B normalized steel with no lining. The tank was wrapped with insulation (0.65-inch Fiberfrax with 4-inches of fiberglass insulation compressed to 3.5 inches total thickness) and an 11 gauge steel jacket.<sup>63</sup> The general drawings provide that 1/2-inch thick full-height head shields were built into the jacket. The tank car had a stub sill underframe. Valves and fittings include one Midland spring-loaded pressure relief device with a start-to-discharge pressure of 247.5 psig. The manufacturer provided that the top fittings protective housing contains air and liquid valves for loading and unloading, a thermometer well to measure temperature, a liquid gauging device, and a sample line. The car was not equipped with a bottom outlet.
