**G650 Flight Test Accident
Gulfstream Party Submission**

DCA11MA076

May 21st, 2012

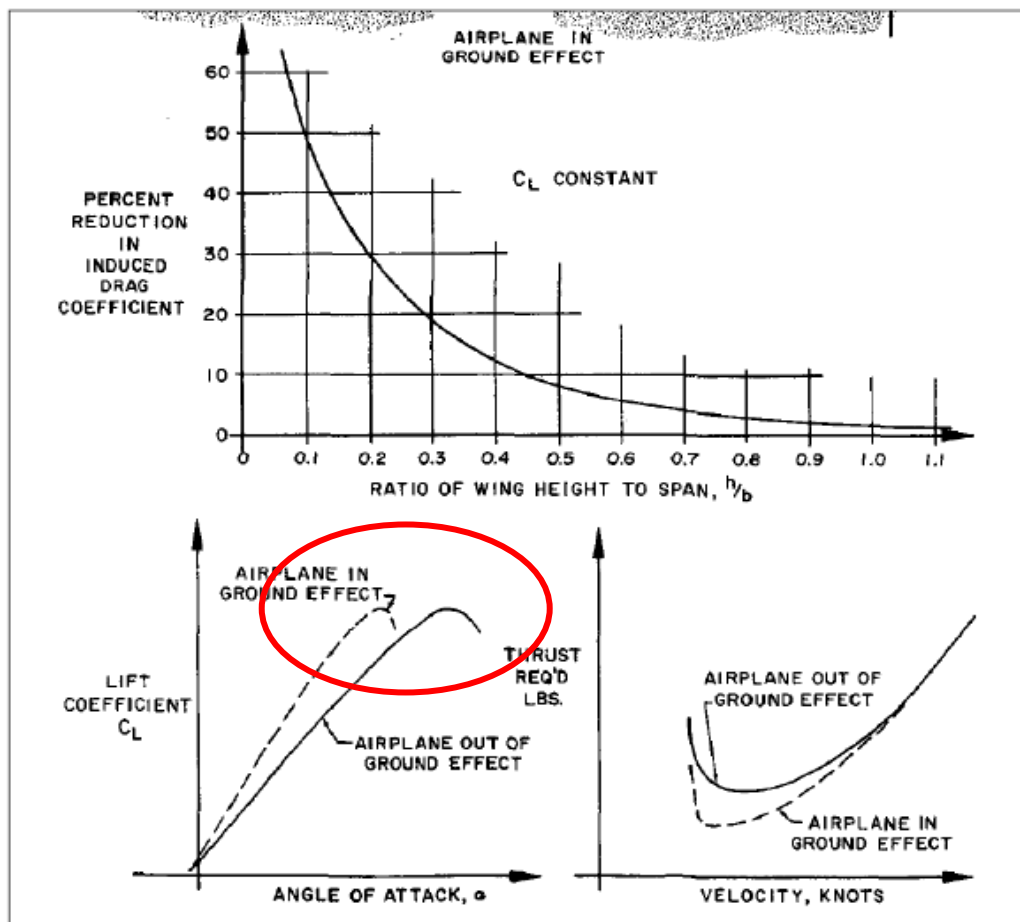
FIGURE 1 - GROUND EFFECTS ON AIRPLANE AERODYNAMICS EXCERPTED FROM REFERENCE 1

An IGE stall angle decrement on the order of 2° had been used on previous Gulfstream models. Historically, this assumption provided adequate margins of safety without further verification, since tail power limitations⁹ forced the takeoff speeds to be relatively faster. It was believed that this decrement would approximate the actual decrement for the G650 as well. For the G650 test program, it was also assumed that the maximum coefficient of lift (C_{LMAX}) at in ground effect stall was equal to the C_{LMAX} at free air stall. This assumption is best characterized by the highlighted portion of Figure 1.

This analysis assumed that the C_{LMAX} would be equal for both IGE and free air (which is consistent with the US Navy's textbook "Aerodynamics for Naval Aviators," previously set out in Section 3.1 and Figure 1). However, had Flight 088's roll-off been used as a data point representing stall in comparison to flight test derived free air stall, this assumption regarding C_{LMAX} would have been proven incorrect (see Section 7.1).

Figure 6 contradicts the widely-accepted industry literature illustrated by Figure 1. Reference 5, a paper focusing on the effect of leading edge contamination, also implies that the C_{LMAX} at ground effect stall is equal to the free air stall C_{LMAX} .
