NTSB File No.: DCA17FA109

Aircraft: Shorts SD3-30

Registration No.: N334AC

Written by: Les Doud
Air Safety Investigator – Hartzell Propeller Inc.

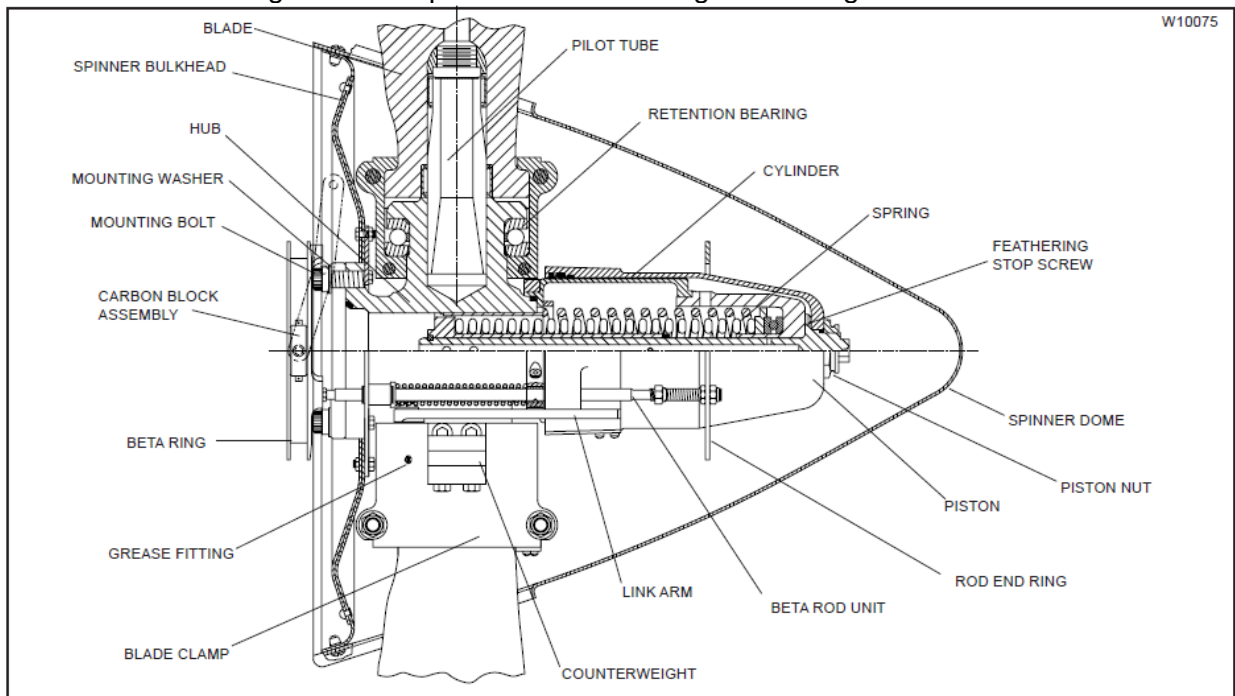
Figure 1 – Propeller General Arrangement Diagram

General Comments: The SD3-30 propeller model examined is a 111.3-inch diameter, 5-blade single-acting, hydraulically operated, constant speed model with feathering and reversing capabilities. Oil pressure from the propeller governor is used to move the blades to the low pitch (blade angle) direction. Blade mounted counterweights provide twisting moment and a feathering spring provides force to actuate the blades towards the high pitch direction in the absence of governor oil pressure. The propeller incorporates a Beta mechanism that actuates when blade angles are lower than the flight idle position to provide position feedback to the engine/propeller controls. The blades are of aluminum construction. The hub and blade clamps are steel. Propeller rotation is clockwise as viewed from the rear. Refer to Figure 1 for a propeller general arrangement diagram and component terminology.
