Date of Accident:	February 3, 2014
Location:	Bellevue, Tennessee
NTSB File No.:	ERA14FA112
Aircraft:	Gulfstream Commander 690C
Registration No.:	N840V
Serial No.:	11727
Operator:	per the FAA registry:
	Mid Kansas Agri Co.
	Pawnee Rock, KS 67567-9510
Written by:	Dan Boggs Air Safety Investigation Manager Rev. 1 by Les Doud - Air Safety Investigator
Date:	February 11, 2014 Revision 1 - February 15, 2016

PROPELLER TEARDOWN REPORT

Location:	AMF air salvage, S	pringfield TN
Propeller Model:	HC-B3TN-5NL with	LT10876ANS(B)-2Q blades
Representatives:	Dan Boggs Jay Eller Luke Schiada	Hartzell Propeller Inc. Honeywell NTSB

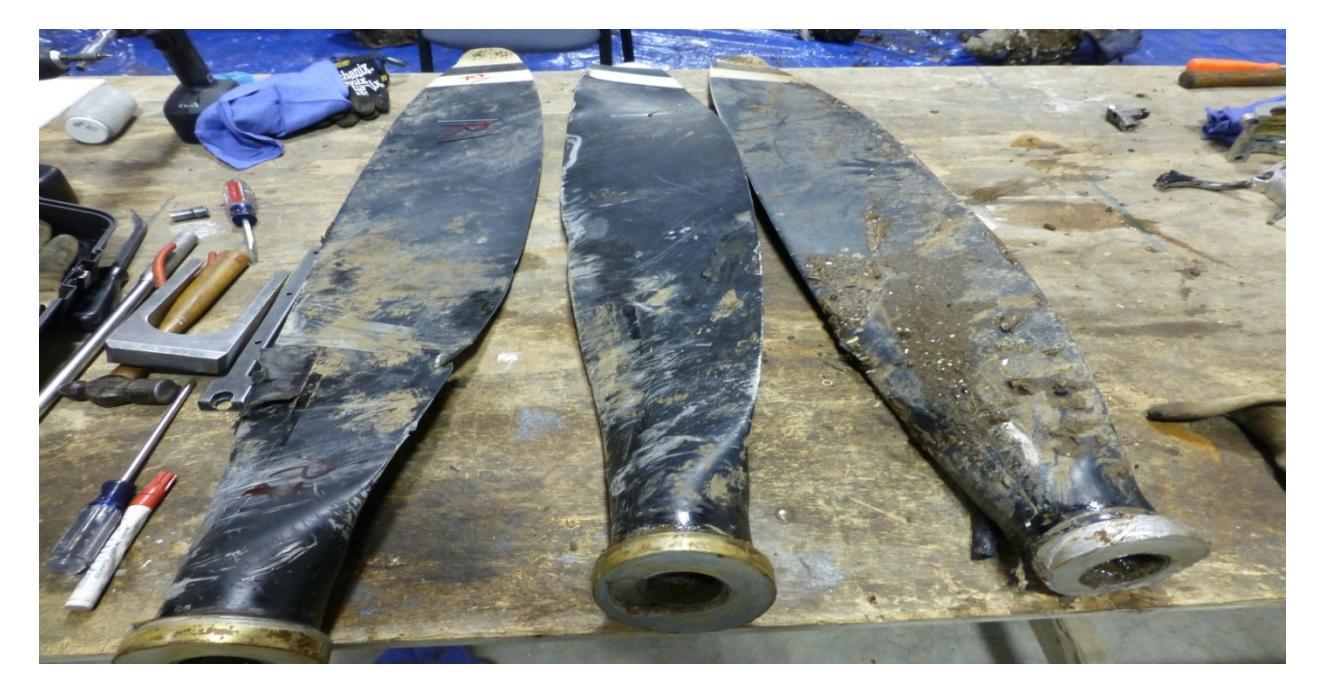
Blade # 1 paint, camber side paint, flat side bend twist lead edge damage trail edge damage butt impression	 scratches, rotational scoring. scratches. none. none. nicks and gouges at midblade. tear approximately 20" from the base. hub mark at the 12 o'clock position.
Blade # 2 paint, camber side paint, flat side bend twist lead edge damage trail edge damage butt impression	 scratched, rotational scoring. scratched, rotational scoring. bent aft at tip. Tip torn off. none. gouges and bends. Q-tip un-bent/flattened, portion of tip approximately 1"x2" along leading edge fractured. tear approximately 24" from base. hub mark at the 3 o'clock position.
Blade # 3 paint, camber side paint, flat side bend twist lead edge damage trail edge damage butt impression	 scratches. scratches. Tip bent. none. nicks and gouges at tip. Q-tip partially un-bent, portion of tip approximately 1"x1" along leading edge fractured. dents. butt ring was torn off.

Photo #7, right propeller blades.
