National Transportation Safety Board Tank Car Damage Assessment Form

4				
Reporting Marks	CBTX 7	41712	Car Location City/State			
Date inspected	Railr	oad	DOT Specification	DOTIII		
Last Contained	A John Wall		Was product released?	YES		
(Indicate One)	Jacket No		Does car contain product	NO		
Car builder	ARI	Stub Sill Design		Built Date	7-2012	
Capacity (GAL)			LD Limit (LB)

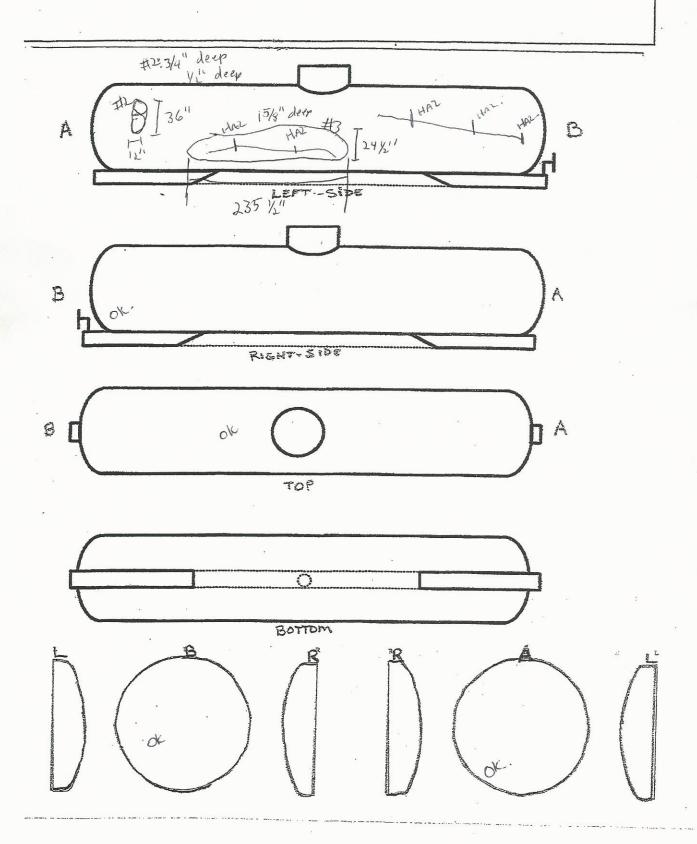
Tanl	c Car D	Car In	itials & CBTX 742045		
Tar	nk Car C	haracteristics/Feat	ures	Materia	
Type of Car:	Mon-pre	ssure Pressure DCn	yogenic Other_		
Specification N	o: DOT V	11 S 100 W1 Tank Test	pressure:	Tan	k Capacity: 3/800
Build Date:	9-2012	. Underframe:	Continuous 🗹	Stub S	Sill
Jacketed: Y	IN The	ermal Protection: Jack	keted T Sprayed	-on	Insulated: Y
Construction M	laterial: Ty	oe/Grade	Thickness		Stress: TMCON
	Fittings L	Damage	Jacket, Ta	ank a	nd Head Damage
Type fitting	Damaged?	Description Damage/Leak	Indicate location and s gouges, wheel burns, the appropriate diagra	dents, ra	damage (punctures, cracks, scores, il burns, underframe, and leaks) on
☐ Liquid Valve	☑ M. □ Leaking	3"			
☐ Vapor/ Air Valve	☑ M □ Leaking	ヹ			
Bottom Outlet Type:	Y € Leaking	12 J			
Pressure Relief Device Type:	Y N □ Leaking				
☐ Vacuum Relief Valve	Y M □ Leaking				
Gauging Device Type:	Y N □ Leaking				
☐ Manway Cover Plate	① M □ Leaking

☐ Fill Hole	☑ Leaking				
☐ Sample Line	Y N Leaking				H
☐ Thermo- meter Well	Y N □ Leaking				
☐ Washout	Y N □ Leaking			\	
□ Sump	Y N □ Leaking				
☐ Other Type:	Y N Leaking	v.		/ .

0934. F

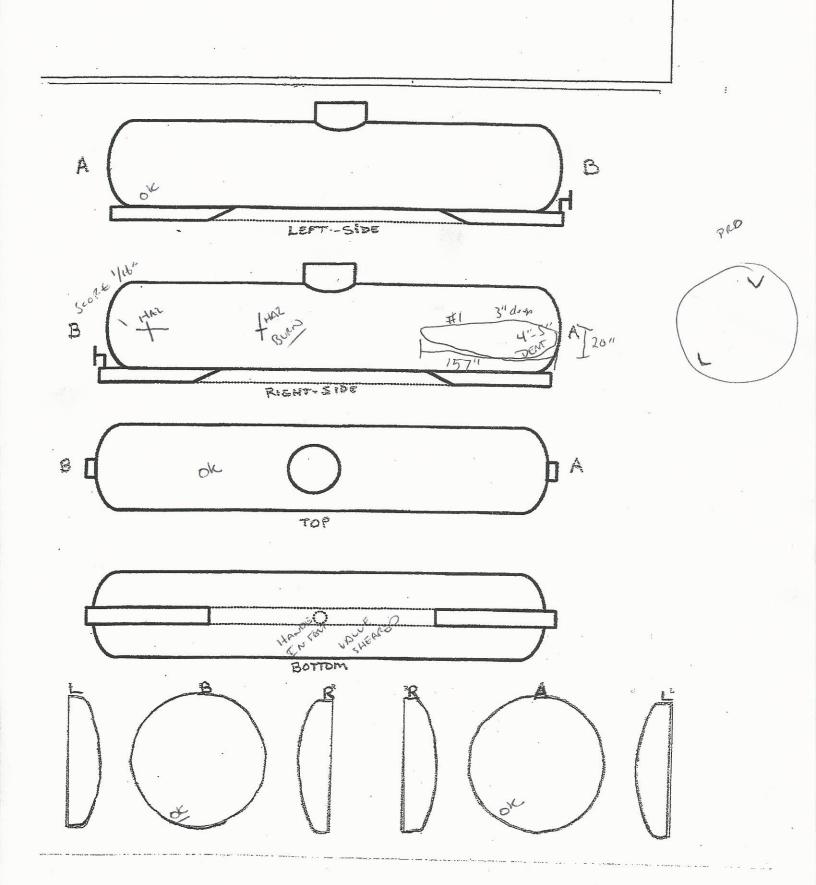
2533856

Tank Car Damage Assessment				Car Initials & CTCX 735779		
Tai	nk Car C	haracteristics/Feat	tures	Materia	al	
Type of Car:	⊠ Non-pre	essure Pressure Cr	yogenic Other_			
Specification N			pressure:		ak Capacity: 30100	
Build Date:	2-2017	Underframe:	☐ Continuous ➤	Stub S	Sill	
Jacketed: Y	W The	ermal Protection: Jac	keted T Sprayed	l-on	Insulated: Y N	
Construction M	laterial: Ty	pe/Grade	. Thickness		Stress: TMCON	
	Fittings L	Damage	Jacket, T	ank a	nd Head Damage	
Type fitting	Damaged?	Description Damage/Leak	Indicate location and gouges, wheel burns, the appropriate diagra	dents, ra	f damage (punctures, cracks, scores, il burns, underframe, and leaks) on	
⊠ Liquid Valve	Y M □ Leaking	3/1			-1	
☐ Vapor/ Air Valve	▼ ☑ □ Leaking	7,,				
Digital Bottom Outlet Type:	Y Mi □ Leaking	SHEARED				
☐ Pressure Relief Device Type:	Y N □ Leaking					
☐ Vacuum Relief Valve	Y N □ Leaking					
Gauging Device Type:	Y N Leaking

☐ Manway Cover Plate	Y N Leaking			(
☐ Fill Hole	Y N Leaking				<i>U</i> '	
☐ Sample Line	Y N □ Leaking				TH	
☐ Thermo- meter Well	Y N □ Leaking					
☐ Washout	Y N Leaking			\		
□ Sump	Y N □ Leaking					
☐ Other Type:	Y N □ Leaking

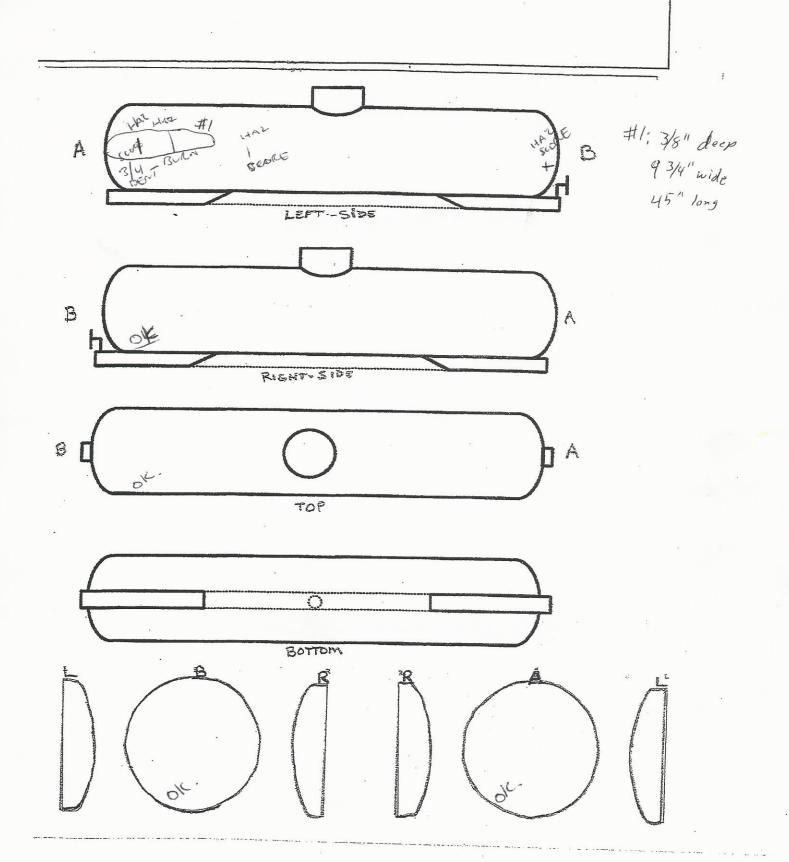
Tank Car Damage Assessment				Car Initials & CTCX 7430		
Tar	nk Car C	haracteristics/Feat	ures	Materia	al	
Type of Car:	⊠ Non-pre	ssure Pressure DCn	ogenic Other_			
Specification N	o: DOT	115100W Tank Test	pressure:	Tan	k Capacity: 31790	
Build Date: 0	5-20.12	Underframe: [Continuous E	Stub S	Sill	
Jacketed: Y	N The	ermal Protection: Jack	keted T Sprayed	l-on	Insulated: Y N	
Construction M	laterial: Typ	oe/Grade	Thickness		Stress: TMCON	
	Fittings L	Damage	Jacket, T	ank a	nd Head Damage	
Type fitting	Damaged?	Description Damage/Leak	Indicate location and a gouges, wheel burns, the appropriate diagra	dents, ra	damage (punctures, cracks, scores, il burns, underframe, and leaks) on	
包 Liquid Valve	☑ -Æ	3"				
	☑ DE Leaking	λ'				
Bottom Outlet Type:	Y De Leaking	Charles In the Control of the Contro				
Pressure Relief Device Type:	Y ⊠ □ Leaking					
☐ Vacuum Relief Valve	Y N □ Leaking					
☐ Gauging Device Type:	Y N Leaking

☐ Manway Cover Plate	T N □ Leaking			(
☐ Fill Hole	Y M Leaking	e e e e e e e e e e e e e e e e e e e				
☐ Sample Line	Y M □ Leaking				H	
☐ Thermo- meter Well	Y N Leaking					
☐ Washout	Y M □ Leaking			\		
□ Sump	Y N Leaking					
☐ Other Type:	Y N C Leaking	*

1005 HES. 3. F.

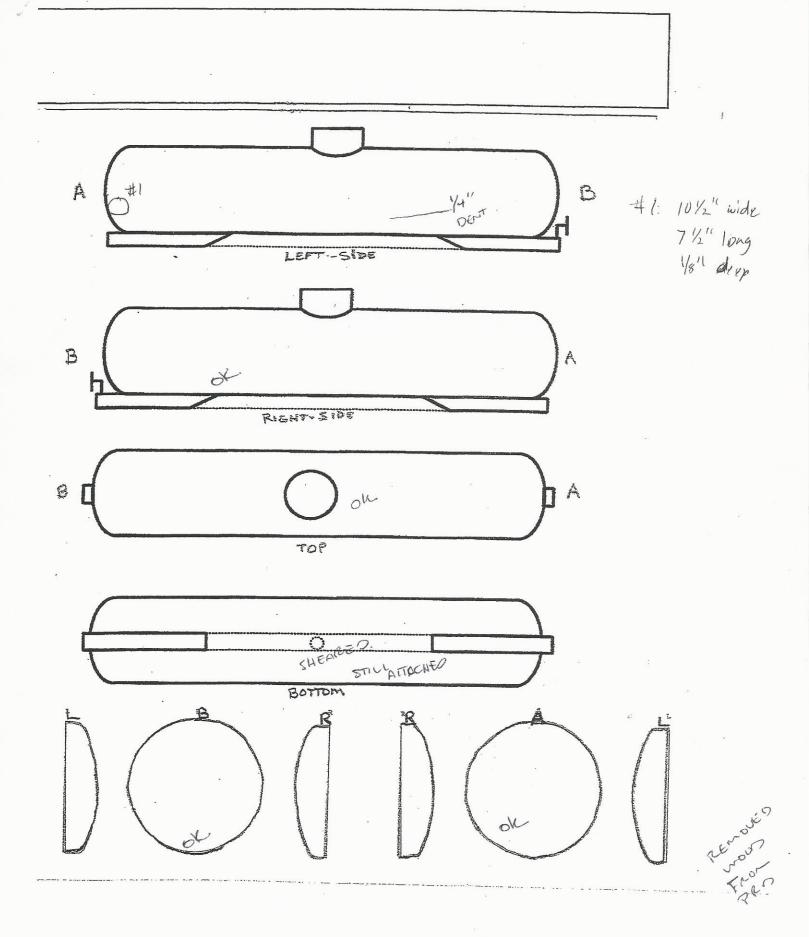
CTCX 735774

Tanl	Car D	amage Assess			
Tar	k Car Ci	haracteristics/Feat	ures	Materia	al Control of the Con
Type of Car:	Ø Non-pre	ssure Pressure Cry	ogenic Other_		
Specification N	DOT II	I A 100W (Tank Test	pressure:	Tan	k Capacity: 30090
Build Date: 🔿			Continuous Z	Stub S	ill
Jacketed: Y	M The	ermal Protection: Jack	keted T Sprayed	-on	Insulated: Y N
Construction M	laterial: Ty	pe/Grade	Thickness		Stress: TMCON
	Fittings L	Damage	Jacket, Ta	ank a	nd Head Damage
Type fitting	Damaged?	Description Damage/Leak		dents, ra	damage (punctures, cracks, scores, il burns, underframe, and leaks) on
☑ Liquid Valve	☑ Leaking	31'		Г	
Vapor/ Air Valve	Y ⊸N □ Leaking	ん'			
Ø Bottom Outlet Type:	Y ₩ Leaking	TORN OFF			
☐ Pressure Relief Device Type:	Y N □ Leaking				
☐ Vacuum Relief Valve	Y N Leaking				
☐ Gauging Device Type:	Y N Leaking				
☐ Manway Cover Plate	Y N Leaking			(
☐ Fill Hole	Y N Leaking				· .
☐ Sample Line	Y M □ Leaking				H

☐ Thermo- meter Well	Y N □ Leaking				
☐ Washout	Y N □ Leaking			\	
□ Sump	Y N Leaking				
Other Type:	Y N D Leaking

1025 HOS 20.10F

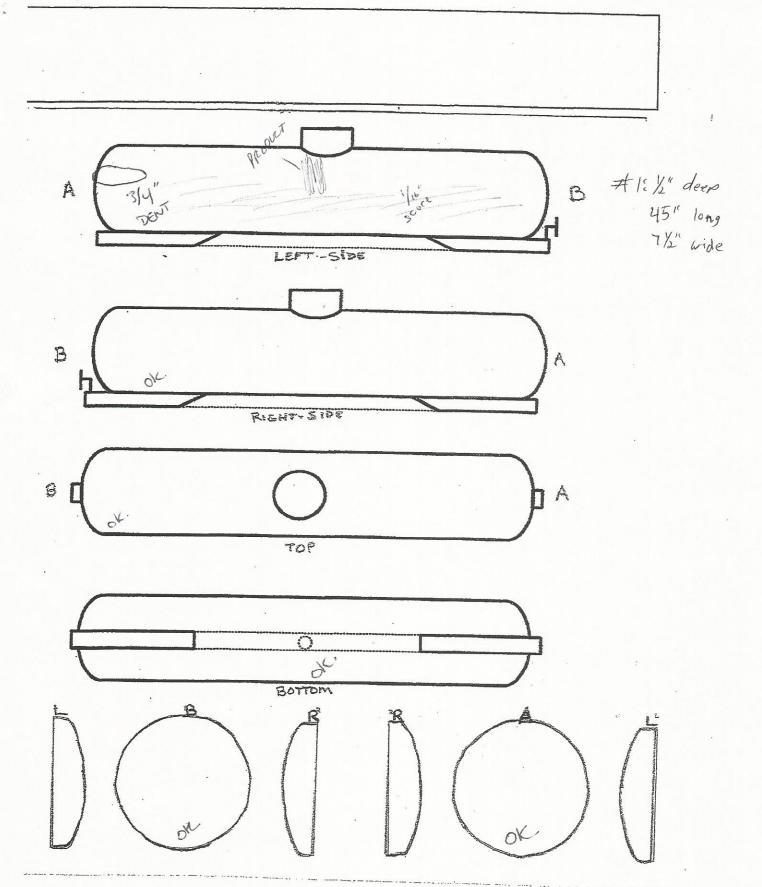
Tank Car Damage Assessment					Car Initials & Number CBTX 741925		
Tar		haracteristics/Feat		Materia			
Type of Car:	⊠Non-pre	ssure Pressure DCr	yogenic Other_				
Specification N	o. Dotill	S 100W (Tank Test	pressure:	Tan	k Capacity: 31870		
Build Date:	9-2012:	Underframe:	☐ Continuous 万	₹ Stub S	Sill		
Jacketed: Y	N The	ermal Protection: Jac	keted T Sprayed	l-on	Insulated: Y N		
Construction N	laterial: Ty	oe/Grade	. Thickness		Stress: TMCON		
	Fittings L	Damage	Jacket, T	ank al	nd Head Damage		
Type fitting	Damaged?	Description Damage/Leak	Indicate location and a gouges, wheel burns, the appropriate diagra	dents, ra	damage (punctures, cracks, scores, il burns, underframe, and leaks) on		
∐ Liquid Valve	☑ Leaking	3"					
☑ Vapor/ Air Valve	Y N Leaking	l'			•		
Bottom Outlet Type:	☑ ⑤ Leaking	TPG A					
☑ Pressure Relief Device Type:	Y № □ Leaking	ABSONBENTS PADS IN PLACE					
☐ Vacuum Relief Valve	Y N Leaking

Gauging Device Type:	Y N Leaking						
☐ Manway Cover Plate	Y N □ Leaking			(
☐ Fill Hole	Y N Leaking				<i>U</i> •		
☐ Sample Line	T M □ Leaking				TH		
☐ Thermo- meter Well	Y N □ Leaking						
☐ Washout	Y N □ Leaking						
□ Sump	Y N □ Leaking						
☐ Other Type:	Y N Leaking			/

1017 No. 3 Sex

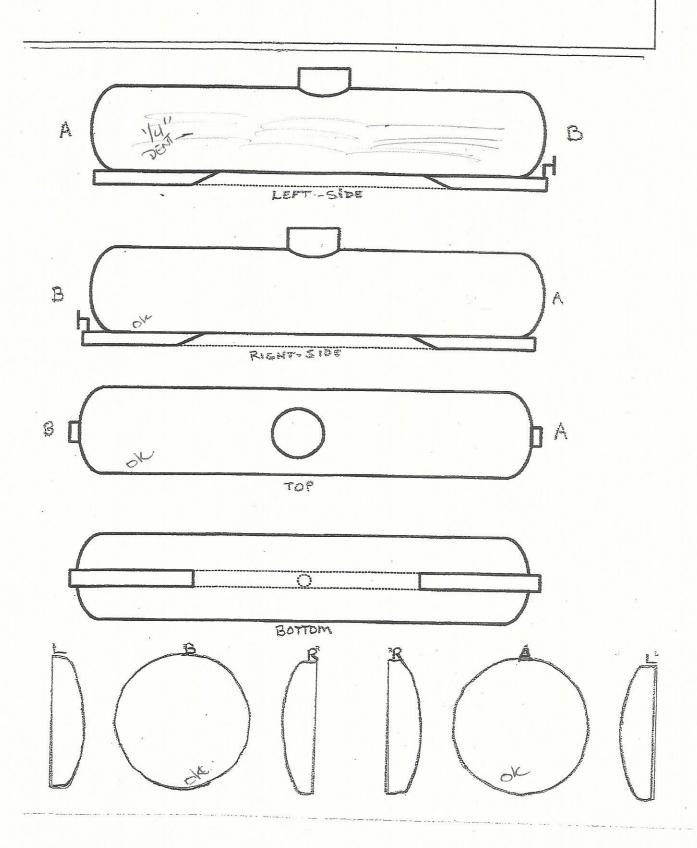
Tank	Car D	amage Assess	Sment Car Initials & Number CBTX 7417		
Tan	k Car C	haracteristics/Feat	ures	Materia	
Type of Car:	□ Non-pre	ssure Pressure Cry	ogenic Other		
Specification N	o: DOT IH	S 100 W Tank Test	pressure:	Tan	k Capacity: 3 800
Build Date:	7-2012	Underframe:	Continuous &	Stub S	Sill
Jacketed: Y	M. The	ermal Protection: J Jack	keted T Sprayed	d-on	Insulated: Y N
Construction M	laterial: Ty	oe/Grade	Thickness		Stress: TMCON
	Fittings L	Damage	Jacket, 7	ank a	nd Head Damage
Type fitting	Damaged?	Description Damage/Leak	Indicate location and gouges, wheel burns the appropriate diagra	dents, ra	damage (punctures, cracks, scores, il burns, underframe, and leaks) on
전 Liquid Valve	Y ï □ Leaking	23/			
	☑ Leaking	べ			
Bottom Outlet Type:	Y ₩ □ Leaking	13 d.			
Pressure Relief Device Type:	Y 個 □ Leaking				
☐ Vacuum Relief Valve	Y N Leaking				
Gauging Device Type:	Y N Leaking				
☐ Manway Cover Plate	Y N Leaking

☐ Fill Hole	Y M □ Leaking				
☐ Sample Line	Y N Leaking	9 4			TA
☐ Thermo- meter Well	Y N D Leaking				
☐ Washout	Y N Leaking				
□ Sump	Y N U Leaking				
☐ Other Type:	Y N Leaking		(3)

11085 7087

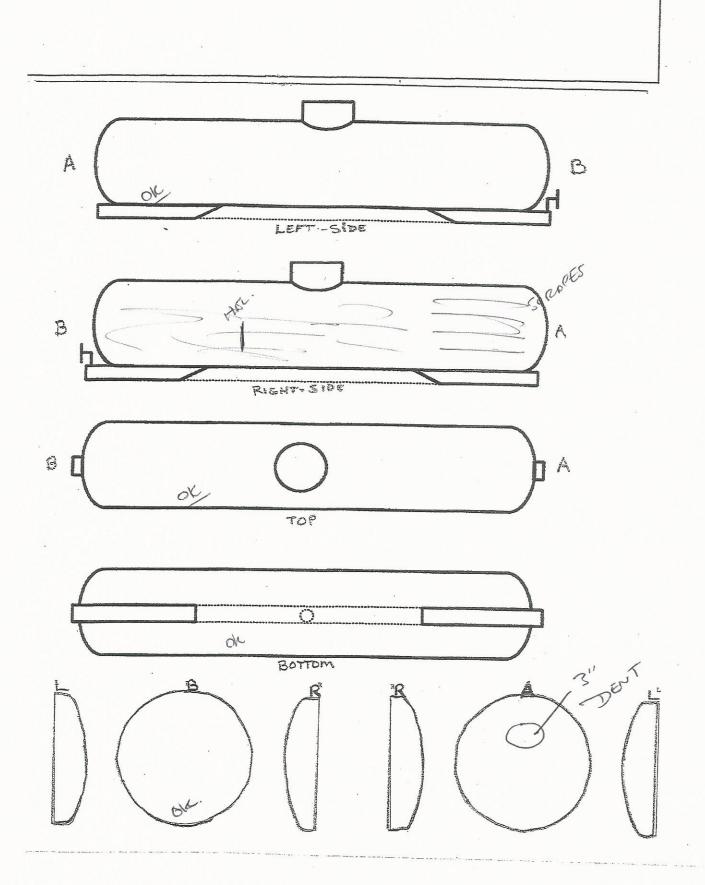
Tanl	c Car D	amage Assess	ment Car Initials & CBTX 74184		
Tar	nk Car C	haracteristics/Feat	ures	Materia	al
Type of Car:	⊠ Non-pre	ssure Pressure Cry	ogenic Other_		
Specification N	o: DOT 11	15 100 w \ Tank Test	pressure:	Tan	ik Capacity: 31870
Build Date: 6	3-2012	Underframe:	Continuous 2	Stub S	Sill
Jacketed: Y	IN The	ermal Protection: Jack	keted T Sprayed	l-on	Insulated: Y N
Construction N	laterial: Ty	oe/Grade	Thickness		Stress: TMCON
	Fittings L	Damage	Jacket, T	ank a	nd Head Damage
Type fitting	Damaged?	Description Damage/Leak	Indicate location and : gouges, wheel burns, the appropriate diagra	dents, ra	damage (punctures, cracks, scores, il burns, underframe, and leaks) on
点 Liquid Valve	Y M □ Leaking	3"			
√apor/ Air Valve	☑ — ☑ □ Leaking	√'			
Bottom Outlet Type:	Y do la Leaking	To January Control of the Control of			
Pressure Relief Device Type:	Y M Leaking				
☐ Vacuum Relief Valve	Y N Leaking

Gauging Device Type:	Y N Leaking				
☐ Manway Cover Plate	Y N Leaking				
☐ Fill Hole	Y N □ Leaking				
☐ Sample Line	Y M □ Leaking				H
☐ Thermo- meter Well	Y N Leaking	9			
☐ Washout	Y N Leaking			\	
□ Sump	Y N Leaking				
☐ Other Type:	Y N Leaking

1581 5 REST

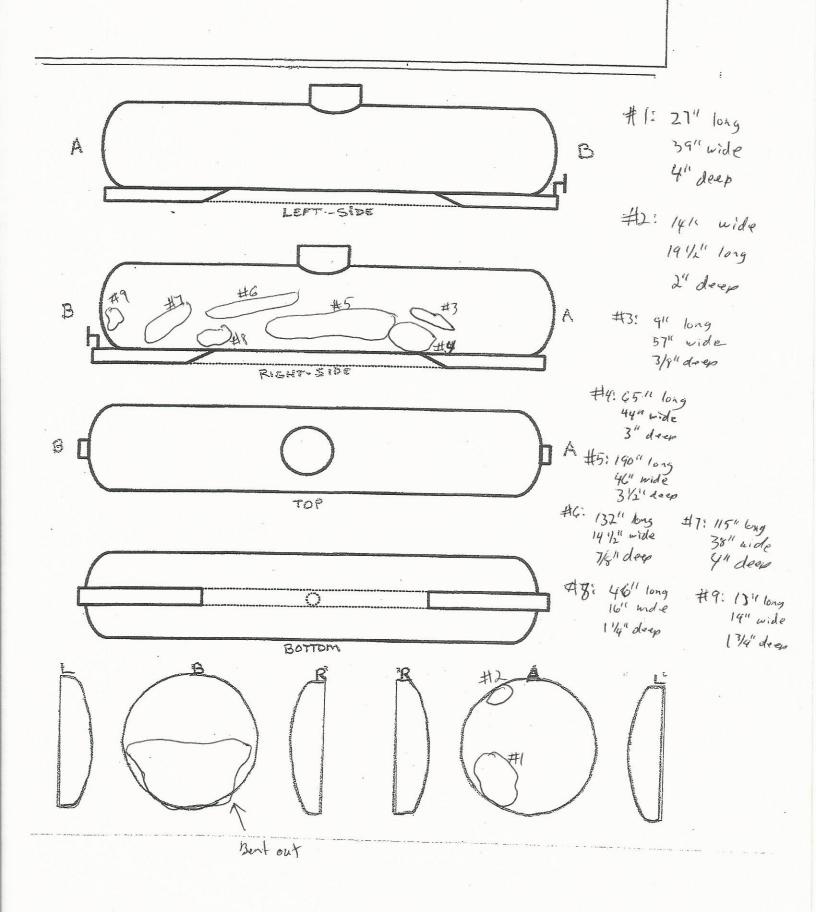
Tanl	Car D	amage Assess	sment Car Initials & Number CBTX 741672				
Tank Car Characteristics/Features Material							
Type of Car: ☐ Non-pressure ☐ Pressure ☐ Cryogenic ☐ Other							
Specification N	. 1115100	Tank Test	pressure:	Tan	k Capacity: 3/9/0		
Build Date: 07	- 2012	Underframe:	☐ Continuous 区	Stub S	Sill		
Jacketed: Y	N The	ermal Protection: Jack	keted T Sprayed	-on	Insulated: Y N		
Construction M	laterial: Ty	oe/Grade	Thickness		Stress: TMCON		
	Fittings L	Damage	Jacket, Ta	ank a	nd Head Damage		
Type fitting	Damaged?	Description Damage/Leak	Indicate location and s gouges, wheel burns, the appropriate diagra	dents, ra	damage (punctures, cracks, scores, il burns, underframe, and leaks) on		
Liquid Valve	Y M □ Leaking	3"					
\(\text{\infty}\) Vapor/ Air Valve	☑ R □ Leaking	, (I					
D Bottom Outlet Type:	Y M	value and handle are infact					
☐ Pressure Relief Device Type:	Y N □ Leaking						
☐ Vacuum Relief Valve	Y N □ Leaking

☐ Gauging Device Type:	Y N □ Leaking						
☐ Manway Cover Plate	Y N □ Leaking			(
☐ Fill Hole	Y N □ Leaking				<i>U</i> *		
☐ Sample Line	Y N □ Leaking				H		
☐ Thermo- meter Well	Y N □ Leaking						
☐ Washout	Y N □ Leaking						
☐ Sump	Y N □ Leaking						
☐ Other Type:	Y N □ Leaking			/

1433 11 pst 77.2°F

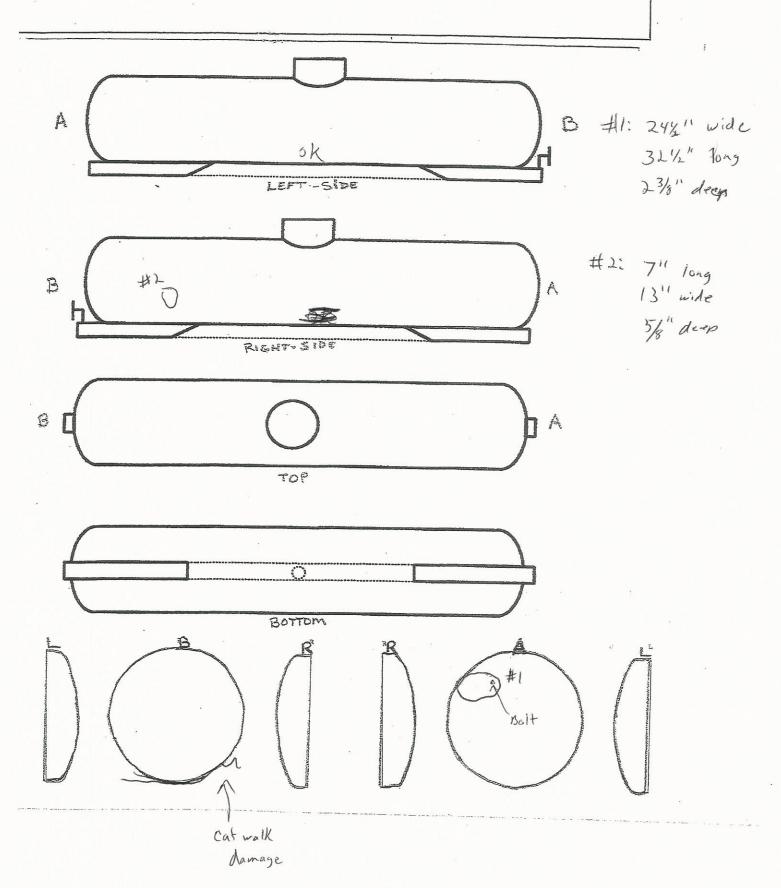
Tank Car Damage Assessment				Car Initials & Number CBTX 743190	
Tar	nk Car C	haracteristics/Feat	ures	Materia	3
Type of Car:					
Specification N	00w Tank Test	pressure: Tank Capacity: 31830			
Build Date: 04-2013 Underframe: Continuous Stub Sill					
Jacketed: Y N Thermal Protection: J Jacketed T Sprayed-on Insulated: Y N					
Construction Material: Type/Grade Thickness Stress: T M C O N					Stress: TMCON
	Fittings L	Damage	Jacket, Tank and Head Damage		
Type fitting Damaged? Description Damage/Leak			Indicate location and severity of damage (punctures, cracks, scores, gouges, wheel burns, dents, rail burns, underframe, and leaks) on the appropriate diagram(s).		
⊠ Liquid Valve	☑ M □ Leaking	311			
Vapor/ Air Valve	Y M □ Leaking	211			
☐ Bottom Outlet Type:	Y ₩ □ Leaking	value and hadle intact			
☐ Pressure Relief Device Type:	Y N □ Leaking				
☐ Vacuum Relief Valve	Y N □ Leaking	a.			
☐ Gauging Device Type:	Y N Leaking

☐ Manway Cover Plate	Y N Leaking				
☐ Fill Hole	Y M □ Leaking				
☐ Sample Line	Y M □ Leaking			1	H
☐ Thermo- meter Well	Y N Leaking	1			
☐ Washout	Y N □ Leaking				
☐ Sump	Y N Leaking				
☐ Other Type:	Y N Leaking			<i>)</i>

1400 hrs 14 psi 85.4°F

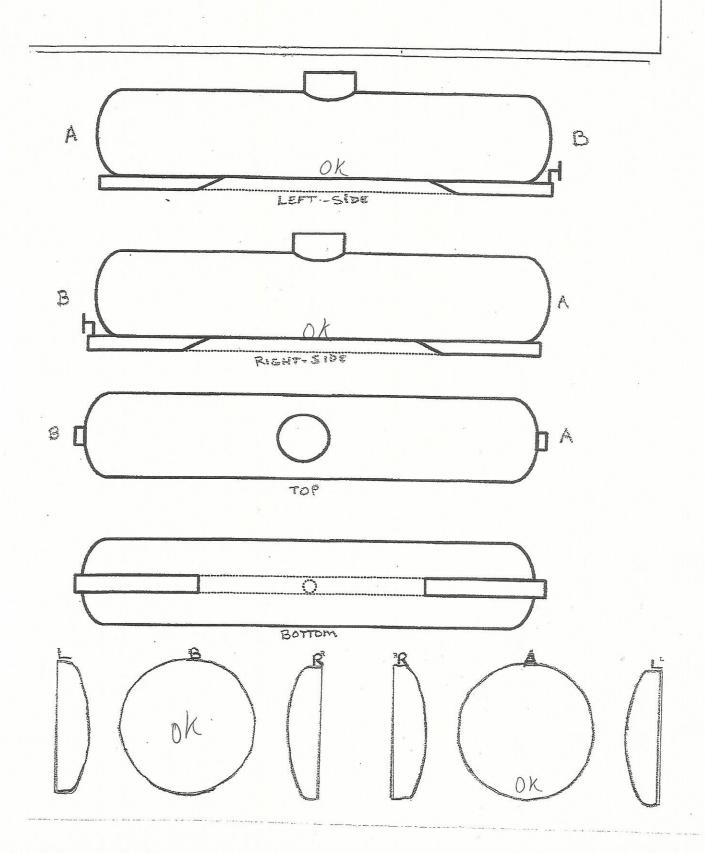
Tank Car Damage Assessment				Car Ini	tials & CBTX 743/97		
Tank Car Characteristics/Features Material							
Type of Car: Non-pressure Pressure Cryogenic Other							
					oressure: Tank Capacity: 3 9 10		
Build Date: 04 - 1.013 Underframe: ☐ Continuous ☐ Stub Sill							
Jacketed: Y N Thermal Protection: J Jacketed T Sprayed-on Insulated: Y N							
Construction M	Construction Material: Type/Grade Thickness Stress: T M C O N						
I	Fittings E	Damage	Jacket, Tank and Head Damage				
Type fitting	Damaged?	Description Damage/Leak	Indicate location and severity of damage (punctures, cracks, scores, gouges, wheel burns, dents, rail burns, underframe, and leaks) on the appropriate diagram(s).				
☑ Liquid Valve	Y M □ Leaking	3/1					
☐ Vapor/ Air Valve	☑ M □ Leaking	Ju					
Bottom Outlet Type:	▼ Ø □ Leaking	intact		n			
☐ Pressure Relief Device Type:	Y N □ Leaking						
☐ Vacuum Relief Valve	Y N Leaking

☐ Gauging Device Type:	Y M □ Leaking						
☐ Manway Cover Plate	y N □ Leaking		191	(
☐ Fill Hole	Y N □ Leaking			aginti estere aprova constituta il reco			
☐ Sample Line	Y N Leaking				H		
☐ Thermo- meter Well	Y N Leaking						
☐ Washout	Y M □ Leaking			\			
☐ Sump	Y N □ Leaking						
☐ Other Type:	Y N Leaking			/

1325 hrs 74.7°F

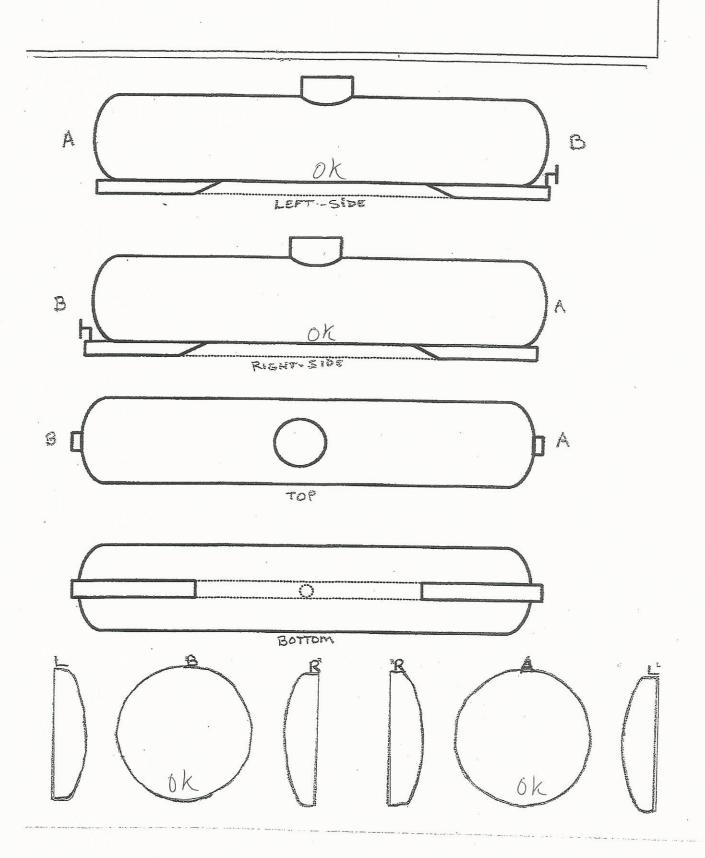
Tank Car Damage Assessment				Car Initials & Number CBTX 7 43147	
Tan	haracteristics/Feat	ures	Materia		
Type of Car: Non-pressure Pressure Cryogenic Other					
Specification N	Tank Test	pressure: Tank Capacity: 3/8/20			
Build Date: 03-2013 Underframe: ☐ Continuous △ Stub Sill					Sill
Jacketed: Y N Thermal Protection: J Jacketed T Sprayed-on Insulated: Y N					
Construction M	laterial: Ty	oe/Grade	Thickness		Stress: TMCON
Fittings Damage			Jacket, Tank and Head Damage		
Type fitting	Damaged?	Description Damage/Leak	Indicate location and severity of damage (punctures, cracks, scores, gouges, wheel burns, dents, rail burns, underframe, and leaks) on the appropriate diagram(s).		
剤 Liquid Valve	☑ ÞÐ □ Leaking	311			
区 Vapor/ Air Valve	Y A □ Leaking	211			
Bottom Outlet Type:	Y 風 □ Leaking	intact			
Pressure Relief Device Type:	Y N □ Leaking				
☐ Vacuum Relief Valve	Y N Leaking	· · ·			
Gauging Device Type:	Y N □ Leaking	,

☐ Manway Cover Plate	Y N Leaking			(
☐ Fill Hole	Y N Leaking				
☐ Sample Line	Y M □ Leaking				TH
☐ Thermo- meter Well	Y N Leaking				
☐ Washout	Y N □ Leaking			\	
□ Sump	Y N Leaking				
☐ Other Type:	Y N C Leaking

1453 hrs 85.5°F 15 psc

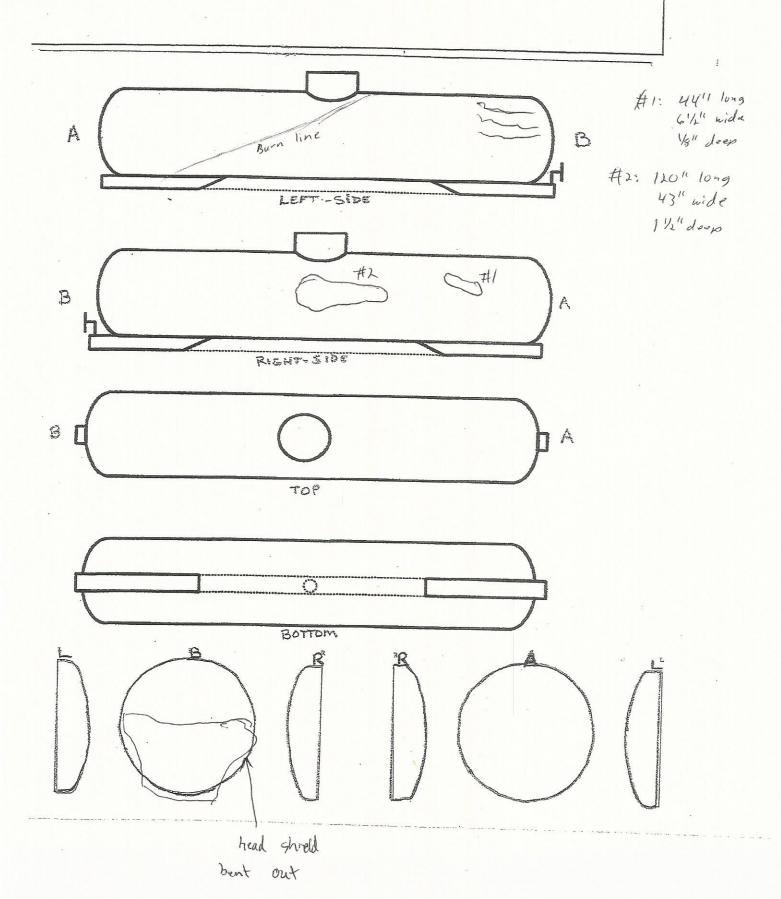
Tank Car Damage Assessment				Car Initials & Number GATX 286291		
Tank Car Characteristics/Features Mater					al	
Type of Car: ☐ Non-pressure ☐ Pressure ☐ Cryogenic ☐ Other						
Specification N	o. not a	Tank Test	pressure: Tank Capacity: 31700			
Build Date: burnt of Sunderframe: Underframe: Continuous Stub Sill						
Jacketed: Y N Thermal Protection: J Jacketed T Sprayed-on Insulated: Y N						
Construction N	Construction Material: Type/Grade Thickness Stress: T M C O N					
	Fittings L	Damage	Jacket, Tank and Head Damage			
Type fitting Damaged? Description Damage/Leak			Indicate location and severity of damage (punctures, cracks, scores, gouges, wheel burns, dents, rail burns, underframe, and leaks) on the appropriate diagram(s).			
区 Liquid Valve	M M □ Leaking	3"				
☼ Vapor/ Air Valve	☑ Leaking	Σ''				
☐ Bottom Outlet Type:	Y N □ Leaking			-		
☐ Pressure Relief Device Type:	Y N Leaking					
☐ Vacuum Relief Valve	Y № □ Leaking	19	H

☐ Gauging Device Type:	Y N Leaking					
☐ Manway Cover Plate	Y N Leaking					
☐ Fill Hole	Y M □ Leaking		Ų			
☐ Sample Line	Y M Leaking				H	
☐ Thermo- meter Well	Y N Leaking					
☐ Washout	Y N □ Leaking					
☐ Sump	Y N □ Leaking					
☐ Other Type:	Y N Leaking			<i>)</i> .

1350 hrs. 8,4,4°F
