Federal Railroad Administration
Tank Car Damage Assessment Form

Reporting Marks	UTLX 207398		Car Location City/State	Paulsboro, NJ	
Date inspected	12/17/12	Railroad	CRSH	DOT Specification	111A100W1
Last Contained	Ethanol			Was product released?	NO
(Indicate One)	Jacket	Non-jacketed		Does car contain product	YES
Car builder	Union Tank	Stub Sill Design		Built Date	04/2007
Capacity (GAL)	30220		LD Limit (LB)	196600

Reporting Marks	OC PX 80323		Car Location City/State	Paulsboro, NJ	
Date inspected		Railroad	CR	DOT Specification	105 J 300 W
Last Contained	vinyl chloride stabilized		Was product released?	No	
(Indicate One)	Jacket	X	Non-jacketed	Does car contain product	Yes
Car builder	Trinity	Stub Sill Design	TRN023	Built Date	20060301
Capacity (GAL)	24650		LD Limit (LB)	182200

Reporting Marks	OCPX 80234		Car Location City/State	
Date inspected		Railroad	DOT Specification	105J300W
Last Contained	Vinyl Chloride		Was product released?	Yes
(Indicate One)	Jacket		Does car contain product	No
Car builder	TrinityRail	Stub Sill Design	Built Date	11/90
Capacity (GAL)		LD Limit (LB)	178200 lbs

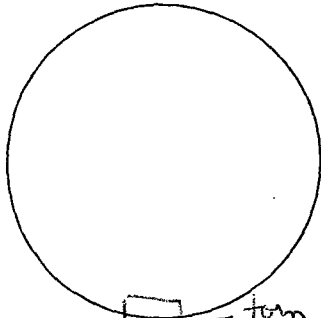
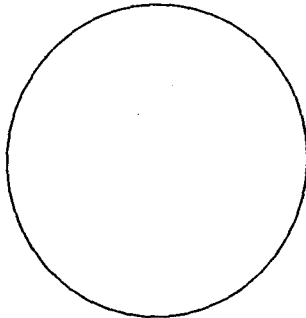
THIS CAR WAS DERAILED AND LANDED ON ITS SIDE HALF SUBMERGED IN CREEK

1.	Affected?	TANK	Location?	LEFT SIDE	Dimensions:	Length	90"	Width	84"	Depth	4"
-	Defect type?	DENT	Shape?	OBLONG	Possible Cause?	IMPACT WITH GROUND

2.	Affected?	TANK	Location?	L/S BOT	Dimensions:	Length	33"	Width	18"	Depth	2.25"
-	Defect type?	DENT	Shape?	OBLONG	Possible Cause?	IMPACT WITH DEBRIS

3.	Affected?	TANK	Location?	L/S TOP	Dimensions:	Length	?	Width	?	Depth	?
-	Defect type?	DENT	Shape?	OBLONG	Possible Cause?	IMPACT WITH GROUND					
4.	Affected?		Location?		Dimensions:	Length		Width		Depth

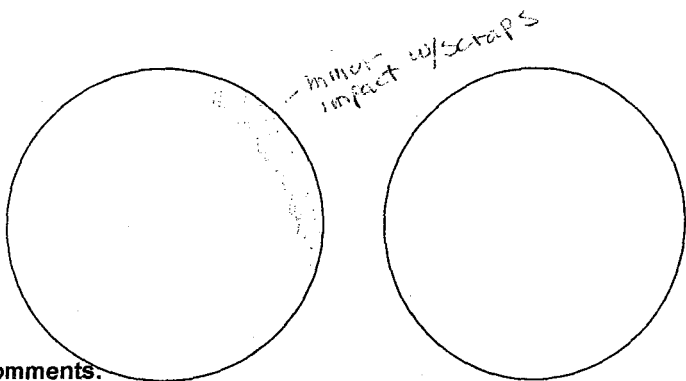
A-Head

1.	Affected?	jacket	Location?	AR _{top}	Dimensions:	Length	6"	Width		Depth	
-	Defect type?	puncture	Shape?	slit	Possible Cause?						
2.	Affected?	jacket	Location?	AR	Dimensions:	Length	36"	Width	1/2"	Depth	thru

-	Defect type?	tear	Shape?	line	Possible Cause?						
3.	Affected?	jacket	Location?	AR	Dimensions:	Length		Width		Depth	
-	Defect type?	fold	Shape?		Possible Cause?	ladder torn from pads

4.	Affected?	jacket	Location?	R ladder	Dimensions:	Length		Width		Depth	
-	Defect type?	tear	Shape?	2 circles	Possible Cause?						
5.	Affected?	jacket	Location?	BR _{end}	Dimensions:	Length	11'	Width		Depth

-	Defect type?	fold/crush	Shape?	linear	Possible Cause?	struck bottom of creek					
6.	Affected?	jacket	Location?	BR	Dimensions:	Length		Width		Depth	
-	Defect type?	dent	Shape?	circular	Possible Cause?

7.	Affected?	jacket	Location?	BR _{top}	Dimensions:	Length		Width		Depth	
-	Defect type?	dent/scraps	Shape?	rectangle	Possible Cause?						
8.	Affected?	jacket	Location?	BL	Dimensions:	Length		Width		Depth

-	Defect type?	dent w/ hole	Shape?	u	Possible Cause?	4" slit
