National Transportation Safety Board

Hazardous Materials Group Chairman's Factual Report

Carrier: Consolidated Rail Corporation (Conrail)
Train No.: FC4230
Location: Paulsboro, New Jersey
Date/Time: November 30, 2012, at 6:59 a.m. EST
NTSB No.: DCA-13-MR-002

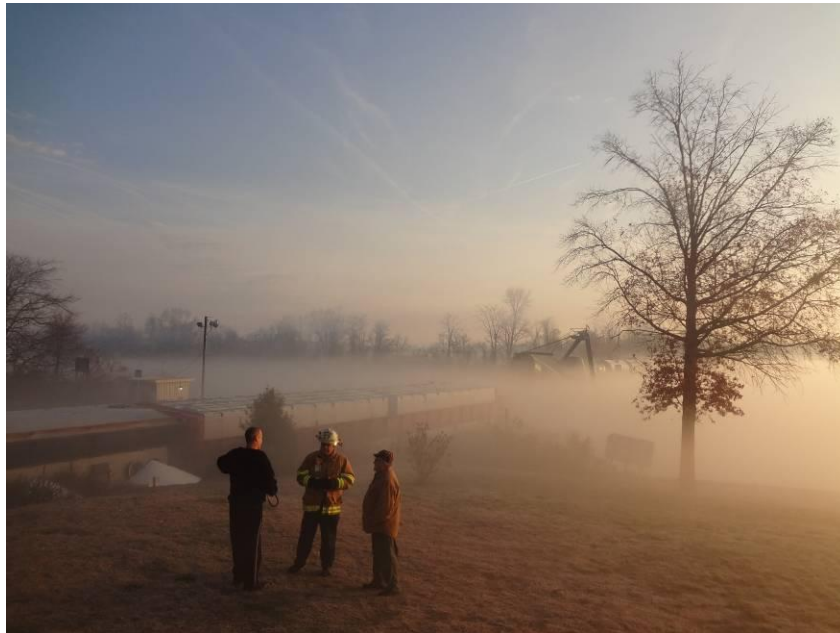
Figure 8 – Paulsboro Assistant Fire Chief, wearing firefighting gear, in an area – surrounded by fog or cloud - overlooking the derailment site at approximately 7:44 a.m. on November 30, 2012.²⁶ (Photograph courtesy of the wife of the Paulsboro Assistant Fire Chief)
