**HAZARDOUS MATERIALS GROUP
FACTUAL REPORT**

**Derailment of Union Pacific Railroad Train UEGKOT 09 with
Subsequent Hazardous Materials Release
Graettinger, Iowa, March 10, 2017**

DCA17MR007

Report Date: August 9, 2017

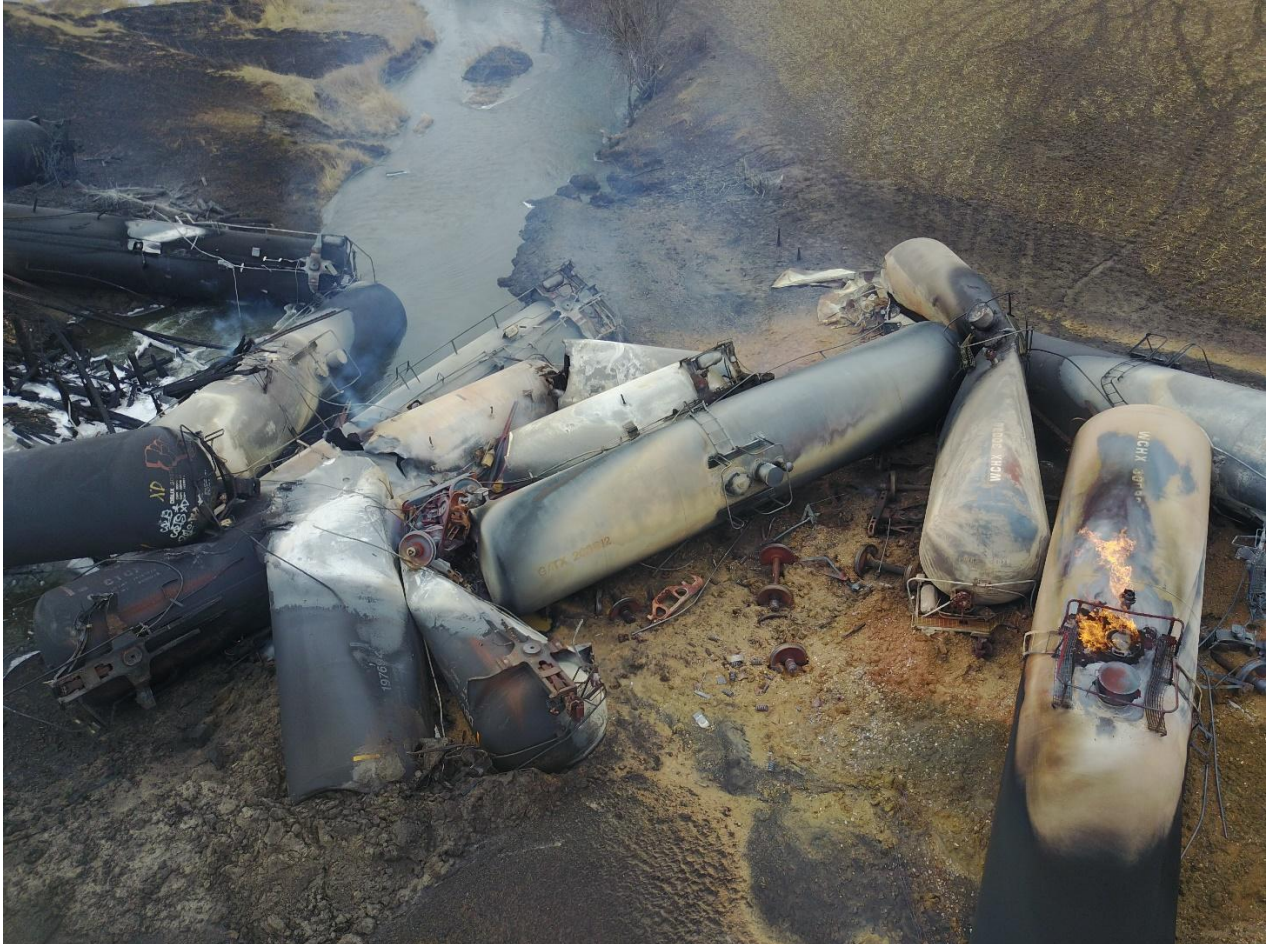
Figure 1: Accident scene at Jack Creek, Graettinger, Iowa

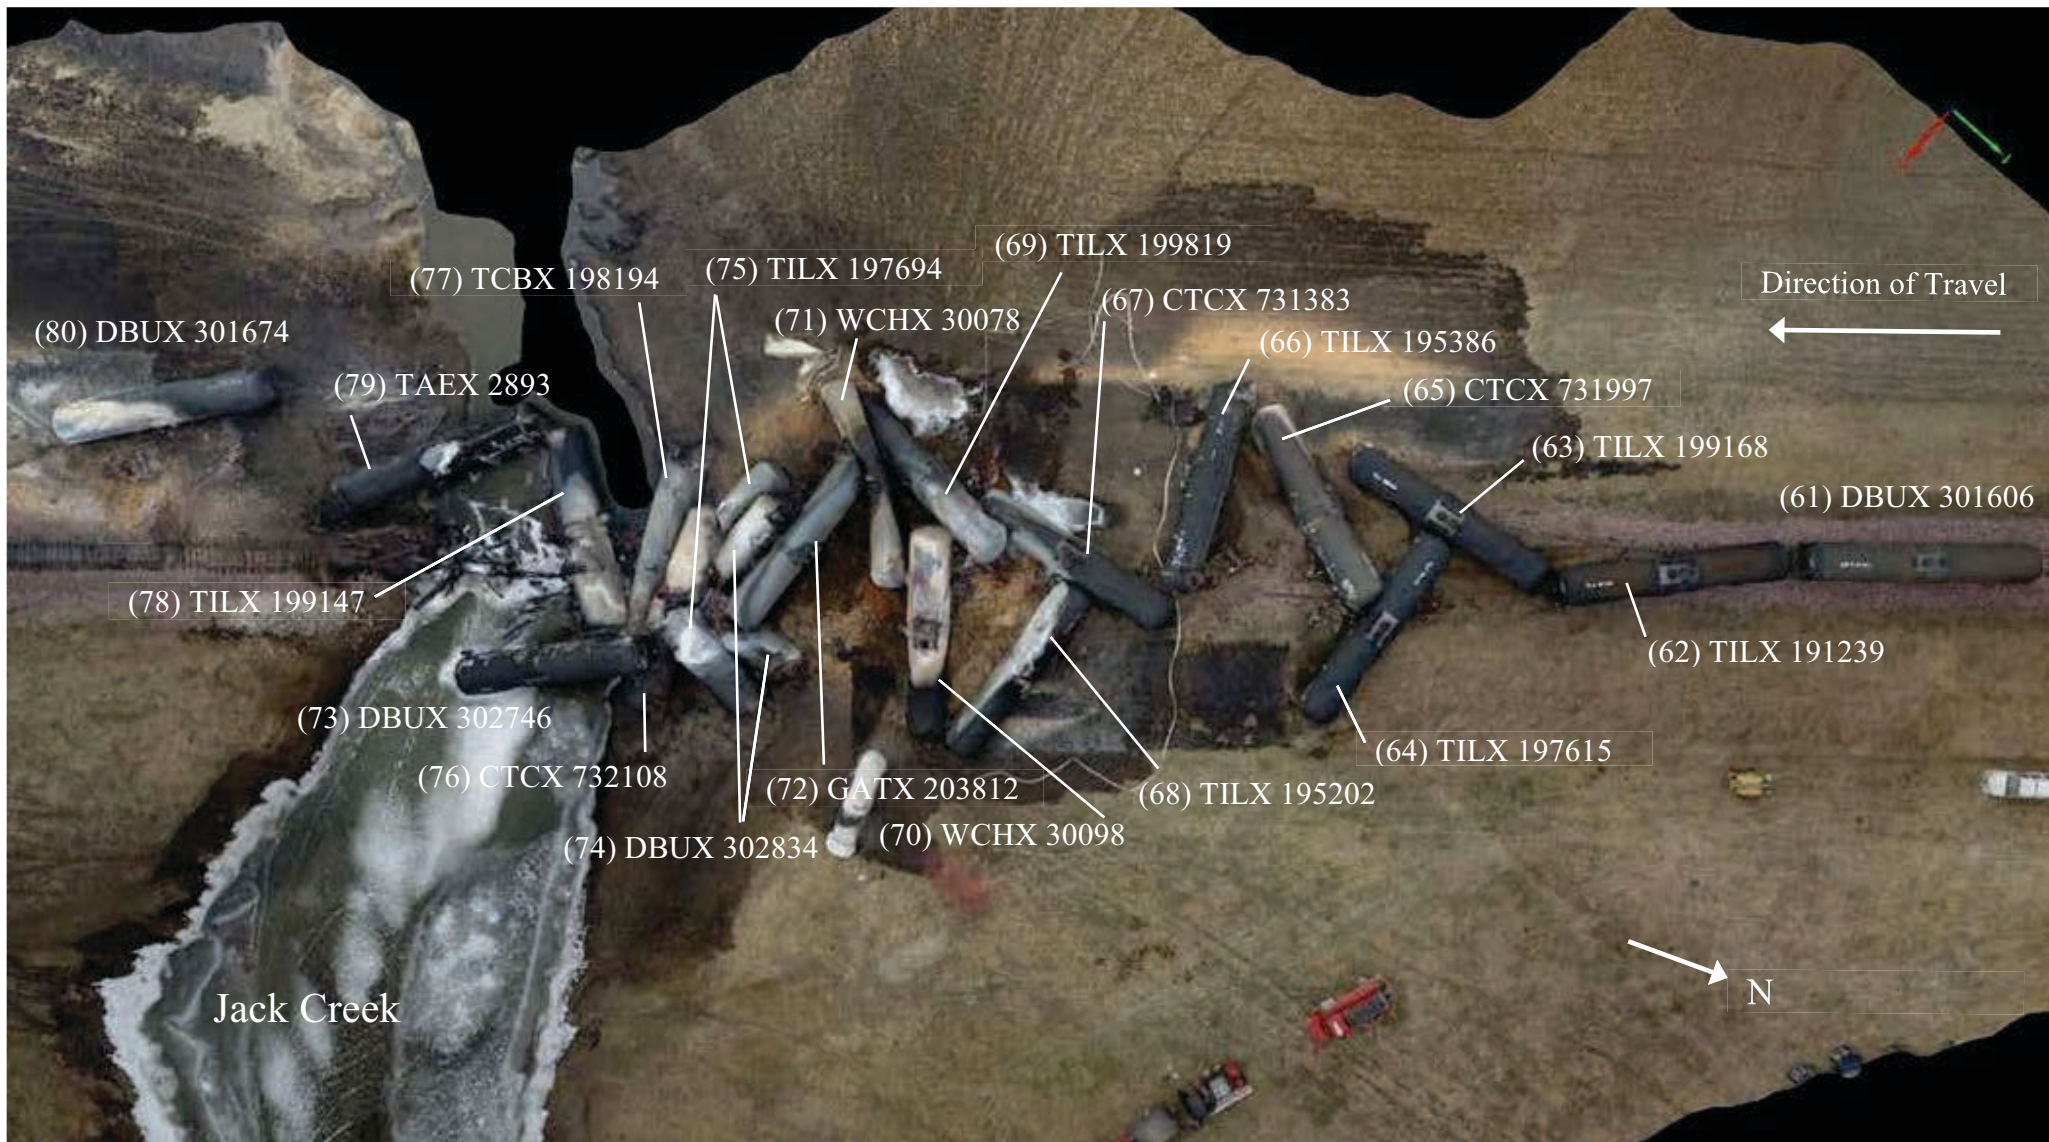
Twenty (20) tank cars derailed in positions 21 through 40 in the train.⁹ Eleven (11) of the derailed tank cars were breached from mechanical damage, while three (3) tank cars released product from only from leaking bottom outlets or thermal damage. A total of fourteen (14) cars released product that fueled a post-accident fire that burned for over 36 hours. The Union Pacific program manager for

The orientation of the tank cars following the derailment is indicated in Figure 5. On March 11, 12, and 13, 2017, the Hazardous Materials Group entered the derailment scene and collected observations relative to the tank car accident performance, car-to-car impacts, and other impacting objects. Following transloading operations, the wrecking contractor, Hulcher Services, moved the tank cars from the right-of-way and staged them in a nearby farm field.

Figure 5: Derailment Scene and Tank Car Identification
