NATIONAL TRANSPORTATION SAFETY BOARD Office of Aviation Safety Aviation Engineering Division Washington, DC 20594 DATE

STRUCTURES/FLIGHT CONTROLS

EXAM

NTSB Case No.: ERA13FA273

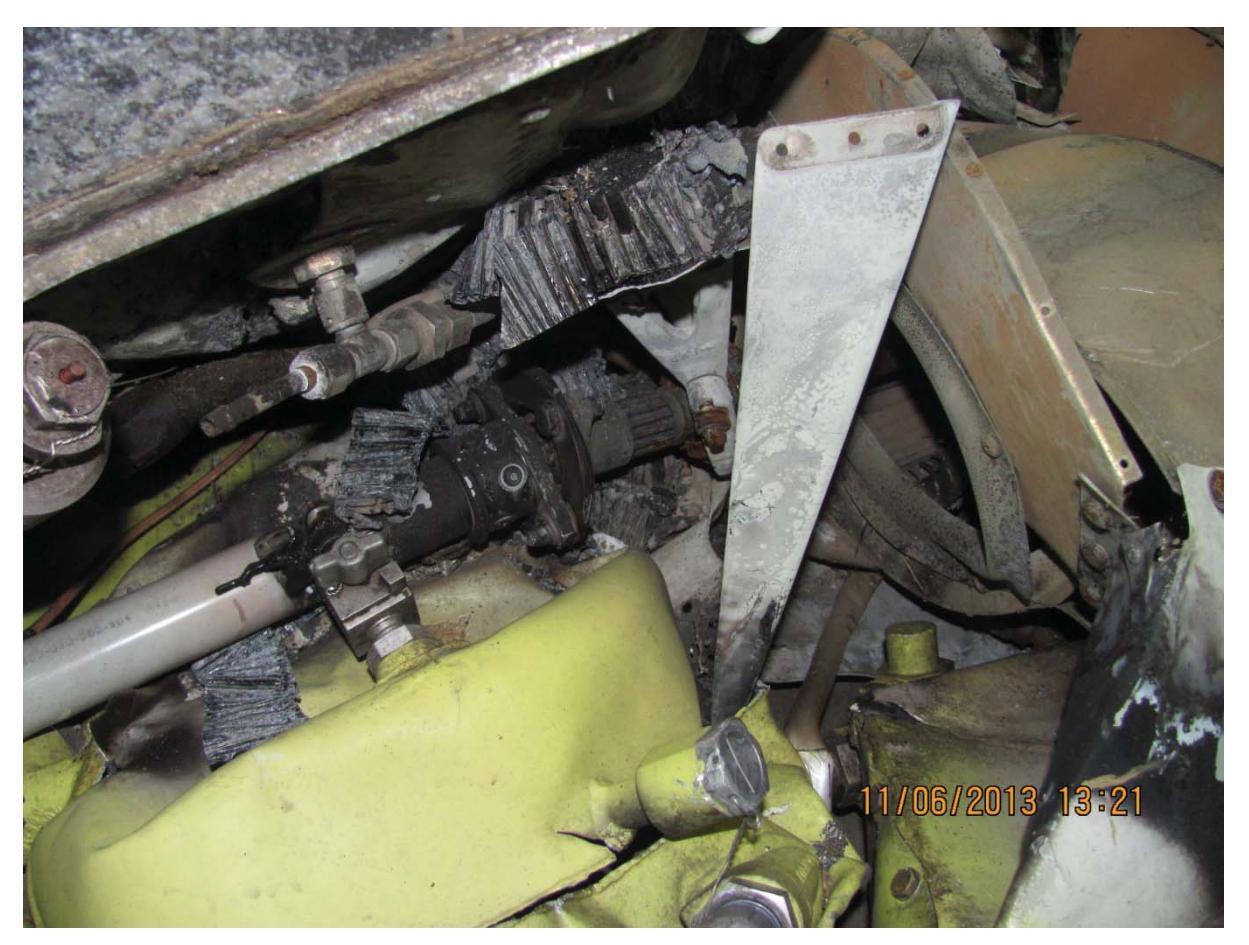
<u>Photo 7</u> The tail rotor drive shaft was still attached to the spline that transfers power from the engine to the shaft.

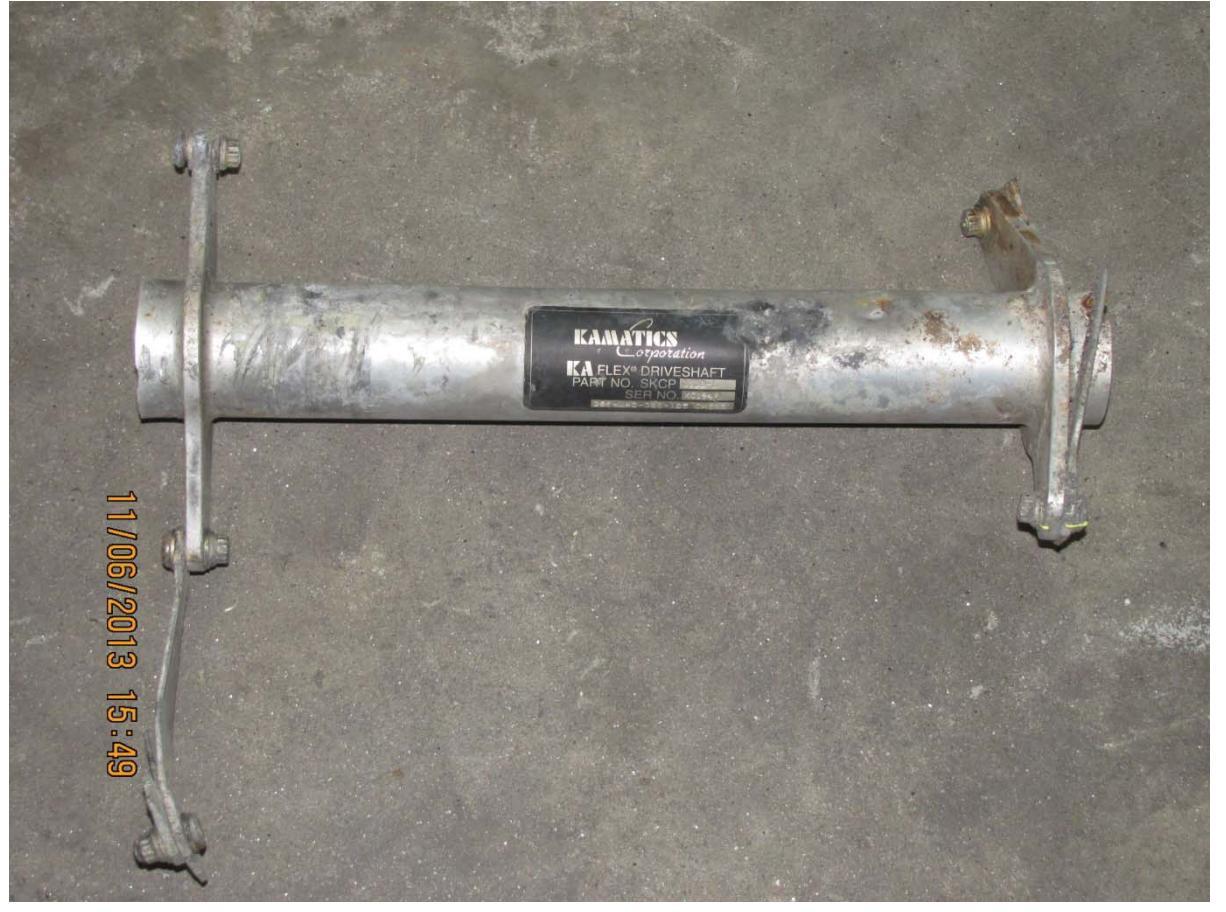
<u>Photo 18</u> The K-flex drive shaft was found in the parking lot, about mid-distance between the fuselage and main rotor blades.

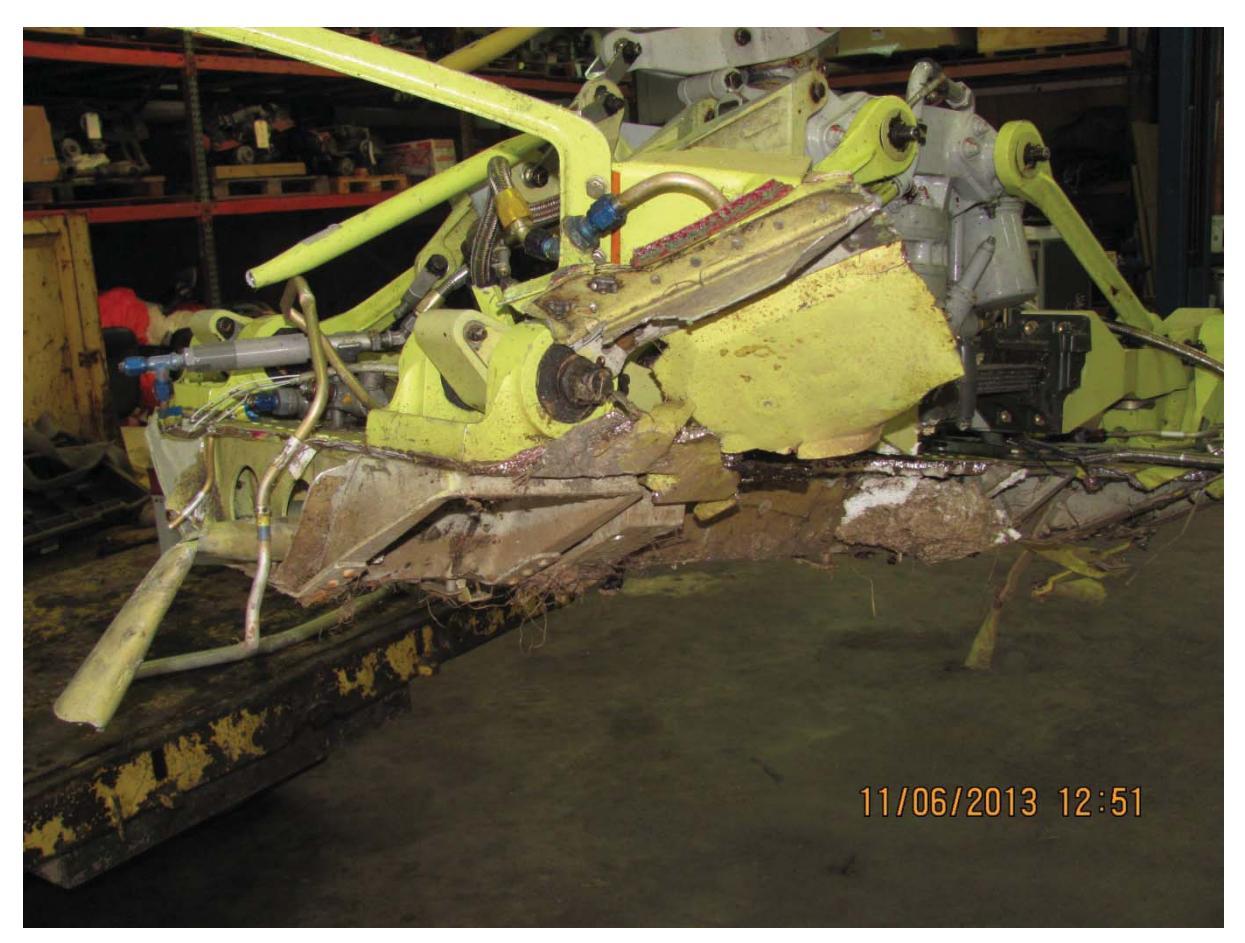
The upper deck structure had separated cleanly from the fuselage. All fractures were consistent with static overload.

Photo 19 Forward left quadrant of upper deck.

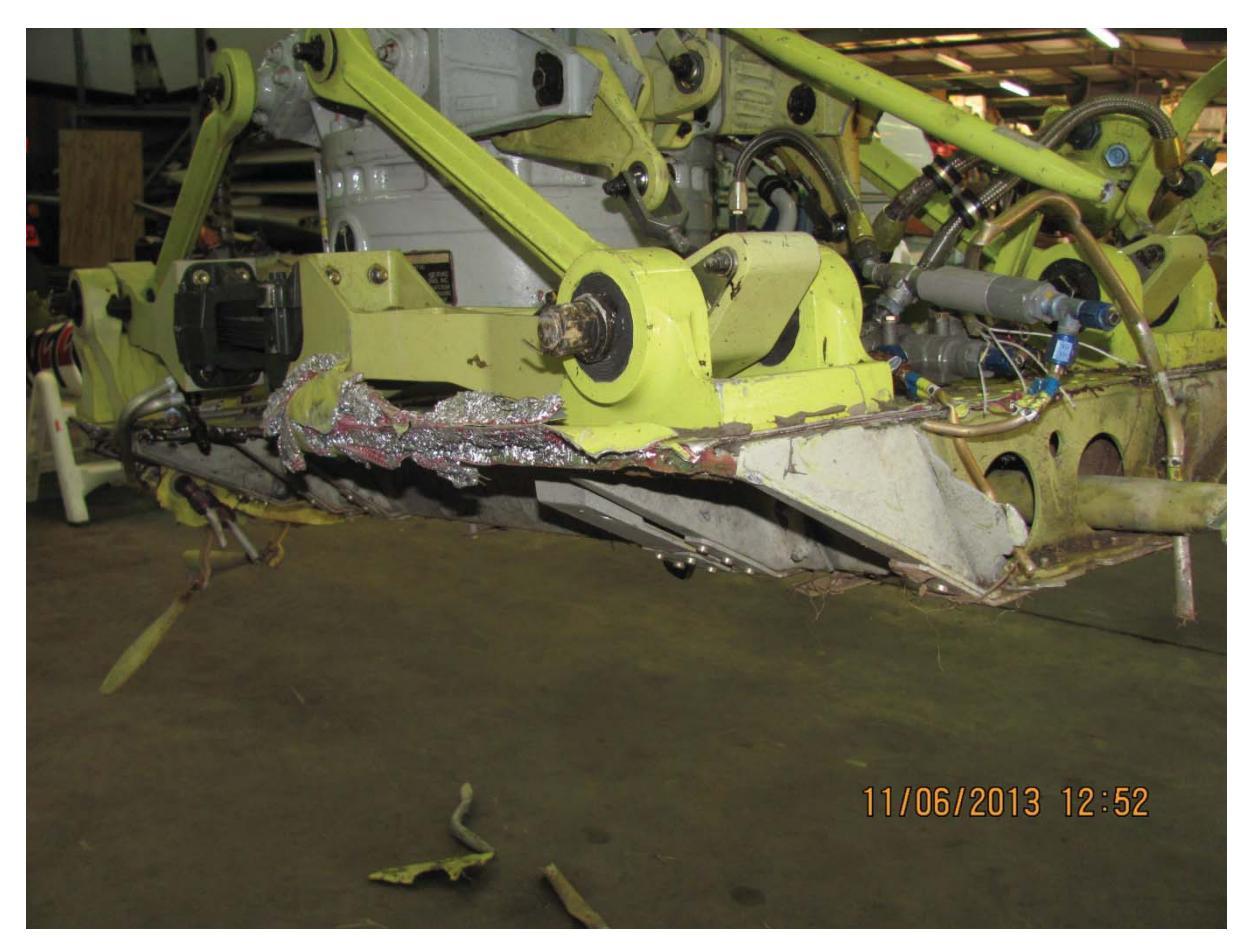
Photo 20 Forward right quadrant of upper deck.

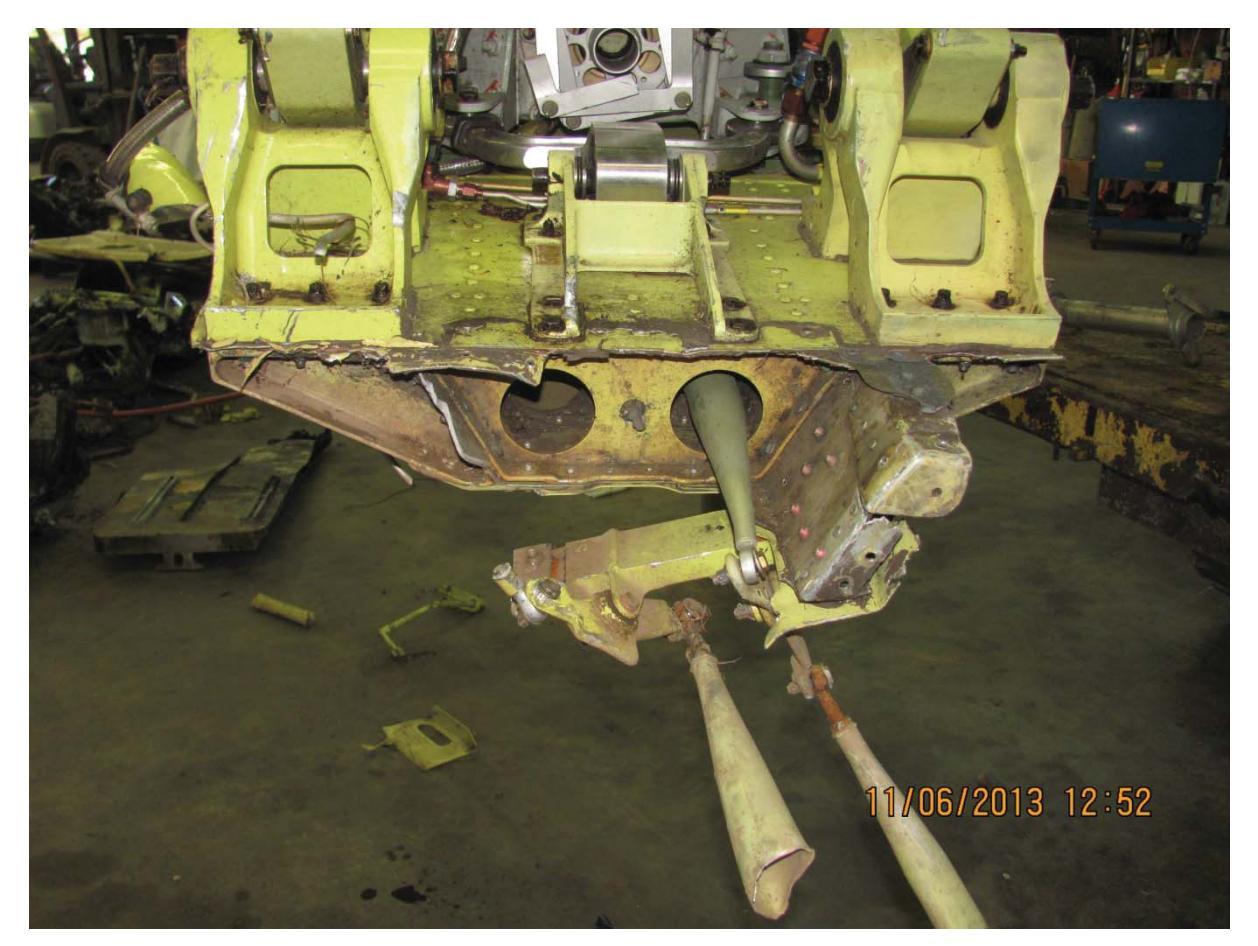
Photo 21 Aft portion of upper deck.

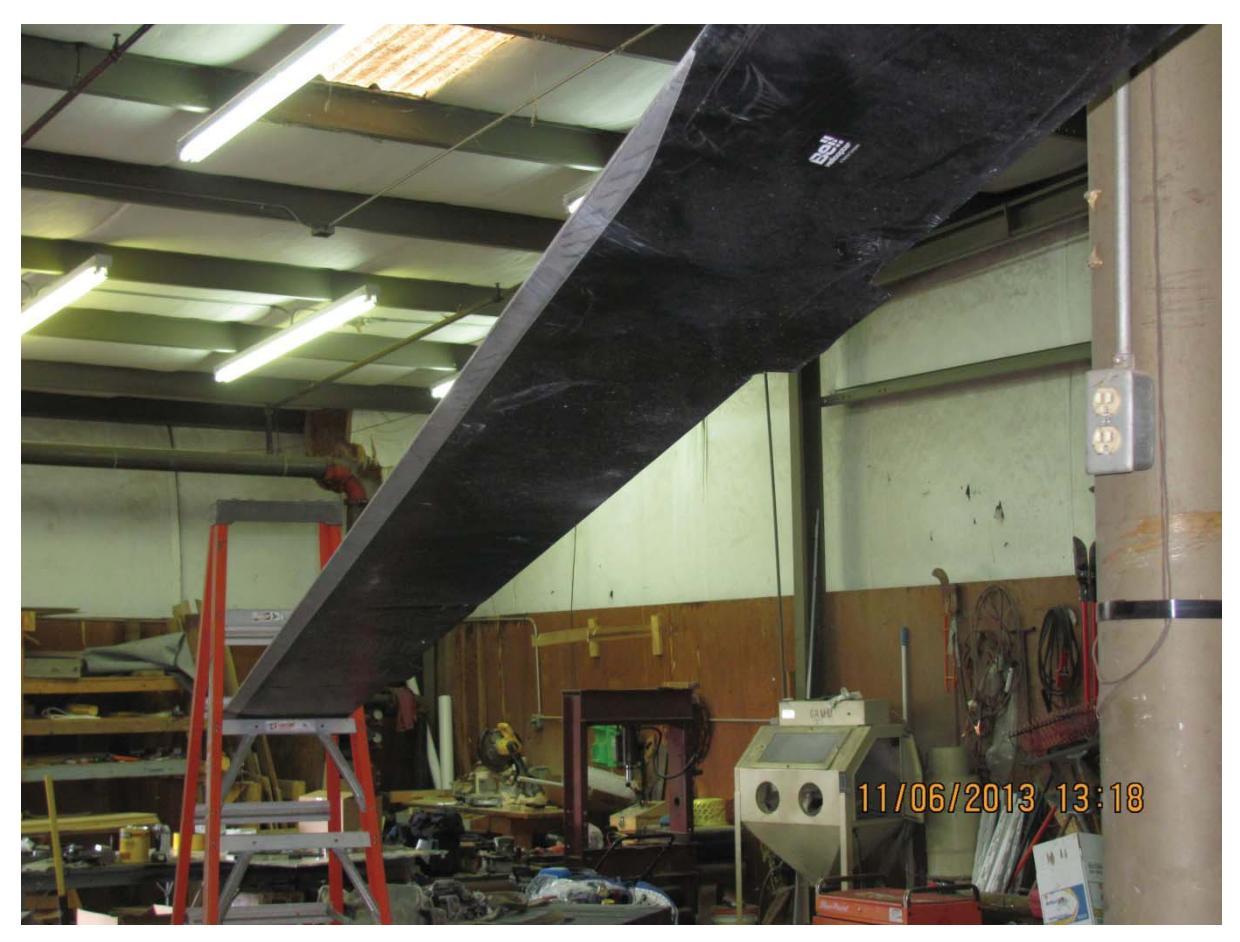
<u>Photo 22</u> One main rotor blade remained intact.

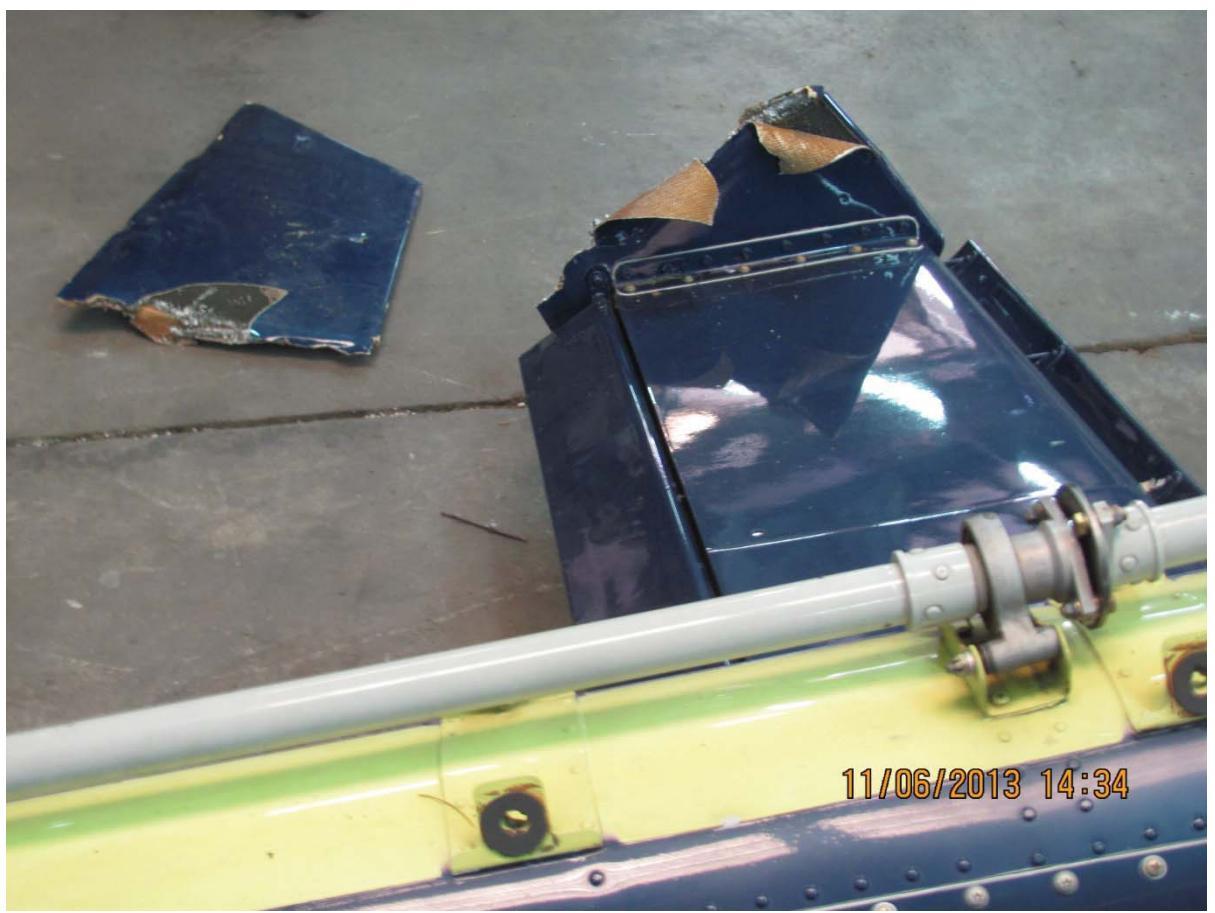
<u>Photo 25</u> Pulling on the large push-pull tube that was exposed at the fracture of the tail boom deflected the elevator trailing edge down (note, the tube in this photo is the tail rotor drive shaft).

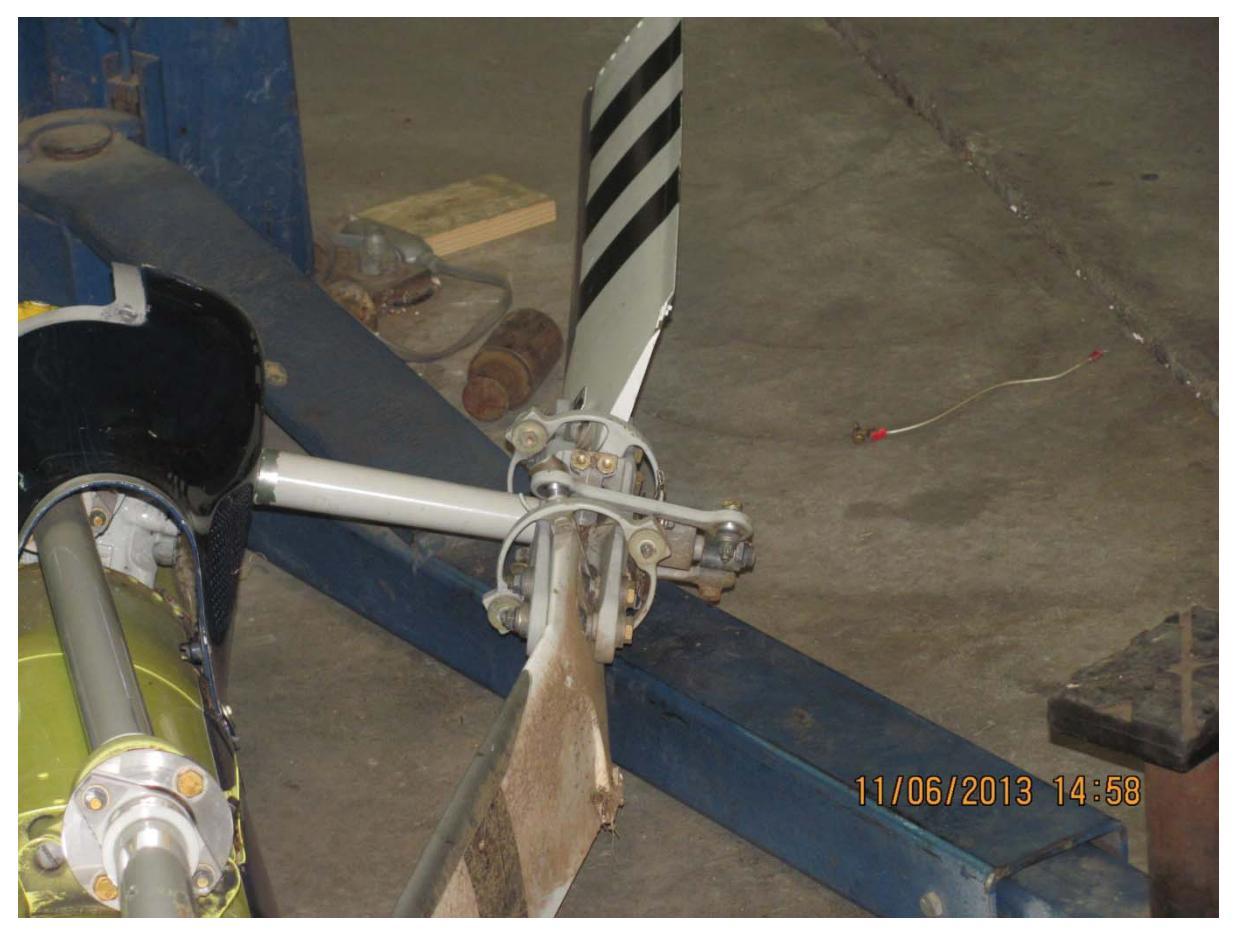
<u>Photo 27</u> The tail rotor blade deflected to a more tail right force position when the push-pull tube was deflected aft (push).

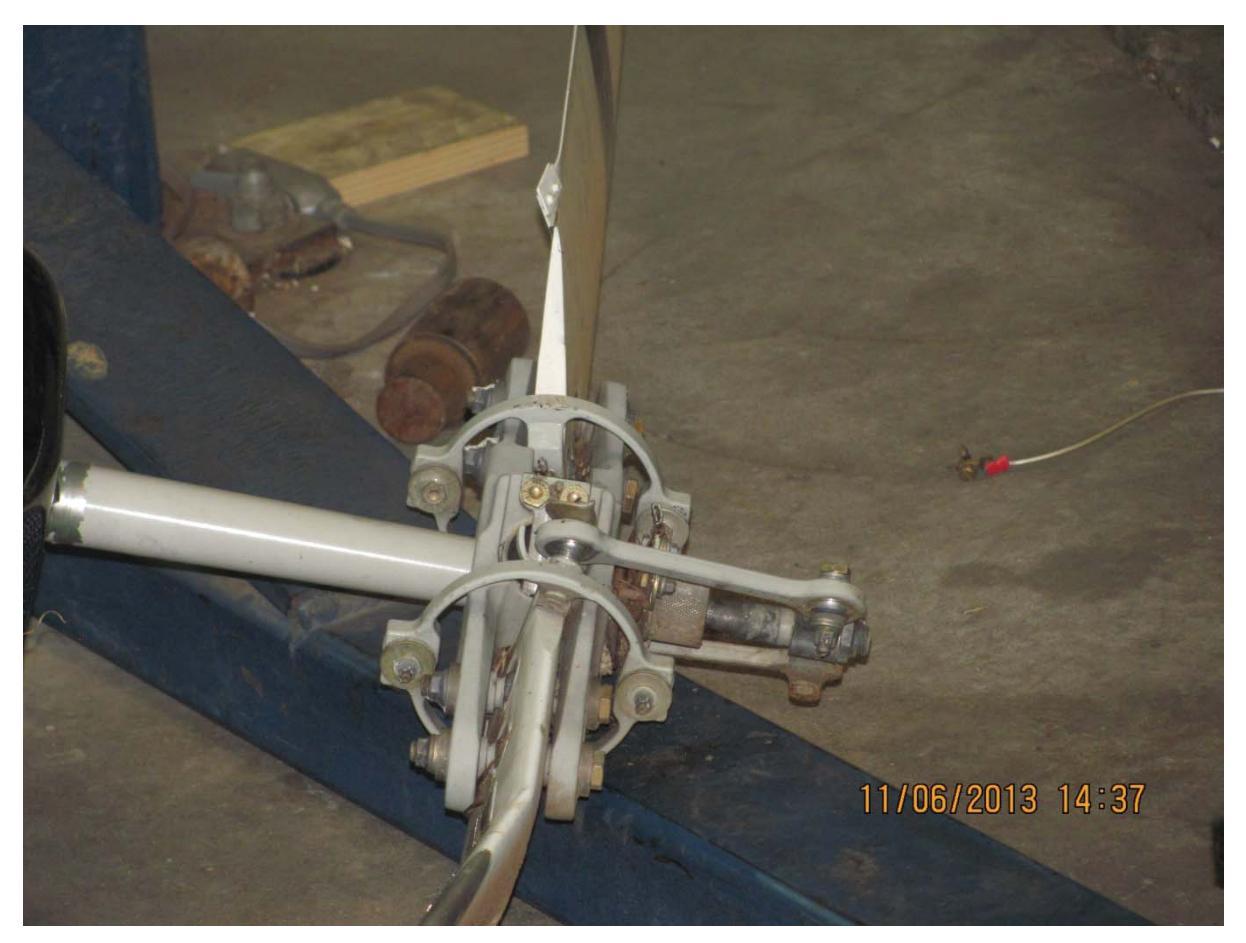
<u>Photo 28</u> The tail rotor blade deflected to a more tail left force position when the push-pull tube was deflected forward (pulled).

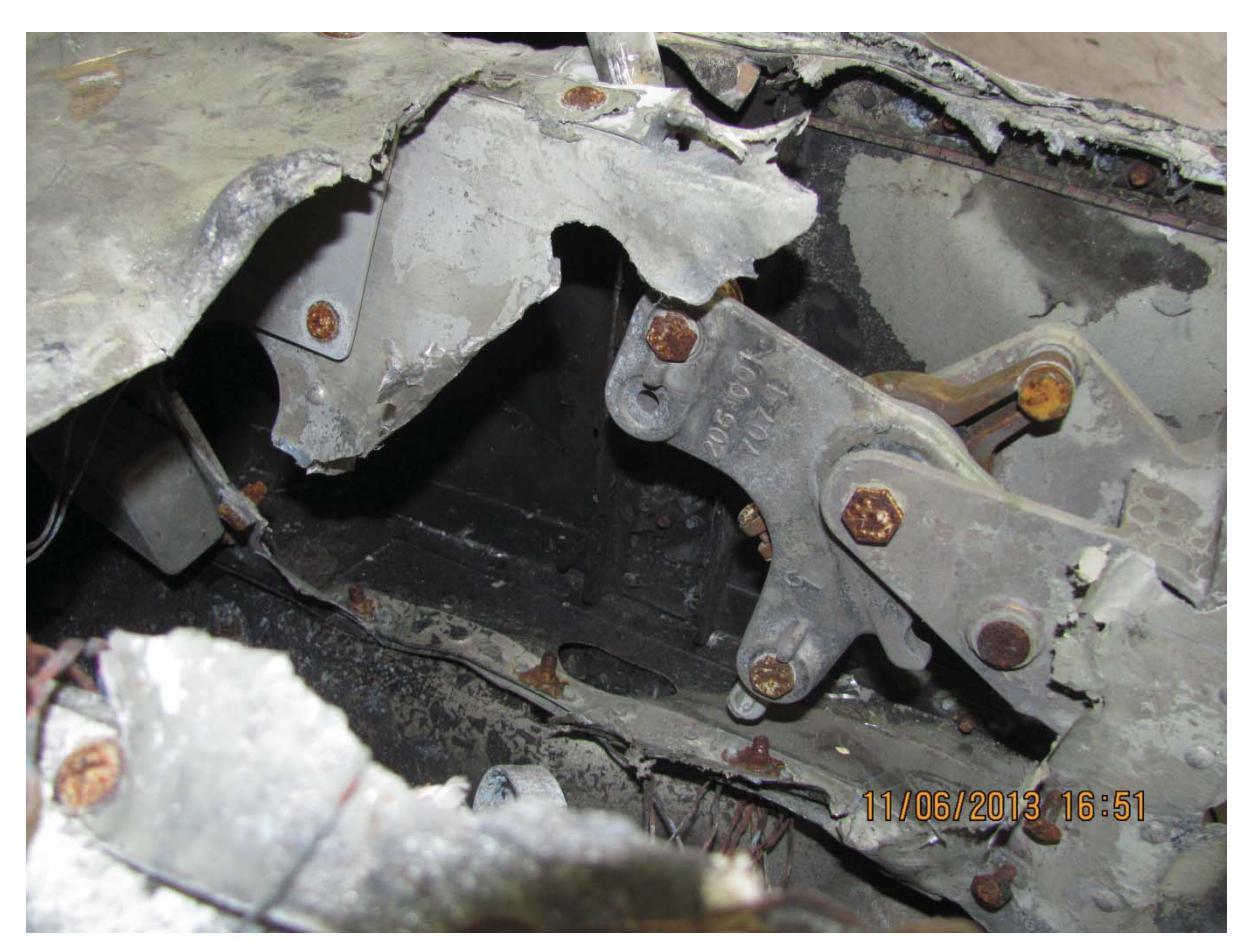
<u>Photo 33</u> Flight control – the empty hole is for the co-pilot pedal controls. The copilot pedals and control links had been removed for the EMS operation.

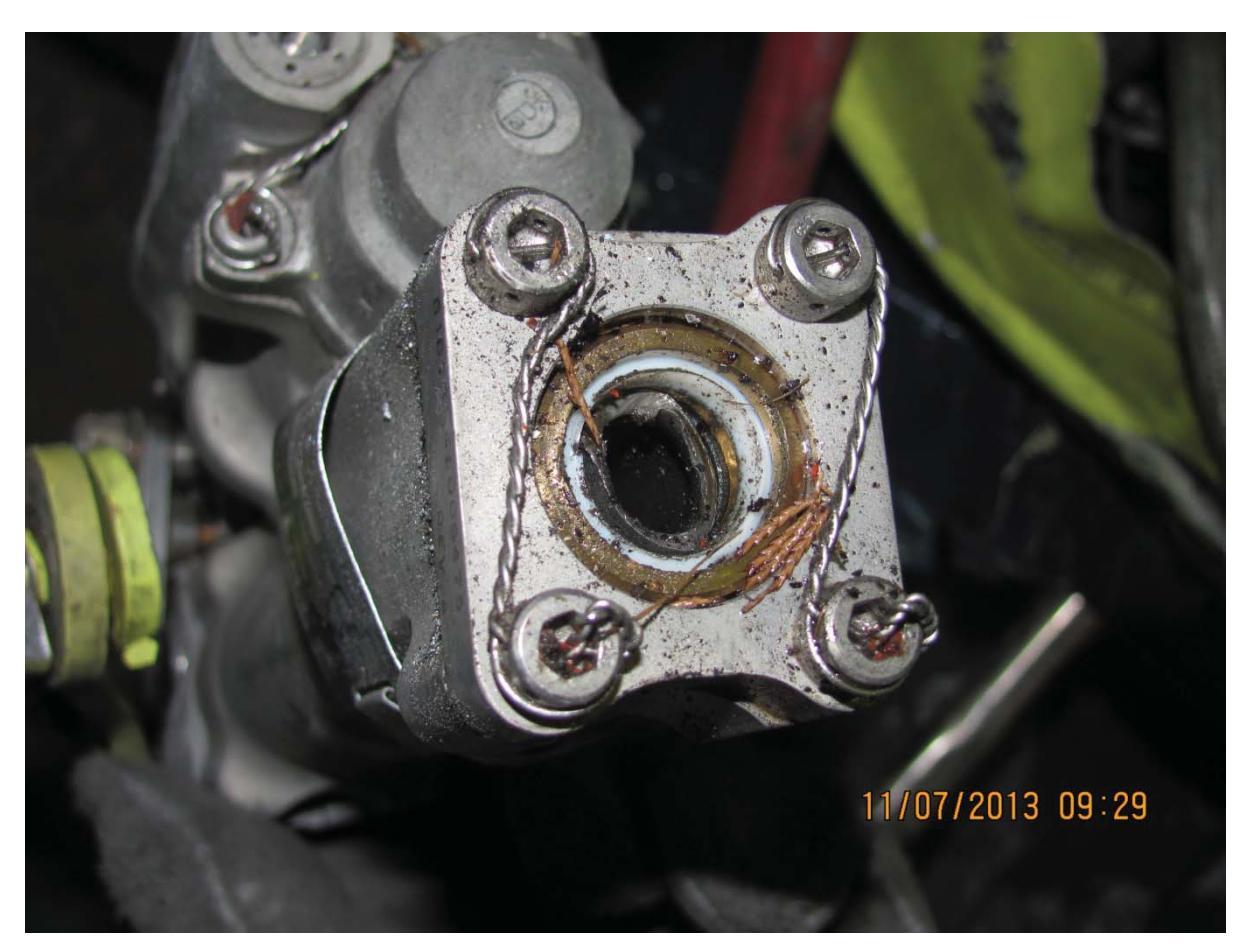
<u>Photo 46</u> Actuator 1 – Collective Pitch Hydraulic Actuator - with Separated

Hydraulic Piston
