HIGHWAY GROUP CHAIRMAN'S FACTUAL REPORT

**RAILROAD INTERSECTION AT GRADE COLLISION INVOLVING
UNION PACIFIC RAILROAD TRAIN (UPRR) 2ASMAR-2 AND
BURLINGTON NORTHERN SANTA FE TRAIN (BNSF) UKCKHKMO-
05T FOLLOWED BY DERAILMENT AND IMPACT INTO AND PARTIAL
COLLAPSE OF THE MISSOURI HIGHWAY BRIDGE A4376 SPANNING
MISSOURI STATE ROUTE M
NEAR CHAFFEE, MISSOURI
MAY 25, 2013 ABOUT 2:30 A.M.**

DCA-13-MR-004

NATIONAL TRANSPORTATION SAFETY BOARD

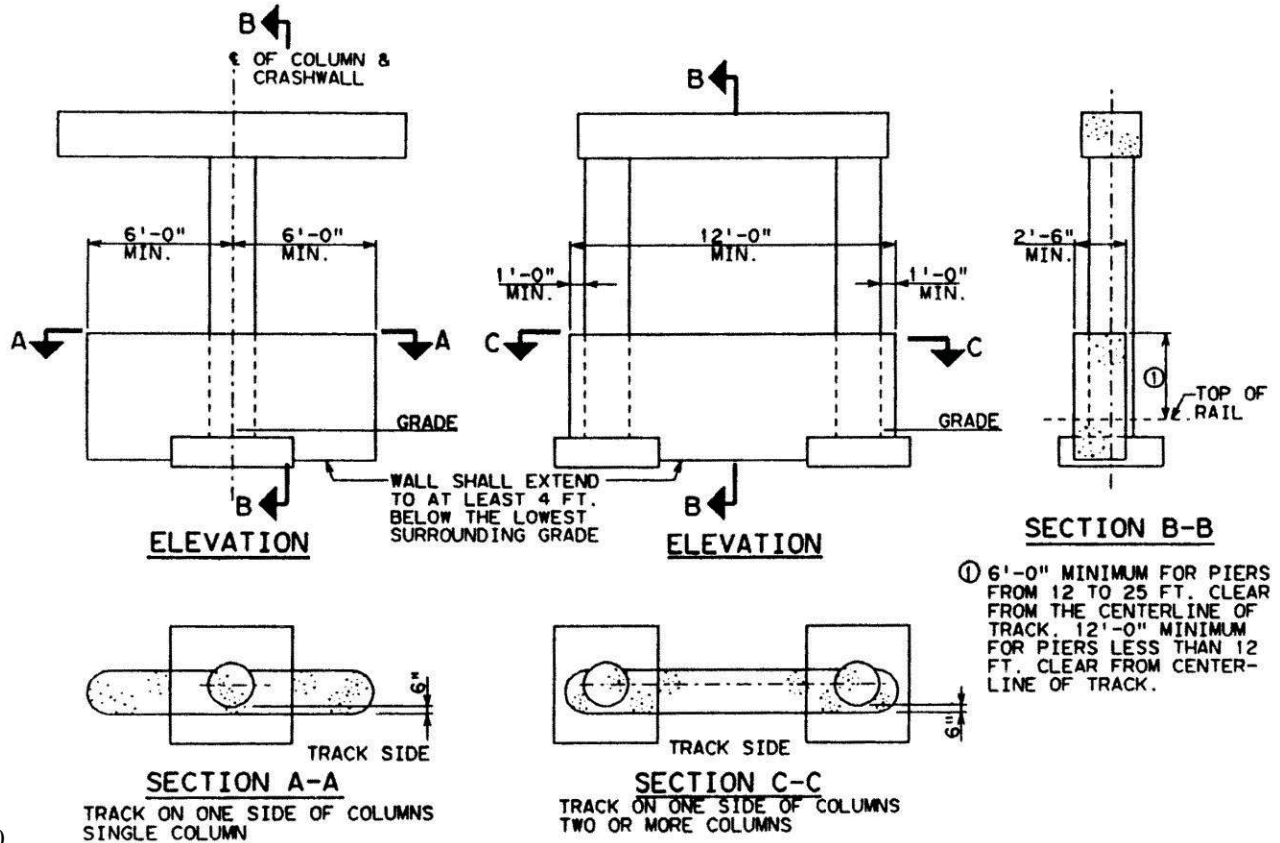
Figure 2

The American Railway Engineering and Maintenance-of-Way Association (AREMA) had the following 2005 design guidelines in their 2012 edition. Crash walls or piers of heavy construction are recommended for piers if the horizontal clearance from the centerline of the rails to the piers is less than 25 feet.

- 4.0 a. To limit damage by the redirection and deflection of railroad equipment, piers supporting bridges over railways and
- 5.0 with a clear distance of 25 feet (7600 mm) or less from the centerline of a railroad track shall be of heavy construction

- 16.0d. Consideration may be given to providing protection for bridge piers over 25 feet (7600 mm) from the centerline of
- 17.0track as conditions warrant. In making this determination, account shall be taken of such factors as horizontal and

- 18.0vertical alignment of the track, embankment height, and an assessment of the consequences of serious damage in the
- 19.0case of a collision.
- 20.0
