Collapse of the Interstate 5 Skagit River Bridge  
Following a Strike by an Oversize Combination Vehicle  
Mount Vernon, Washington  
May 23, 2013

**Accident Report**

NTSB/HAR-14/01  
PB2014-106399

NTSB/HAR-14/01  
PB2014-106399  
Notation 8509A  
Adopted July 15, 2014

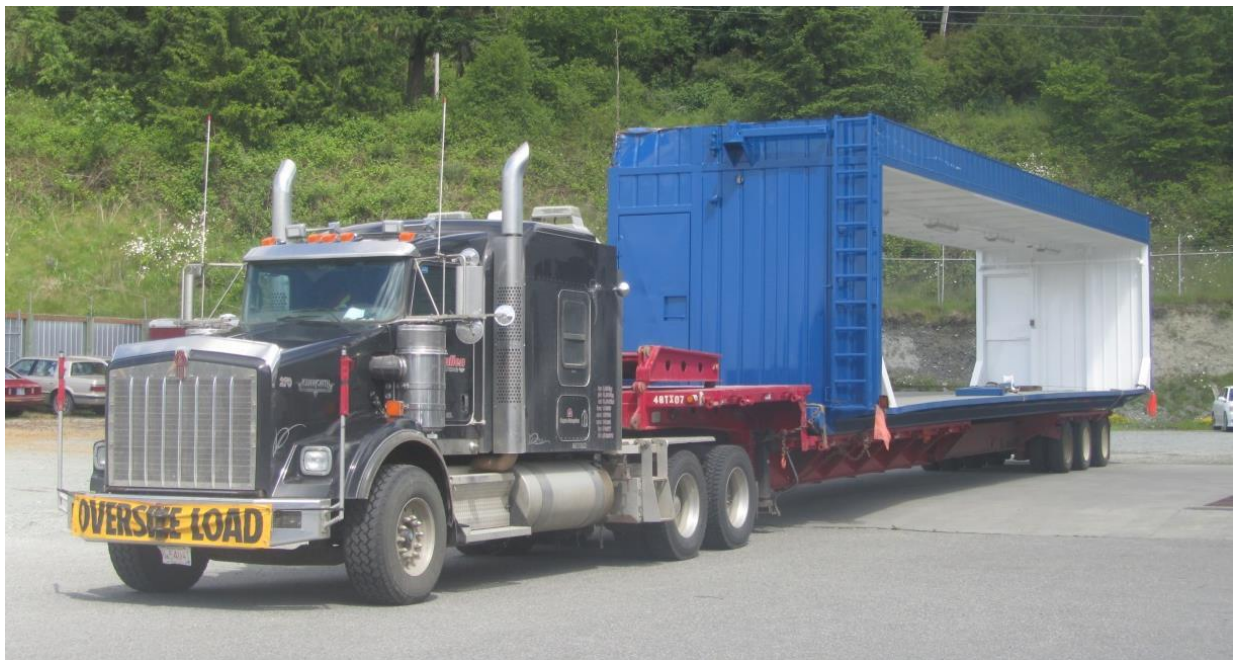
**Figure 1.** The oversize combination vehicle with the casing shed section loaded on it.

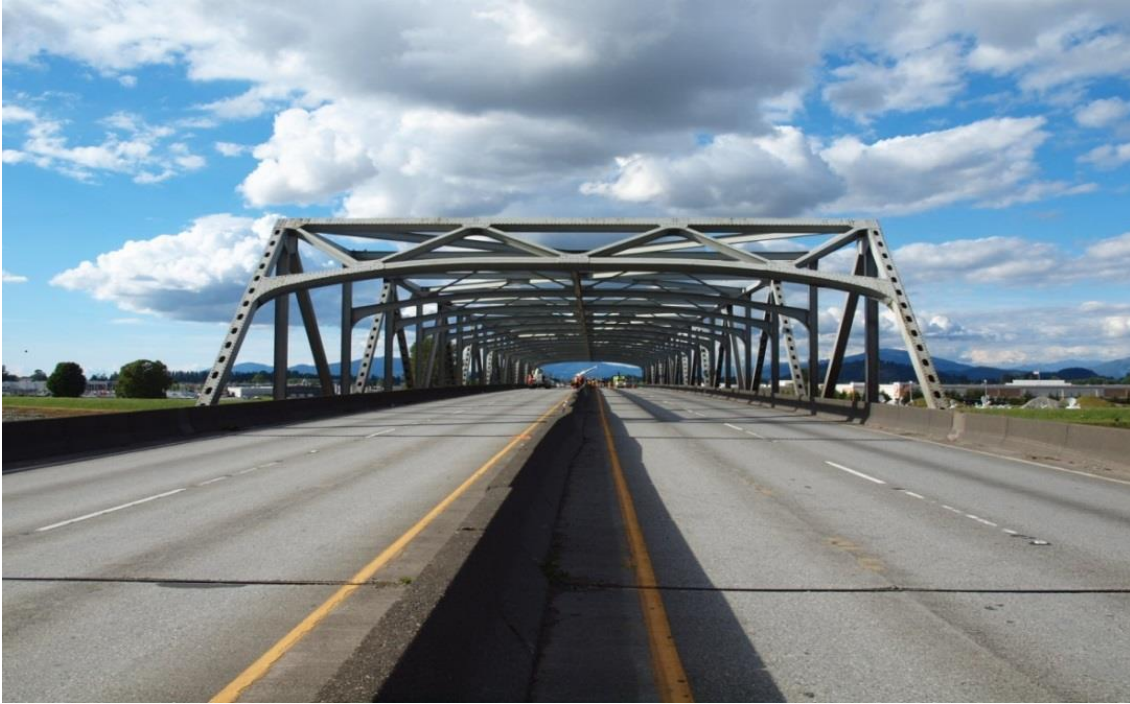
**Figure 5.** Looking northward at the Skagit River Bridge on May 24, 2013. The through-truss structure is the portion above the roadway.

As the oversize load entered the through-truss structure, its upper right corner collided with the north portal and multiple sway braces on the far right side of the truss structure on both spans 8 and 7. The impacts caused sufficient damage to load-bearing members of the bridge's structure to initiate buckling in the upper chord of the west truss, which resulted in the

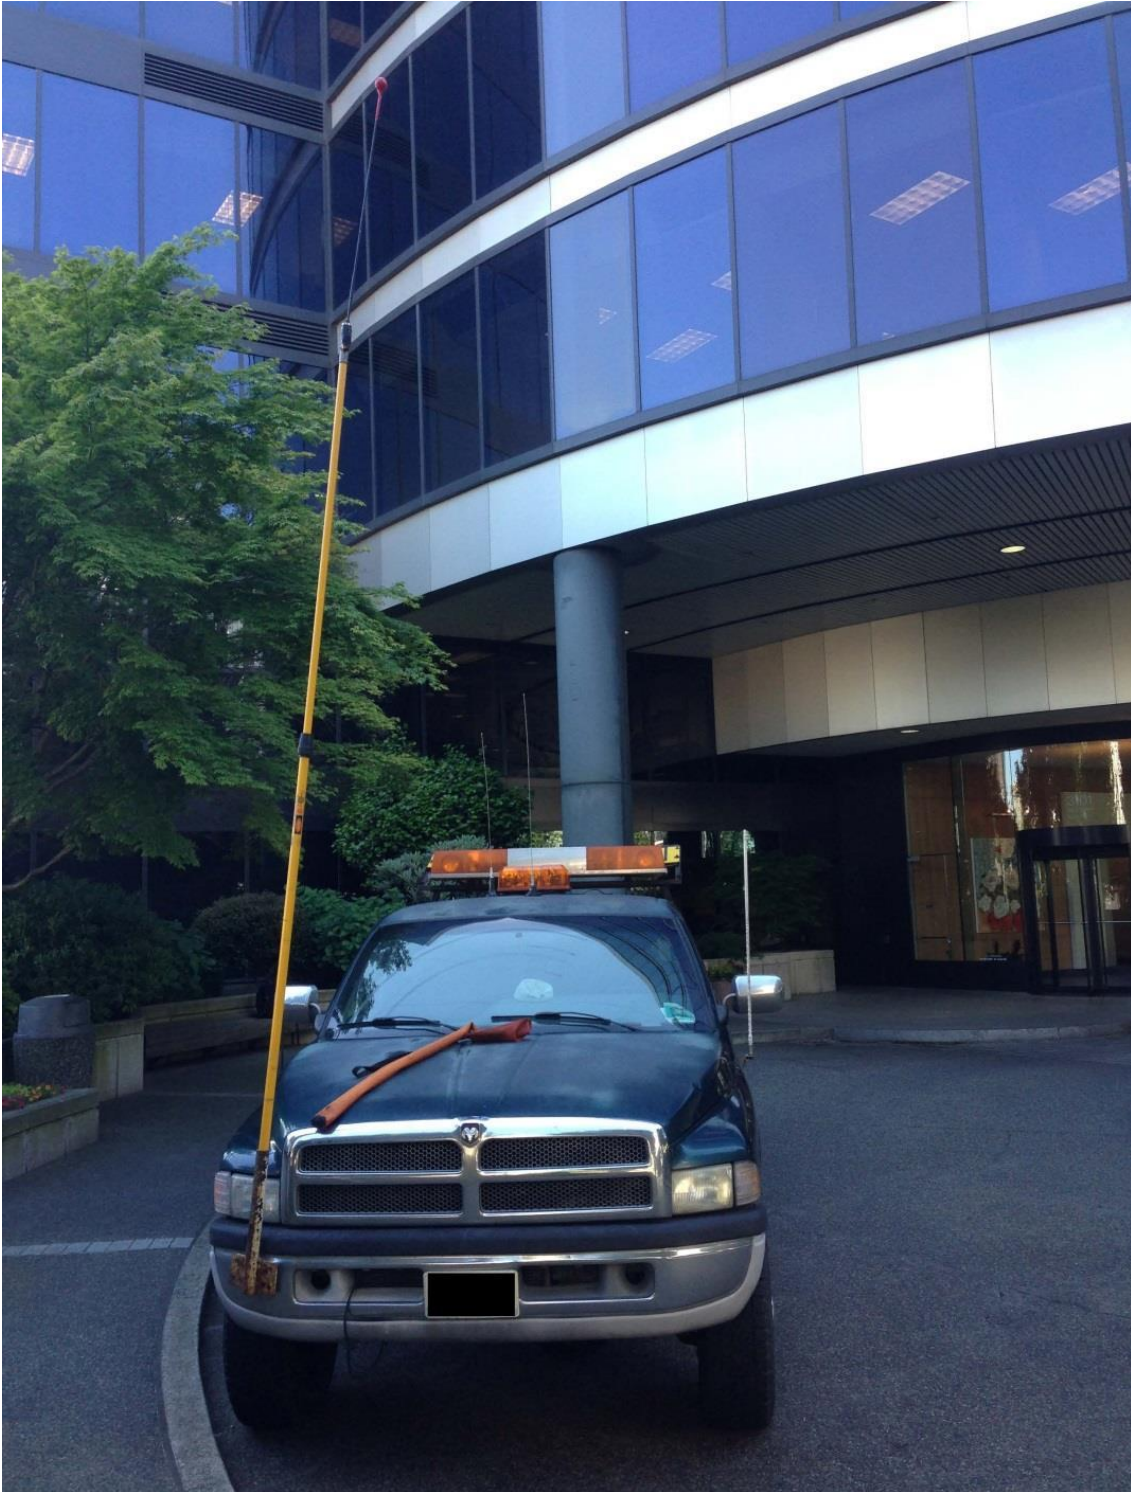
<sup>17</sup> While on the scene at the south side of the bridge, the Washington State Patrol measured the height from the ground to the top of the height pole on the pilot/escort vehicle at 16 feet.

**Figure 11.** Pilot/escort vehicle, showing the placement of the height pole on the front bumper.

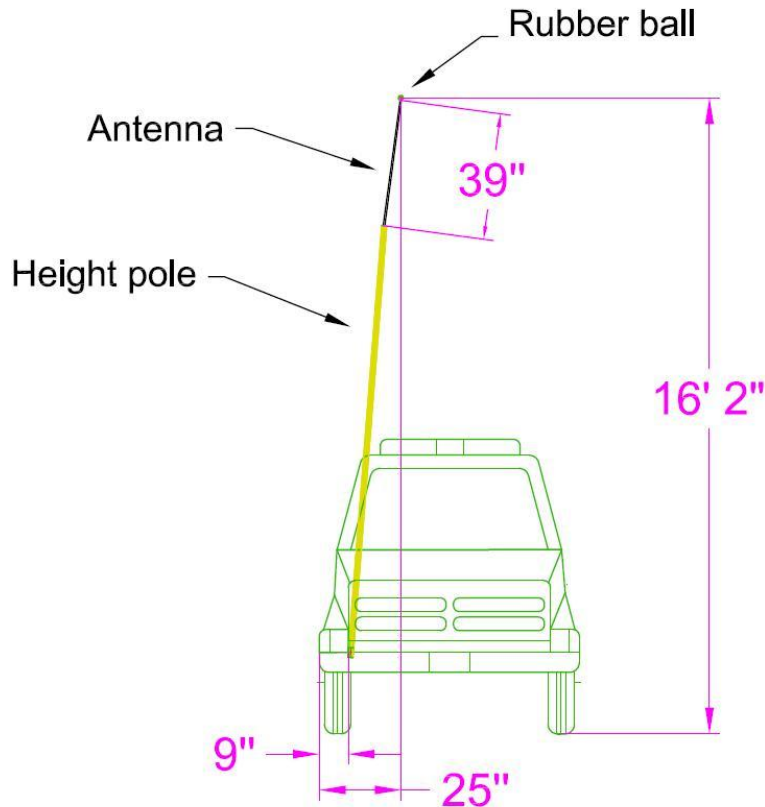
**Figure 12.** Diagram of the pilot/escort vehicle, viewed from the front. (The measurement of 16 feet 2 inches is the vertical distance from the roadway surface to the top of the height pole [the rubber ball].)
