**HIGHWAY FACTORS GROUP CHAIRMAN FACTUAL REPORT**  
(61 pages)

**NATIONAL TRANSPORTATION SAFETY BOARD  
OFFICE OF HIGHWAY SAFETY  
WASHINGTON, DC 20594**

LOCATION: Interstate 95 (I-95) New England Thruway, at Mile Marker 3.2, in New York City, Bronx County, New York  
VEHICLE 1: 1999 Prevost Motorcoach  
OPERATOR: World Wide Travel of Greater New York Ltd.  
DATE: March 12, 2011  
TIME: Approximately 5:37 a.m. EST

**NTSB #: HWY-11-MH-005**

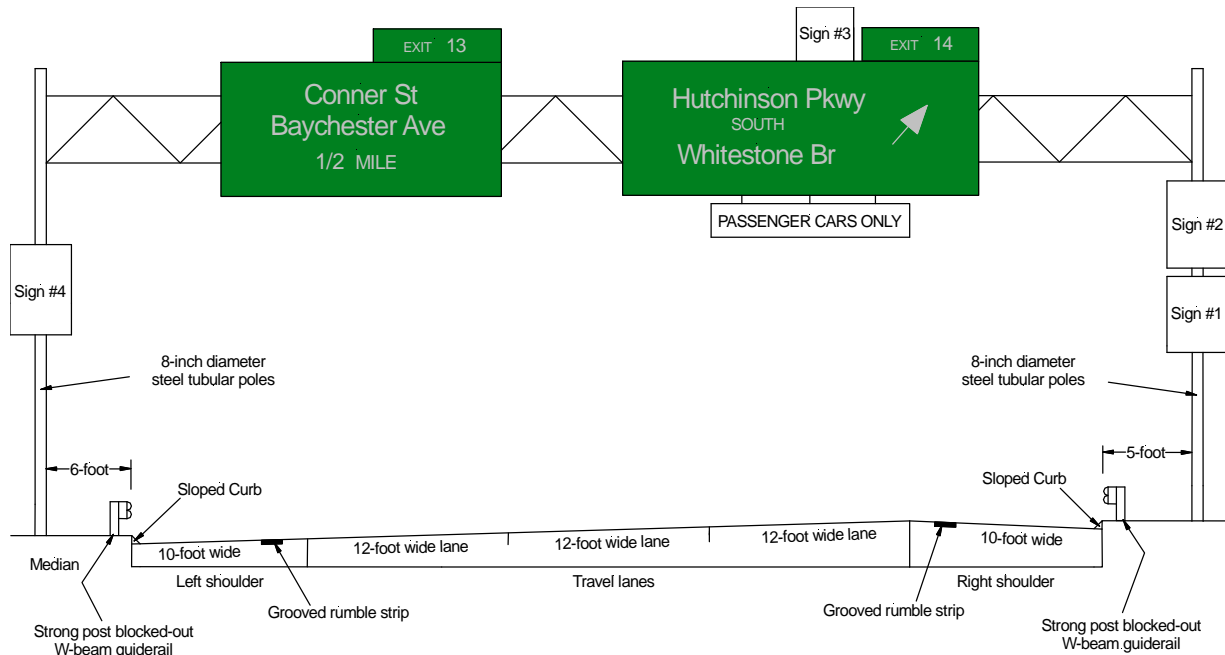
**Figure 2 – Typical section of the southbound lanes of I-95 in the vicinity of the accident**

Figure 2 illustrates a typical section of the southbound lanes of I-95 in the vicinity of the accident.

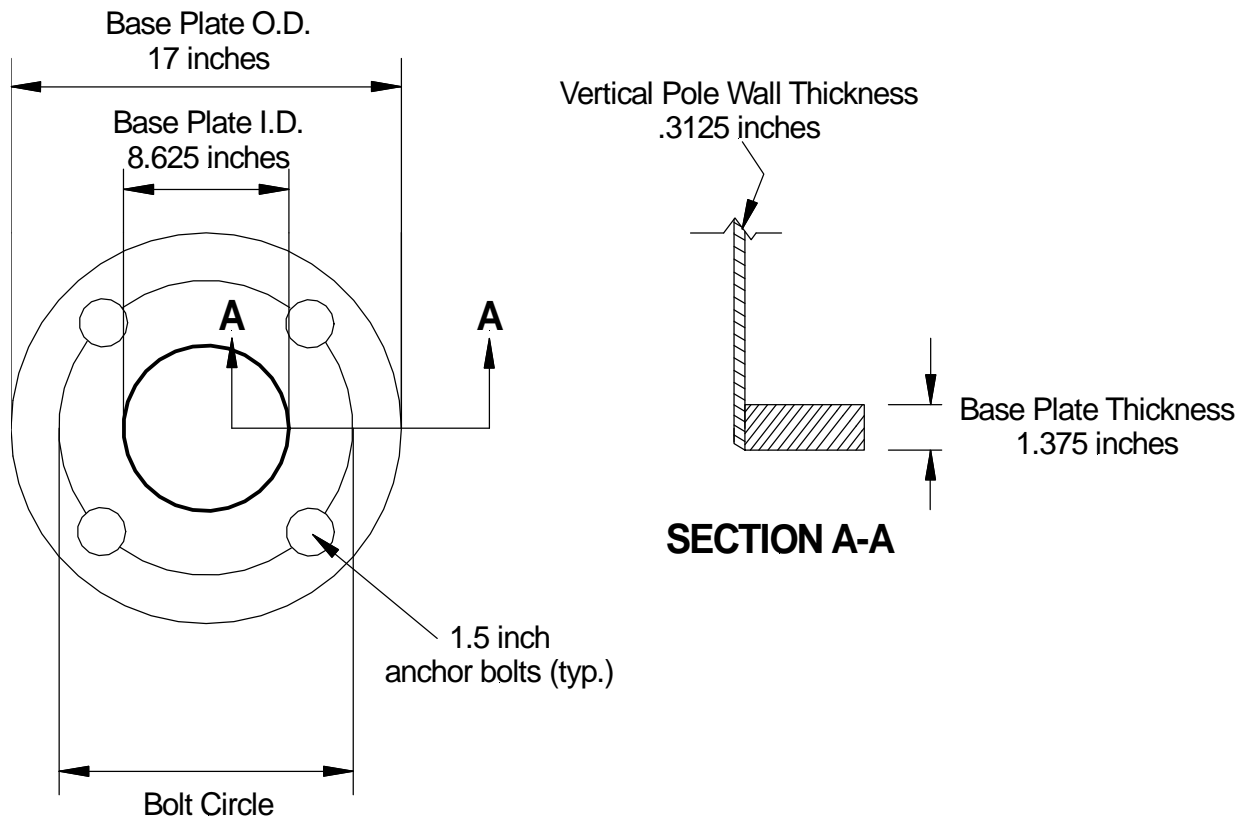
**Figure 5 – Base Plate and Connection Details of the Vertical Poles**

The height of the east vertical pole supporting the overhead sign structure support was approximately 28 feet and the height of the west vertical pole was approximately 27 feet (see Highway Factors Photograph (HWY Photo-04) illustrating the height of the east vertical pole was approximately 28 feet and the height of the west vertical pole was approximately 27 feet). Figure 5 illustrates the base plate and connection details of the vertical poles. The bolts used to anchor the base plate were 1 ½ inch diameter anchor bolts<sup>34</sup>. The base plate outside diameter was 17 inches and the base plate inside diameter was 8.625 inches. The base plate thickness was 1.375 inches and the vertical pole wall thickness was .3125 inches.
