**HIGHWAY FACTORS GROUP CHAIRMAN'S  
FACTUAL REPORT**

**Collapse of a Bridge Span  
Mount Vernon, WA; 05/23/2013**

**HWY13MH012**

**NATIONAL TRANSPORTATION SAFETY BOARD  
OFFICE OF HIGHWAY SAFETY  
WASHINGTON, D.C. 20594**

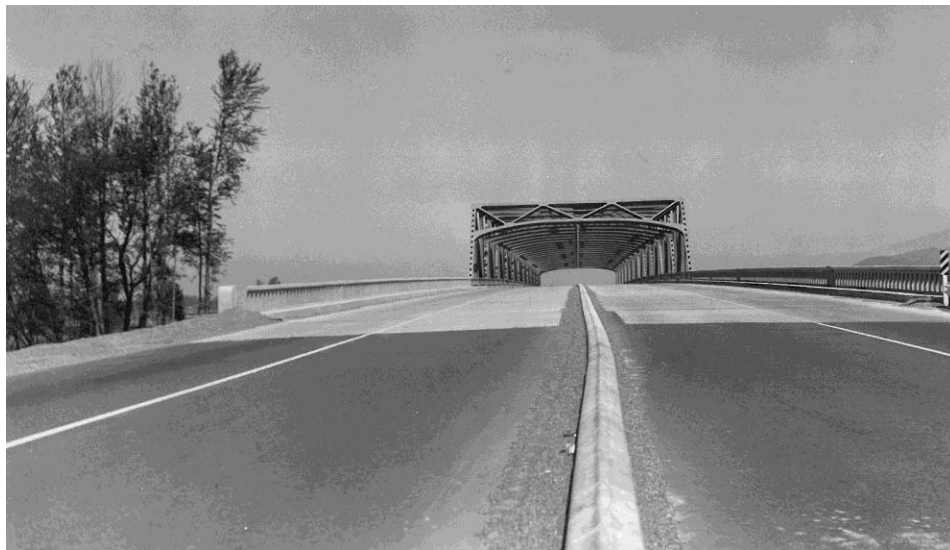
**Photograph 1** – I-5 Bridge over the Skagit River looking to the north when it was originally constructed in 1955

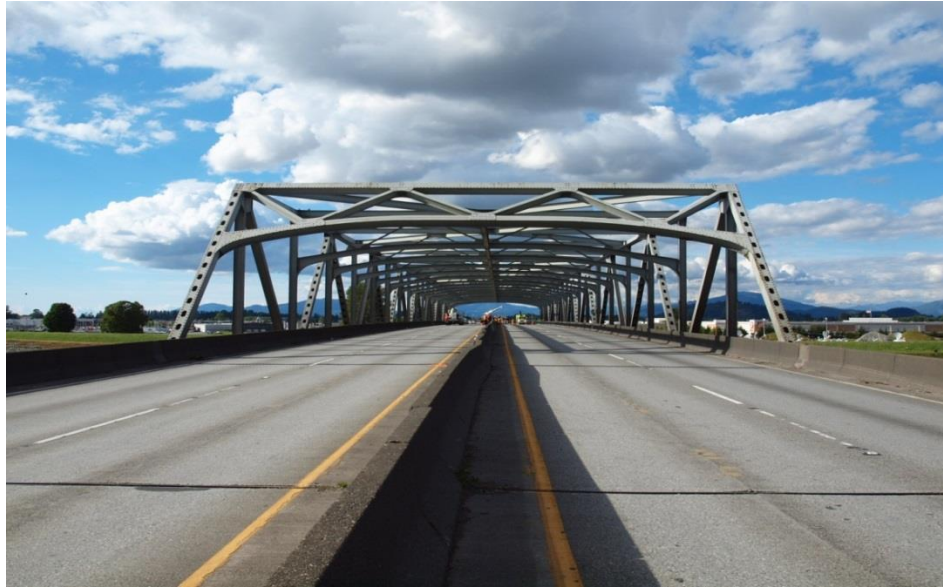
**Photograph 2** illustrates the I-5 Bridge over the Skagit River looking to the north on May 24, 2013. The pavement markings on the I-5 Bridge were reconfigured to four lanes in August 1956. A research of Washington State Department of Transportation (WSDOT) records indicated that the I-5 Bridge over the Skagit River functioned as a two lane bridge (one lane in each direction) for approximately one to two years before I-5 was widened to a four lane divided highway. I-5 was widened to a four lane divided highway south<sup>1</sup> of the I-5 Bridge in July 1956 and north<sup>2</sup> of the I-5 Bridge in August 1956.

**Photograph 2** – I-5 Bridge over the Skagit River looking to the north on May 24, 2013

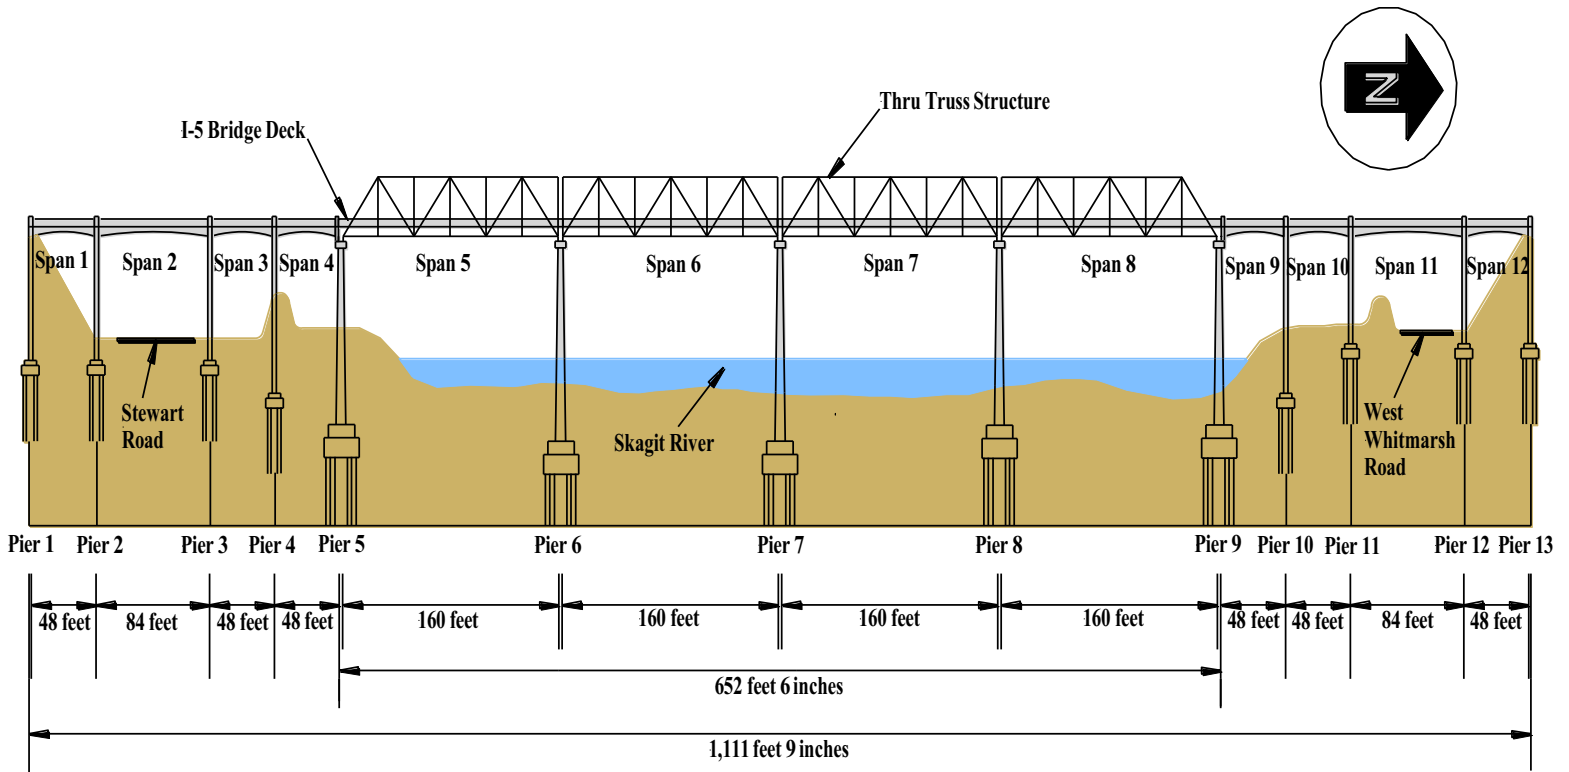
**Figure 2** – Layout of the I-5 Bridge over the Skagit River

**Figure 2** illustrates the layout of the I-5 Bridge over the Skagit River. The I-5 Bridge had 13 piers, 12 spans, and a total length of 1,111 feet and 9 inches. The main span type was a thru truss structure. The number of spans in the thru truss structure was four (Spans 5, 6, 7, and 8). Five piers supported the thru truss structure (Piers 5, 6, 7, 8, and 9).

The portion of the bridge that collapsed was Span 8. The length of Span 8 was approximately 160 feet. The total length of the thru truss structure was approximately 652 feet and 6 inches. The number of spans in the south approach spans was four (Spans 1, 2, 3, and 4) and the number of spans in the north approach spans was four (Spans 9, 10, 11, and 12).

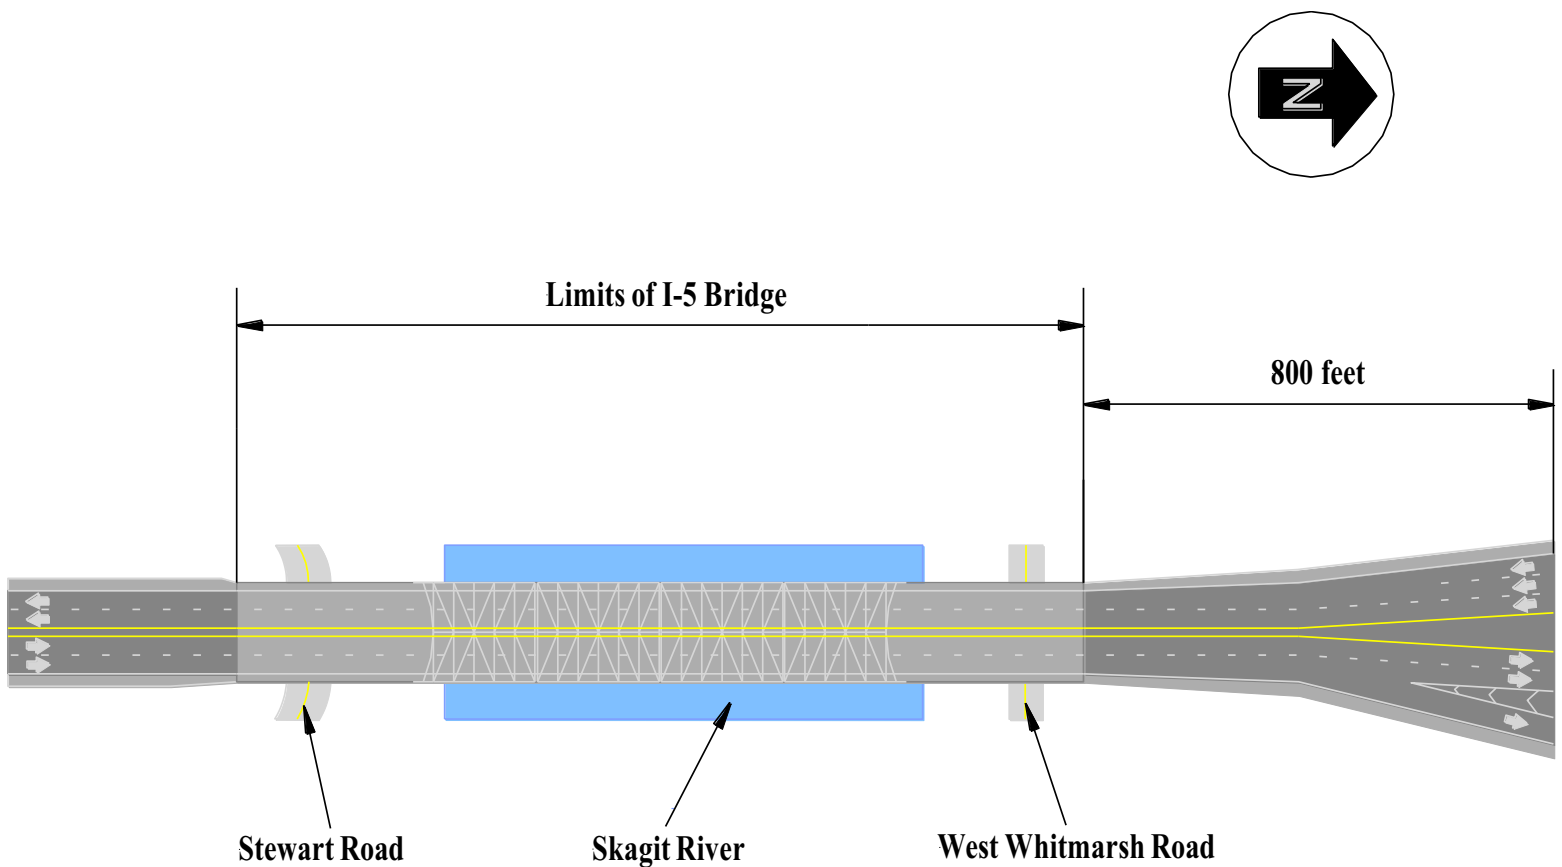
**Figure 8** – Transition of Lane Configurations on the North End and South End of the I-5 Bridge

**Figure 8** illustrates the transition of lane configurations on the north end and south end of the I-5 Bridge. Beyond the north end of the I-5 Bridge, the lane configuration transitioned from three lanes to two lanes because of the on ramp from George Hopper Road to I-5 in the southbound direction and the off ramp from I-5 to George Hopper Road in the northbound direction. Approximately 800 feet north of the I-5 Bridge, the travel lanes on I-5 were approximately 12 feet wide and the paved shoulders were approximately 8 feet wide. Beyond the south end of the I-5 Bridge, the travel lanes on I-5 were approximately 12 feet wide and the paved shoulders were approximately 10 feet wide.

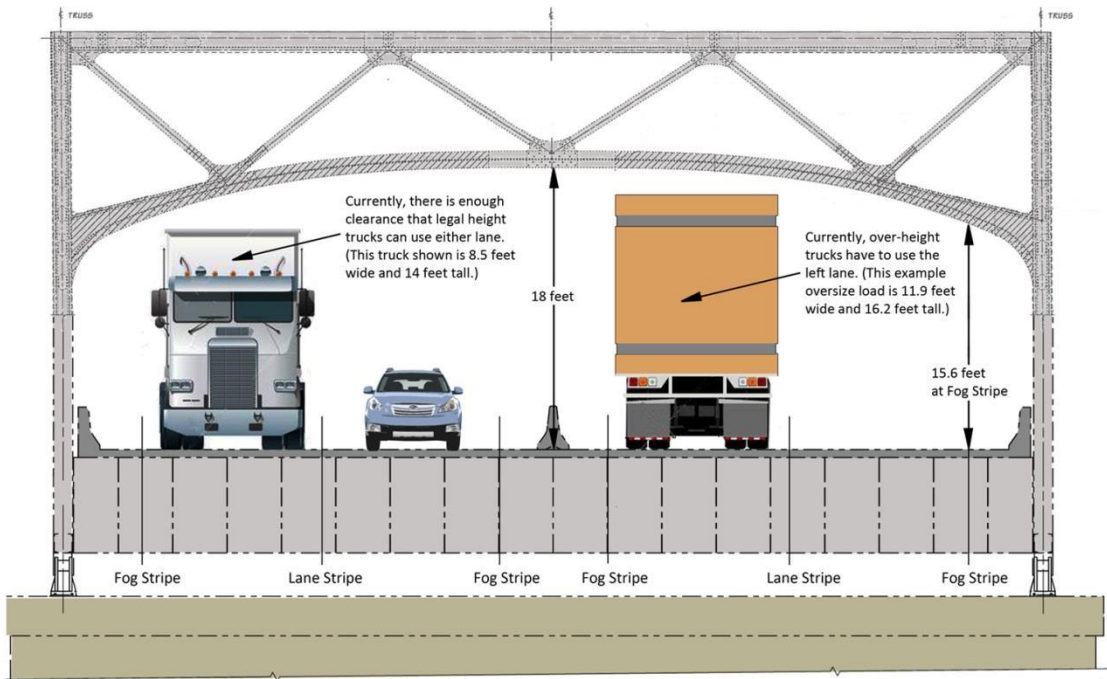
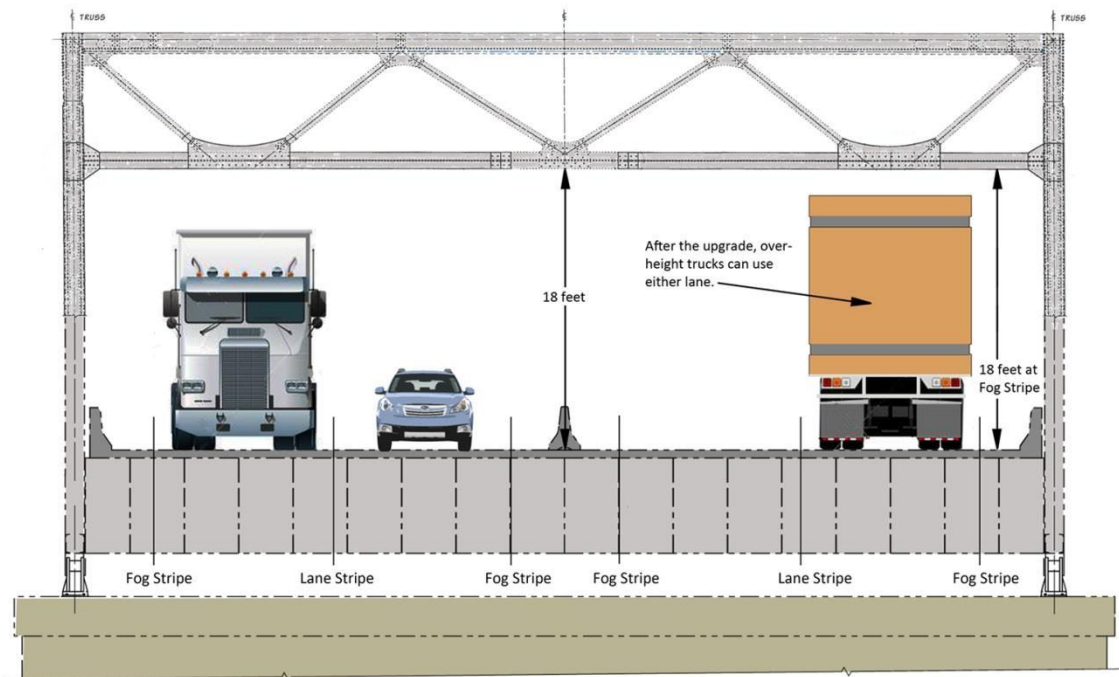
**Figure 9 – I-5 Bridge vertical clearance upgrade to 18 feet across all lanes**

*“The reconstruction of the Skagit River Bridge included the rehabilitation of the remaining trusses to the current functionality standards. The project was to retrofit and reinforce the lateral force resisting system for the truss spans. The truss rehabilitation project consisted of adding portal frames to the existing inclined end posts, and raising the lower chord elements of all the existing sway frames to a minimum vertical clearance of 18.0’ to the bridge deck.”*

The WSDOT awarded a contract in August 2013 to upgrade the vertical clearance of the I-5 Bridge to 18 feet across all lanes in the remaining 3 thru truss spans (Spans 5, 6 and 7). The contract also included a proposal to retrofit several bridge supports with reinforced steel components to add strength to the bridge in the event it was struck again in the future. The work began on September 9, 2013 and the estimated completion date was late November 2013. **Figure 9** illustrates the vertical clearance upgrade to 18 feet across all lanes. The WSDOT project web page indicated the following:

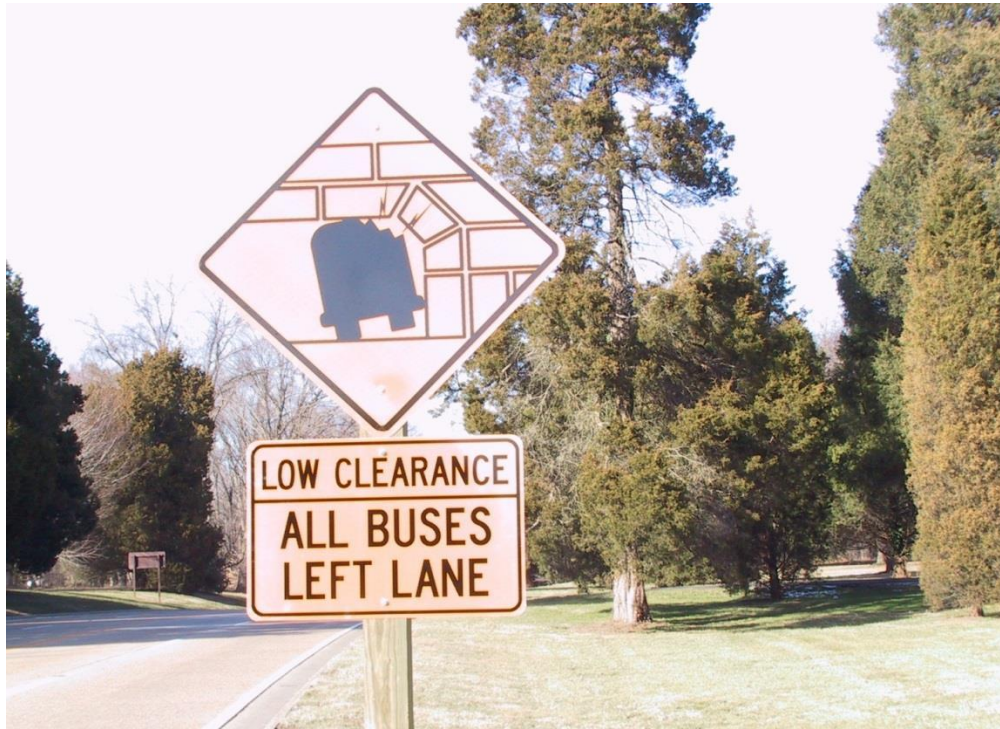
**Photograph 7** illustrates a new low clearance sign developed by the National Park Service after the accident. The new low clearance sign conveys a motor coach bus striking a stone arched bridge overpass in the right lane. The purpose of the sign would be for motor coach buses to stay in the left lane while traveling underneath the overpass. The National Park Service installed the new low clearance sign at four locations on the George Washington Memorial Parkway before the Alexandria Avenue Bridge; two locations before the bridge for southbound motorists and two locations before the bridge for northbound motorists.

**Photograph 7** – New low clearance sign developed by the National Park Service as a result of the Alexandria Avenue Bridge Overpass accident on November 14, 2004 in Alexandria, VA

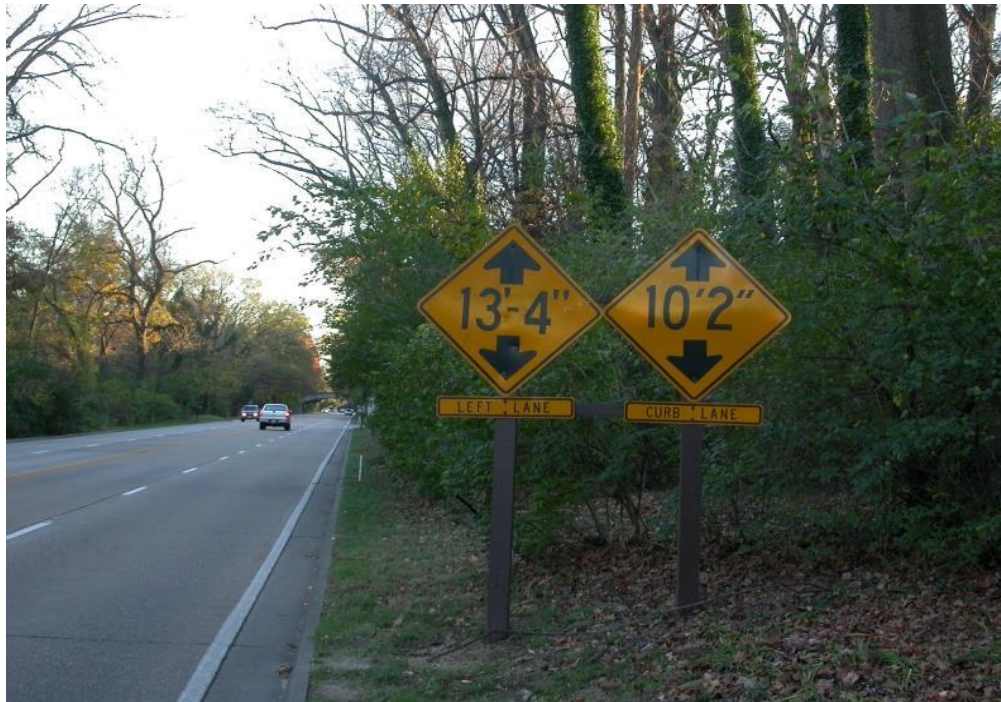
Prior to the accident, among the existing signs posted in the southbound lanes preceding the Alexandria Avenue Bridge were those indicating the vertical clearance of the bridge. MUTCD Low Clearance Signs (W12-2) were placed next to the southbound lanes before the bridge, and mounted MUTCD Low Clearance Signs (W12-2) were placed on the bridge's face over the left and right lanes. **Photographs 8 and 9** illustrate the MUTCD Low Clearance Signs (W12-2) that existed prior to the accident next to the southbound lanes before the bridge and placed on the bridge's face over the left and right lanes.

**Photograph 8** – MUTCD low clearance signs (W12-2) that existed prior to the accident next to the southbound lanes before the Alexandria Avenue Bridge Overpass in Alexandria, VA

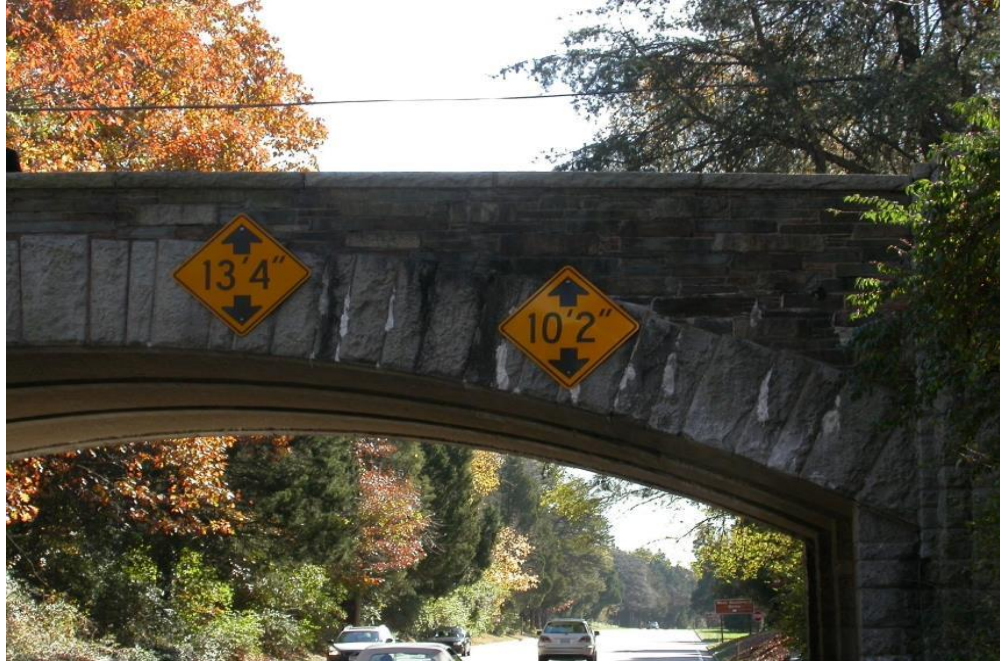
**Photograph 9** – MUTCD low clearance signs (W12-2) that existed prior to the accident placed on the Alexandria Avenue Bridge Overpass face over the left and right lanes in Alexandria, VA
