**HIGHWAY FACTORS GROUP CHAIRMAN'S
FACTUAL REPORT**

HWY15FH010

**NATIONAL TRANSPORTATION SAFETY BOARD
OFFICE OF HIGHWAY SAFETY
WASHINGTON, D.C.**

Location: Eastbound Interstate 610 (I-610) overpass above Telephone Road, Houston, Harris County, Texas

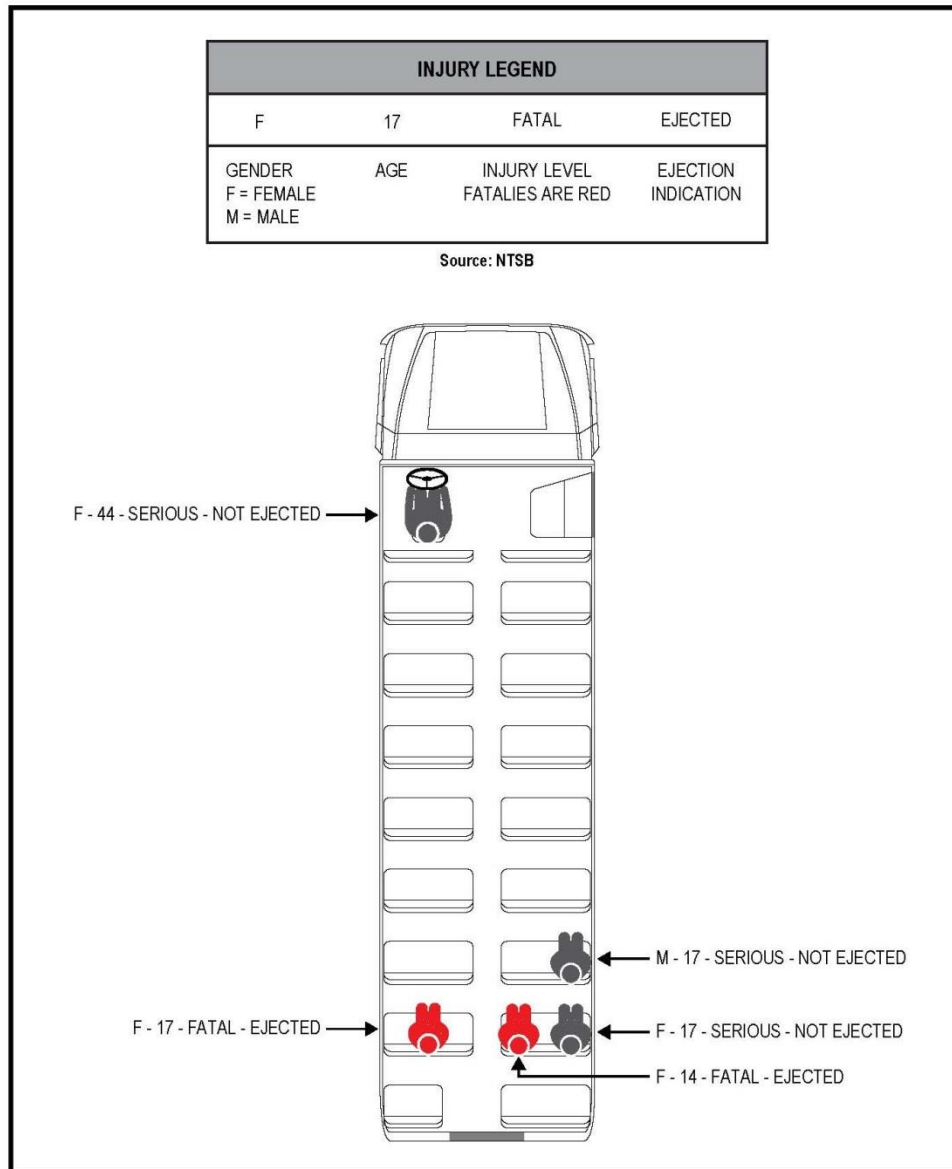
Figure 5 is a seating chart of the HISD school bus that illustrates the gender, age, injury level, and whether the passengers were ejected from the bus. The two HISD students who were ejected from the bus were the same two students who were fatally injured in the crash.

Figure 5 – Seating chart of HISD school bus involved in the crash
