**NATIONAL TRANSPORTATION SAFETY BOARD
OFFICE OF HIGHWAY SAFETY
WASHINGTON, D.C.**

**HIGHWAY FACTORS GROUP CHAIRMAN'S
FACTUAL REPORT**

Location: Rail crossing, Main Street, Biloxi, Harrison County, Mississippi
Vehicle #1: 2016 Van Hool CX45 Motorcoach
Operator #1: Echo Transportation of Dallas, Texas
Vehicle #2: CSX Freight Train, consisting of 3 locomotives, 27 loaded cars, and 25 empty cars
Operator #2: CSX Transportation
Date: Tuesday, March 7, 2017
Time: 2:12 p.m. CST
NTSB #: **HWY17MH010**

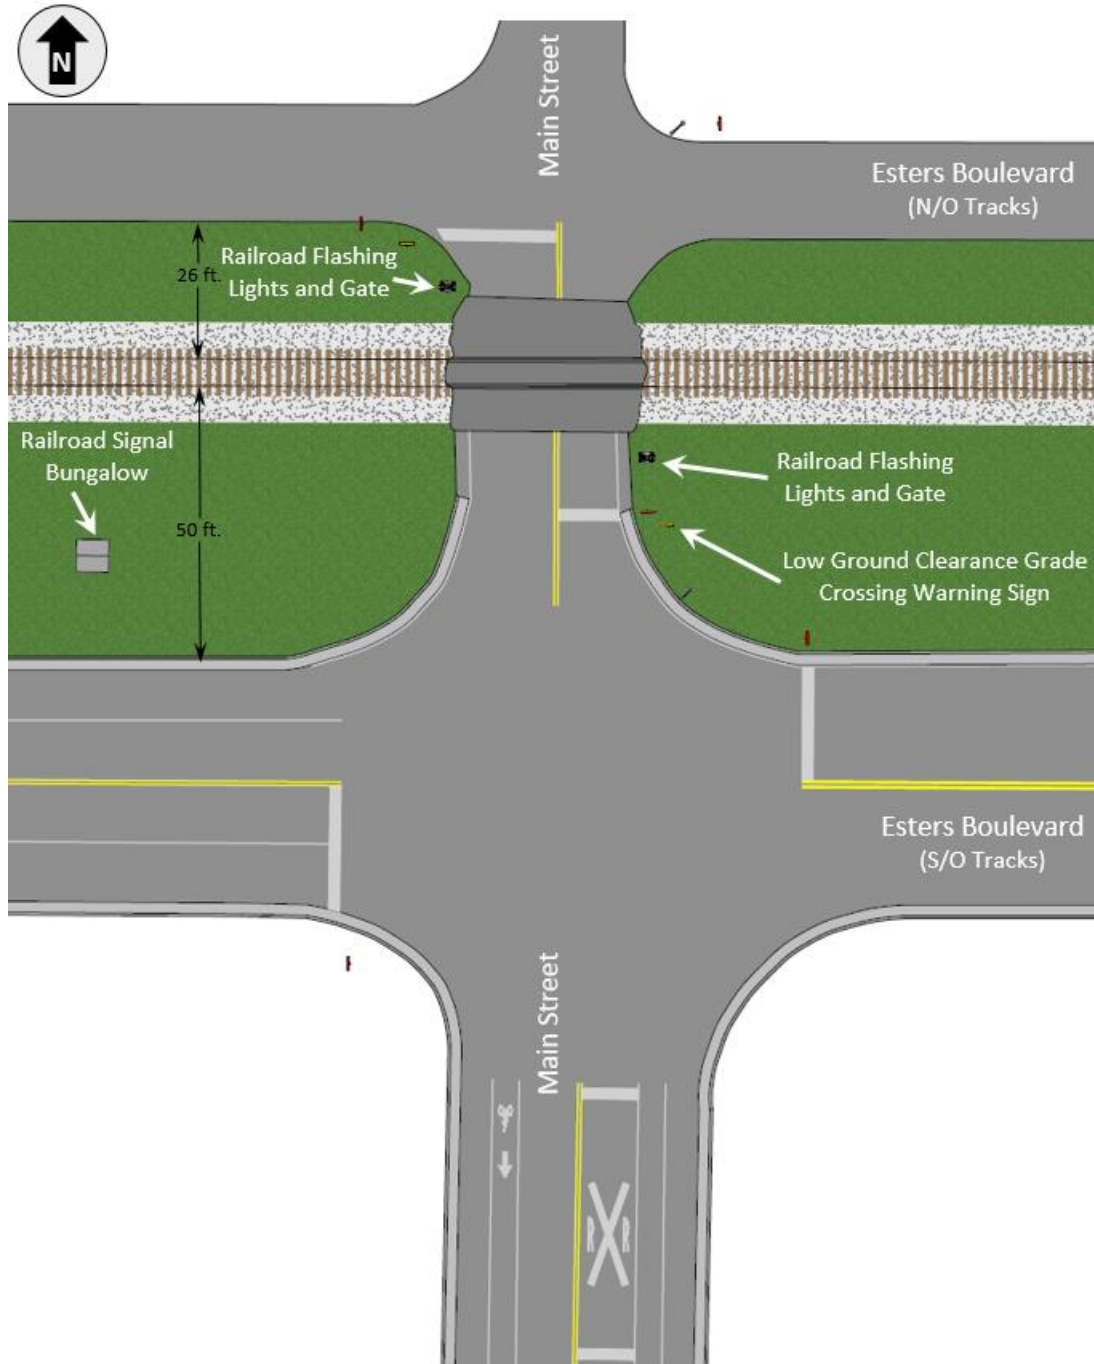
Figure 3: Layout of the Main Street and CSX Railroad Grade Crossing

The design and configuration of Main Street and Esters Boulevard differs between the north and south sides of the Main Street railroad grade crossing, and at the crossing itself. The design and configuration of each of these road segments will be explained in greater detail in the following sub-sections. **Figure 3** illustrates the general layout of the road segments surrounding the Main Street grade crossing.

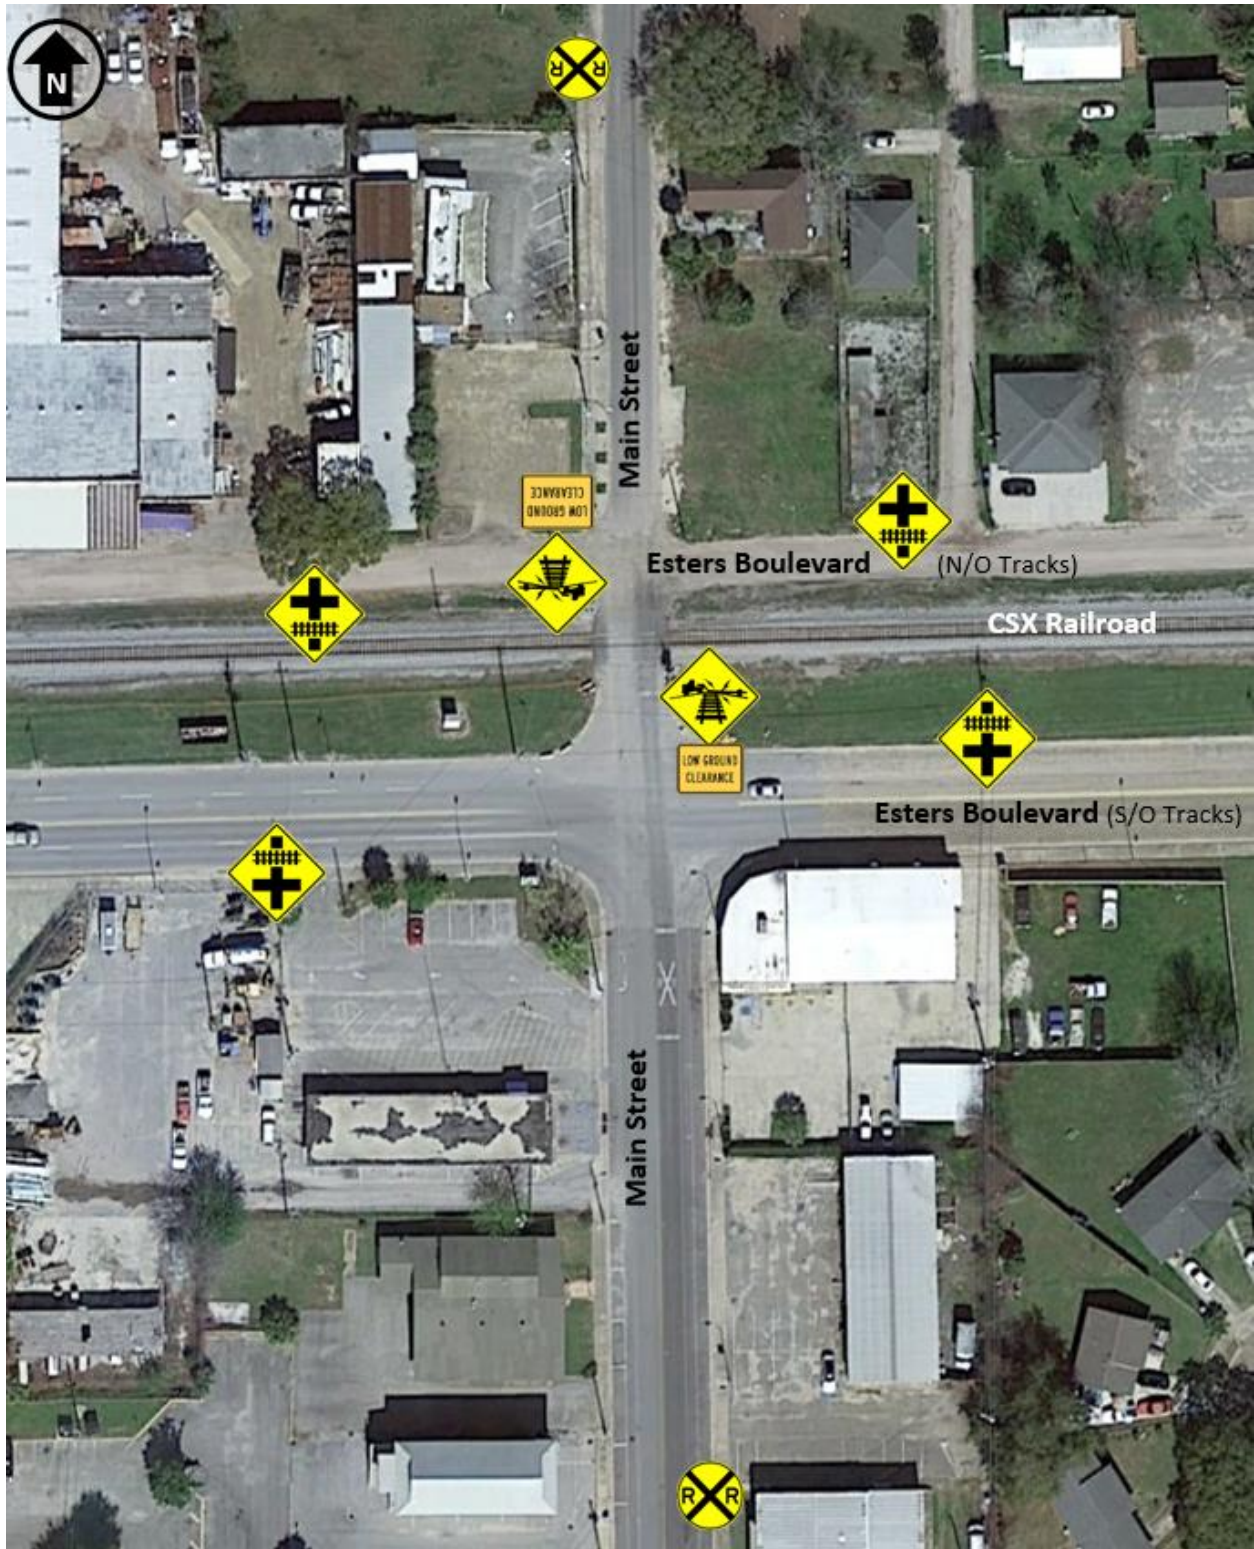
Figure 4: Crossing Related Advanced Warning Signs Near the Main Street Grade Crossing (modified from: Google Earth)

Parallel Grade Crossing and Intersection Advanced Warning signs were in place along the sections of eastbound and westbound Esters Boulevard, located both north and south of the tracks. The placement of the advanced warning signs ranged from approximately 105-feet to 170-feet in advance of the Main Street grade crossing. An aerial view of the area surrounding the Main Street grade crossing is shown in **Figure 4**, and has been annotated to show the crossing related advanced warning signs.

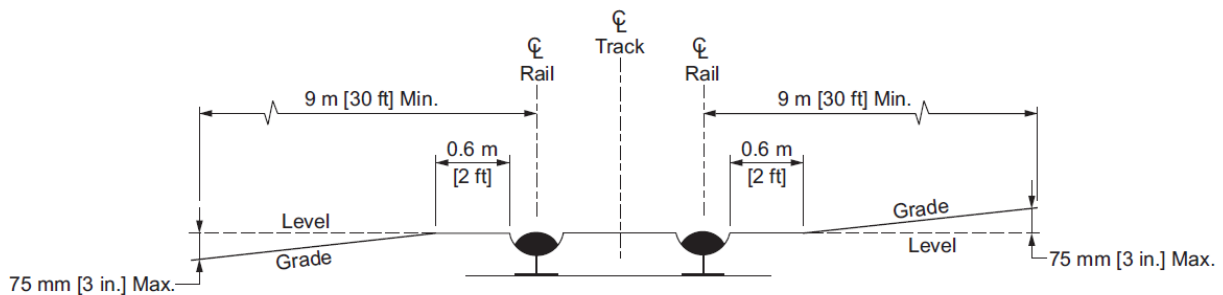
Figure 11: AASHTO and FHWA Recommended Grade Crossing Design Profile (source: Figure 9-75 in AASHTO Policy on Geometric Design of Highways and Streets)

To prevent drivers of low-clearance vehicles from becoming caught on the tracks, both AASHTO and FHWA recommend that the crossing surface should be level with the top of the rails for at least 2-feet outside the rails. They both also recommend that the road surface should not be more than 3-inches higher or lower than the top of the nearest rail at a distance of 30-feet from the nearest rail in most cases. These dimensions are shown graphically in **Figure 11**.

Main Street crossing to the south of the tracks, 2-feet from the south rail, the crossing surface was approximately $\frac{1}{8}$ -inch below the top of the south rail. To the north of the tracks, 2-feet from the north rail, the crossing surface was approximately $\frac{1}{2}$ -inch below the top of the north rail. The northbound approach grade was found to be approximately 14.4-inches below track level at a distance of 30-feet from the nearest rail, with the southbound approach grade being approximately 45.4-inches below track level at a distance of 30-feet from the nearest rail.²² The northbound approach grade was found to be approximately 4.5-inches below track level at a distance of 10-feet from the nearest rail, and the southbound approach grade was found to be approximately 13.4-inches below track level at a distance of 10-feet from the nearest rail.

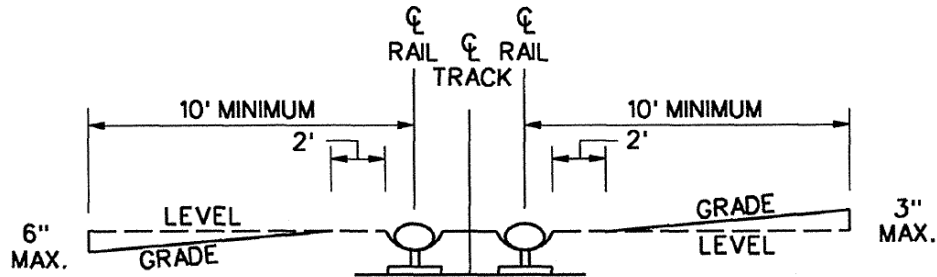
Figure 12: MDOT Recommended Grade Crossing Design Profile (source: Figure 8-3C in MDOT Roadway Design Manual)

When designing a new crossing, the 2001 MDOT Roadway Design Manual, which was in effect at the time of the collision, recommended that the crossing surface should be level with the top of the rails for at least 2-feet outside the rails. MDOT also recommended that the road surface should not be more than 3-inches above, or 6-inches below the top of the nearest rail at a distance of 10-feet from the nearest rail unless the railroad track superelevation dictated otherwise. The MDOT design guidance is shown graphically in **Figure 12**. It should be noted that, at the time of this report, the MDOT Roadway Design Manual was in the process of being revised. Some of the revisions to the MDOT Roadway Design Manual are expected to include changes in the highway-railroad grade crossing vertical design profile.²⁰ Once revised, the grade crossing vertical design profile is expected to match the criteria recommended by AASHTO and FHWA described earlier in this section. Revisions to the MDOT Roadway Design Manual are tentatively expected to be completed by the end of 2017. Additionally, the MDOT Rails Division, who is responsible for the approval of all grade crossing design and improvement plans for new or reconstructed crossings
