**NATIONAL TRANSPORTATION SAFETY BOARD
OFFICE OF HIGHWAY SAFETY
WASHINGTON, D.C.**

**HIGHWAY FACTORS GROUP CHAIRMAN'S
FACTUAL REPORT**

Location: Intersection of Northern Boulevard and Main Street, Flushing, NY
Vehicle #1: 2015 Motor Coach Industries Motorcoach
Operator #1: Dahlia Group Inc., of Flushing, NY
Vehicle #2: 2015 New Flyer Transit Bus
Operator #2: New York City Transit
Vehicle #3: 2009 Honda Odyssey
Operator #3: Parked at curb, not running, unoccupied
Vehicle #4: 2002 Toyota Sequoia
Operator #4: Parked at curb, not running, occupied by two passengers (one in the driver's seat, and one in the right-front passenger seat)
Date: Monday, September 18, 2017
Time: 6:16 a.m. Eastern Daylight Time (EDT)
NTSB #: **HWY17MH015**

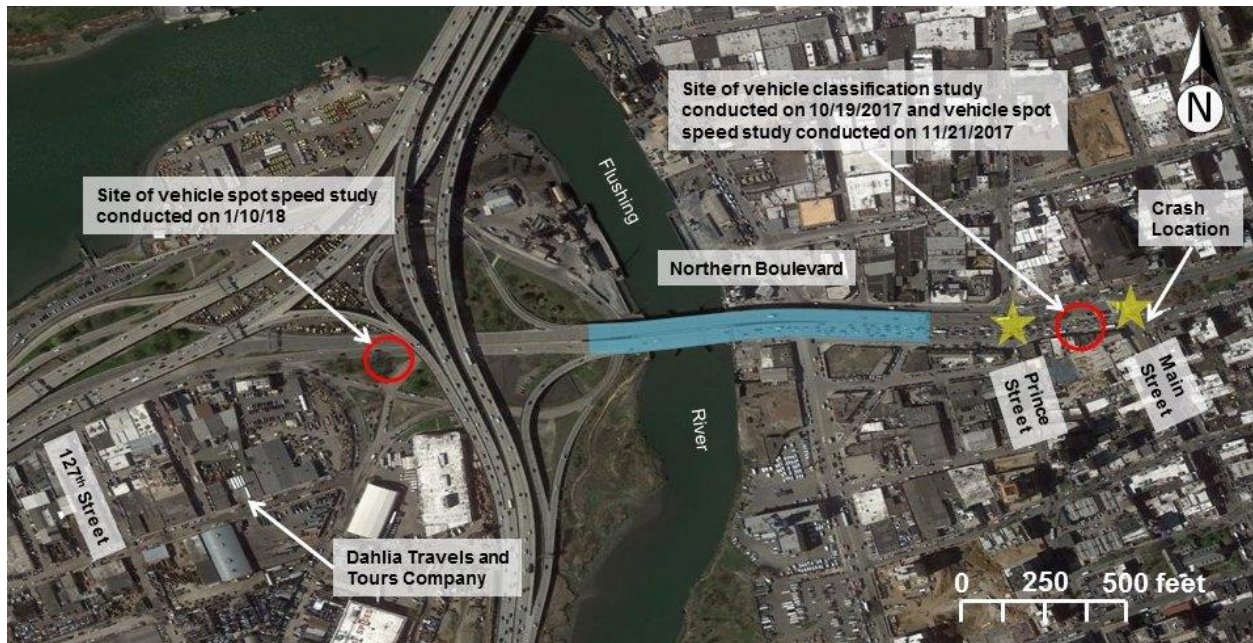
Figure 10 – Site of locations for vehicle spot speed studies and vehicle classification study conducted by NYCDOT (Source: Google Earth Maps revised)

The NYCDOT conducted vehicle spot speed studies at two locations on Northern Boulevard (see **Figure 10** for site locations). One location was located east of the elevated portion of Northern Boulevard across the Flushing River and the second location was located west of the elevated portion of Northern Boulevard. NTSB investigators requested the studies be conducted at the two locations to help triangulate differences in speeds and determine if vehicles were gaining speed while travelling over the bridge. In addition to the speed study, NYCDOT conducted a vehicle classification study east of the elevated portion of Northern Boulevard. Both locations used road tubes placed over the travel lanes, instead of a radar gun, for better accuracy.
