**Teardown & Testing Report  
Of One Model DP-F2  
Part Number 3244896-9  
Serial Number C68008**

This report presents the findings of functional testing and teardown inspection conducted on one Model DP-F2 Main Fuel Control Part Number 3244896-9 Serial Number C68008 at the Honeywell Engines Systems and Services Facility in Montreal, Canada on August 31, 2005.

The testing/teardown was conducted at the request of, and under the cognizance of National Transportation Safety Board (NTSB).

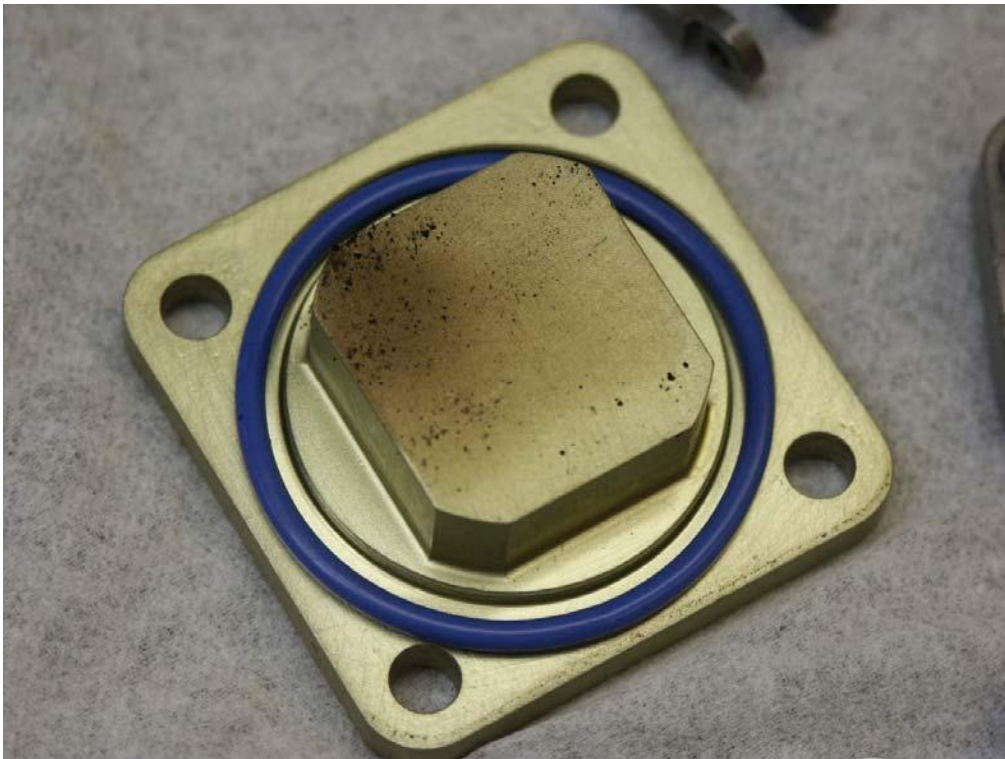
**Figure 33 wear debris in bellows MOR cavity**

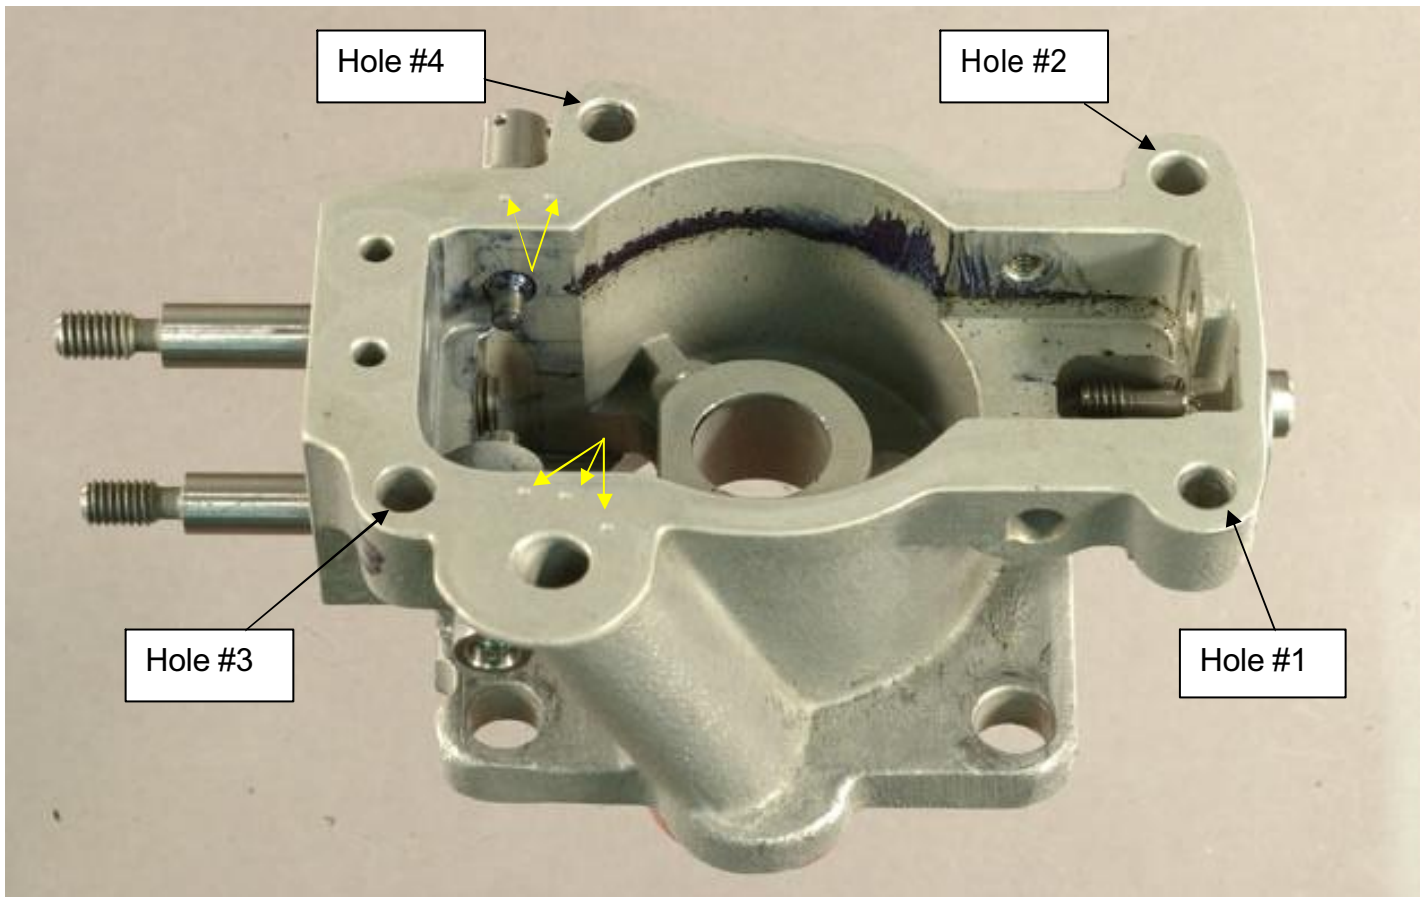
**Figure 1.**

The bolt holes and mating surfaces between the the drive body and flow body of the fuel control were documented in Figures 1 - 6 , pages 3 - 8. The bolt holes were labeled #1 through #4, hole #3 being the hole from which the bolt had pulled out. Except for a slight witness mark around one of the bolt holes (not the one in which the bolt had pulled out), the mating surfaces were unworn. There was no

The drive body half of the fuel control showing the bolt holes and the surface that mates to the flow body. The five shallow dimples in the surface were from hardness measurements made at the time of this investigation (yellows arrows).

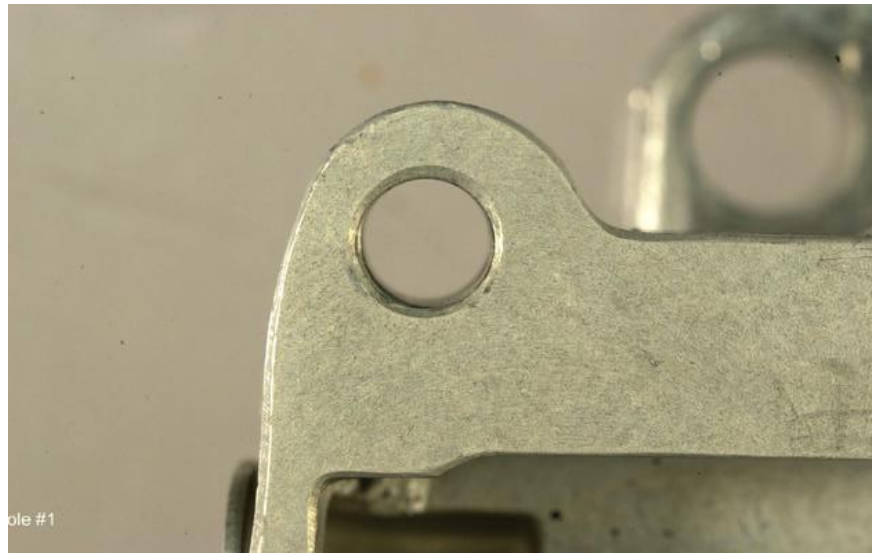
**Figure 2.**

Close up views of bolt hole #1 and the surrounding interface on the drive body. Thread marks from the bolt are seen in the hole ID.

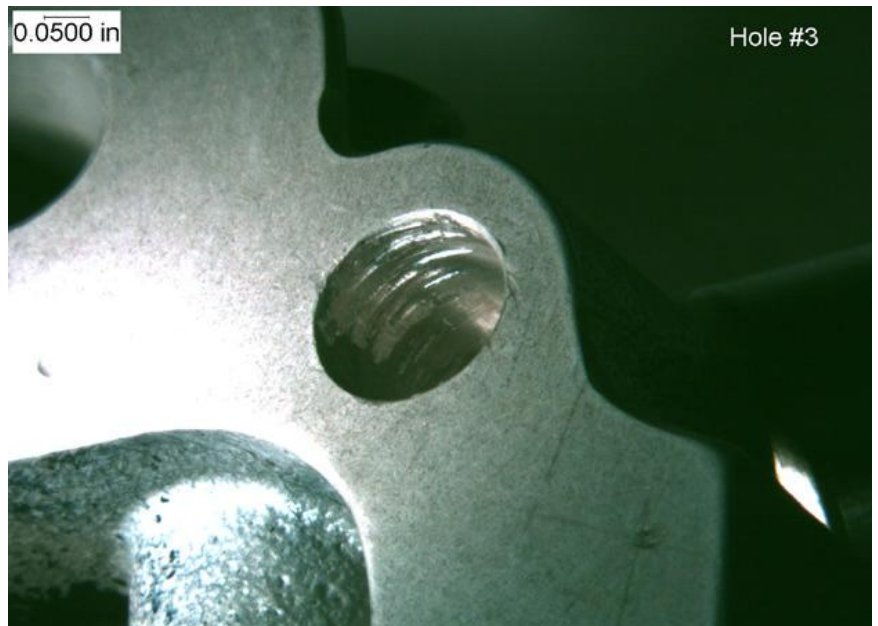
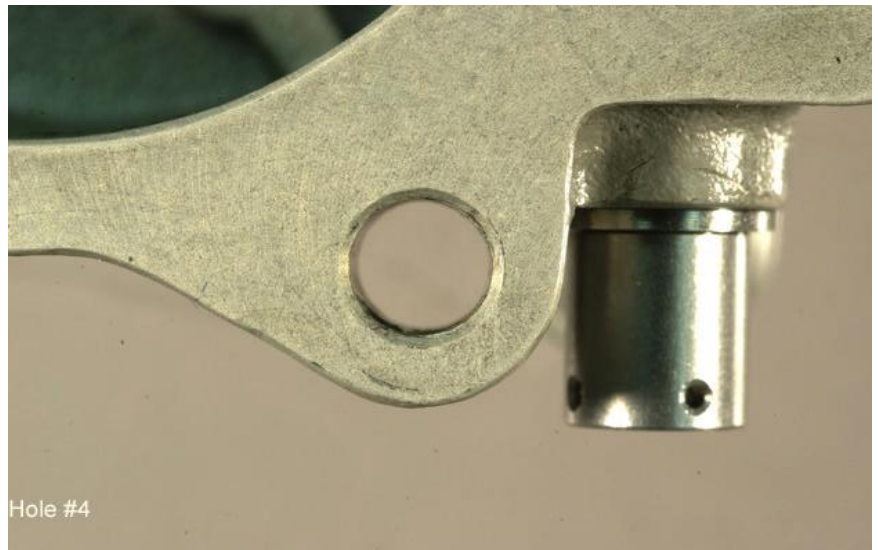
#### Figure 4.

Close up views of bolt hole #4 and the surrounding interface on the drive body. Thread marks from the bolt are seen in the hole ID.

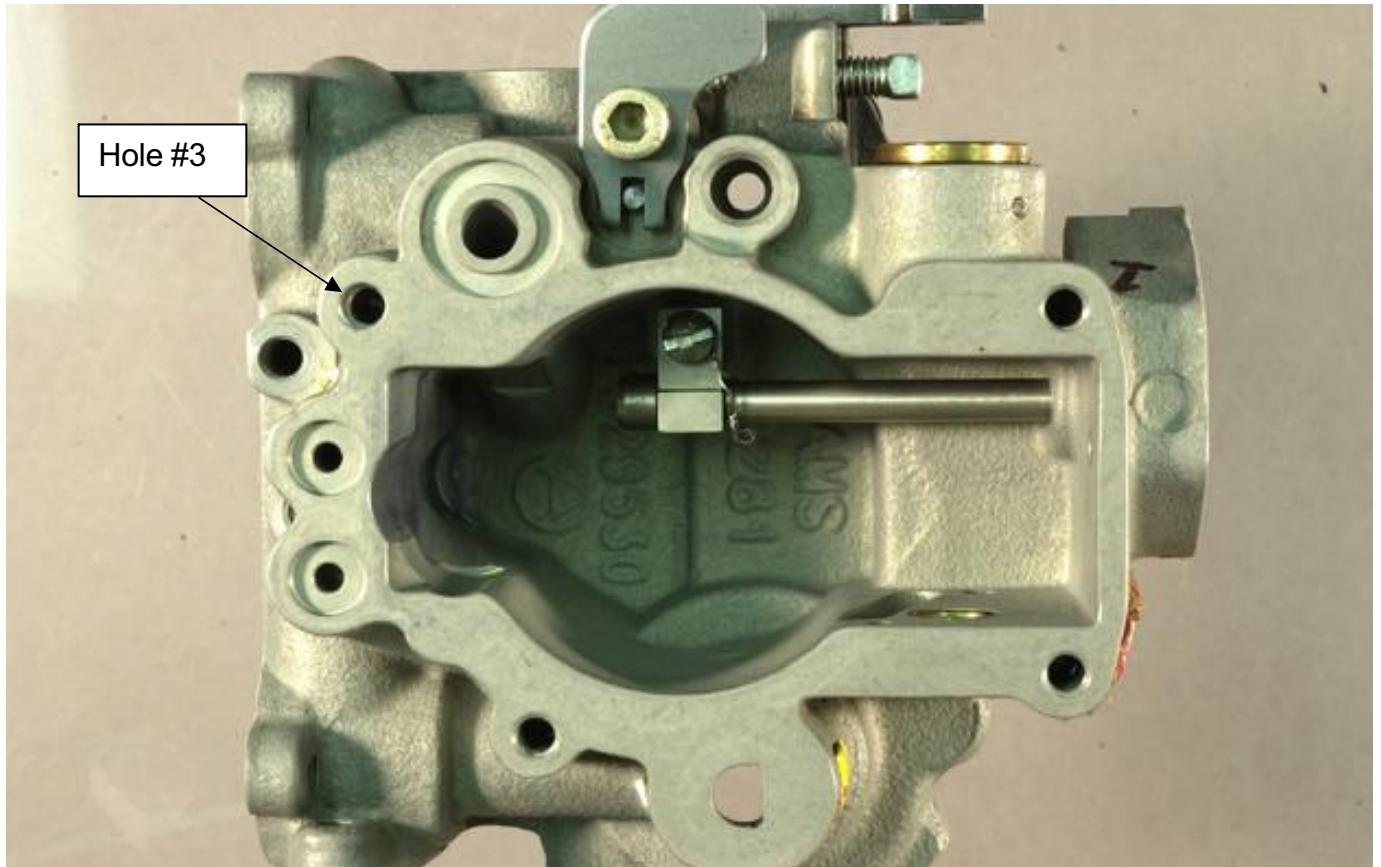
**Figure 5.**

The flow body half of the fuel control showing the bolt holes and the surface that mates to the drive body.

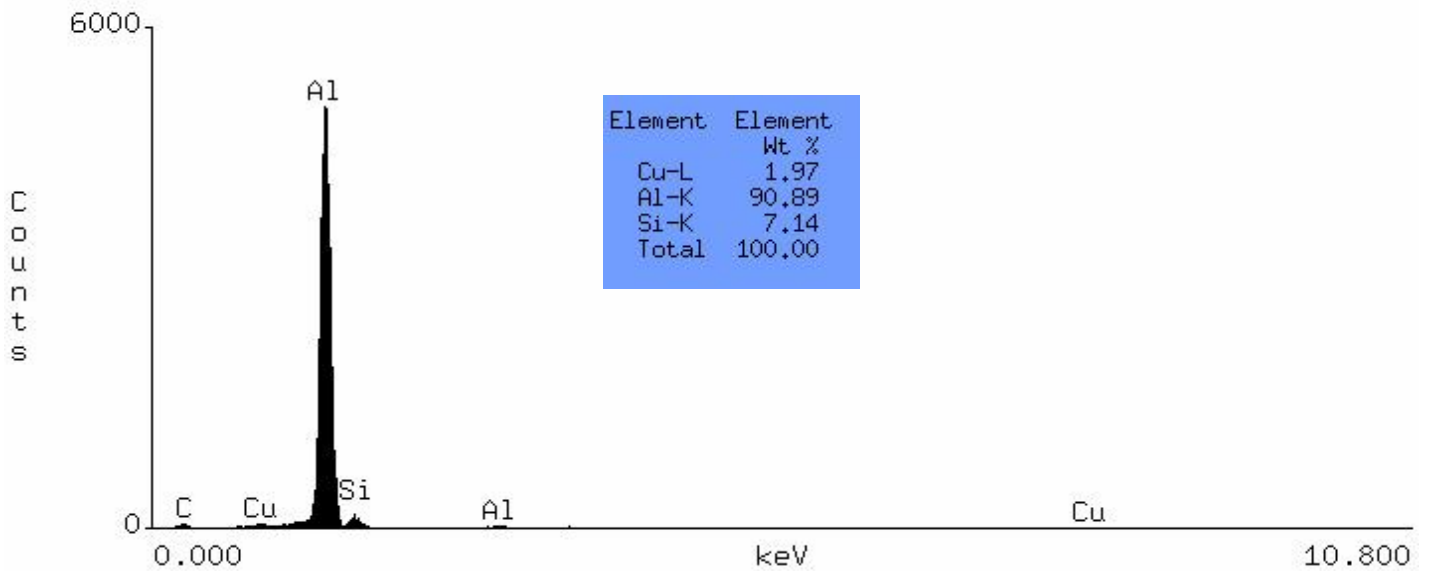
**Figure 7.**

A scanning electron microscope / energy dispersive (SEM/EDS) system was used to examine the material remaining between the threads of the bolt that pulled out of the flow body. Results from the EDS elemental analysis of this material concluded it was the flow body alloy. A typical spectrum of the analysis is shown in Figure 7, page 9. The material between the bolt threads showed smearing in approximately the axial direction of the bolt. Apparently, the ID threads of the flow body had been sheared off, Figures 8 – 10, pages 10 - 12. Much of the original fracture morphology of this sheared material had been obliterated by smearing. However, isolated regions of shear dimples were found indicating the fracture was due to a shear overload condition, Figure 11, page 13.

EDS spectrum of the material between the threads of the bolt that had pulled from bolt hole #3 of the flow body. The composition was consistent for flow body material.

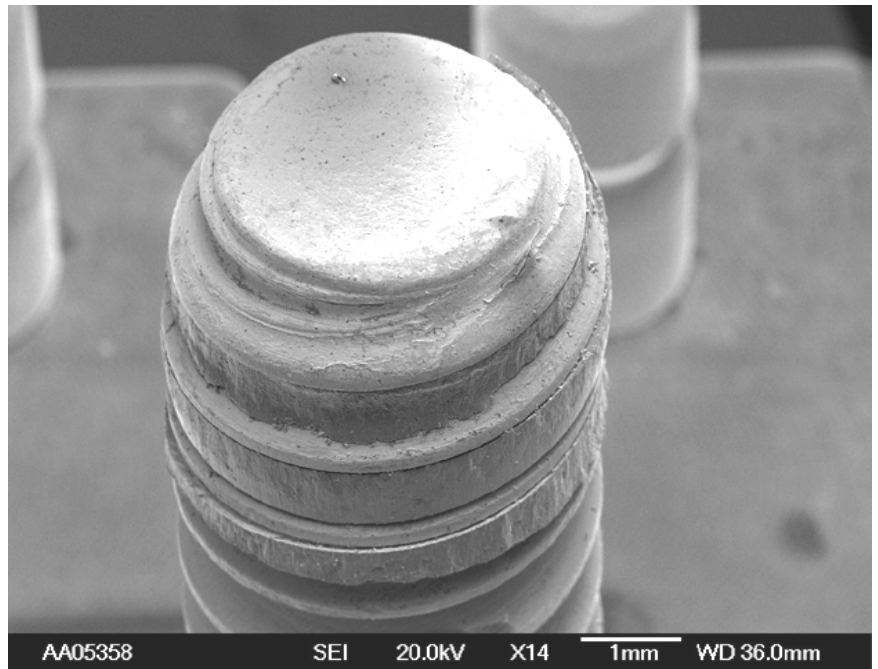
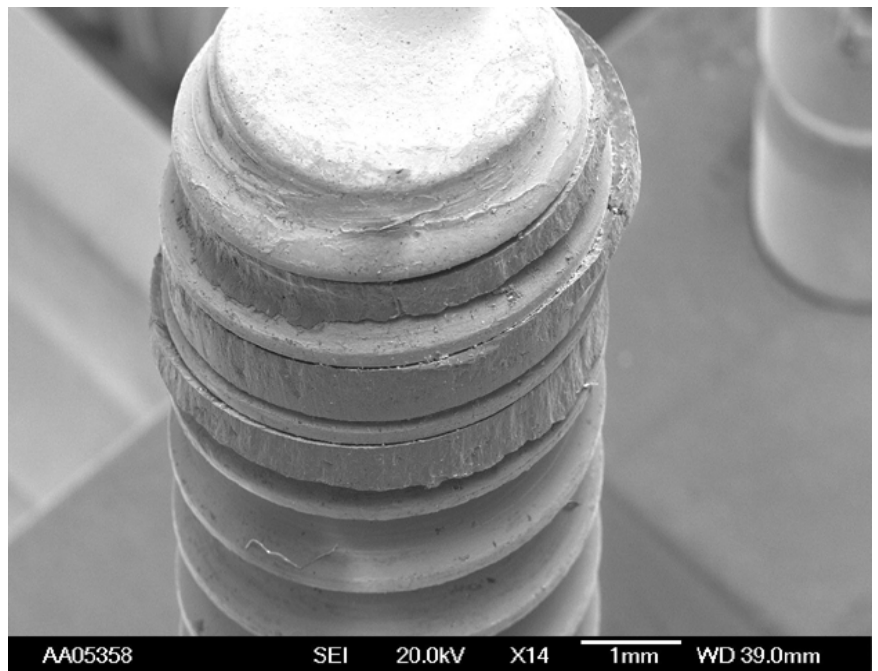
**Figure 8.**

SEM photomicrographs of the material between the threads of the bolt that pulled out of hole #3 in the flow body.

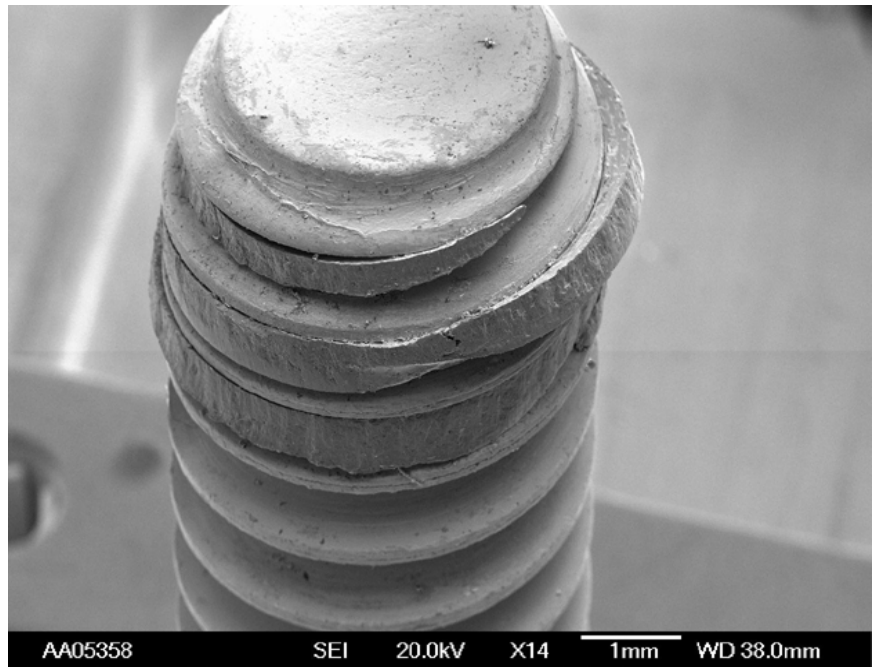
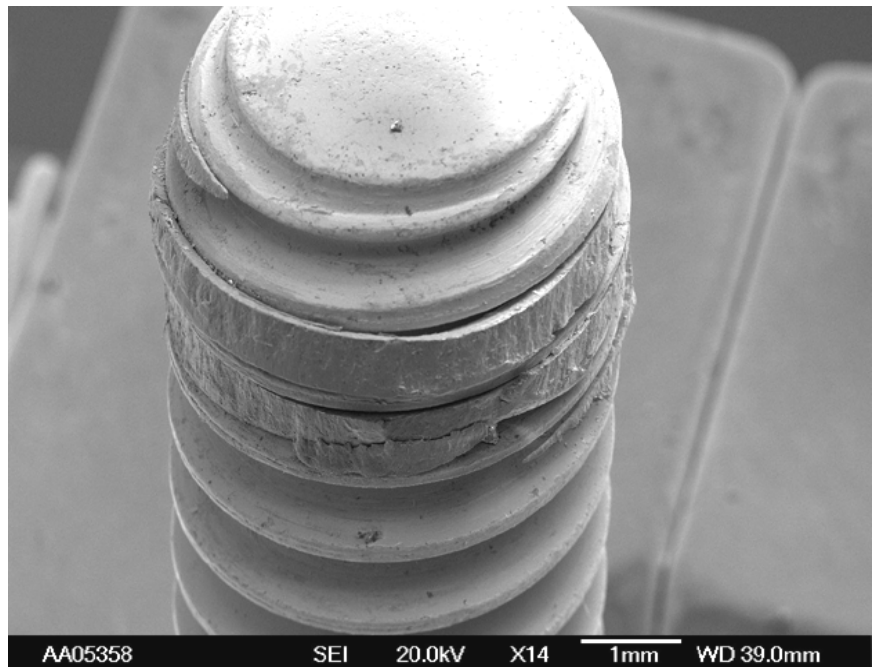
**Figure 9.**

SEM photomicrographs of the material between the threads of the bolt that pulled out of hole #3 in the flow body.

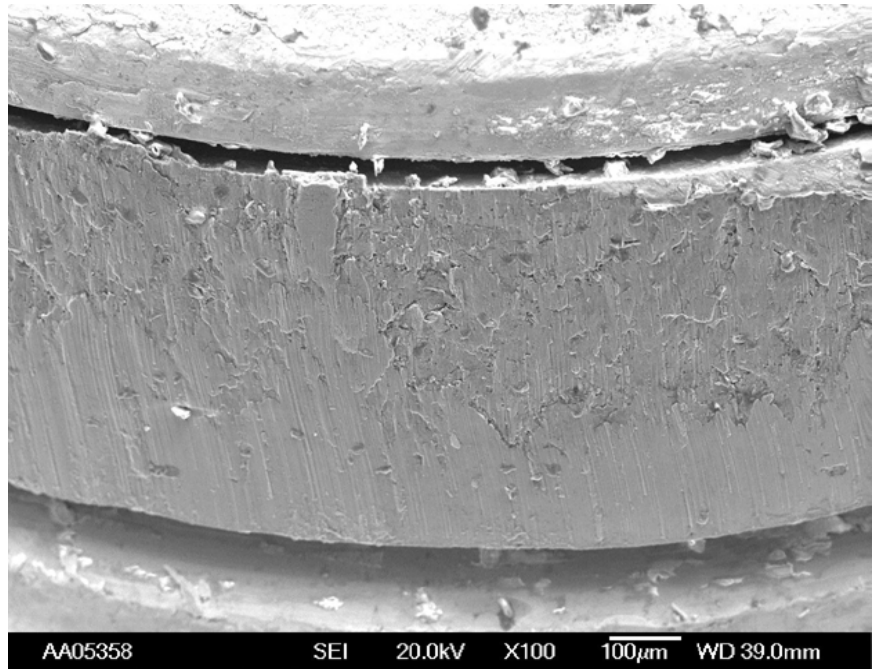
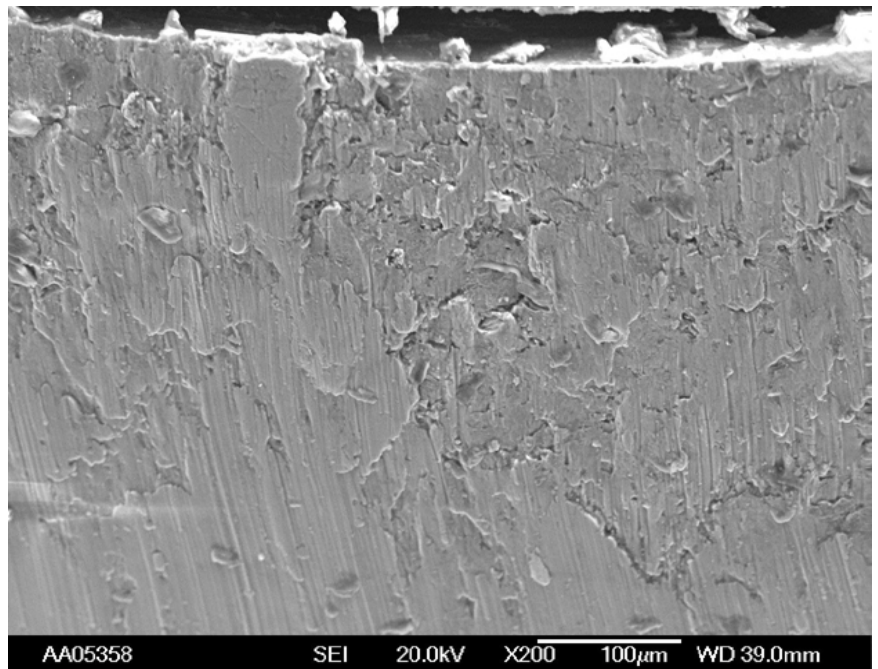
**Figure 10.**

SEM photomicrographs of the sheared surfaces of the material between the threads of the bolt that pulled out of hole #3 in the flow body.

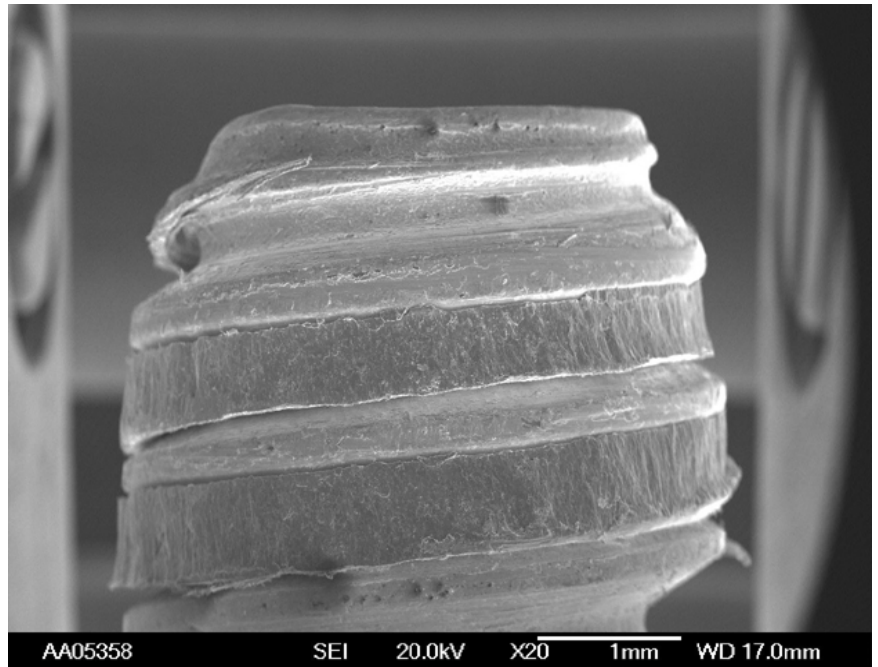
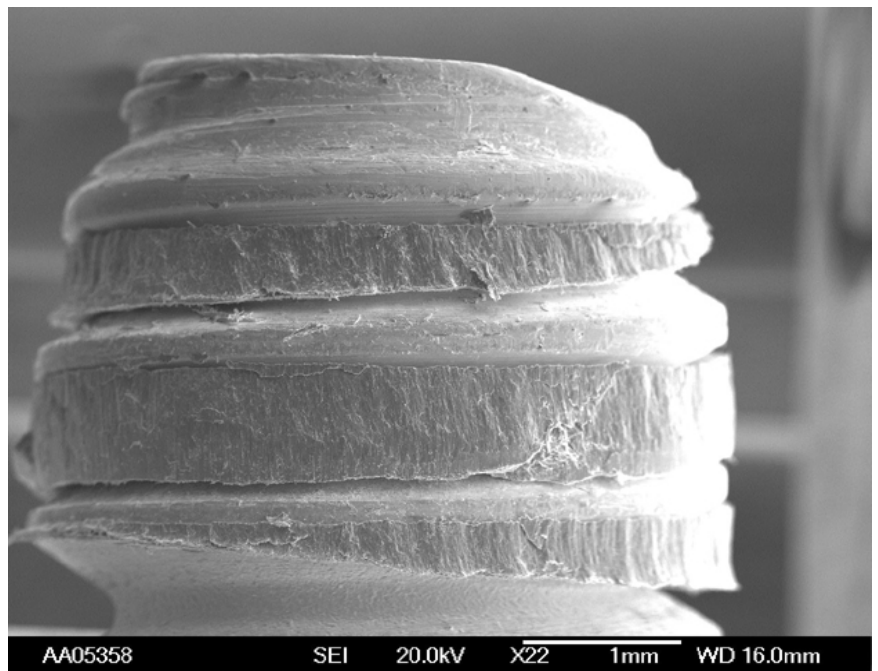
**Figure 12.**

For comparison purposes, a test was performed to simulate a condition in which the ID threads in a flow body were sheared by over torquing a bolt with an approximately two and one half thread engagement. SEM analysis of the sheared material between the bolts revealed a morphology much like that observed in the incident bolt. Shear dimples were readily apparent, but the orientation of the smearing appeared to be more canted from the axial direction, Figures 12 - 13, pages 14 - 15.

SEM photomicrographs of the material between the threads of the bolt that simulated shearing of the ID threads by over torquing a bolt with an approximately two and one half thread engagement.

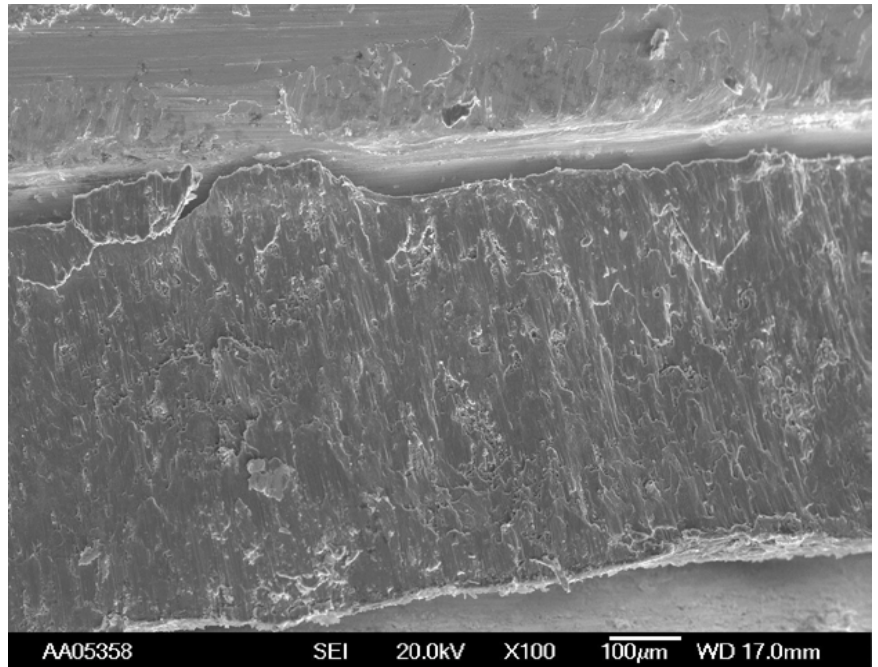
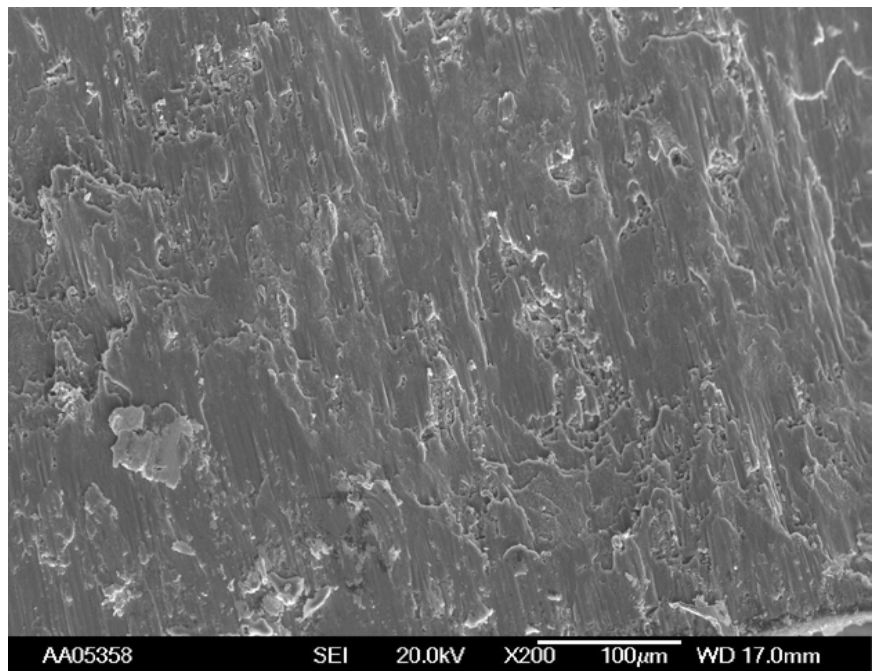
**Figure 13.**

SEM photomicrographs of the material between the threads of the bolt that simulated shearing of the ID threads by over torquing a bolt with an approximately two and one half thread engagement. A shear dimple rupture morphology is evident.

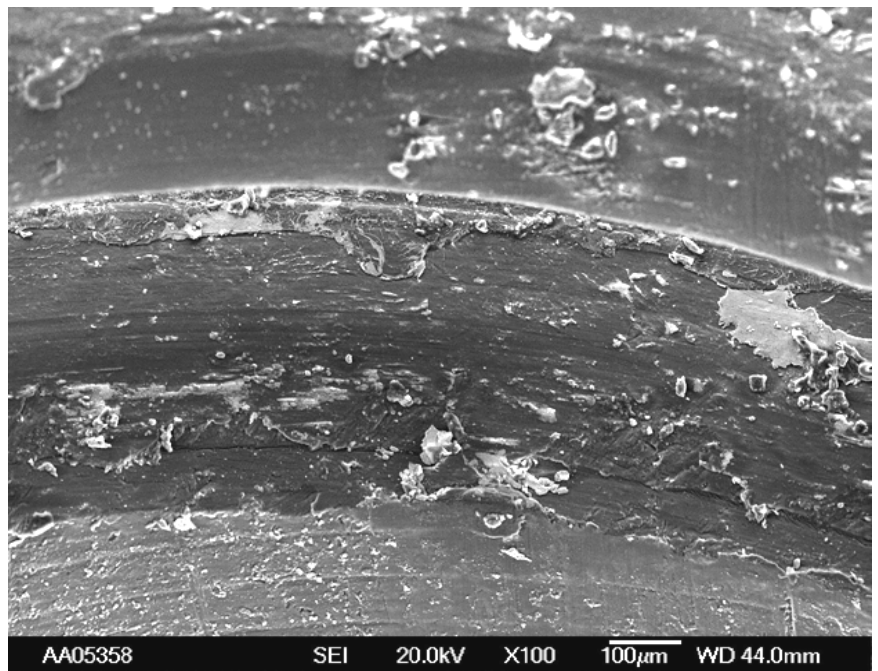
**Figure 18.**

Very little circumferential scoring from the bolt threads were observed, Figures 14 – 17, pages 16 - 17. In contrast, there was significant scoring of the ID thread of the flow body by over torquing the bolt, Figures 18 - 20, pages 18 - 19.

SEM photomicrograph of the sheared material “unscrewed” from the over torqued bolt test the three regions identified are shown in the subsequent photographs.

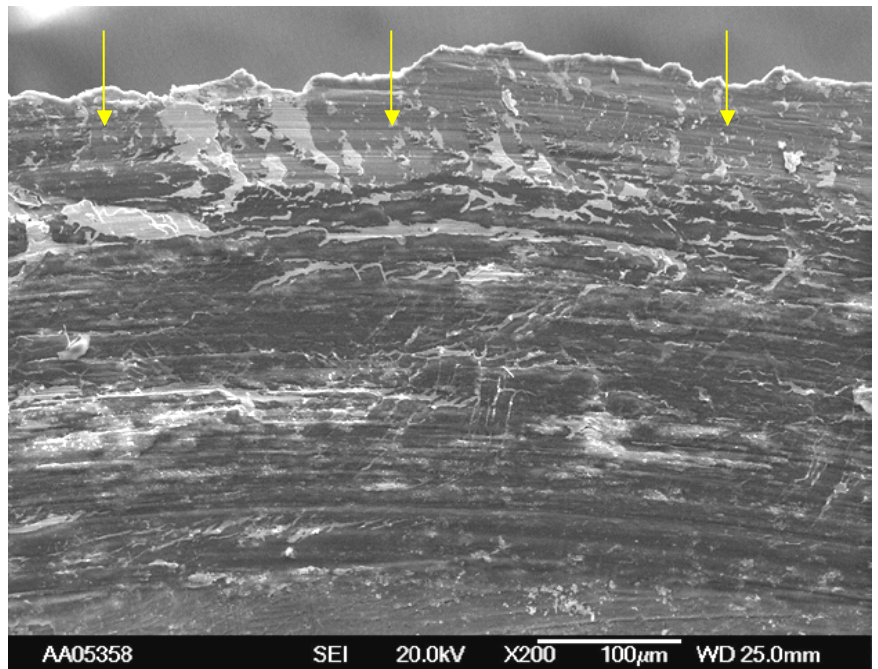
SEM photomicrographs of region "B" of Figure 18. Over torquing of the bolt caused significant circumferential scoring of the ID thread of the flow body (arrows).
