**Accident involving AS 350B2 N852HW
Laboratory Investigation Report**

Tests of hydraulic pump HPI and tail rotor load compensator

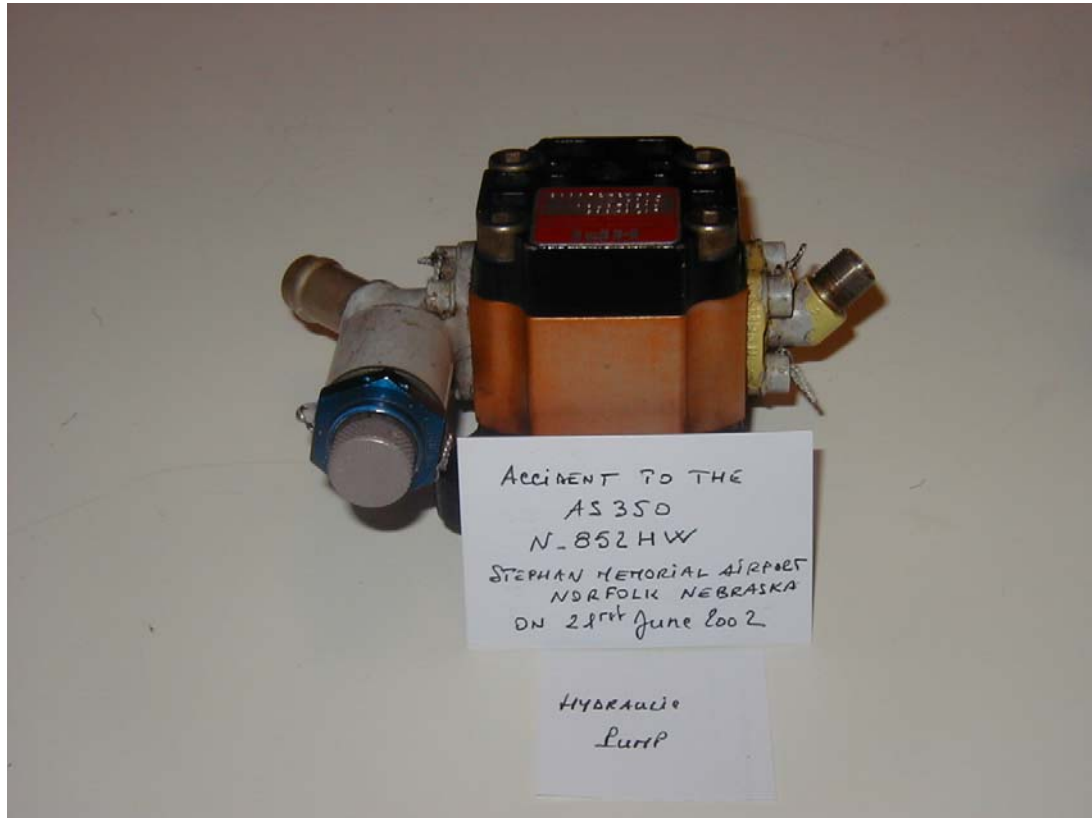
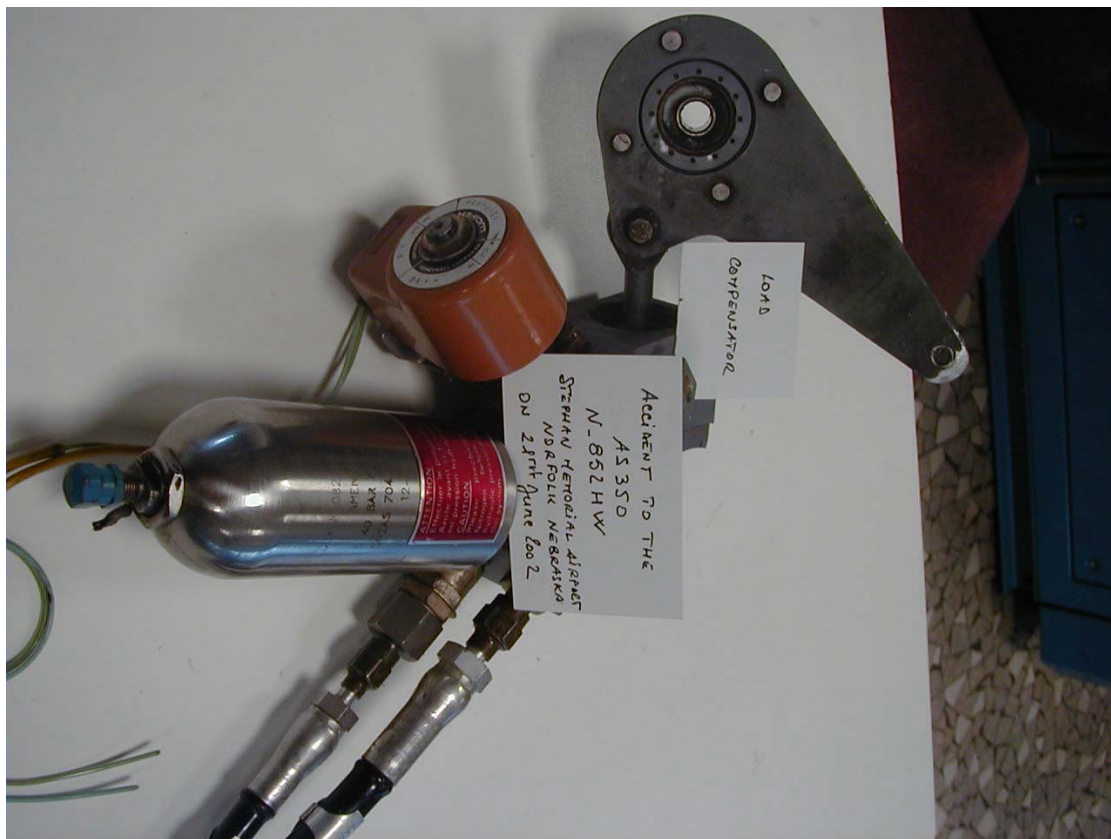
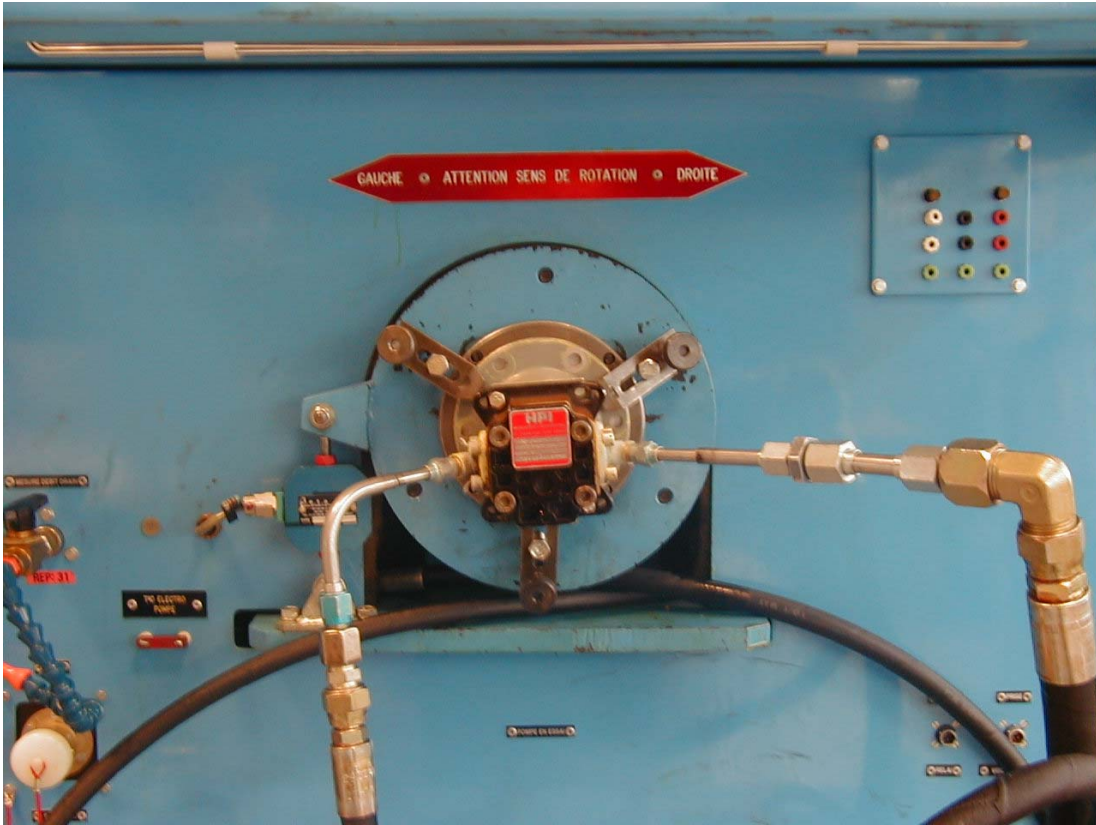
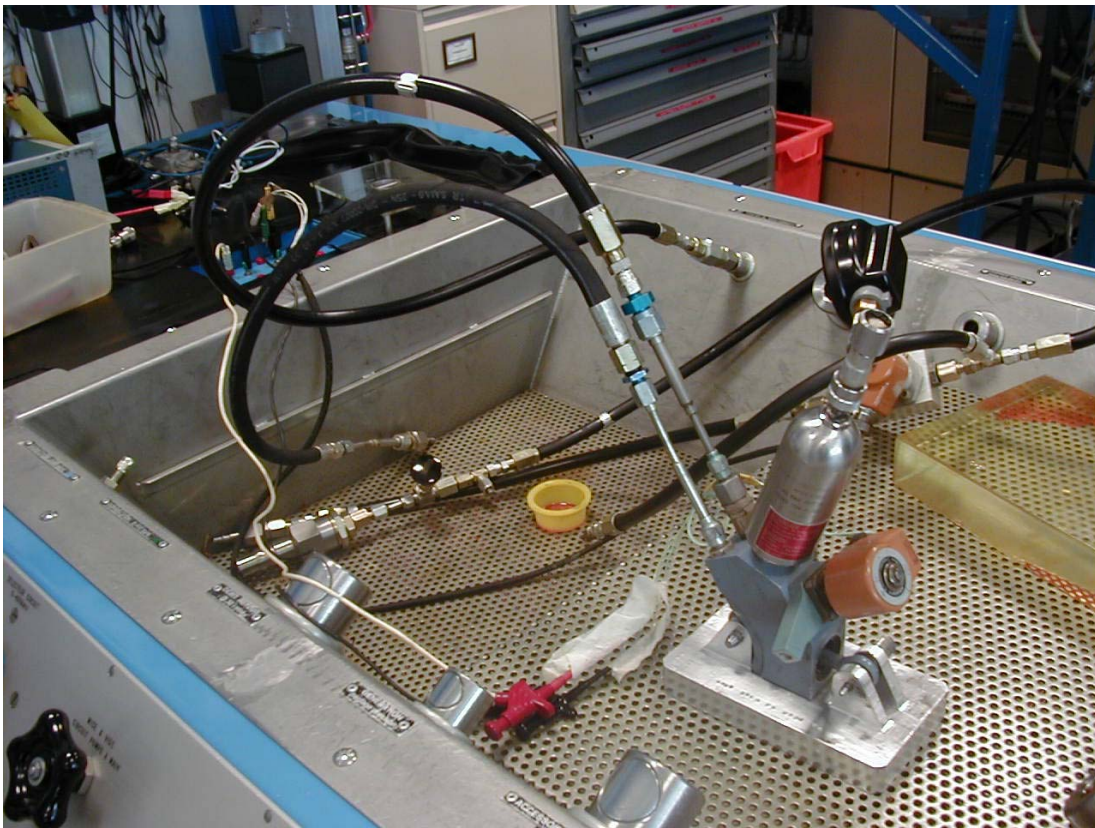
PHOTOS

The HPI hydraulic pump test meets the parameters requirements
Compensator actuator accumulator was deflated. Tests have evidenced lack of sealing on the diaphragm between the nitrogen chamber and the oil. But it is important to note that the tail rotor load compensator system itself was able to keep oil pressure. Indeed, there is no leak between the non return valve (18), solenoid valve (14) and pressure relief valve (19)
We remind that, before each flight, the accumulator is tested.
