**NATIONAL TRANSPORTATION SAFETY BOARD  
OFFICE OF RAILROAD, PIPELINE &  
HAZARDOUS MATERIALS INVESTIGATIONS**

**DCA 11 FR 004**

**REAR END COLLISION OF CSXT Freight Trains  
(TRAIN Q19423 with CSXT TRAIN Q61822)**

**DRAFT FACTUAL REPORT**

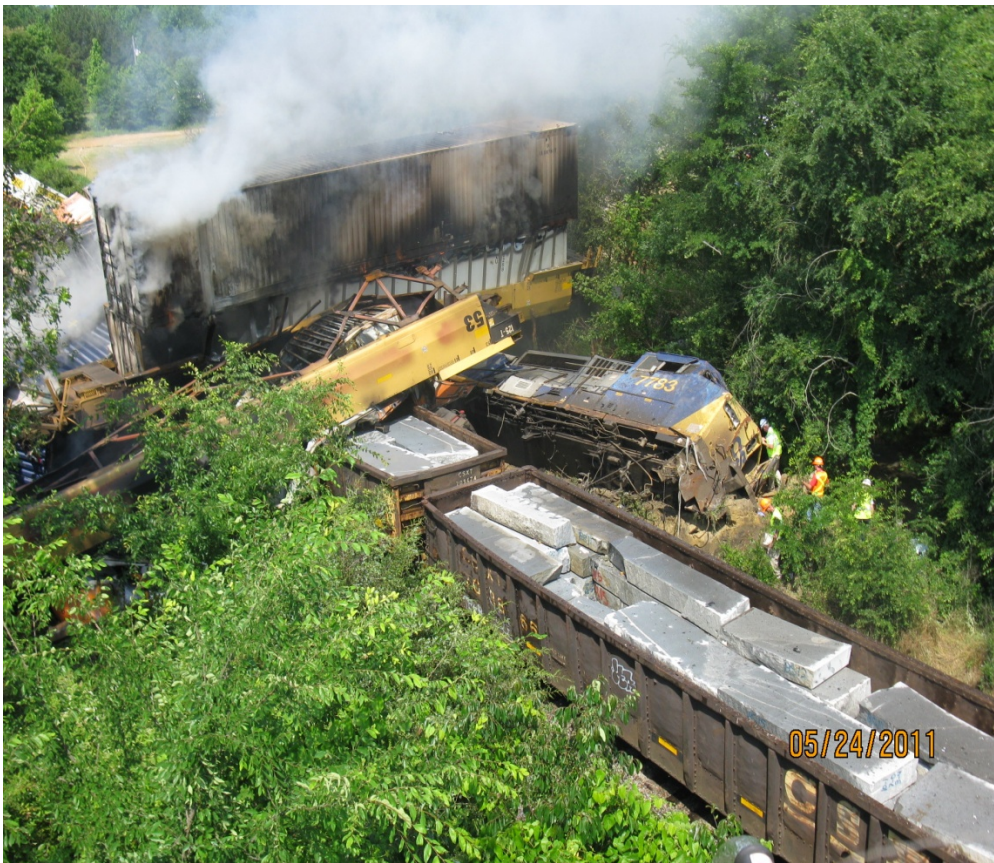
14 CSXT locomotives (7783 and 8429) of striking train Q19423 sustained substantial  
15 damage during the collision and subsequent fire. CSXT estimated that damage to be  
16 approximately \$950,000. Equipment damages to the 4 derailed cars from Q61822 and  
17 the 3 intermodal three pack (9 individual platforms) cars of Q19423 was estimated to be  
18 \$623,000. Track structure damages were estimated at \$43,000. Total damages not  
19 including lading, clean-up, property or environmental costs were \$1,616,000.  
20  
21
