NATIONAL TRANSPORTATION SAFETY BOARD

FACTUAL ACCIDENT REPORT

Accident No.: DCA-12-FR-003
Location: Amarillo, Texas
Date: January 09, 2012
Time: 11:09 a.m., Central Standard Time
Railroad: BNSF Railway
Property Damage: \$150.00
Injuries: 0
Fatalities: 1
Type of Accident: Employee Fatality

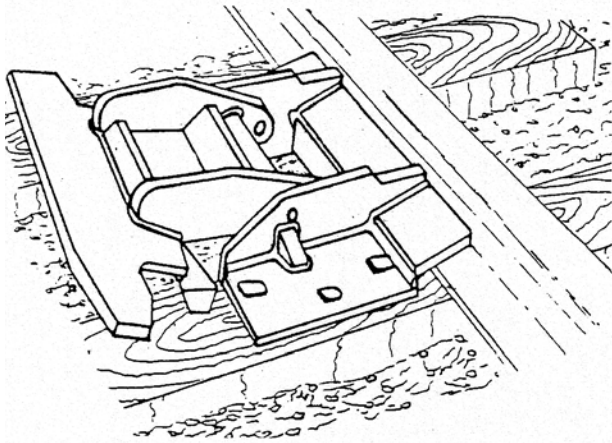
Figure 3
Photograph of the Hinged Derail Involved in the Accident

The derail⁹ involved in the accident was called right hand hinged derail. The derail functions by lifting the flange of the wheel up and deflecting it laterally to drop the wheel clear of the rail head, on the field side of the track. Movement of the rolling equipment is halted by the wheels becoming imbedded in the track ballast. The hinged derail was fastened to the ties with six inch cut spikes. The derail block is lifted by hand in a vertical semi-circle on and off the rail head. See Figure 3, for the hinged derail involved in this accident, and the diagram below to see the off and on positions.

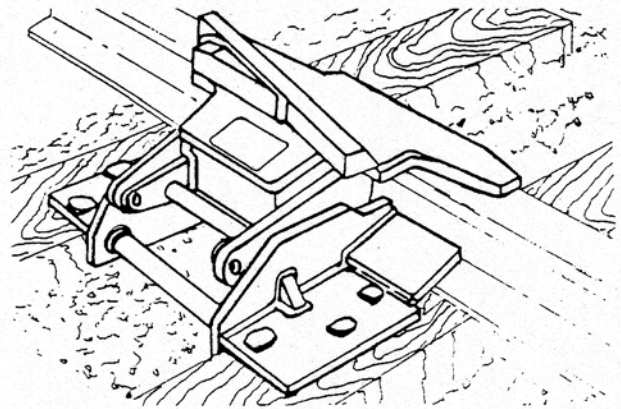
Hinged Derail off the Rail
