NATIONAL TRANSPORTATION SAFETY BOARD

IIC Factual Report

DCA-12-MR-009

**CSXT Transportation Derailment with
Non-Railroad Fatalities**

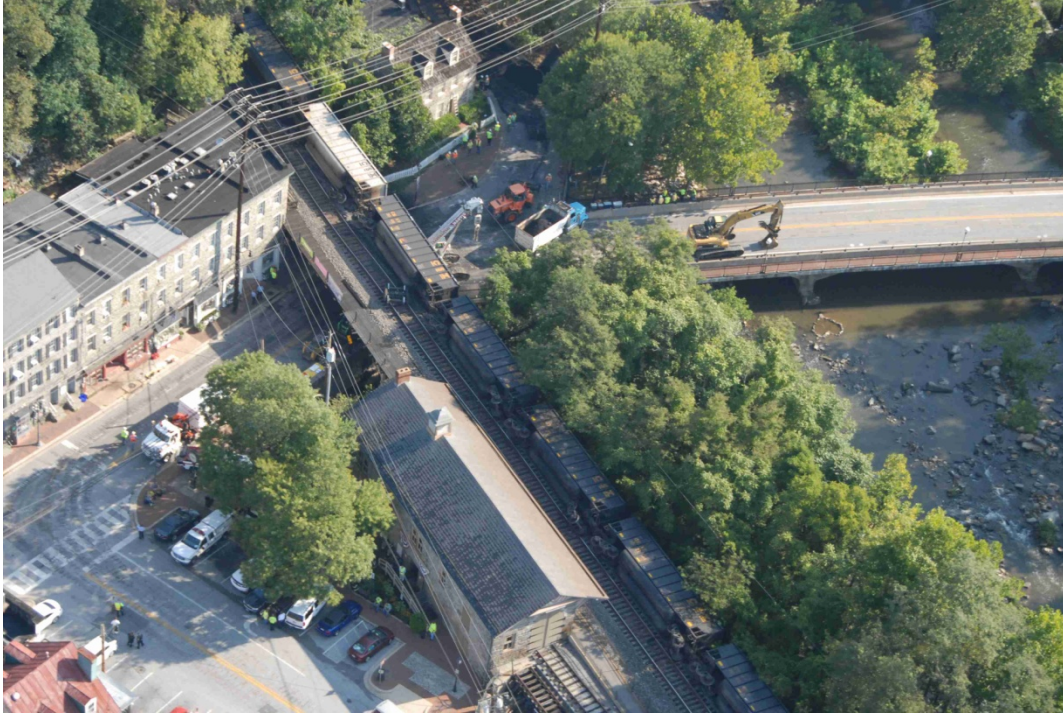
2 Figure 1: The railroad right-of-way and bridge over Main Street in Ellicott City, Maryland. (Photo:
3 Howard County Police)

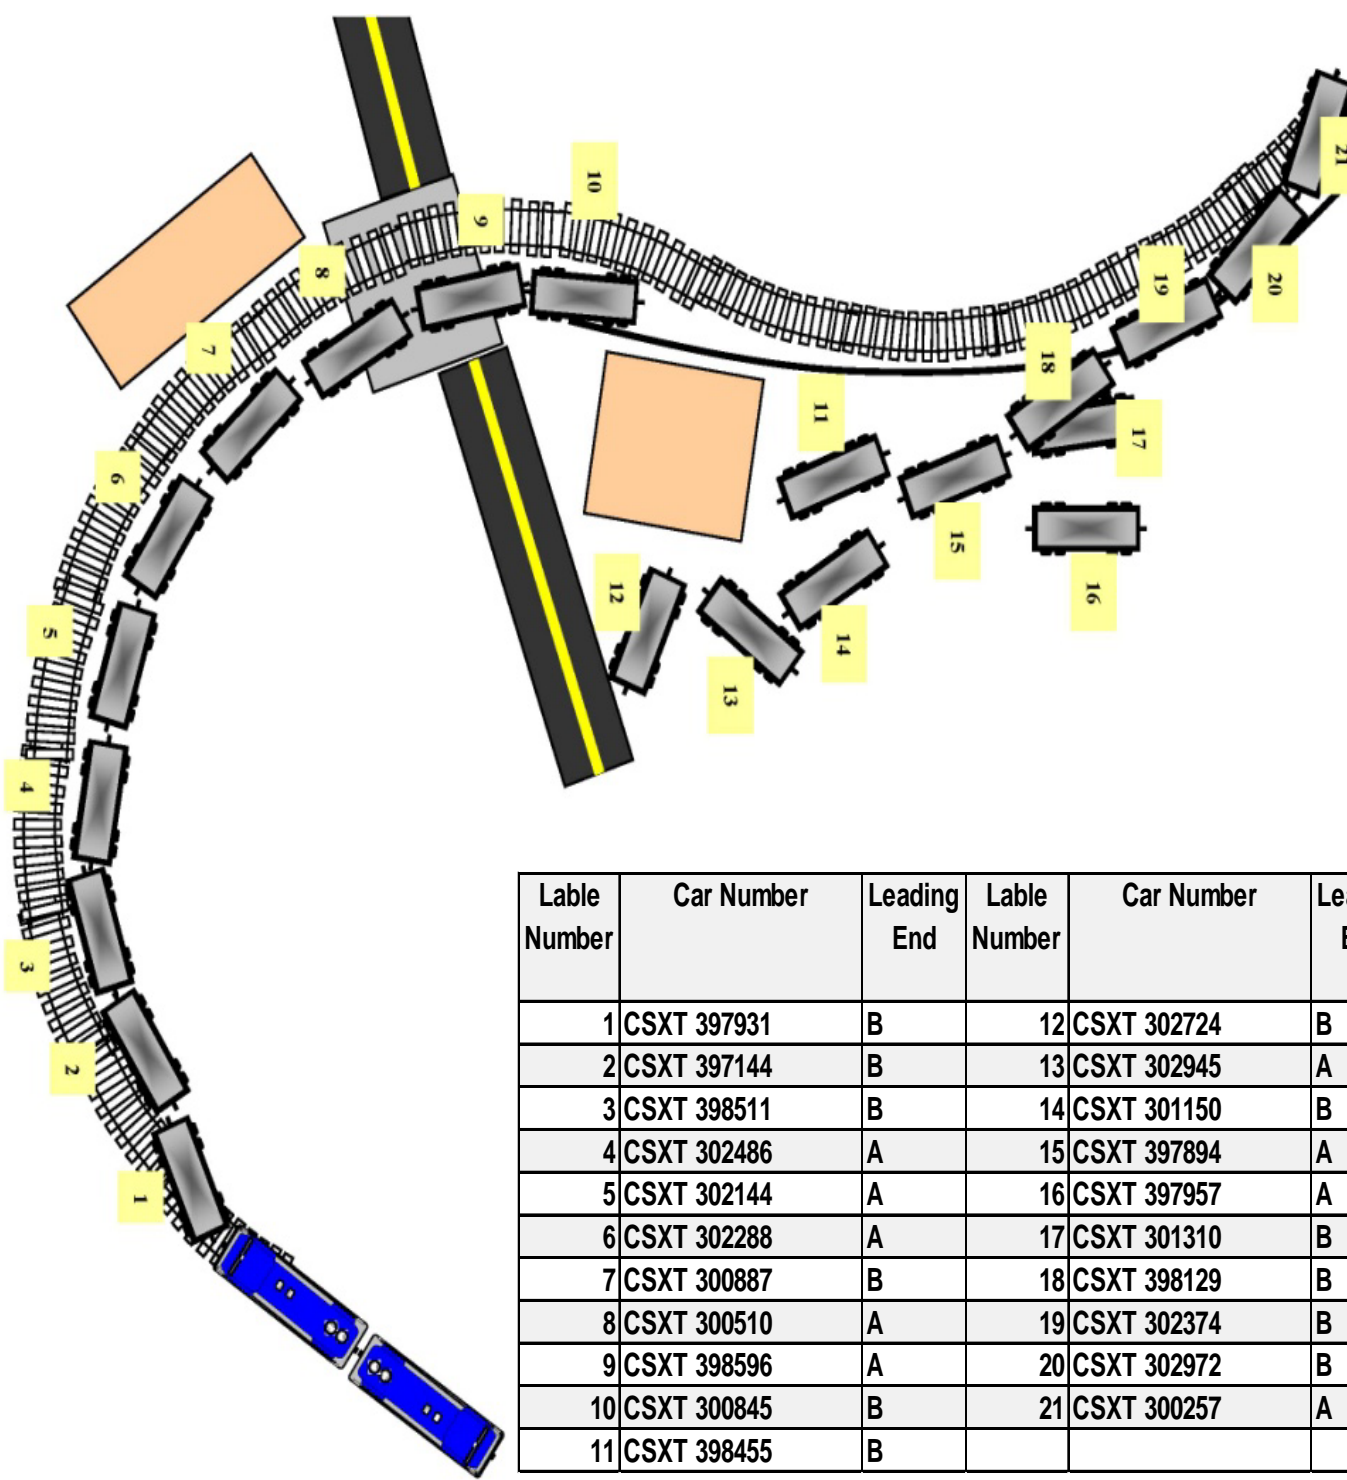
- 1 **Figure 9**
- 2 Not to scale

8
9 The alignment represented reflects the wheel and rail interface expected during curving
10 conditions when CSXT 302724 moved through milepost 12.9 on the Old Main Line in Ellicott
11 City, MD.

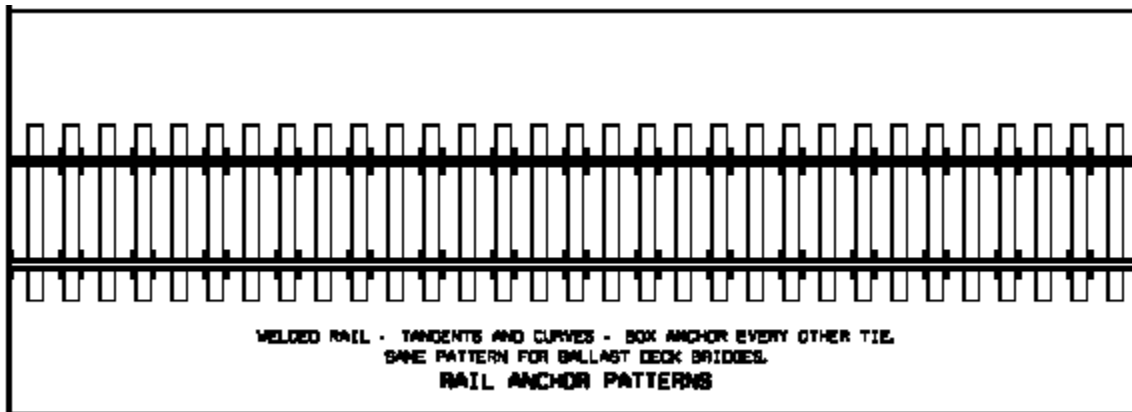
The figure below depicts CSXT's MWI diagram for anchoring welded rail on tangents, curves and ballast deck bridges. The derailment occurred on curved track.

Figure No. 2. The above is a CSXT schematic showing anchor pattern for CWR.

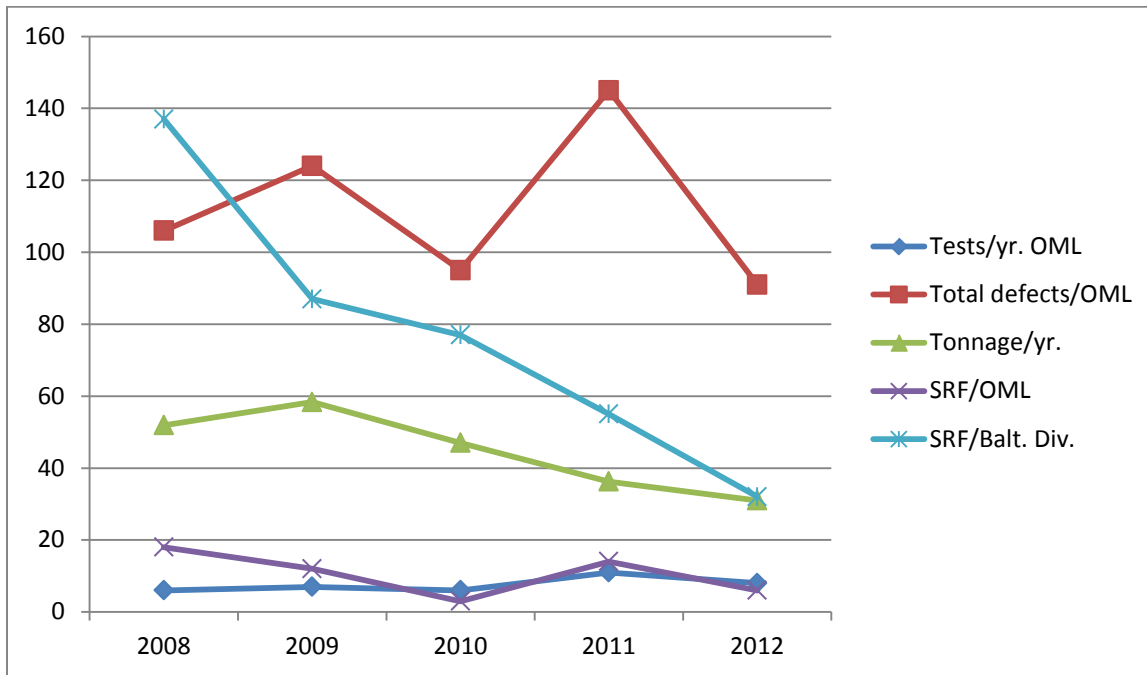
1 Figure 9. Graph of OML annual tonnage data, internal rail flaw detection tests, defect numbers
2 and service rail failures (SRF) for OML and Baltimore Division.

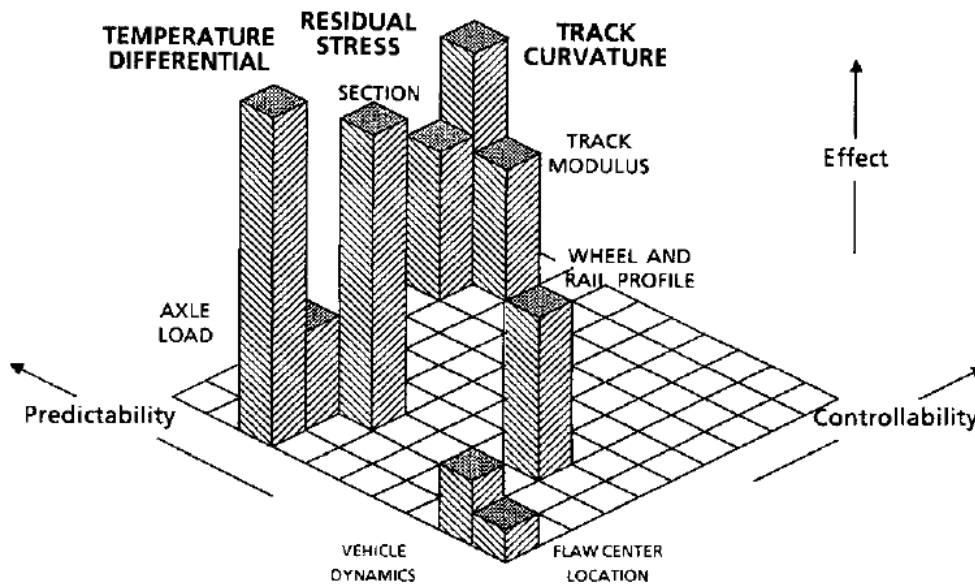
3 In a previously published final report, dated, October 1988, a Volpe report entitled,
4 “Crack Propagation Life of Detail Fractures in Rails”, Volpe cited the following contributing
5 factors effecting detail fracture growth:²¹ (See diagram on subsequent page)

- 6 • Temperature differential, rail residual stress and track curvature have strong effects on
7 detail fracture growth life;
- 8 • Rail section, track foundation quality (modulus), center of contact (wheel and rail
9 profile) and average axle load all have moderate effects on detail fracture growth life;
- 10 • Vehicle dynamics and flaw center location in the rail head have only small effects on
11 detail fracture growth life
