**MP 608 – Marshall, Michigan Incident
NTSB/PHMSA Information Request No. 24**

Request: Provide a list of all leaks discovered on the pipeline including when they were detected, their severity and when they were repaired.

Response: Repair/Leak Records: MP 671.96.pdf, MP 722.81, MP 716.32.pdf, MP 749.93.pdf, MP 751.07.pdf, MP 512.27.pdf, MP 714.93.pdf, MP 475.30.pdf, MP 682.77.pdf, MP 468a.pdf, MP 468b.pdf

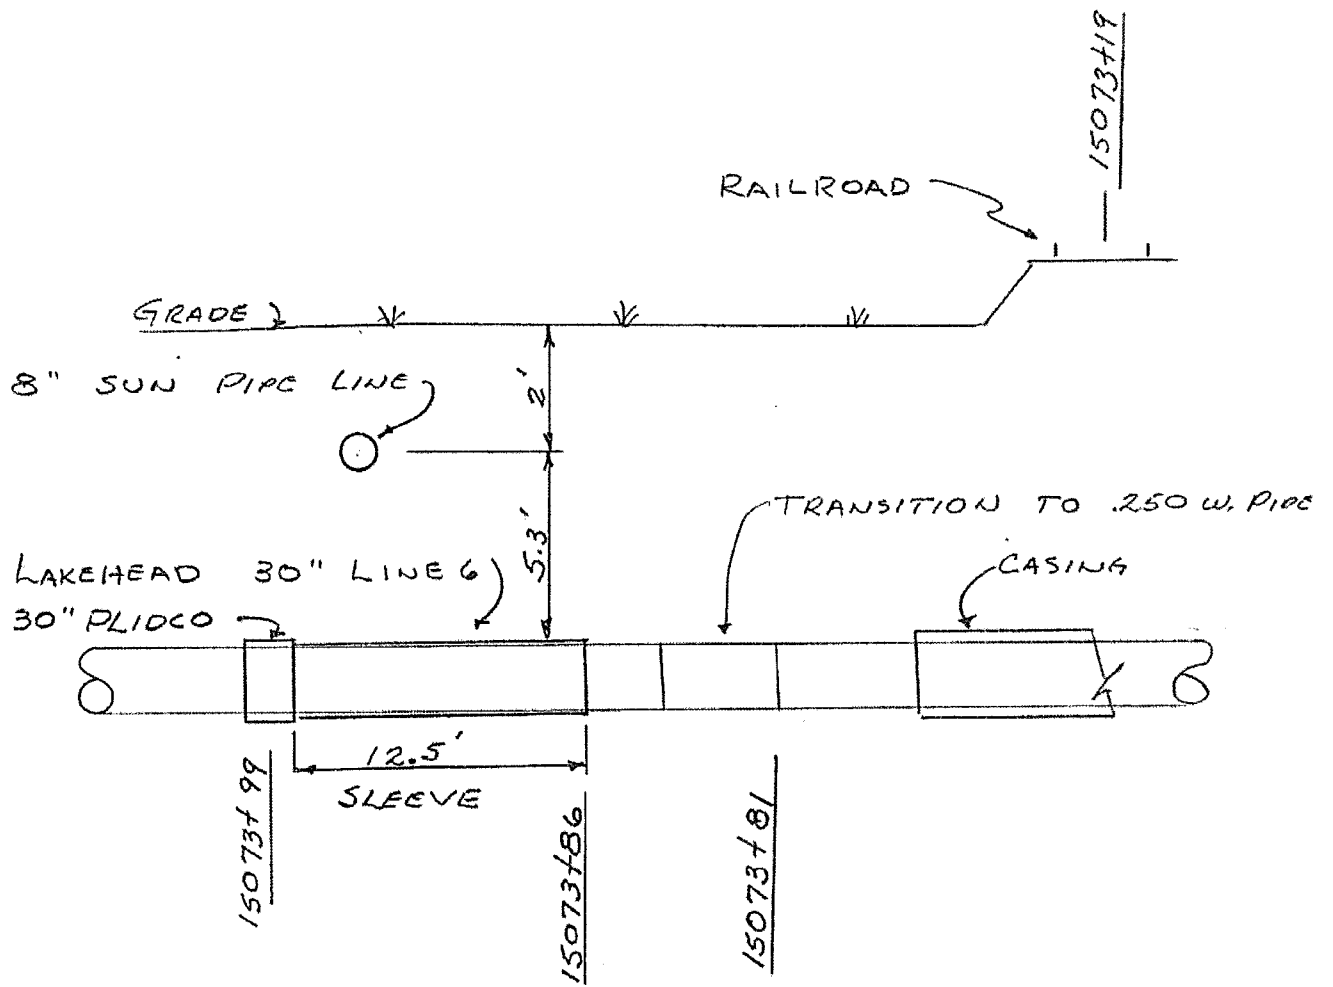
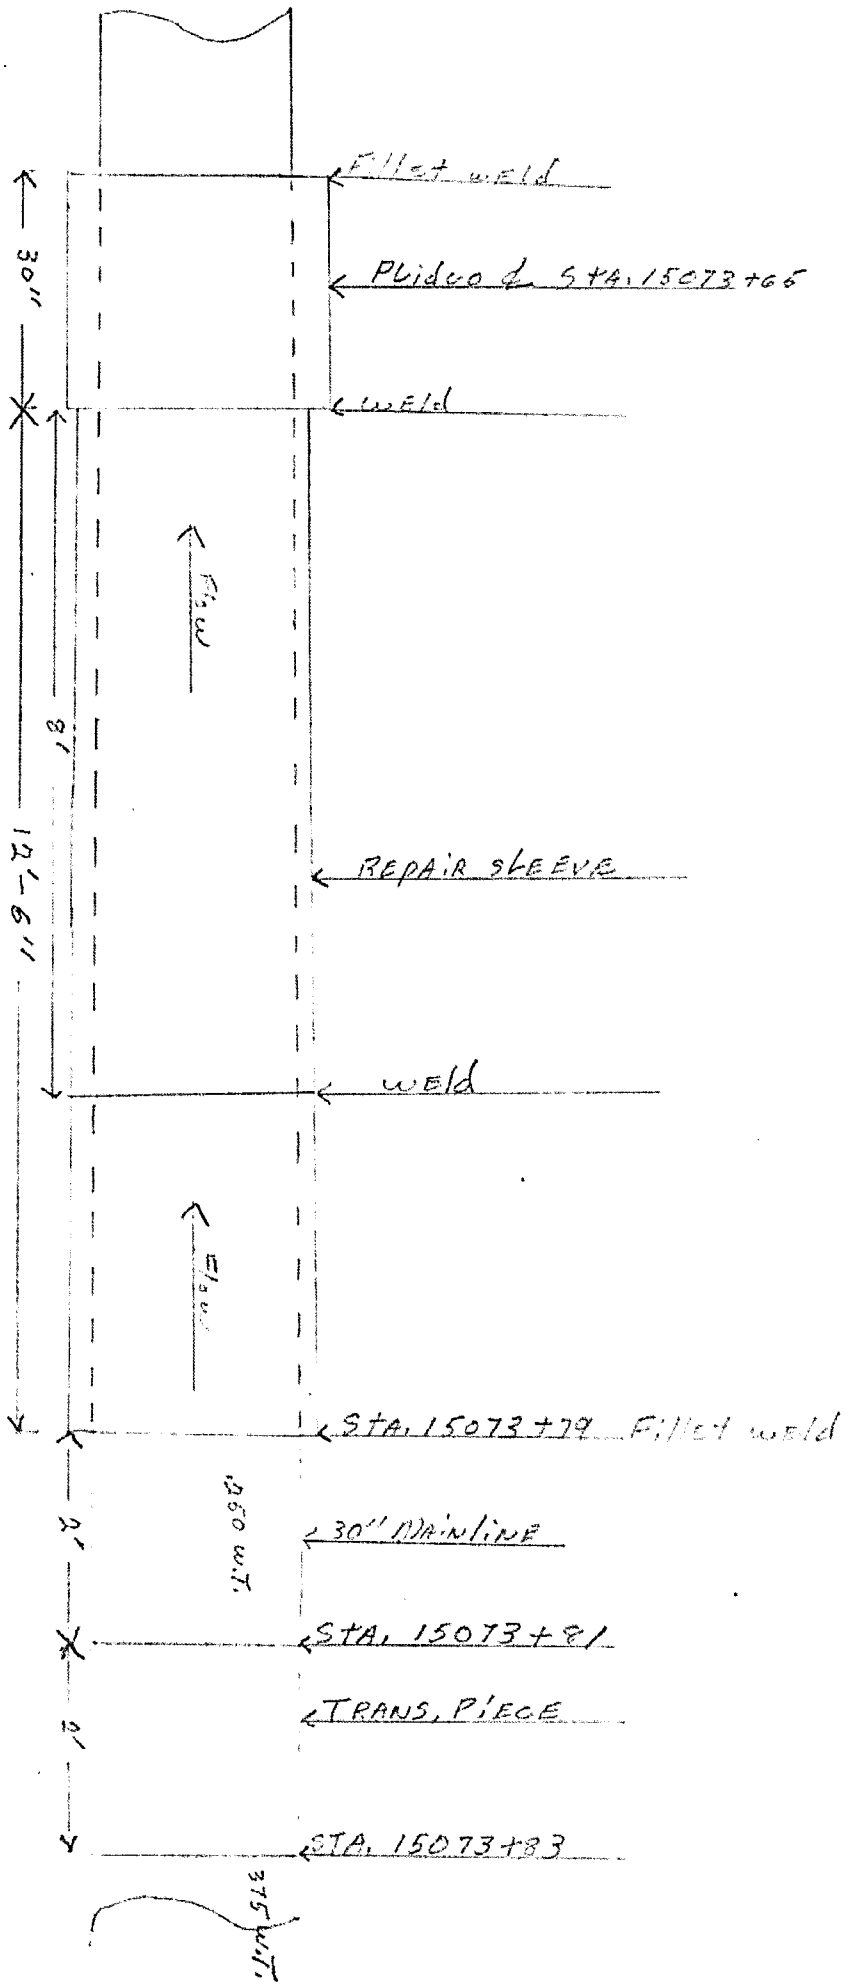
LINE 6, MR 751
 ATLAS SHEET C-432
 30" DIA. PIPE
 TOL. 116, D6-47-85

NATURE AND CAUSE OF BREAK OR LEAK
 Corrosion at 6:00 approximately 2- $\frac{1}{2}$ " diameter was leaking. Also found numerous multiple corrosion pits.

3. REMARKS - GIVE DESCRIPTION OF ANY ABNORMAL CONDITIONS See Attached Drawing.
Info: Leak occurred in an area of external corrosion, approximately 4" in diameter. There are other pitted areas around the leak in addition to numerous pits upstream of the leak. A 30" Plidco repair sleeve was installed over the leak and 12.5 ft. of repair sleeve over the pitted areas upstream.

NATURE OF REPAIR & FITTINGS ADDED TO MAIN LINE: SHOW BY APPROPRIATE SKETCH.
 Installed 30" x 30" Plidco repair sleeve and 12.5 ft. of 30" x .500 W.T. full encirclement repair sleeve.
