NATIONAL TRANSPORTATION SAFETY BOARD

Image Study

Specialist's Study Report By Christopher Babcock

Location: Reno, Nevada
Date: 09/16/2011
Aircraft: P-51D
Registration: N79111
Operator: Aero-Trans Corporation
NTSB Number: WPR11MA454

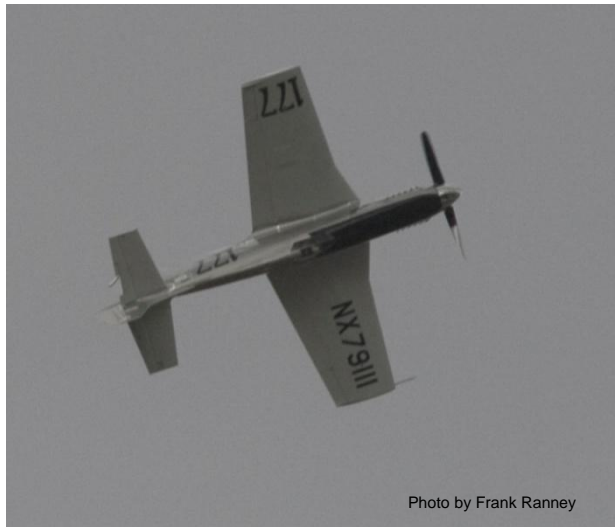
Figure 6. Trim tab begins to separate.

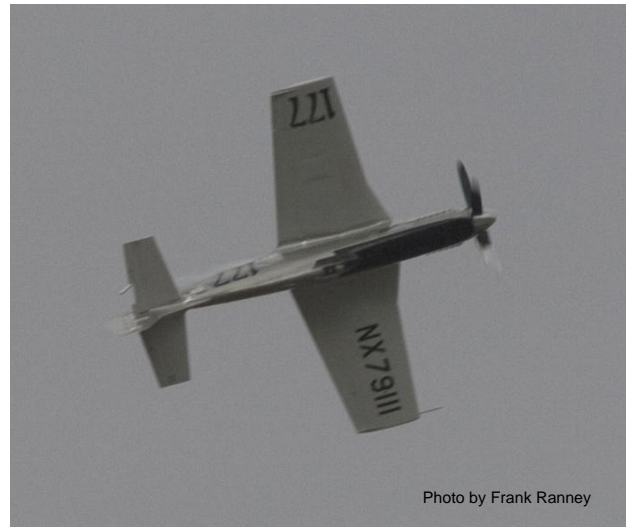
Figure 7.

Images from the Ranney camera were also time correlated. Figures 5 through 9 show a sequence combining images from the Ranney camera and time correlated images from the Kirchenbauer camera to place the Ranney images in time. The Ranney images in Figures 6-8 all have an Exif time stamp of 16:24:45. Exif data from this camera is only recorded to the nearest second. All images from the Ranney camera should be decremented by 12 seconds to adjust to local PDT time within one second.

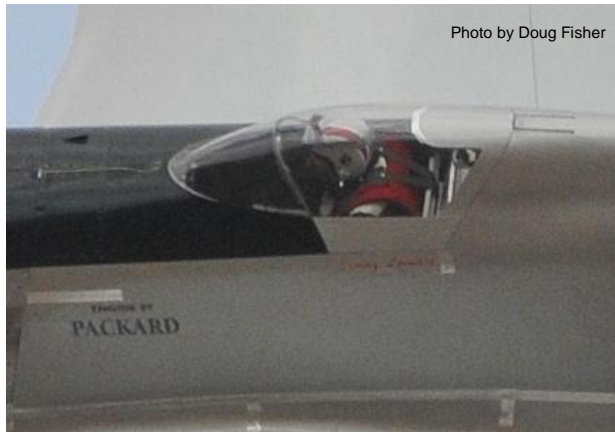
Figure 15, captured as the aircraft rounded pylon 2 on the last lap of the accident flight, shows the pilot's normal flying posture. He is seated leaning forward, away from the seat back. The dual shoulder restraints appear to have no slack in this posture. Figure 16, captured during the 2010 race, appears to show the pilot in a similar posture.

Figure 15. Pilot's normal flying posture.

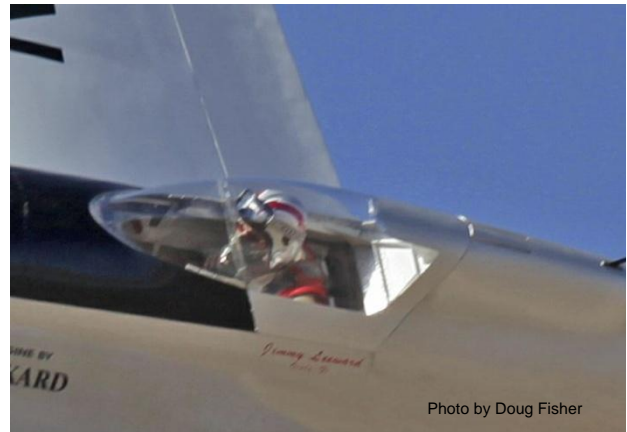
Figure 16. Pilot's normal flying posture in 2010.

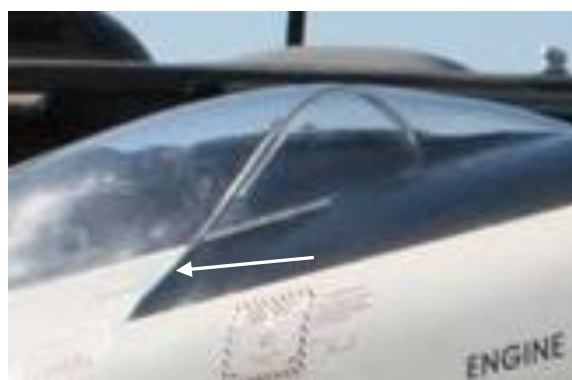
Additionally, Figure 19 shows deformation along the canopy rail and canopy on the first lap of the accident flight in the Valley of Speed. The canopy is not flush with the fuselage as it is in Figure 20 when the aircraft is on the ground.

Figure 20. Canopy flush with fuselage on ground.

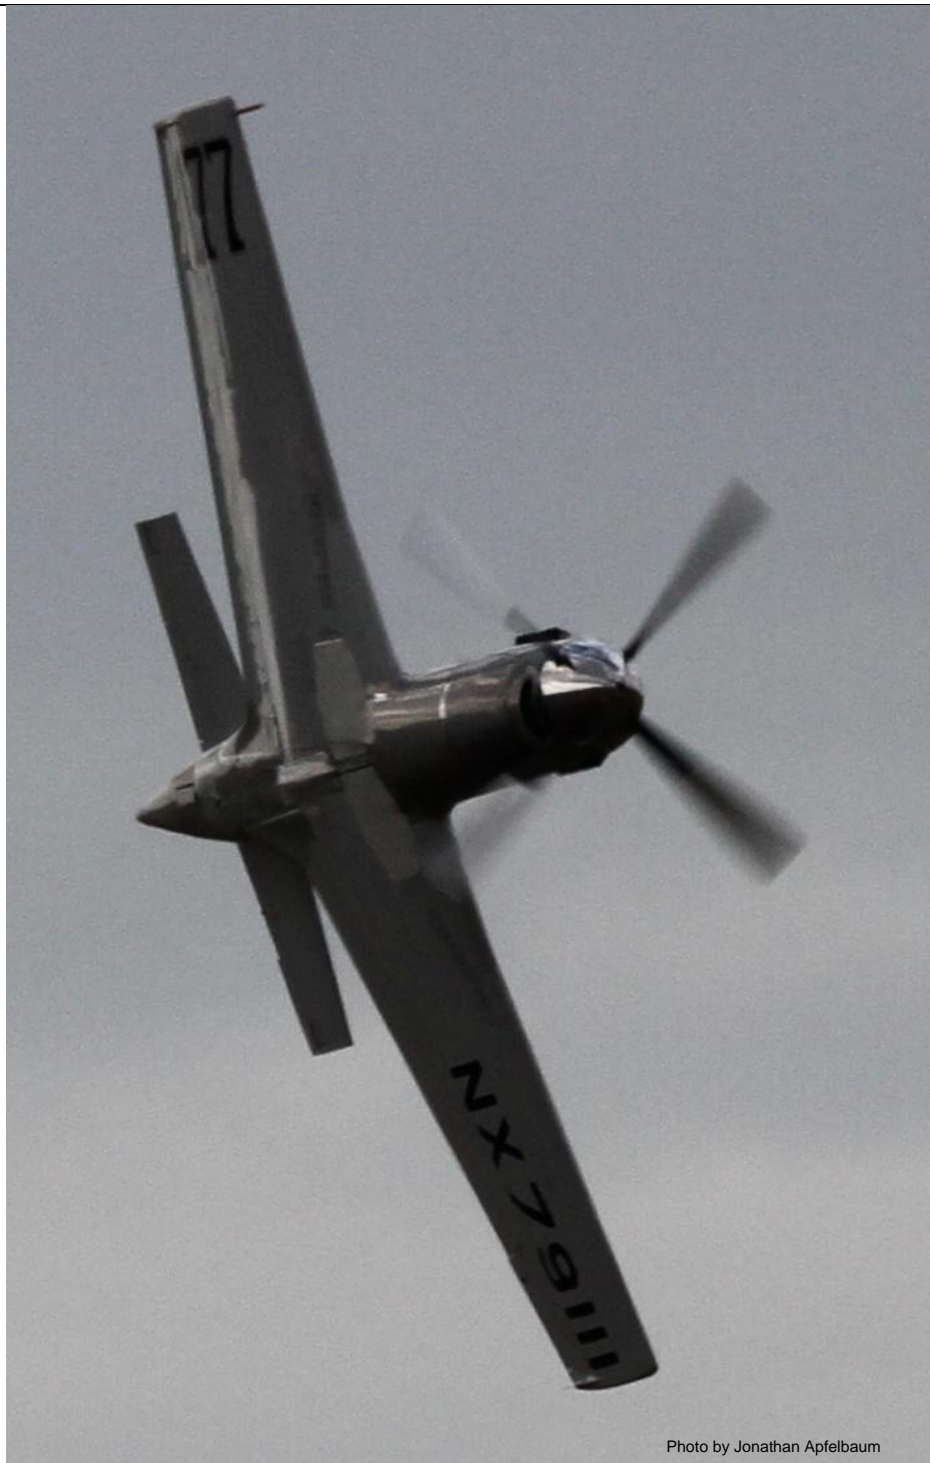
Figure 23 shows the aircraft rounding pylon 8. The positions of the elevator trim tabs are consistent with the observed position during previous laps. Figure 24 shows the aircraft continuing its turn just prior to the roll upset. According to the Video Study, at approximately 16:24:28.8, the aircraft experienced a roll upset to the left. The Airplane Performance Study showed that the roll moment leading to the left roll upset appeared at approximately 16:24:28.2. Figure 25, just prior to the visible roll, shows the aircraft with an increasing right wing down aileron deflection. Figure 26 shows the aircraft approximately 0.5 seconds after the roll upset began. Figure 27 shows the left trim tab trailing edge up

Figure 23. Aircraft rounding pylon 8 on final lap.

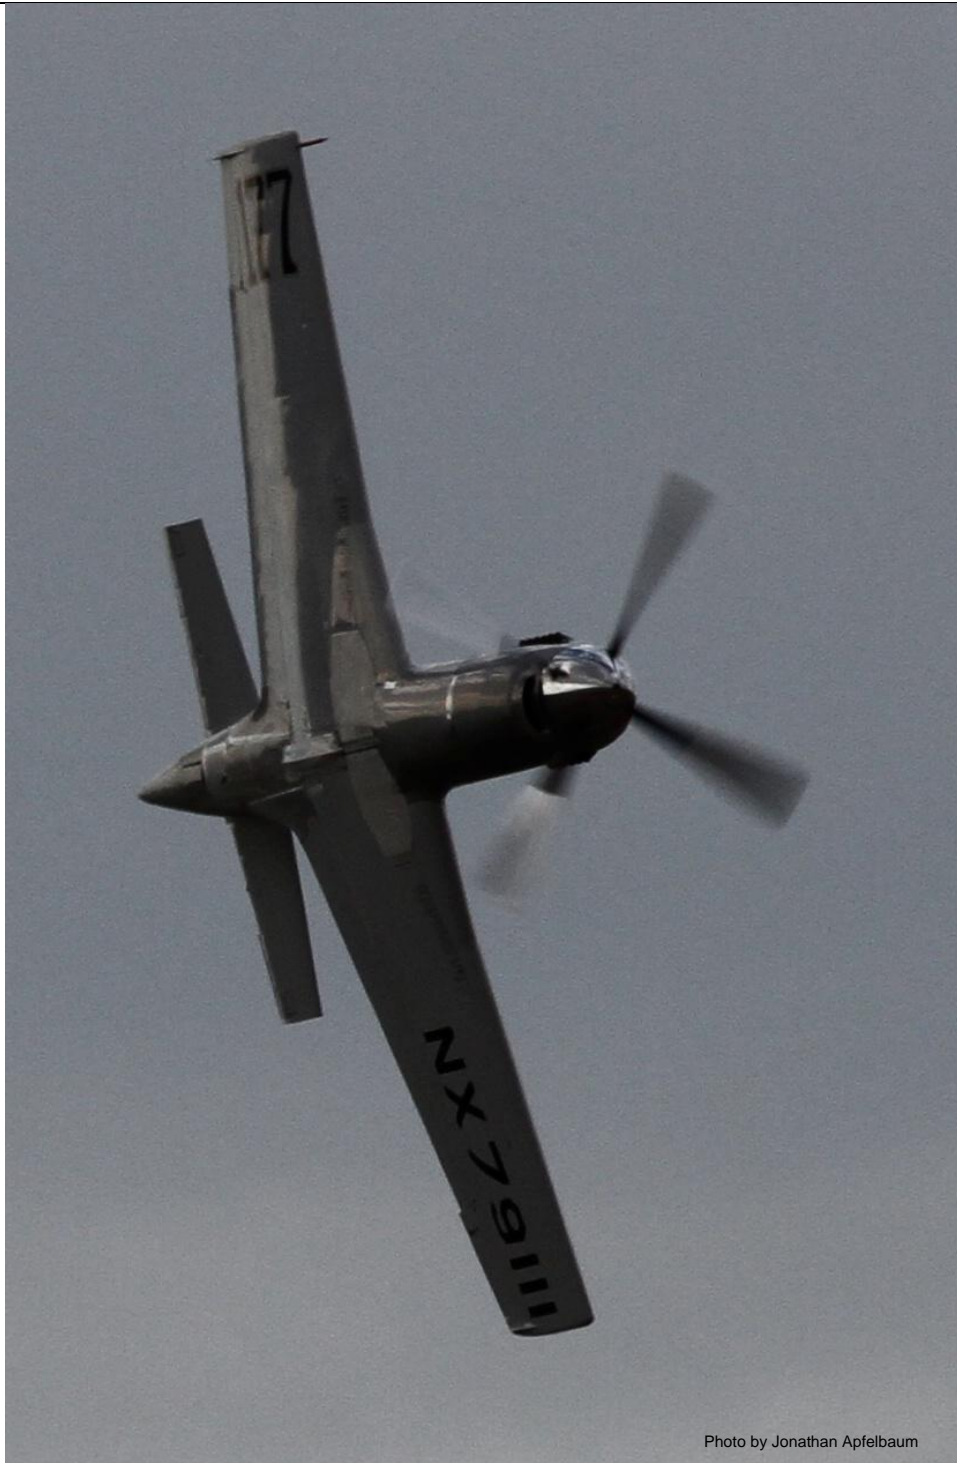
Figure 24. Aircraft just after roll upset begins.

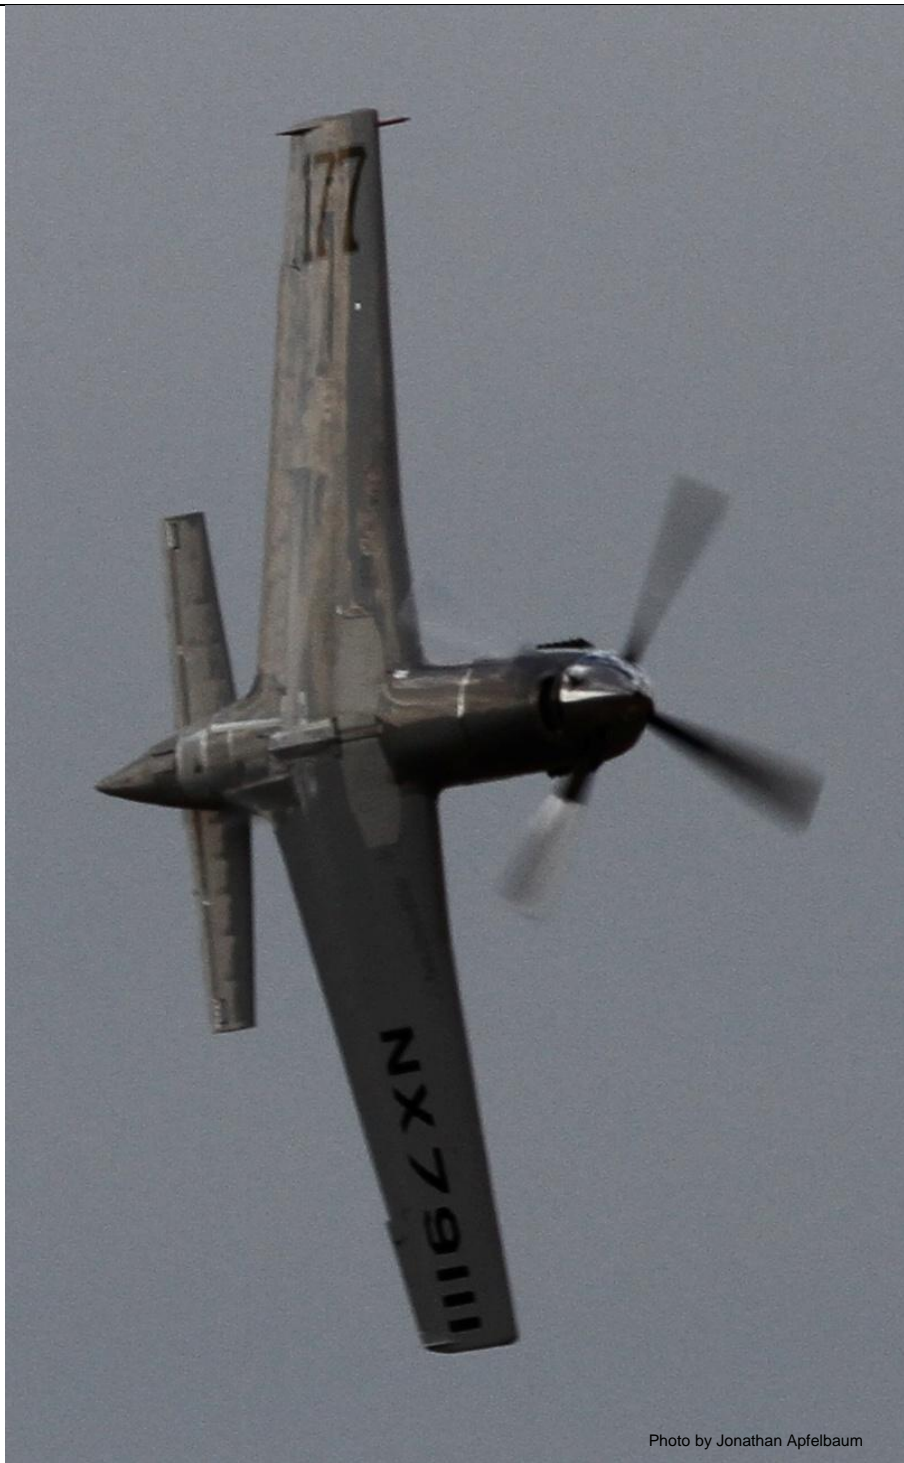
Figure 25. Aircraft in roll upset.

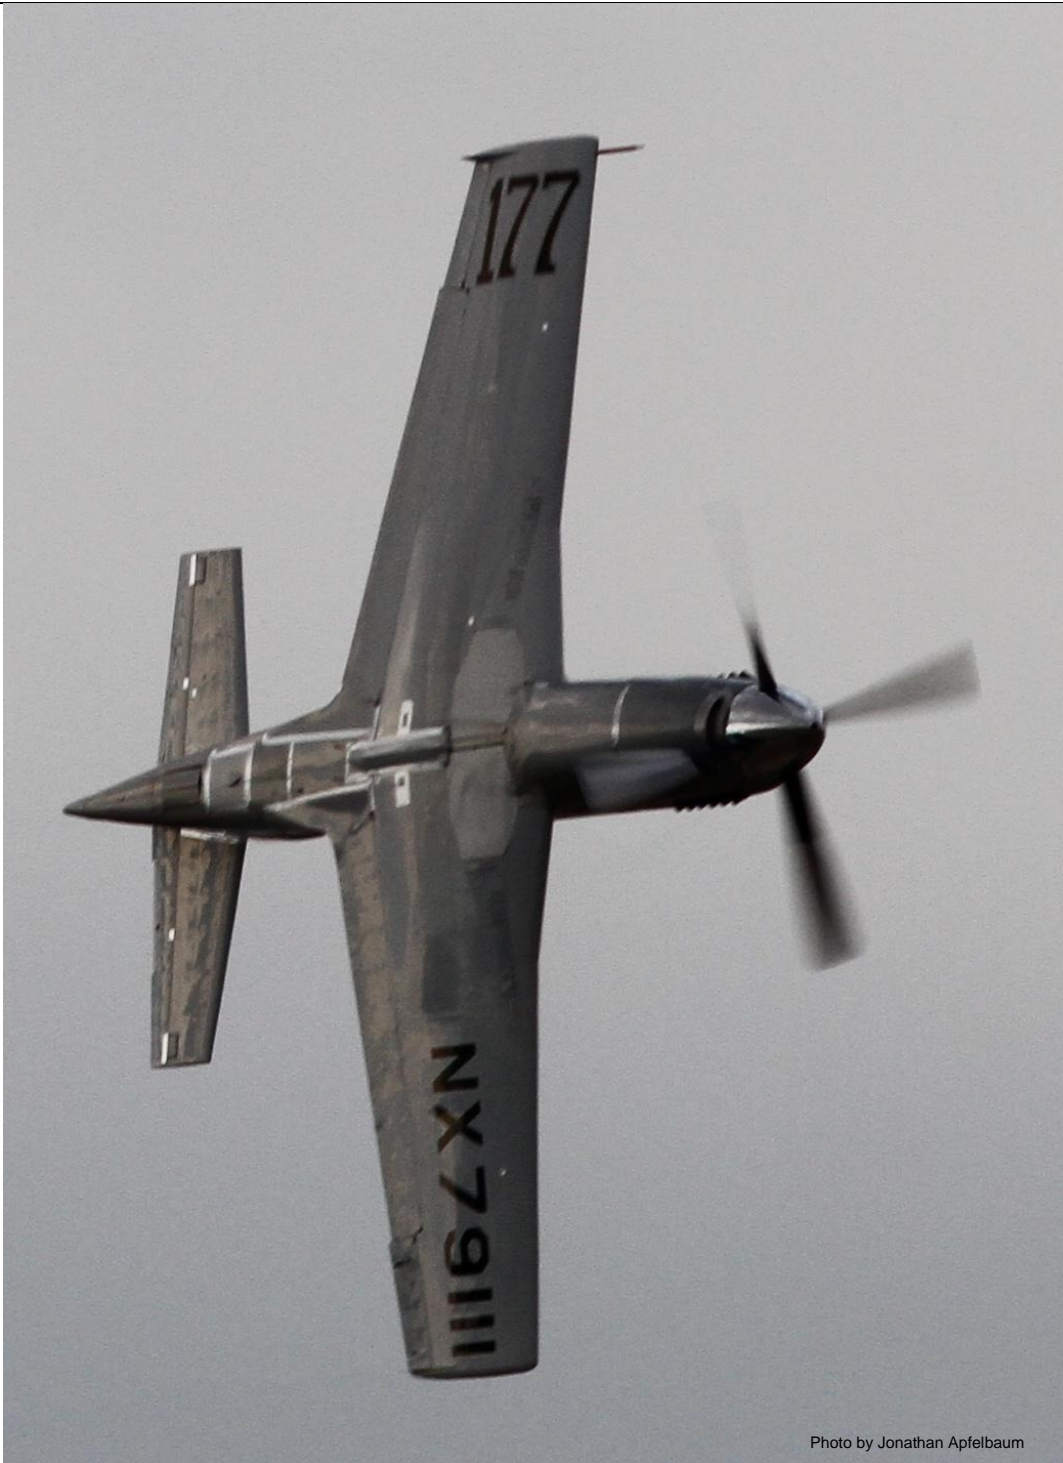
The trim tab system was designed to have at most 13° of trailing edge up travel.⁵ A tab deflection greater than 13° indicates that the control rod is broken. The 25° calculation allows up to 12° of uncertainty to the angle of the aircraft, the elevator, and stabilizer. This puts the failure of the left tab link assembly as late as 16:24:29.46 PDT in the accident sequence.

Figure 27. Aircraft in roll upset.
