NATIONAL TRANSPORTATION SAFETY BOARD

IMPACT STUDY AND ALTITUDE ALERTER OPERATION

ANC10MA068

Location: Aleknagik, Alaska
Date: August 9, 2010
Time: 1442 Alaska Daylight Time (ADT)
Aircraft: de Havilland Canada DHC-3T, N455A

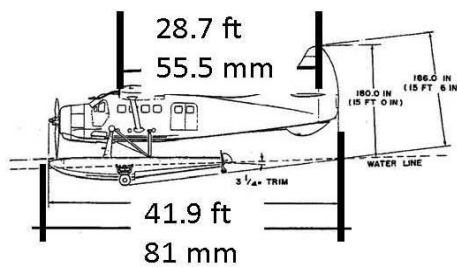
8

Figure 2 - The drawing was used to determine a distance from the wing leading edge to the rudder hinge line. The distance was used to scale Photograph 8. (The scale factor changes when the figure is added to the report.)
