NATIONAL TRANSPORTATION SAFETY BOARD

INITIAL and ON-SCENE INFORMATION

**NTSB Accident: WPR13FA294
Accident Date: June 27, 2013**

Location: Birdseye, Utah
Date: June 27, 2013
Aircraft: Cessna 172M, N4459R, Serial # 17263201
NTSB IIC: Michael Huhn

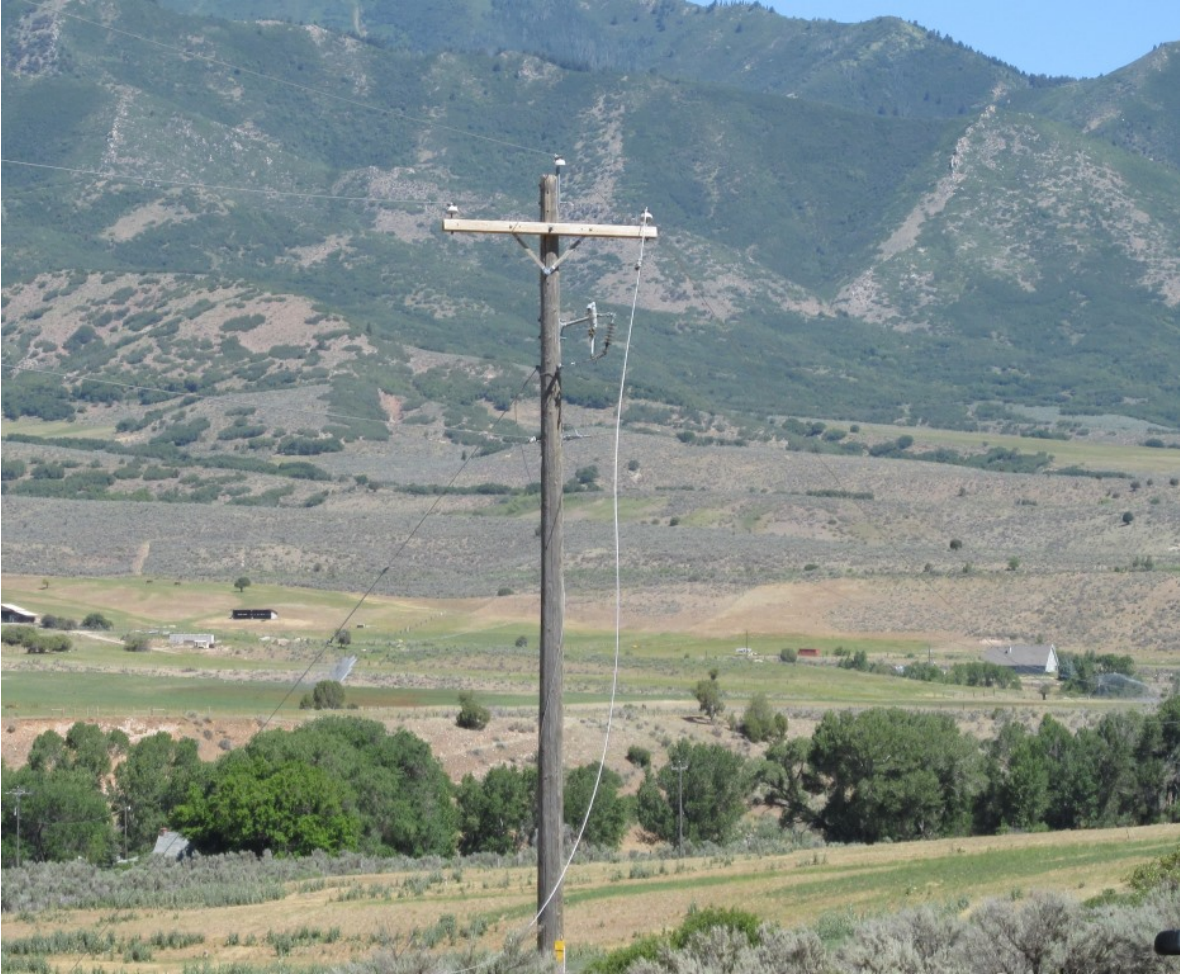
Figure 10 – Pole Supporting Parallel and Transverse Powerlines

A second cable, situated about 4 feet closer to the road than, and 3 feet below, the top cable, was completely fractured. Two other cables in that group were not fractured but displayed electrical arcing burns in the vicinity of the bunching. All three of these cables were also 1/0 ACSR.

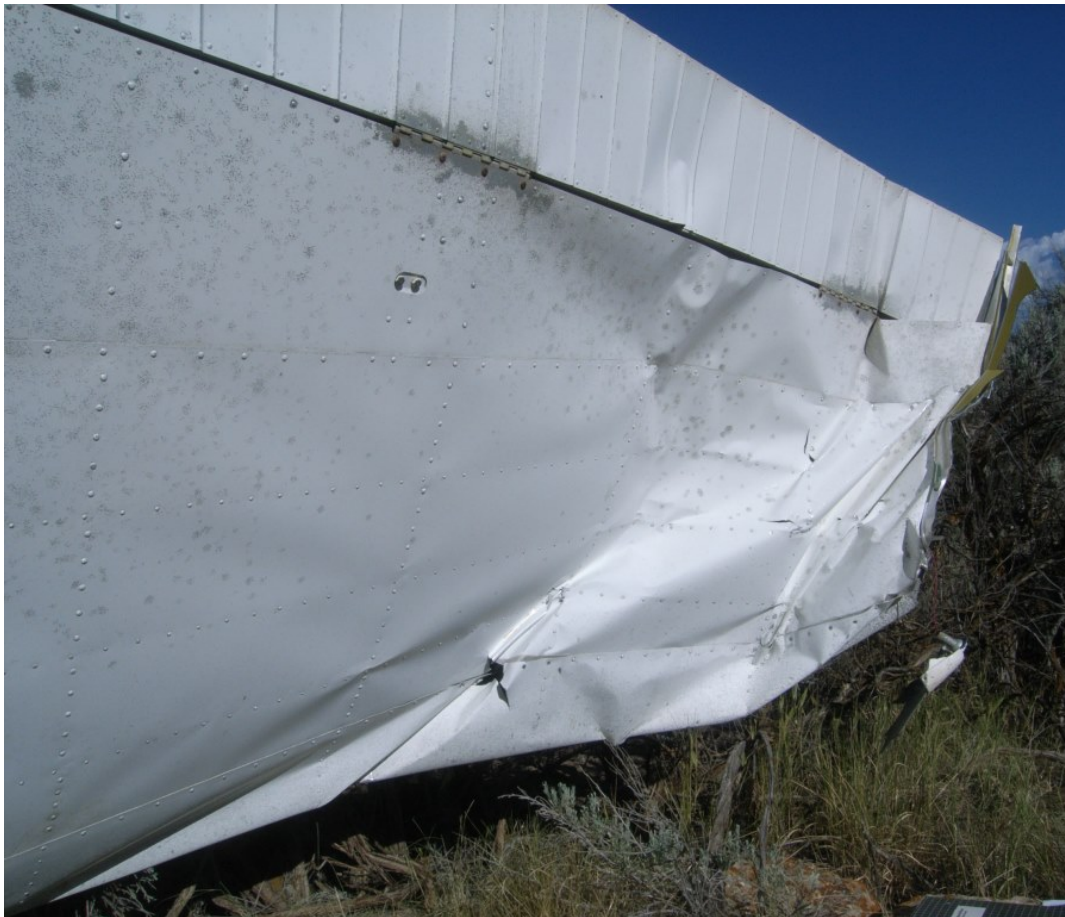
Figure 15 - Left Wing Upper Surface

The engine was displaced up, aft, and left in the airplane axis system. The two blade fixed pitch metal propeller remained attached to the engine. Cockpit occupiable volume was compromised forward of the front seats. The right wing displayed leading edge crush damage at the outboard-most foot of its span. The left wing exhibited tip crush and fragmentation damage. The outboard five feet of the left wing exhibited aft and up crush damage. The flaps were found extended to the full-down landing position of 40 degrees. Both wings and both flaps exhibited crush damage in the lateral direction in their aft inboard regions, and the upper aft fuselage exhibited similar damage in the region of the rear window. The fuselage exhibited slight buckling towards the aft end of the cabin. The aft fuselage, tailcone, and empennage were essentially undamaged.

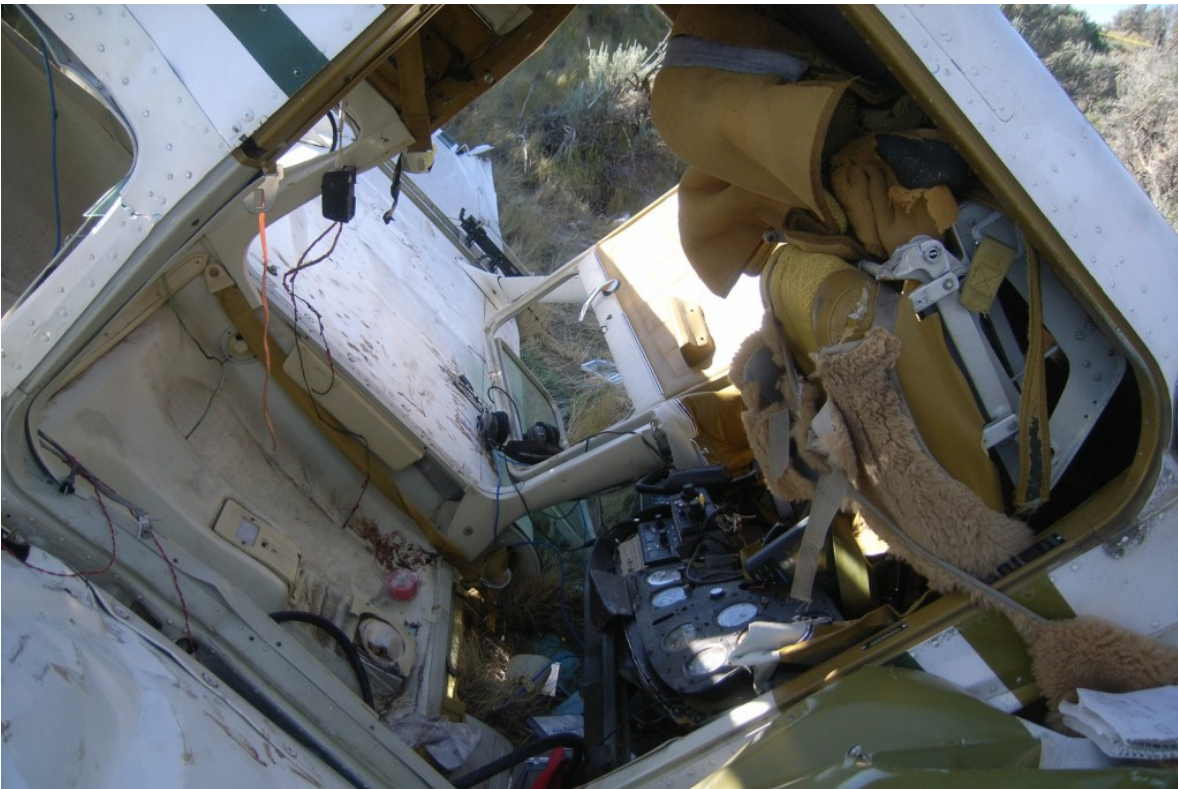
Figure 18 - Cockpit

Although not explicitly documented by the first responders, the evidence was consistent with the test engineer's (right) seat possibly separating from its seat tracks during the impact sequence. The instrument panel and two control wheels sustained moderate crush damage, consistent with ground and occupant impact.

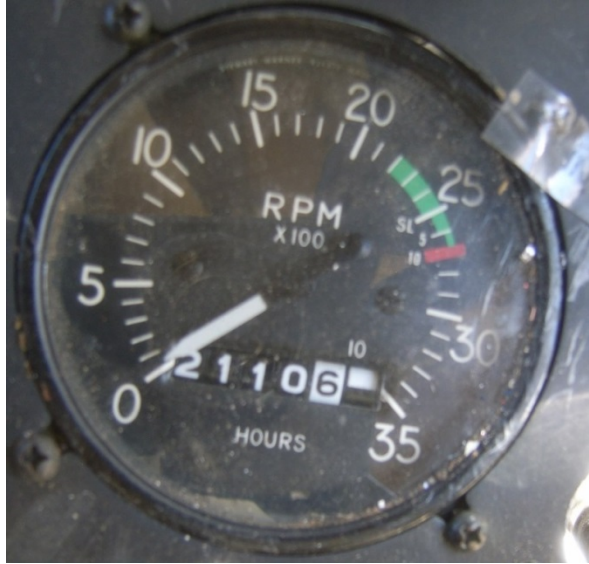
Figure 19 - Tachometer

Hour Meter: 2,542.4
Tach RPM: 0
Tach Hours: 2,110.6
Engine Control Positions

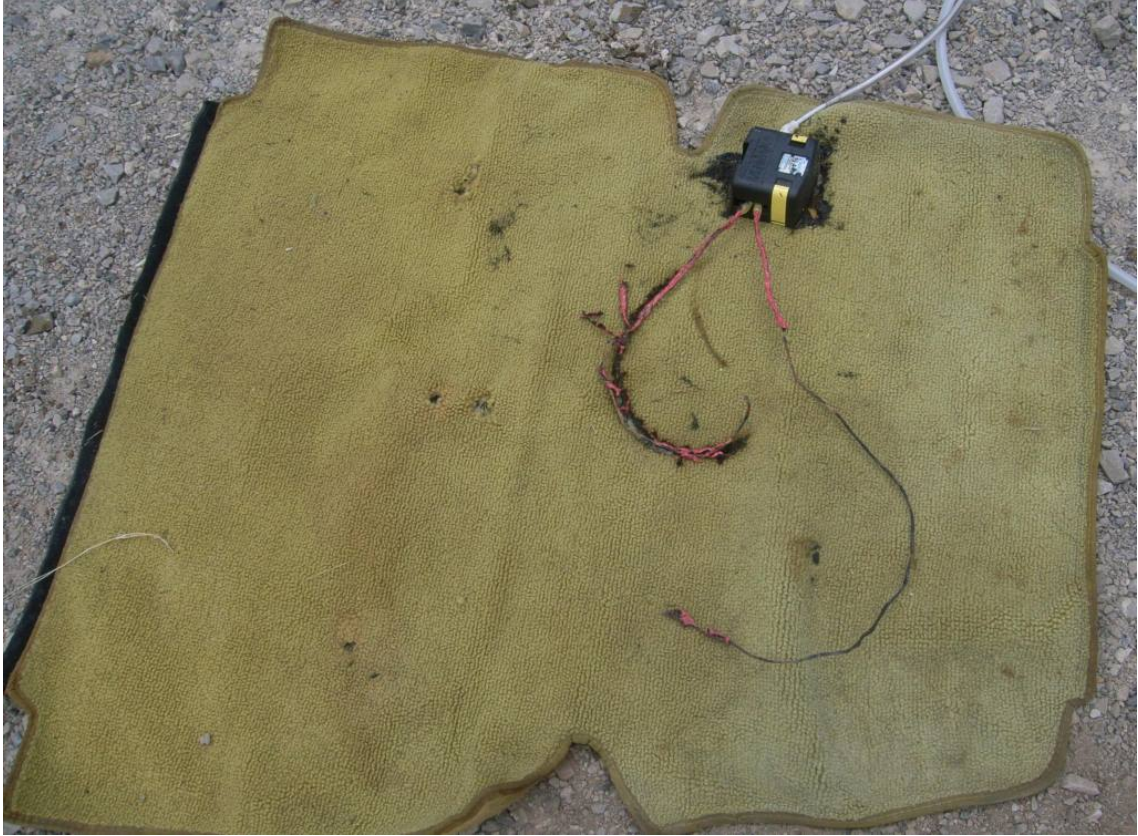
Figure 46 - Isolator on Airplane Carpet

Some of the cabin sidewalls had significant evidence of burned or melted plastic remnants deposited on and/or fused to them. The cabin ceiling was covered with a layer of black sooty particulate matter that was consistent with uncontained, smoky combustion. The aft cabin carpet was partially burned; the burned areas and patterns were congruent with burned portions of the supplemental power (described below).

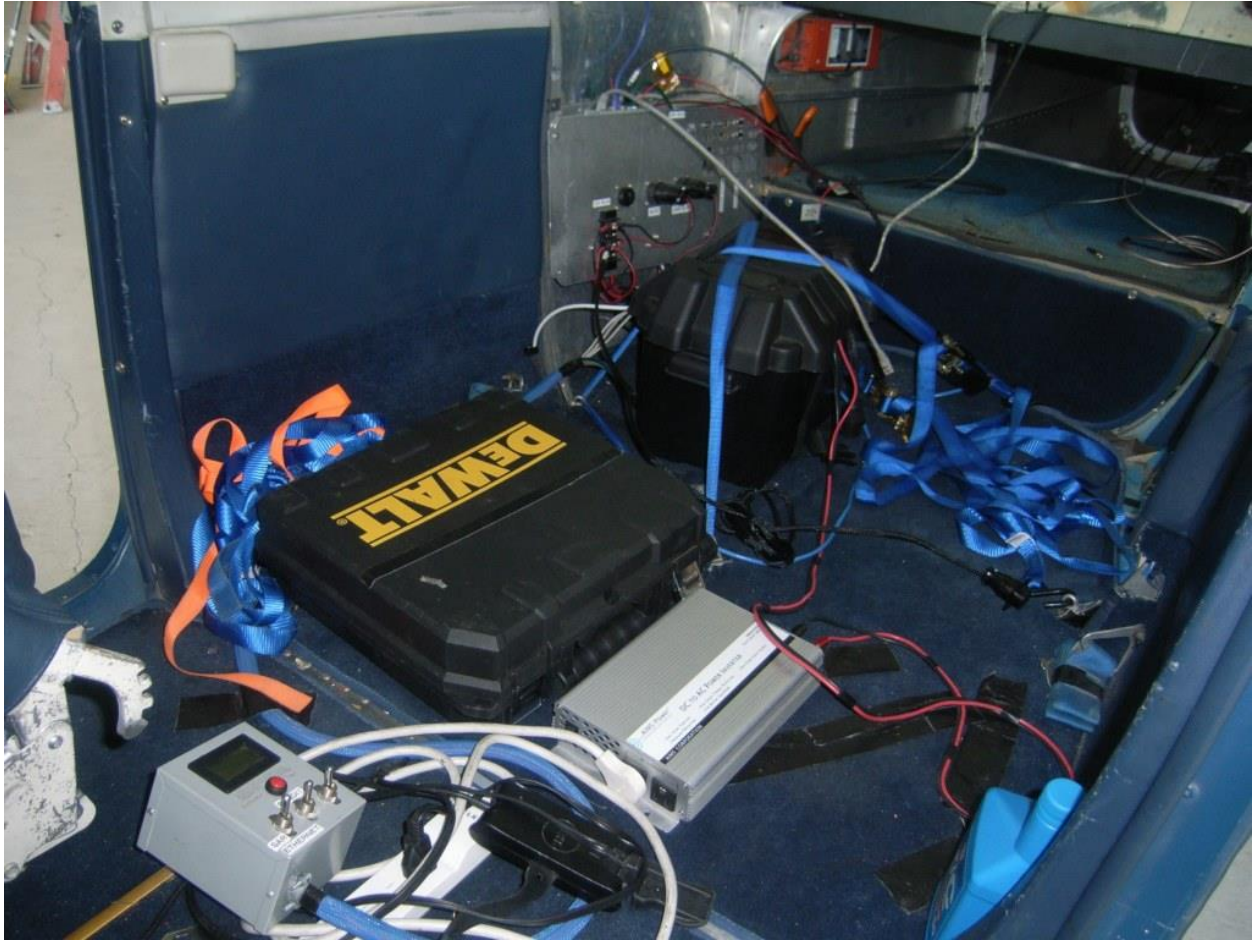
Figure 48 - Supplemental Power Supply (undergoing revision)

A second Cessna 172, N5285H was also modified with a supplemental power system and used by IMSAR as a test platform. According to IMSAR personnel, the supplemental power system in this airplane was similar, but not identical to, that in the accident airplane. This system was produced subsequent to the accident system, which enabled IMSAR to incorporate certain improvements based on their experience with the first system. One primary difference was that the power distribution box was attached directly to the N5285H airframe; the power distribution box was secured to the floor of N4459R by cargo tiedowns. In addition, the N5285H system was not equipped with an "isolator."
