**Investigator-In-Charge
FACTUAL REPORT**

**August 27, 2016, Rupture of a DOT-105 Rail Tank Car
and Subsequent Chlorine Release**

New Martinsville, West Virginia

DCA16SH002

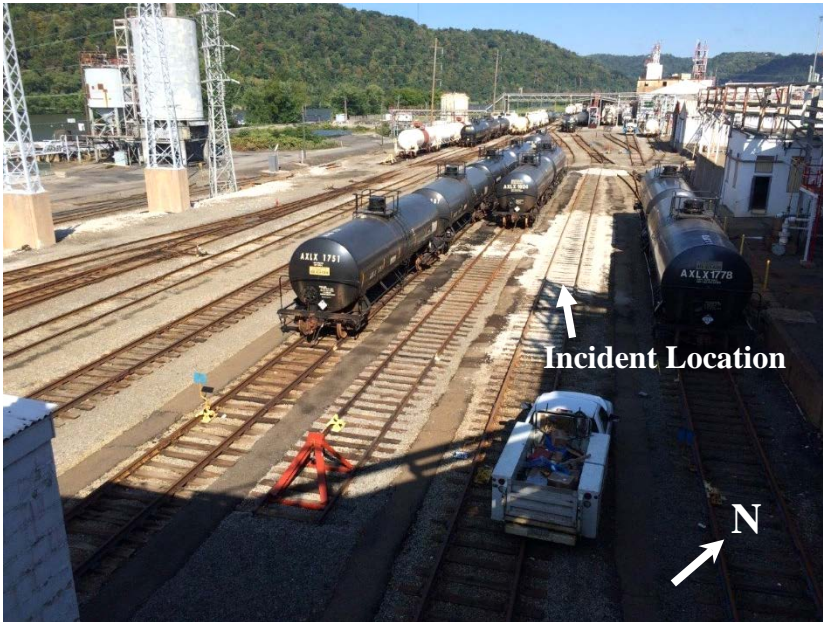
Figure 2: Fresh track ballast added to incident location on Axiall Corporation Track 10.

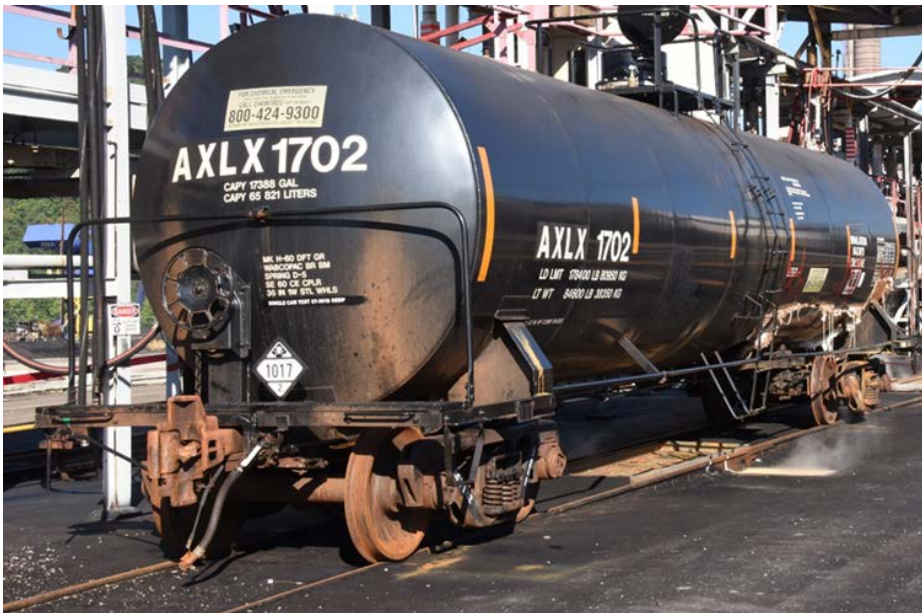
Investigators examined the damaged tank car and found the release occurred through an approximately 42-inch long crack in the 4th ring of the tank near the inboard end of the A end stub sill cradle pad. The NTSB retained custody of relevant tank car parts for further metallurgical examination at NTSB headquarters in Washington, D.C.

Figure 3: Tank Car AXLX1702, August 27, 2016.¹¹

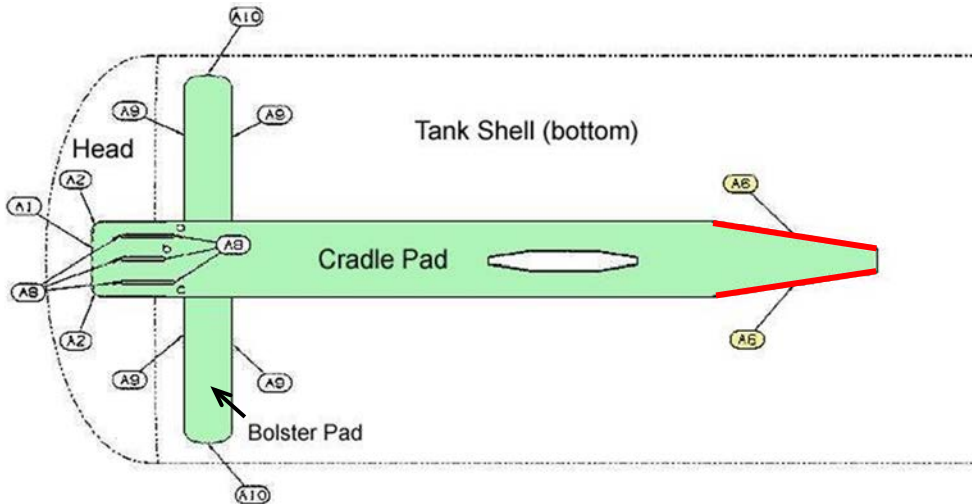
Tank car AXLX1702 was equipped with a type ACF-200 stub sill underframe. About 2,186 specification DOT-105 pressure tank cars are equipped with this underframe design.¹⁵ The design uses cradle pads welded to the tank to transfer running loads from the stub sills through the tank. The cradle pads extend from the respective tank heads across most of the adjacent two rings of the tank. The tank crack occurred at the toe of the inboard end of the A6 welds (red lines in Figure 4).¹⁶

Figure 4: ACF-200 underframe general layout and weld identification numbers from AAR Data Collection Template. The red highlighted A6 welds are referenced in later sections of this report.

For general service tank cars ACF Maintenance Bulletin TC-200 further recommends inspecting the inboard cradle pad termination and repair any tank shell and weld cracks found. If a crack exists in Area 1 (Figure 4), then the crack should be removed by gouging and/or grinding the existing weld to the 45° line and no weld repair is required. The bulletin states that if a crack extends into Area 2 on the illustration, then the weld should be repaired in accordance with Appendix R and W of the *AAR Standards and Specifications for Tank Cars, M-1002*. The repair weld should not extend beyond the 45° lines shown in Figure 5.

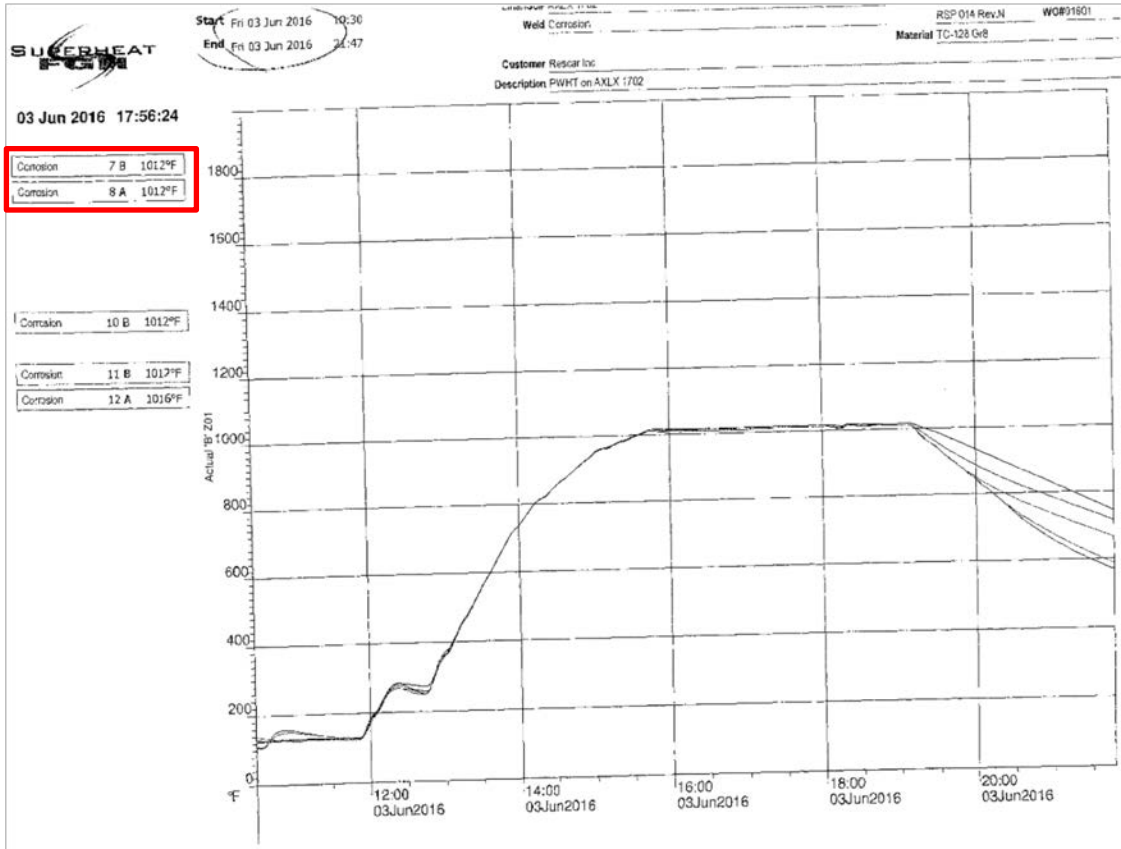
Superheat can abort heat treatment cycles if communication is lost with thermocouples or heating pads do not reach or maintain the target temperature. Superheat records indicate that the area of the tank car where the shell crack occurred received LPWHT as part of a 6-circuit run on May 31, 2016, but the run was aborted (see elements 7 and 8 in Figure 8). Superheat records indicate that LPWHT was successfully completed on this same area of the tank on June 3, 2016 (Figure 9).

Figure 9: Successful post-weld heat treatment run, Superheat chart of June 3, 2016. Channels 7 and 8 are highlighted in the red box.

Rescar shop procedures and the AAR M-1002, Appendix R 8.0 require that girth weld repairs in pressure tank cars manufactured of TC-128 Gr. B carbon steel plate must be hardness tested after post weld heat treatment to verify that heat treatment has been performed correctly. There is no record in the AXLX1702 tank car file that Rescar technicians performed PWHT hardness testing on the tank during the 2016 shop work.⁴⁹

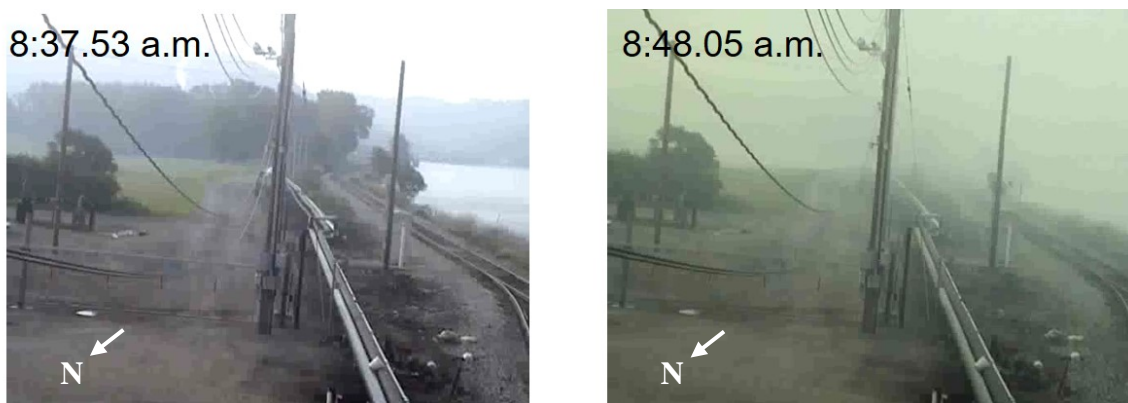
Chlorine gas sensors that are positioned at several locations within the plant first detected the release and went into alarm about 8:28 a.m.⁶⁰ Between 8:29 a.m. and about 11:07 a.m., several in-plant gas sensors near the point of release and near the south plant perimeter (downwind of the release) recorded chlorine concentrations above the OSHA immediately dangerous to life and health (IDLH) concentration (see Figure 10).⁶¹

Figure 10: Axiall security camera views looking south beyond perimeter fence, August 27, 2016. The tree line visible in the left image, but obscured by the chlorine cloud in the right image, is about 6,100 feet southeast of the incident location.

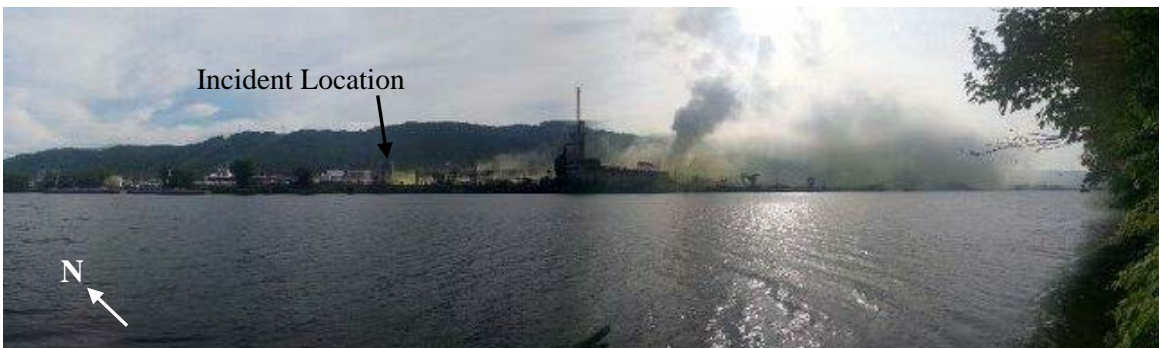
Photographs taken from the Ohio side of the river after the chlorine release at a distance of about ¼ mile are provided in Figures 12 and 13. The images show water vapor from a cooling tower rising nearly vertical with a slight tilt to the south. The green to yellowish lower cloud was the visible indication of the chlorine release, being about 2.5 times heavier than air remained closer to the ground and propagated towards the south.

Figure 12: Axiall Corporation as seen from Rt. 7 (Ohio River Scenic Byway) to the west opposite bank of the Ohio River, August 27, 2016, (courtesy West Virginia Division of Homeland Security and Emergency Management)

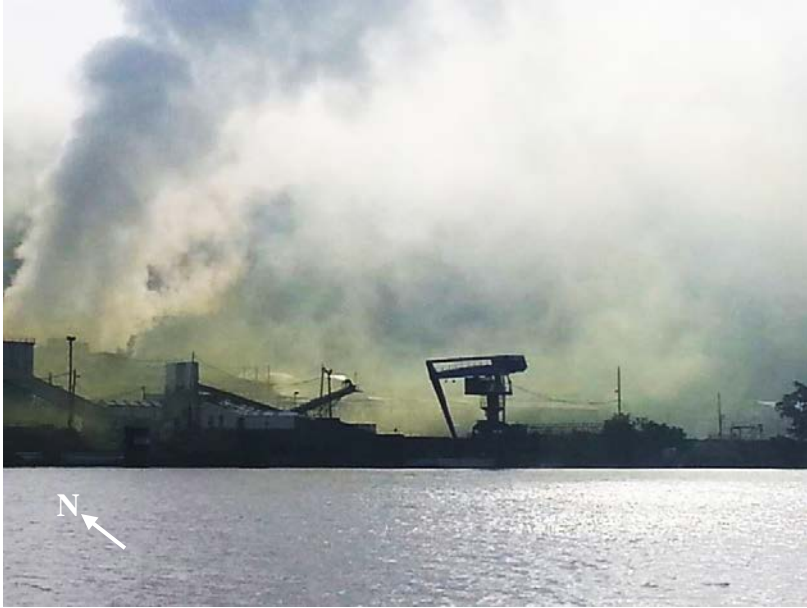
Figure 13: Water vapor from a cooling tower rises nearly vertical with a slight tilt to the south. The green to yellowish lower cloud is the visible indication of the chlorine release. August 27, 2016 (courtesy West Virginia Division of Homeland Security and Emergency Management)

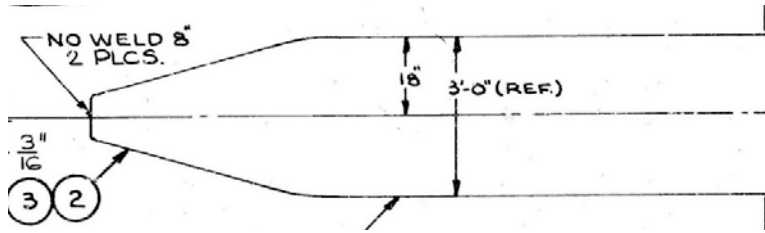
The distance between the cradle pad inboard weld terminations was about 8.5 inches. These welds did not encroach into an 8-inch “no-weld zone” noted in the manufacturer’s drawing for the end of the cradle pads (Figure 15).

Figure 15: Excerpt of tank car manufacturer drawing showing “no-weld zone “at inboard end of cradle pad.”⁶⁷

The configuration of the welds had not been modified to the configuration of the “Inboard Cradle Pad Termination Detail” of ACF Maintenance Bulletin TC-200.
