Continental Motors

ENGINE FIELD INSPECTION REPORT

ENGINE MODEL	IO470D (15)
ENGINE SERIAL NUMBER	105176
AIRCRAFT MAKE & MODEL	Cessna 310F
AIRCRAFT SERIAL NUMBER	310-0070
AIRCRAFT REGISTRATION	N6770X
CMI FILE NUMBER	15-562

EXAMINATION		ACCIDENT DATA	
DATE	5-7-2016	NTSB ACCIDENT #	CEN16FA172
FACILITY	Pulaski Technical College-A&P School	NTSB INVESTIGATOR	Todd Fox
ADDRESS	[REDACTED] North Little Rock, AR North Little Rock Municipal Airport	FAA INVESTIGATOR	Brian Love
		ACCIDENT DATE	5-5-2016
		ACCIDENT LOCATION	North Little Rock Municipal (ORK)

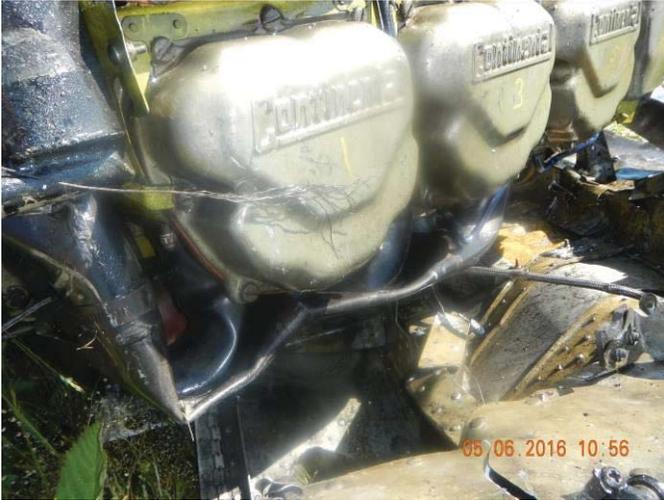
The exhaust risers and collector were crushed upward due to impact forces

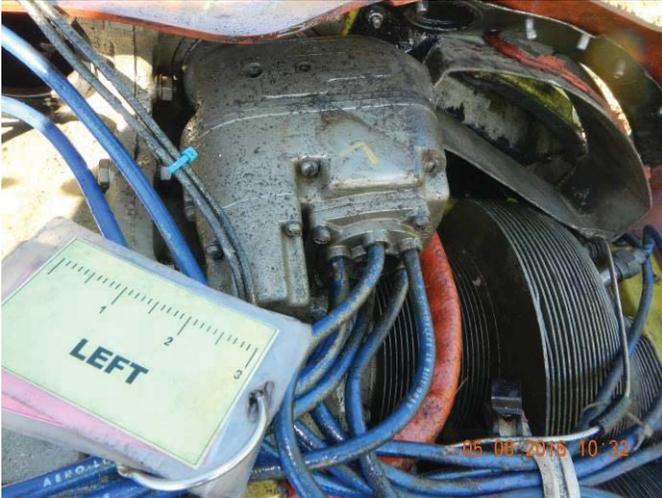
Condition: The left magneto remained attached and intact. The magneto was removed from the engine, bench tested and found to be functional

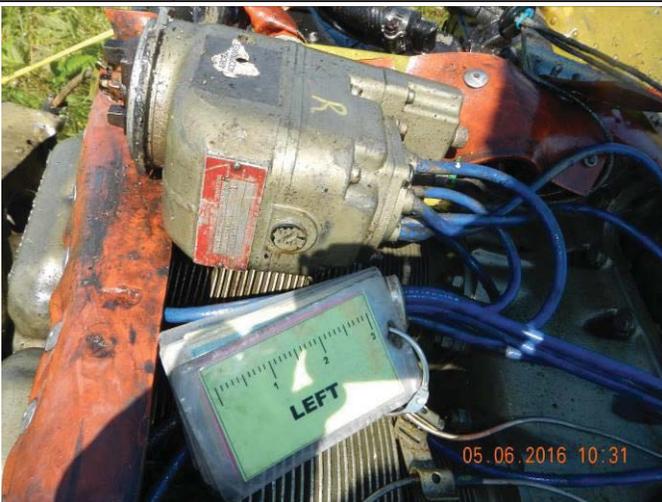
RIGHT MAGNETO

Condition: The right magneto separated from its mount but remained attached to the ignition harness. The magneto was removed from the engine and bench tested. The magneto was found to be functional.

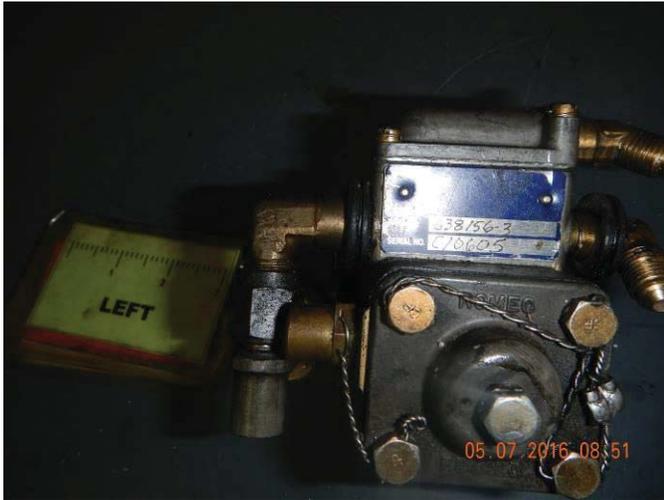
The fuel pump rotated smoothly when manually rotated. Fuel was present in the fuel hoses and the drive gear was intact

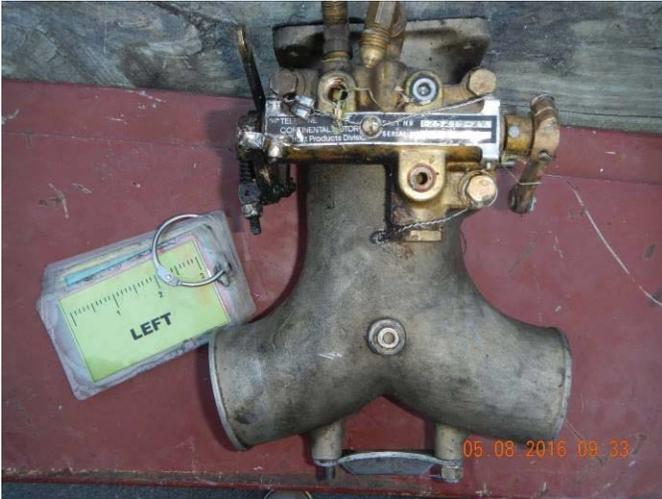
The fuel screen was removed and a small amount of lint-like contaminate was present. The throttle plate was frozen in the wide open position.

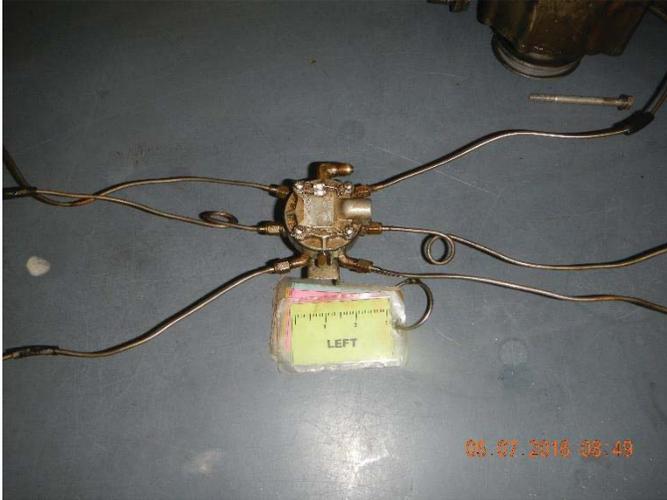
FUEL MANIFOLD VALVE	Manufacturer: TCM Overhauled in the field	P/N: 631427	S/N: 6057208
Condition:	The manifold contained uncontaminated fuel. All components were intact and the fuel screen was uncontaminated.

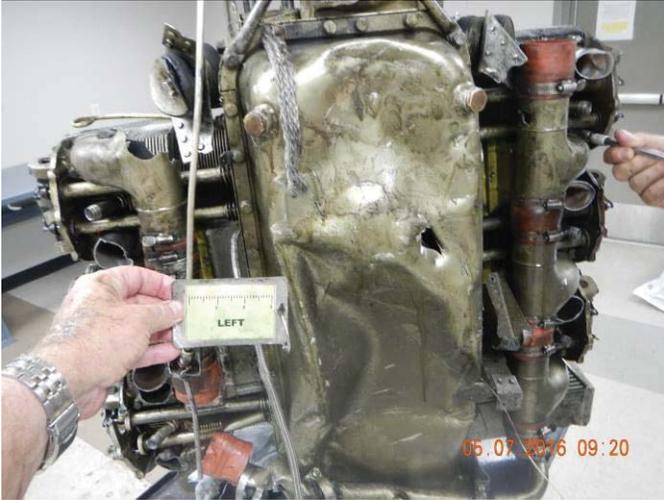
OIL SUMP

Condition: The oil sump received impact damage

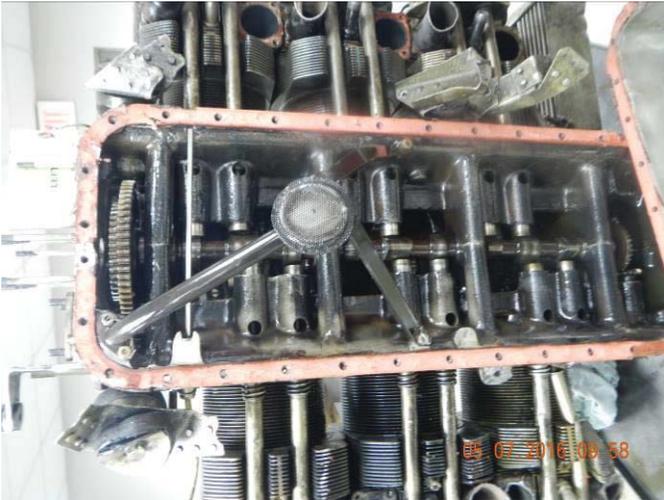
**OIL PICK-UP
TUBE &
SCREEN**

Condition: The screen was intact and contained only a small amount of contaminant

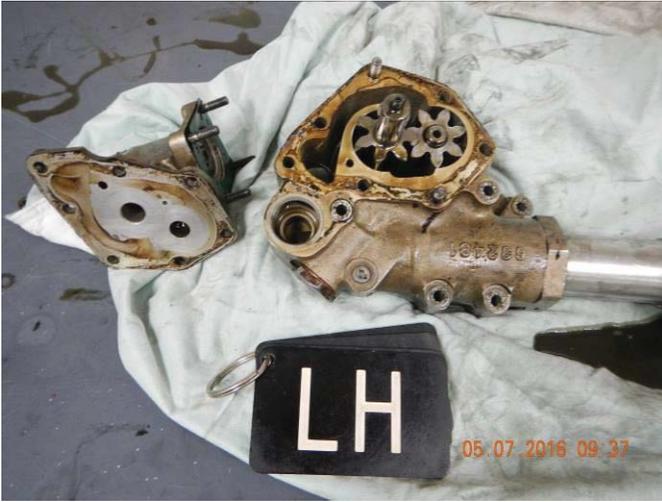
The oil pump was disassembled and showed no evidence of hard particle passage

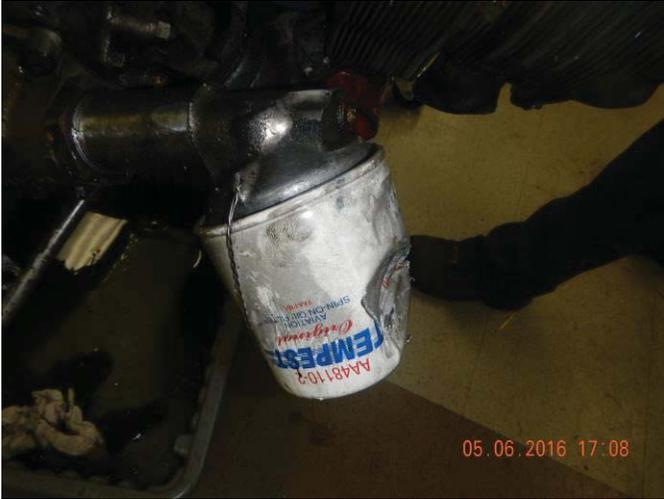
OIL FILTER	Manufacturer: Tempest	P/N: AA48110-2
Condition:	The outer shell was impact damaged. The filter was opened and inspected for contaminants. Only a small amount of contaminant consistent with carbon was noted. No metal was found.

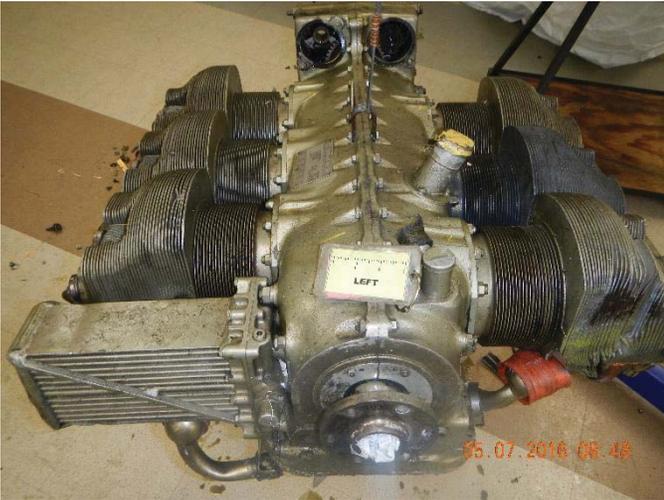
OIL COOLER	Manufacturer: Undetermined	P/N: Undetermined	S/N: Undetermined
Condition:	The oil cooler did not display impact damage. The data tag was missing.

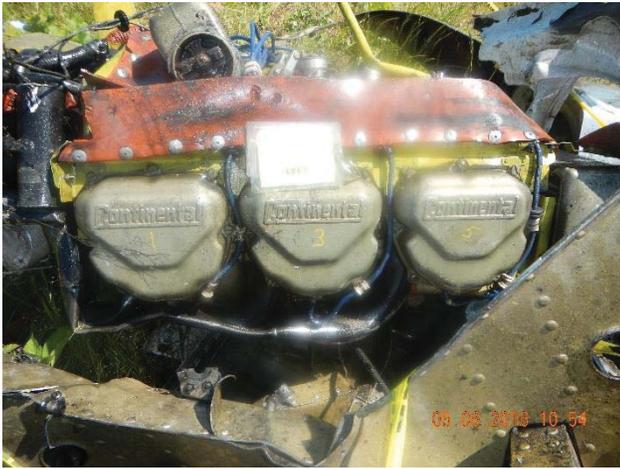
CYLINDER #1	P/N: 186072	S/N: Undetermined	Head Date: Undetermined
Work Orders:	Undetermined		
Condition:	No damage was noted. Red arrow points to cylinder 1

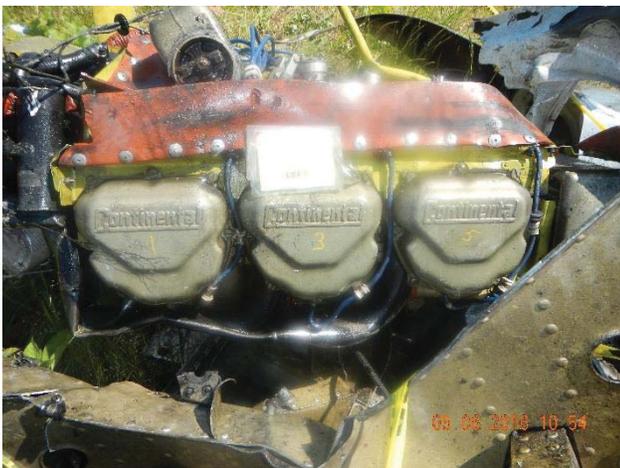
NOTE: The log book entry above indicates that the number 3 cylinder was removed and repaired. The post-accident inspection of this engine reveals that the number 4 cylinder appeared to have had fresh gray paint applied and the number 3 cylinder did not appear to have been removed or installed recently. One of the #4 cylinder base attachment nuts was not an approved part.

CYLINDER #3	P/N: Undetermined	S/N: Undetermined	Head Date: Undetermined
Work Orders:	Undetermined		
Condition:	No damage was noted. Red arrow points to cylinder 3. This cylinder does not appear to have been recently installed.

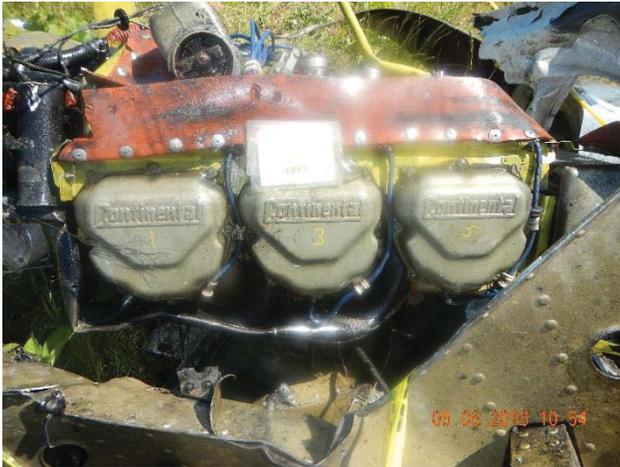
CYLINDER #5	P/N: 649166	S/N: Undetermined	Head Date: 10-91
Work Orders:	Undetermined		
Condition:	Minor damage to the cooling fins was evident. The red arrow points to cylinder 5

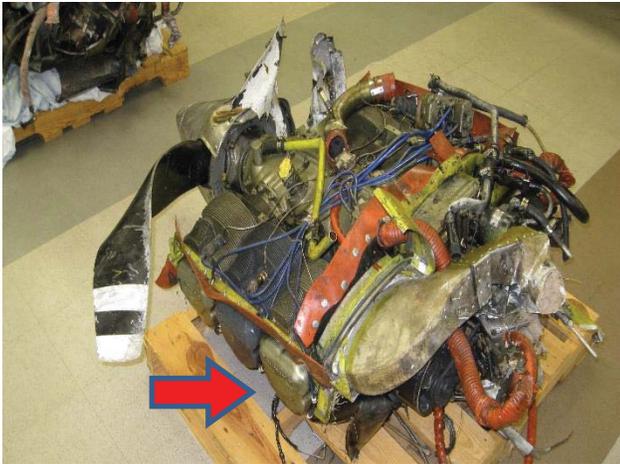
CYLINDER #2	P/N: 538288	S/N: Undetermined	Head Date: Undetermined
Work Orders:	J9590-4		
Condition:	No damage was noted. Red arrow points to cylinder 2

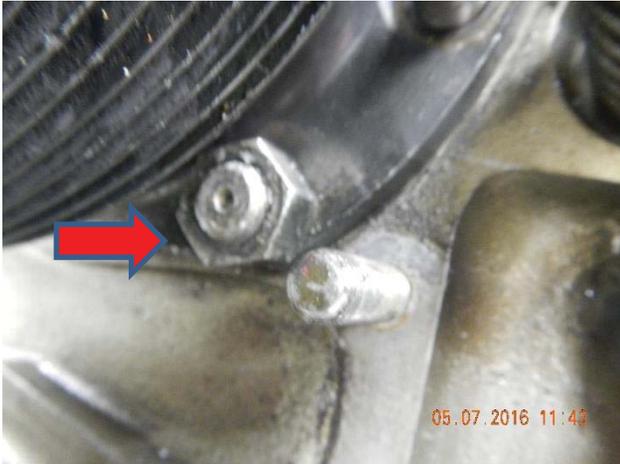
CYLINDER #4	P/N: Undetermined	S/N: 1140S6A	Head Date: Undetermined
Work Orders:	C1561		
Condition:	No damage was evident. This cylinder appears to have been freshly painted and installed recently. One lower deck stud nut was unapproved hardware.

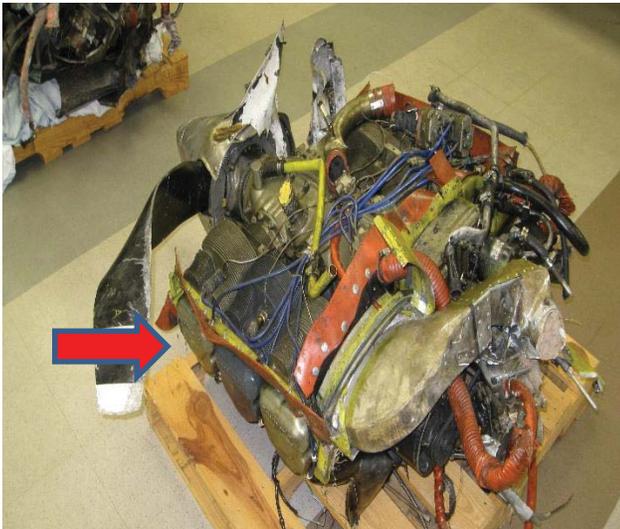
Cylinder # 6 rocker box cover was damaged and small section of the rocker box separated. All other rocker box covers remained intact and attached to its prospective cylinder. Forward cooling fins were impact damaged.

A cold differential cylinder compression test was performed with the following results:
 #1 58/80 # 2 60/80 #3 62/80 #4 60/80 #5 68/80 #6 10/80 (exhaust valve push rod was damaged)

CYLINDER #6	P/N: Undetermined	S/N: Undetermined	Head Date: 10-94
Work Orders:	Undetermined-unreadable.		
Condition:	Minor impact damage was evident to cooling fins on the front of cylinder. Red arrow points to cylinder 6.

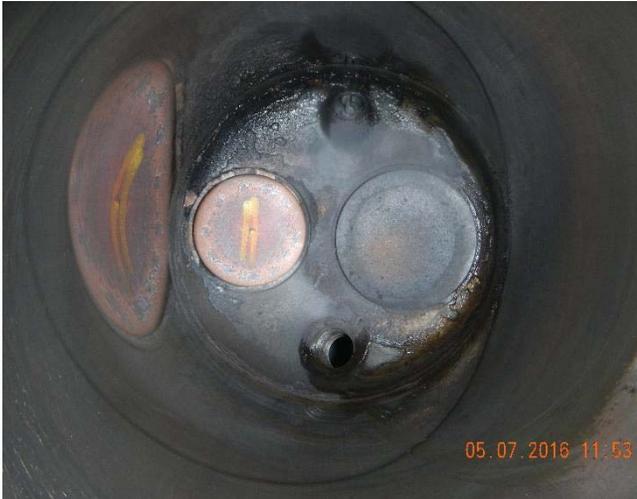
All valves were intact and exhibited normal combustion signatures

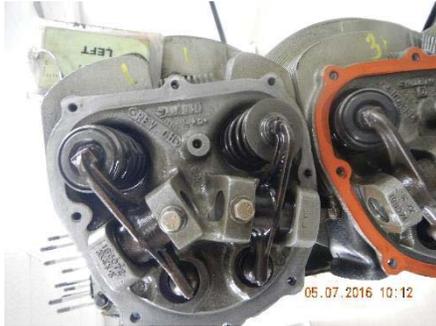
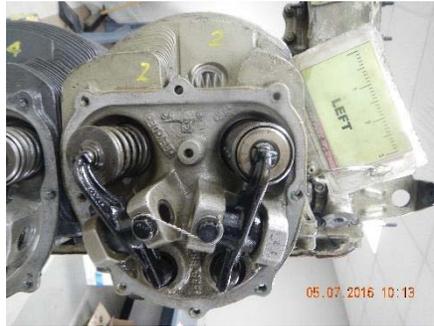
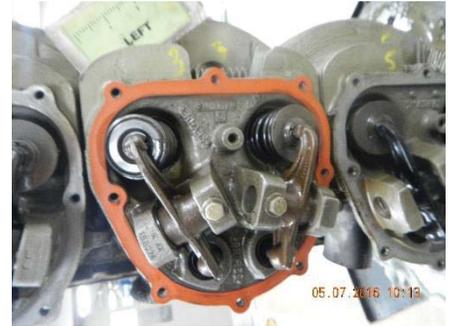
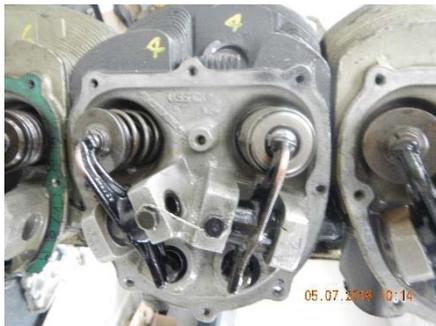
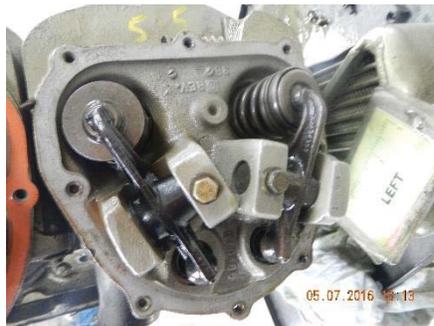
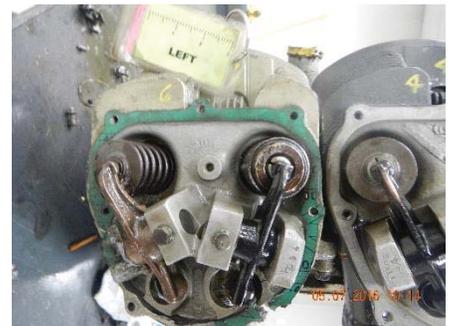
All rocker arms moved normally when the engine was manually rotated with the exception of cylinder 6 where the push rods and push rod housings were impact damaged. **NOTE:** An intact "extra" rocker arm was discovered lying on the inner cylinder baffle between cylinders 1 & 3 which could not be accounted for. A recent cylinder change was accomplished on cylinder 4.

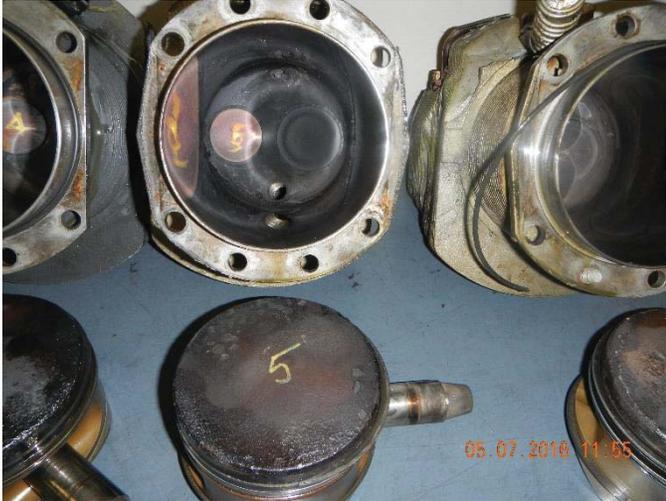
The piston, piston rings and piston pin displayed normal combustion signatures and wear patterns.

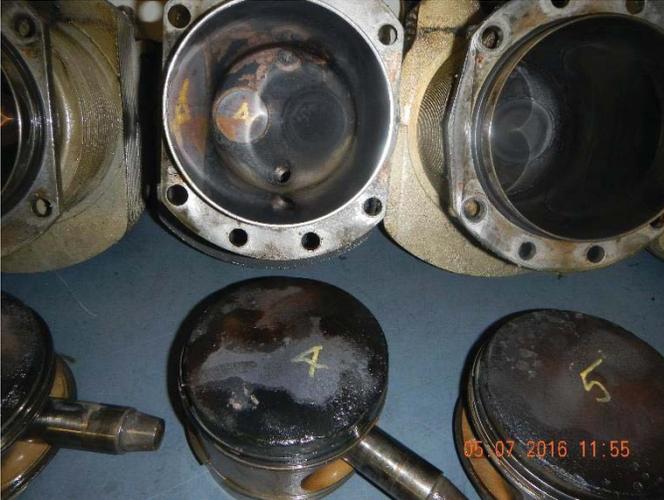
The piston, piston rings and piston pin displayed normal combustion signatures and wear patterns.

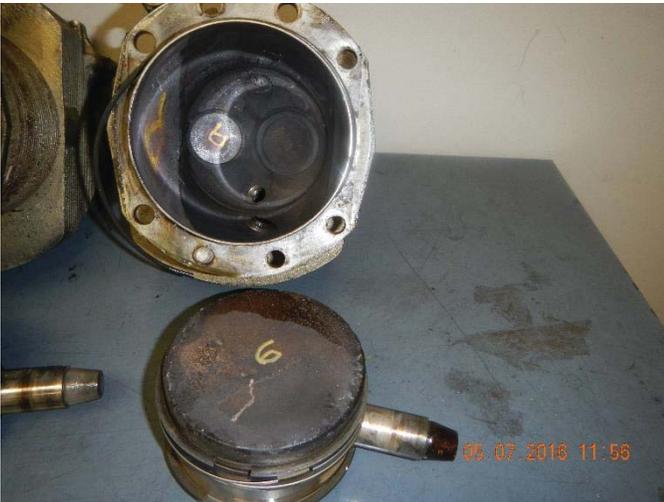
**#6 PISTON,
RINGS AND PIN**

The piston, piston rings and piston pin displayed normal combustion signatures and wear patterns.

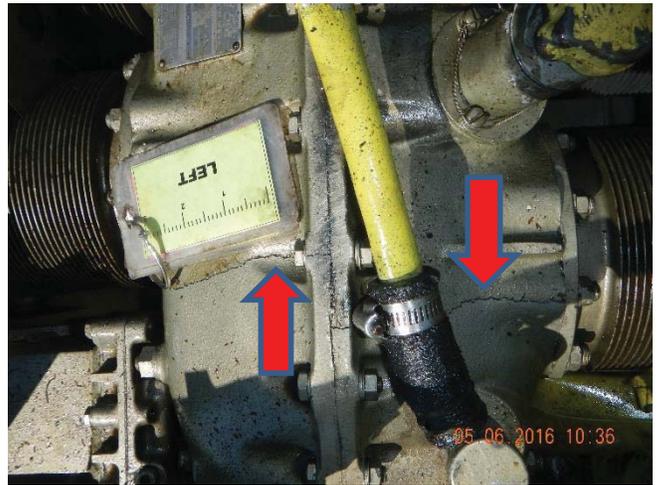
Condition: The crankcase was intact but with a crack on the right half (1-3-5 side) beginning at the top parting line and extending down to the mounting pad for cylinder # 5. A crack on the left crankcase half (2-4-6 side) extended from the top parting line to mounting pad for cylinder # 6. The red arrows point to the cracks.

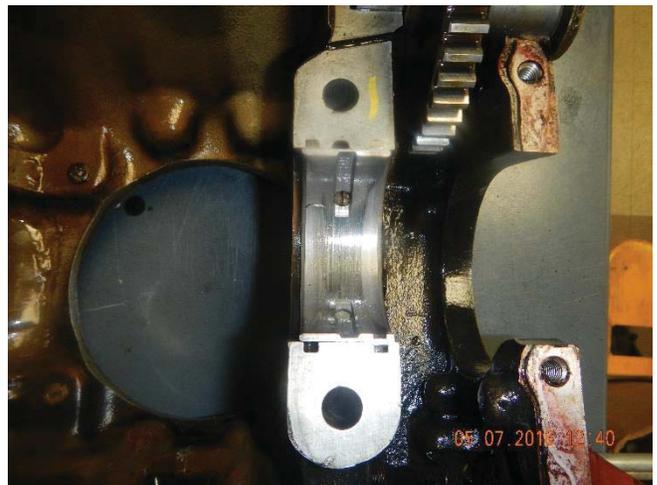
#1 MAIN BEARINGS

Condition: The main bearings exhibited normal wear signatures. Red arrow points to # 1 main bearing.

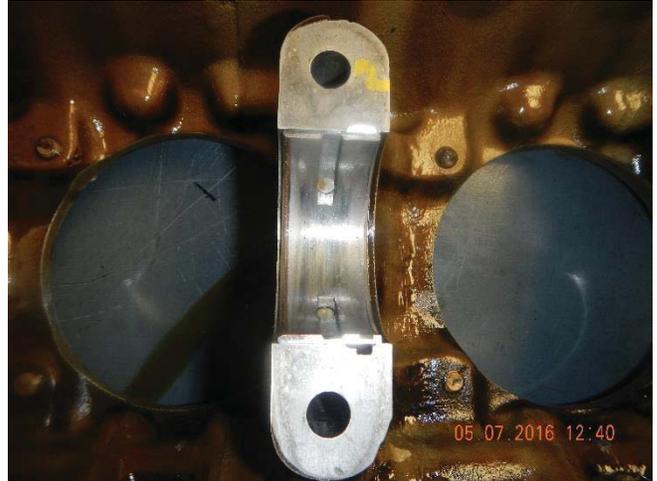
The main bearings exhibited normal wear signatures. Red arrow points to # 2 main bearing.

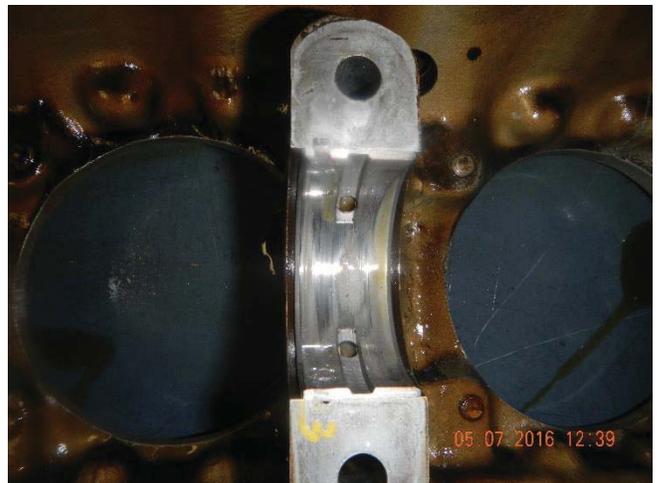
#3 MAIN BEARINGS

The main bearings exhibited normal wear signatures. Red arrow points to # 3 main bearing.

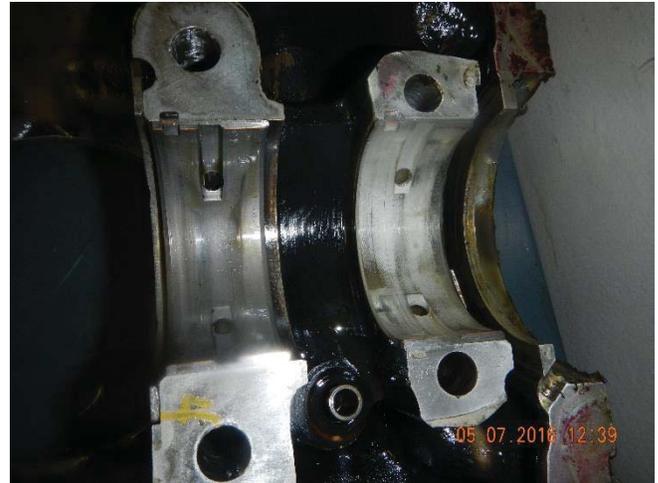
#4 MAIN BEARINGS	P/N: SA630464-MO10	Date Code: 10-00
-------------------------	--------------------	------------------

Condition: The main bearings exhibited normal wear signatures. Red arrow points to # 4 main bearing.

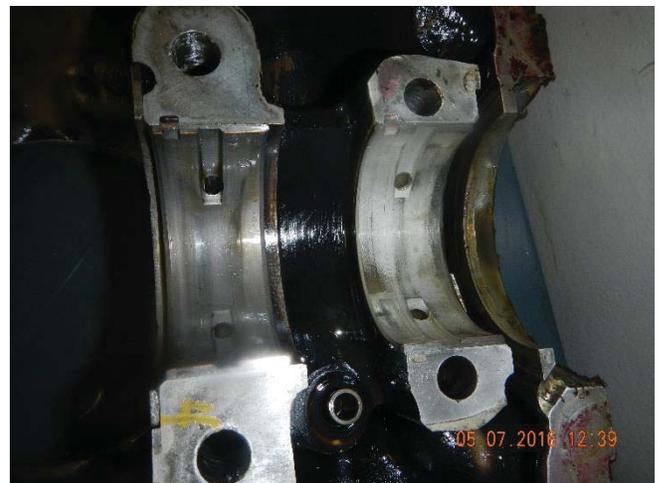
#5 MAIN BEARINGS	P/N: SA530386-MO10	Date Code: 2-03
-------------------------	--------------------	-----------------

Condition: The main bearings exhibited normal wear signatures. Red arrow indicates main bearing # 5.

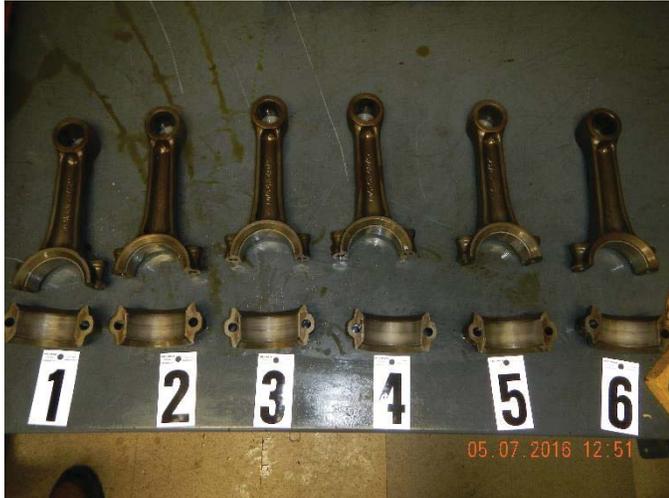
#5 CONNECTING ROD	P/N: 655910	Forging or Serial Number: 40742
Condition:	Normal wear appearance	
#5 CONNECTING ROD BEARING	P/N: SA630826-MO10	
Condition:	Normal wear exhibited

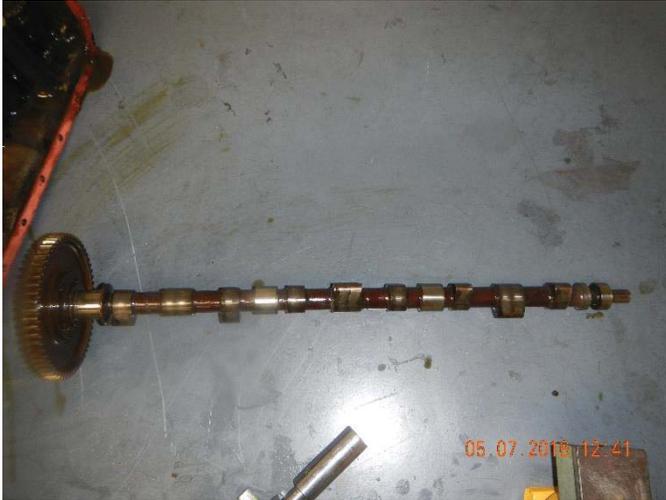
CAMSHAFT	P/N: 535661-V	S/N: Undetermined
Condition:	The cam exhibited normal wear patterns

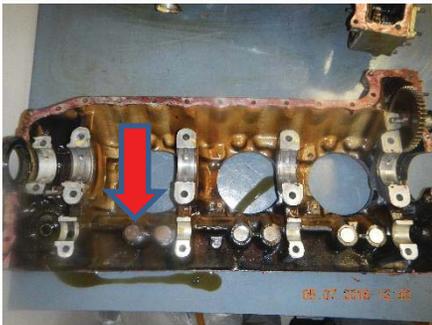
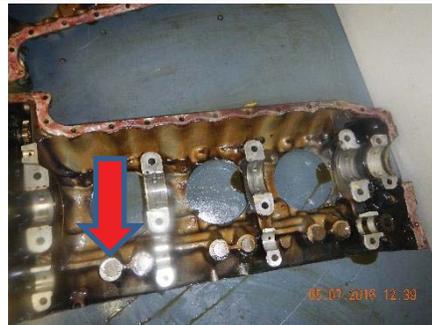
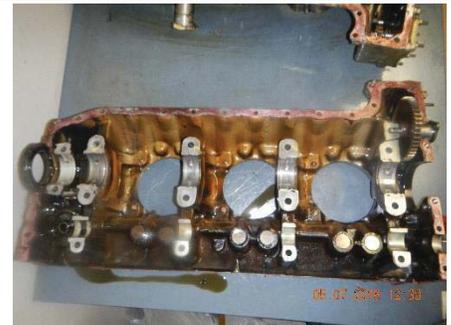
LIFTERS					
INTAKE					
EXHAUST

Condition:	Lifter faces exhibited normal wear patterns except # 2 and # 5 intake lifters which exhibited minor pitting on the lifter faces. Red arrows point to pitted lifters.
------------	--

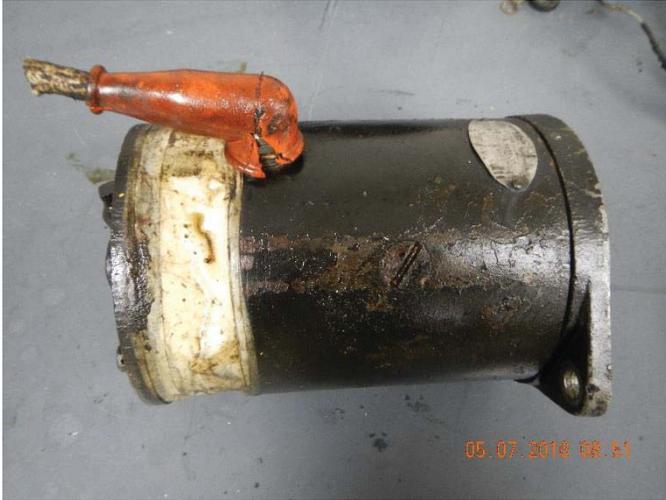
STARTER	Manufacturer: Delco-Remy	P/N: 627861	S/N: 1188234
Condition:	The starter motor was removed and visually inspected. No damage was noted
